MINERALS PROGRAM INSPECTION REPORT PHONE: (303) 866-3567

MINE NAME: Jemadojin Sand Mine	MINE/PROSPECTING ID#: M-2006-017	MINERAL: Sand	COUNTY: El Paso
INSPECTION TYPE: Monitoring	INSPECTOR(S): Timothy Cazier, P.E.	INSP. DATE: August 3, 2021	INSP. TIME: 14:05
OPERATOR: Hourglass Sands LLC	OPERATOR REPRESENTATIVE: Jeff Perry & John Jonkousky	TYPE OF OPERATION: 112c - Construction Regular Operation

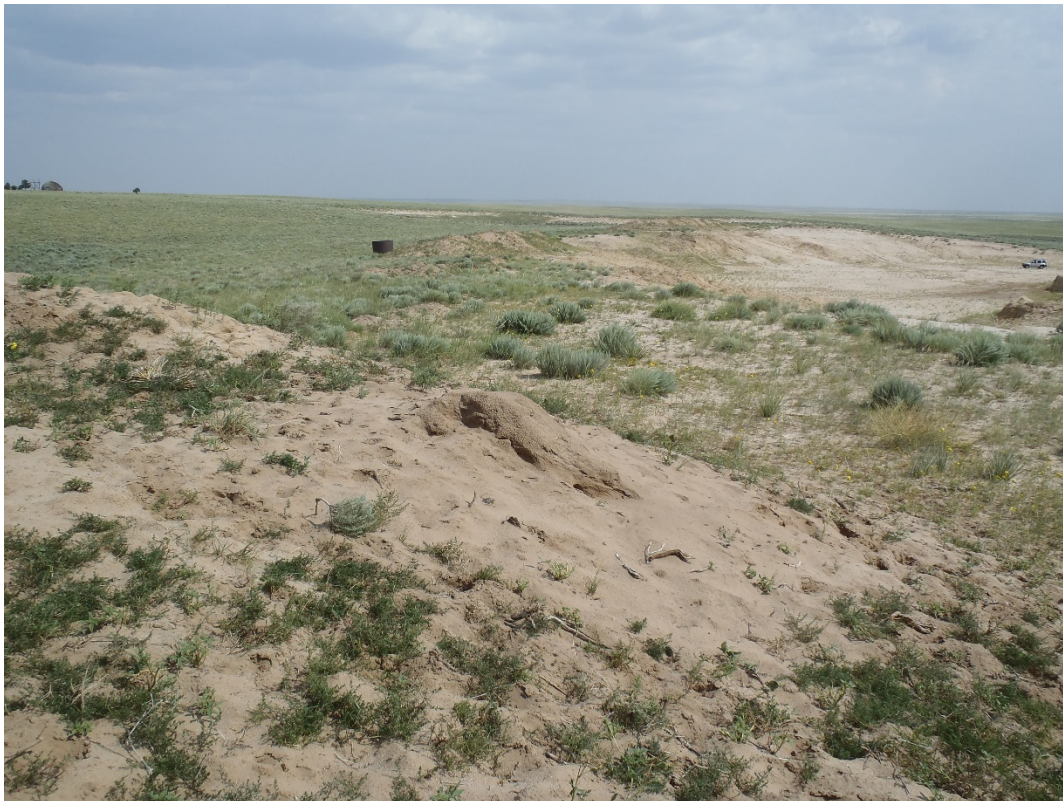
Excess Spoil and Dev. Waste: Likely overburden piles were observed on the north end (see **Photo 1**).

Topsoil: Topsoil was observed to be stockpiled at the pit edges is in the southwest corner of the pit and labeled as such (see **Photos 1 and 7**).

Photo 1. Overburden and/or topsoil stockpiles near north pit edge (looking SE).

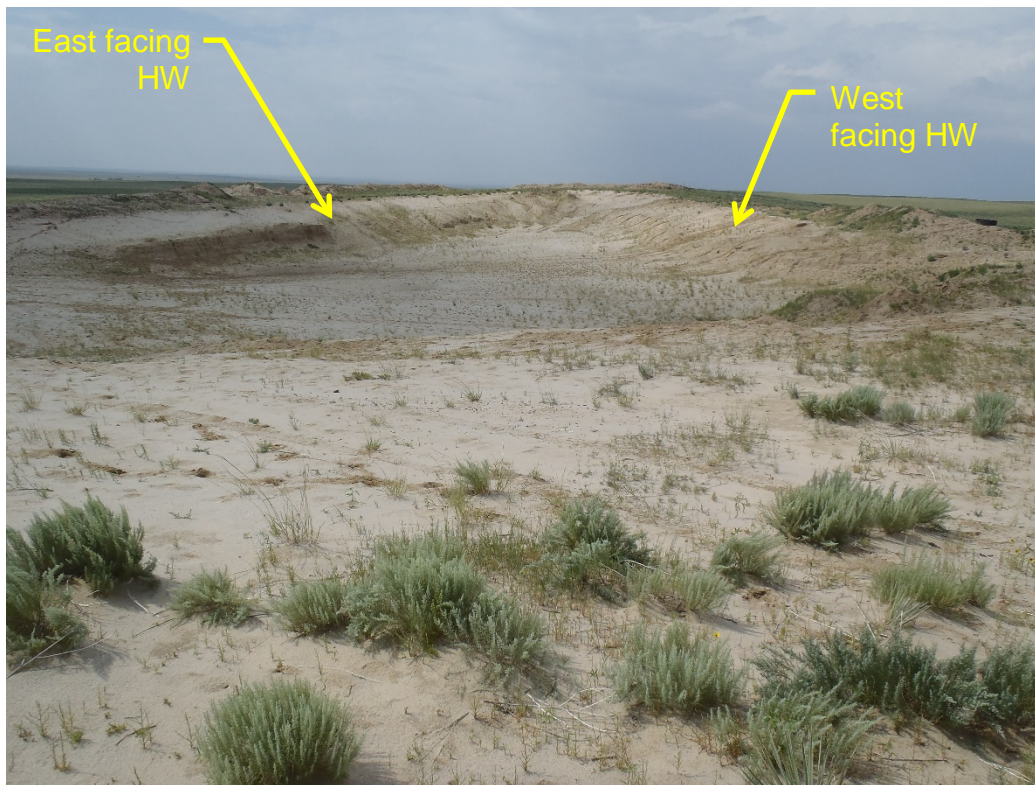
Gen. Compliance with Mine Plan: The operation appeared to be in compliance with the approved mine plan. The south pit has not been mined in several years and has been in reclamation. The most recent mining was done in the newer north pit. The maximum allowed disturbed area was reduced to 19 acres with the approval of SR-2. Google Earth was used to measure the disturbed area, which was estimated to be 13.5 acres (including 9.2 acres of the south pit and 1.9 acres affected by the north diversion cut), based on older 2019 imagery. West facing highwalls were observed to be close to the required final slope, while east facing highwalls require flattening (see **Photos 2 and 3**).

Photo 2. North pit highwalls (looking NW).

Reclamation Success: Grading and topsoiling have been completed in the south pit and the diversion cut. Some slope flattening in the current pit is still required.

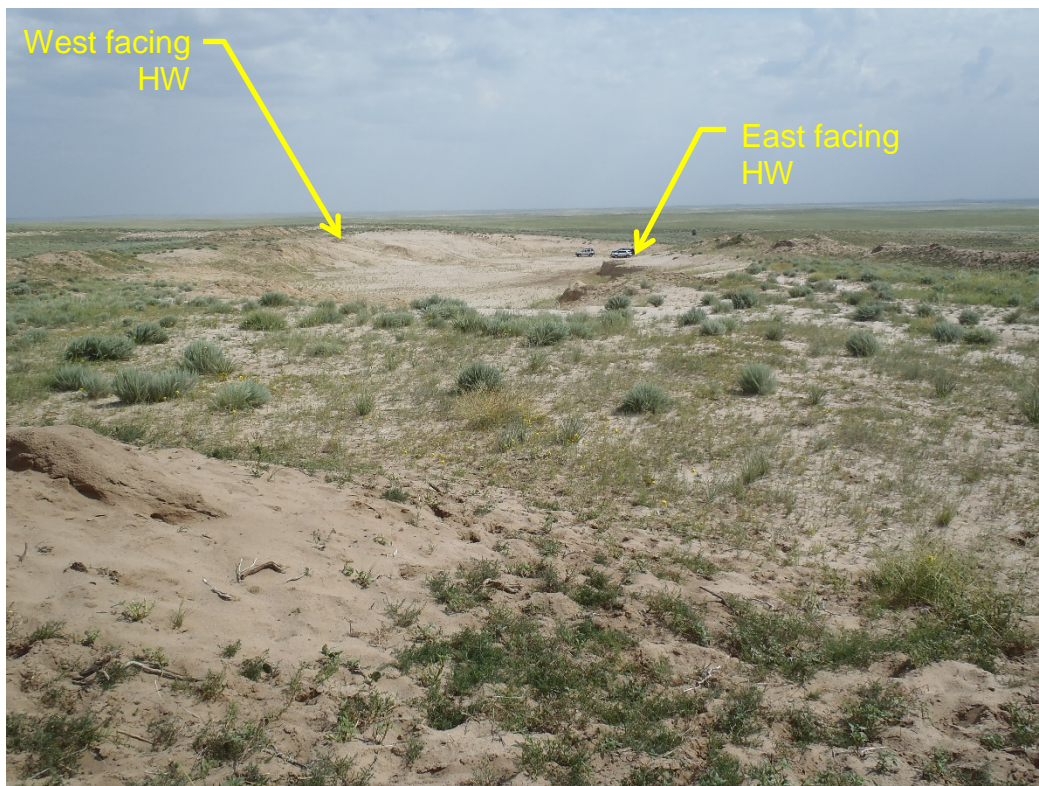
Photo 3. North pit highwalls (looking south).

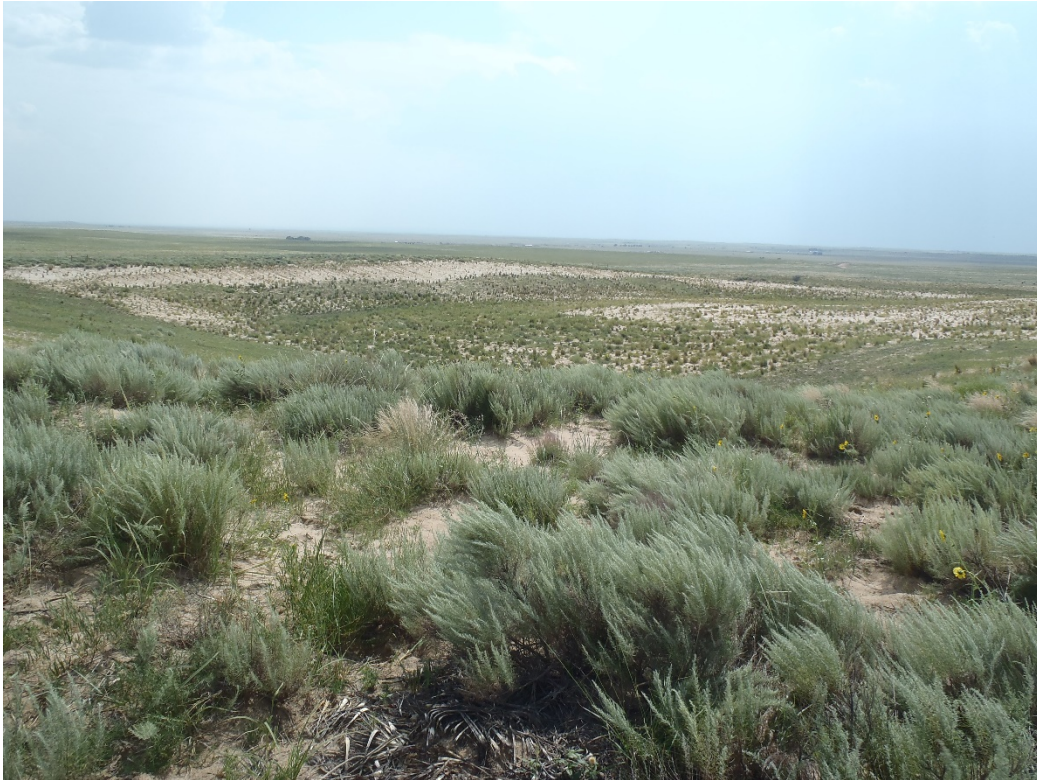
Revegetation: After several years of trying to establish vegetation in both the south pit (see **Photo 4**) and especially the diversion cut (see **Photo 5**), both these disturbances appeared releasable at the time of the inspection. No revegetation effort had been initiated in the north pit and no noxious weeds were observed.

Photo 4. Reclaimed south pit (looking SW).

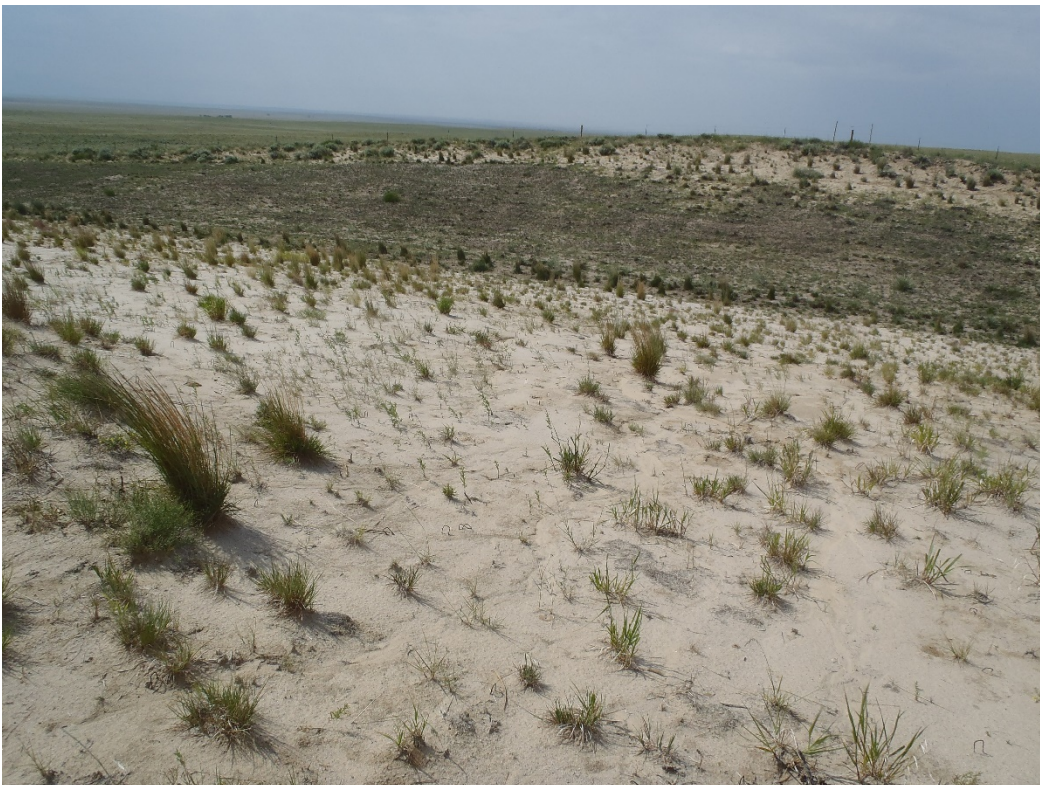
Photo 5. Reclaimed diversion cut (looking NW).

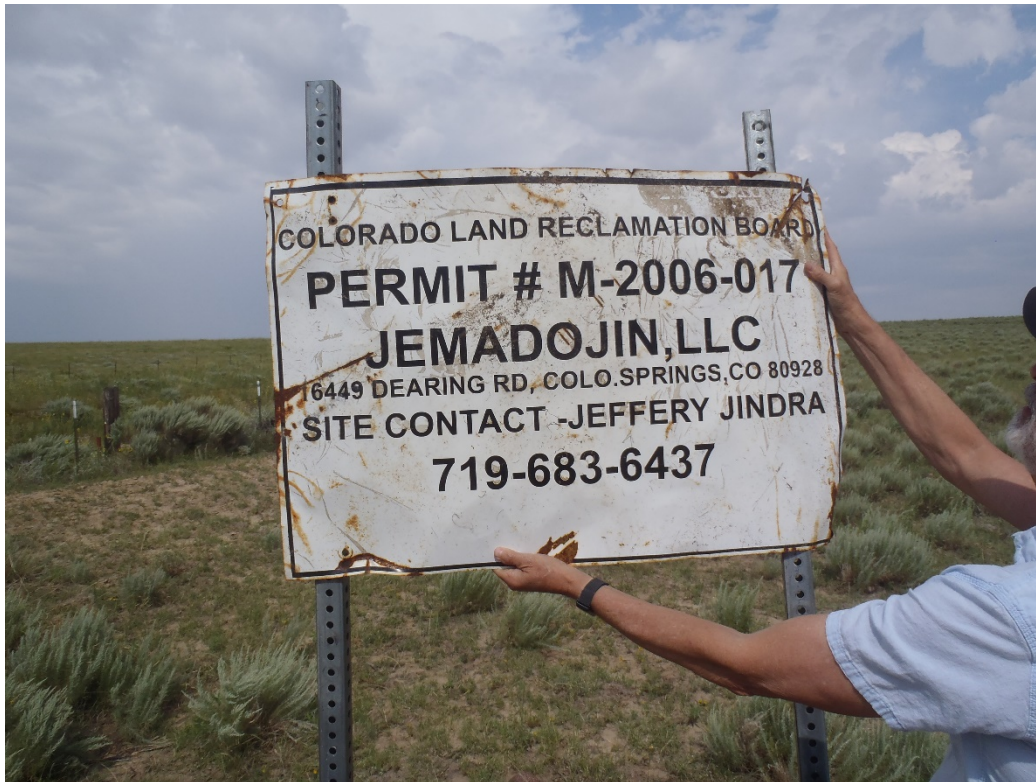
Signs and Markers: The permit sign had blown down, but was found nearby (see **Photo 6**) and berms were observed to delineate the affected area (see **Photo 7**).

Photo 6. Permit sign at entrance.

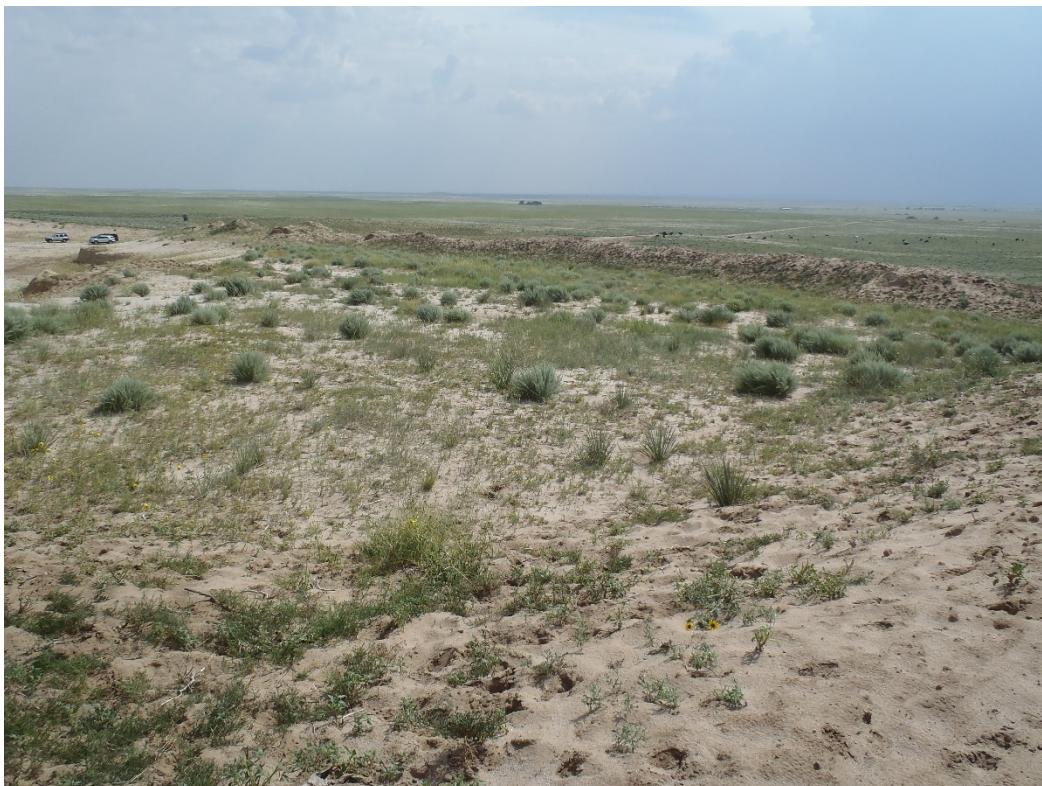
Photo 7. Topsoil/overburden berms delineating affected area (west side of north pit, looking SW).
