**RE: Permit No. M-1980-244; Cripple Creek & Victor Gold Mining Company; Cresson Project;
Schist Island Backfill Weekly Report**

Newmont Mining Corporation
 Cripple Creek & Victor Gold Mine
 VLF2 Phase 3 Site Support 2021
 NewFields Job No. 475.0106.053
 Week Ending Friday, December 31, 2021

FIELD WEEKLY PROGRESS REPORT

PROJECT: VALLEY LEACH FACILITY (VLF2) PHASE 3 CQA HIGH COMPACTION BACKFILL
SITE: CRIPPLE CREEK & VICTOR GOLD MINE (COLORADO)
CONTRACTOR: NEWMONT CC&V MINING OPERATIONS
WEEK ENDING: FRIDAY, DECEMBER 31, 2021

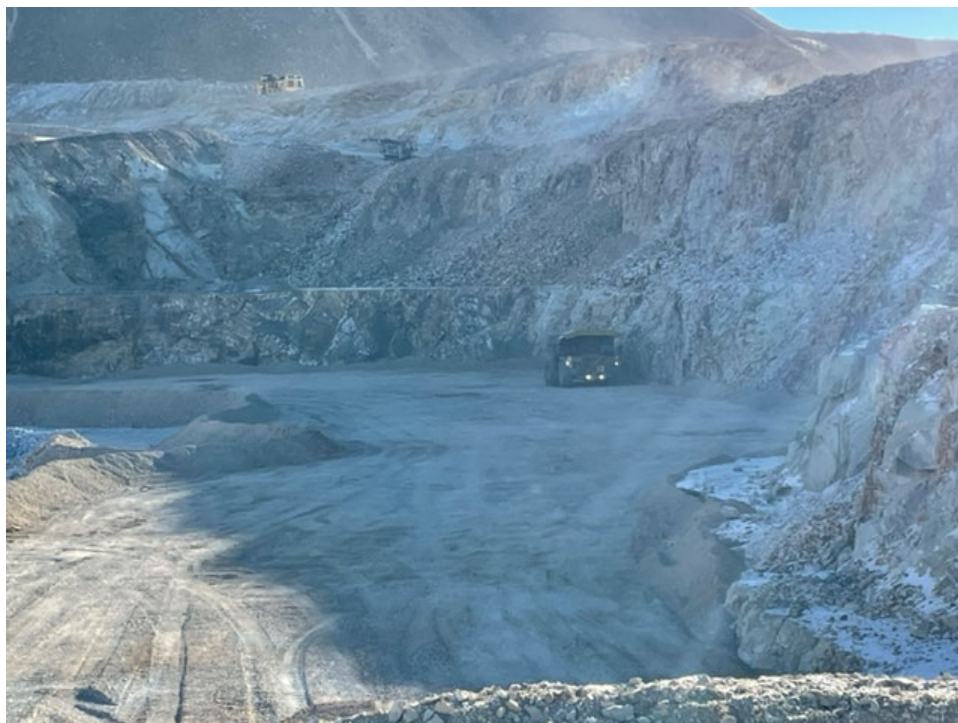
December 30, 2021 – High Compaction Backfill wheel rolling and leveling (GF)

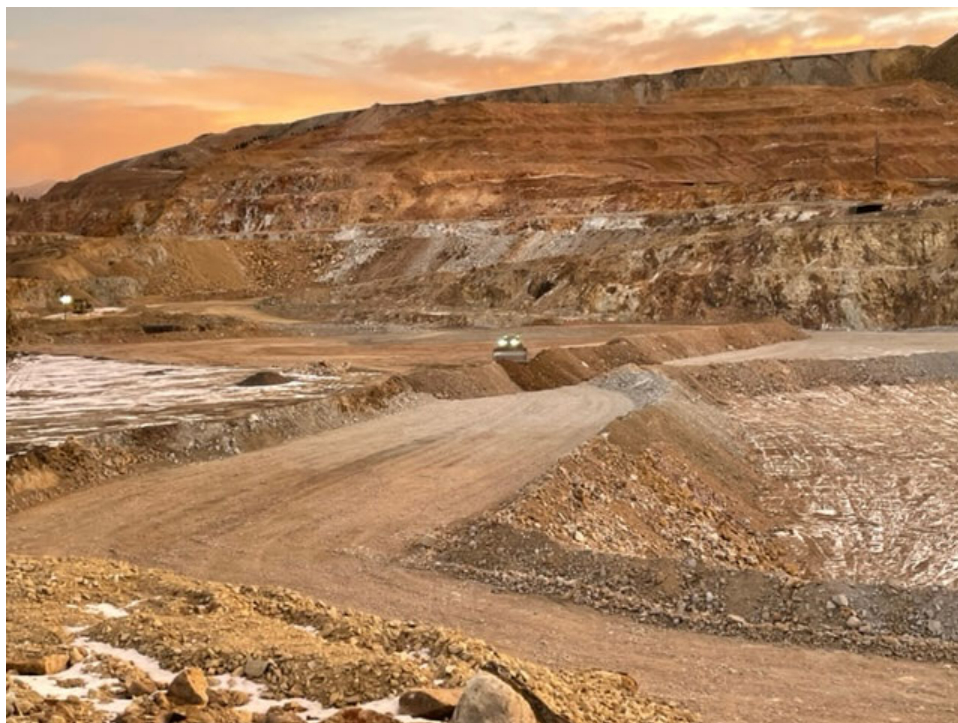
December 27, 2021 – High Compaction Backfill placement (GF)

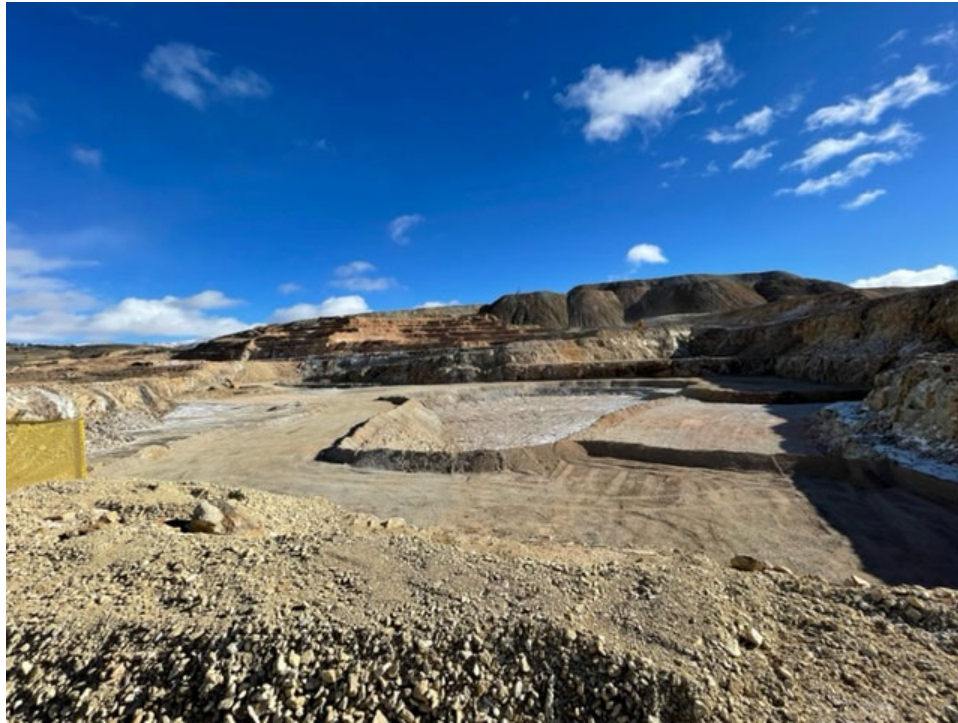
December 29, 2021 – Overview of 9960' lift of High Compaction Backfill placement (GF)
