MINERALS PROGRAM INSPECTION REPORT
PHONE: (303) 866-3567

MINE NAME: Schneller Clay Pit	MINE/PROSPECTING ID#: M-1989-095	MINERAL: Clay (general)	COUNTY: Phillips
INSPECTION TYPE: Surety Release Inspection	INSPECTOR(S): Brock Bowles	INSP. DATE: January 12, 2022	INSP. TIME: 10:00
OPERATOR: Phillips County	OPERATOR REPRESENTATIVE: Mike Salyards	TYPE OF OPERATION: 112c - Construction Regular Operation	
REASON FOR INSPECTION: Surety Release Requested	BOND CALCULATION TYPE: None	BOND AMOUNT: \$0.00	
DATE OF COMPLAINT: NA	POST INSP. CONTACTS: None	JOINT INSP. AGENCY: None	
WEATHER: Clear	INSPECTOR'S SIGNATURE:

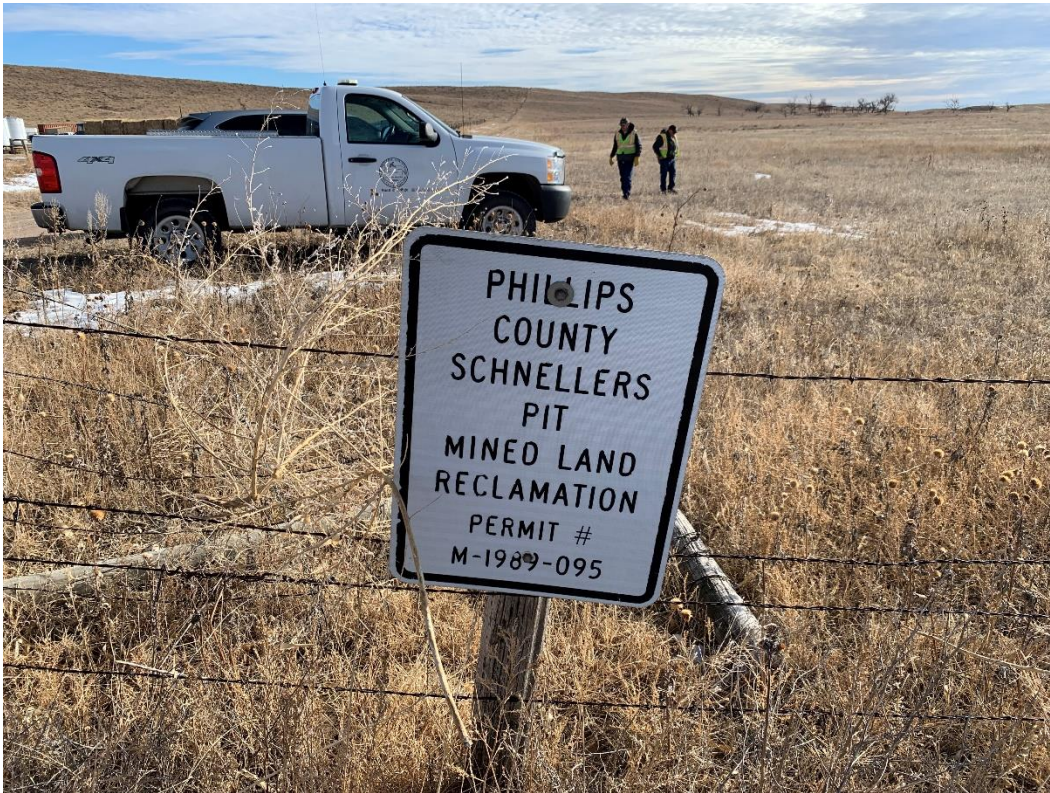
The mine entrance sign was in place facing CR 49 (photo 1). The perimeter was marked on the west and north sides with by a fence. The east side had a line of electric fence post with no wire. The south side was marked with t-posts at the corners.

Photo 1 – Mine entrance sign facing CR 49

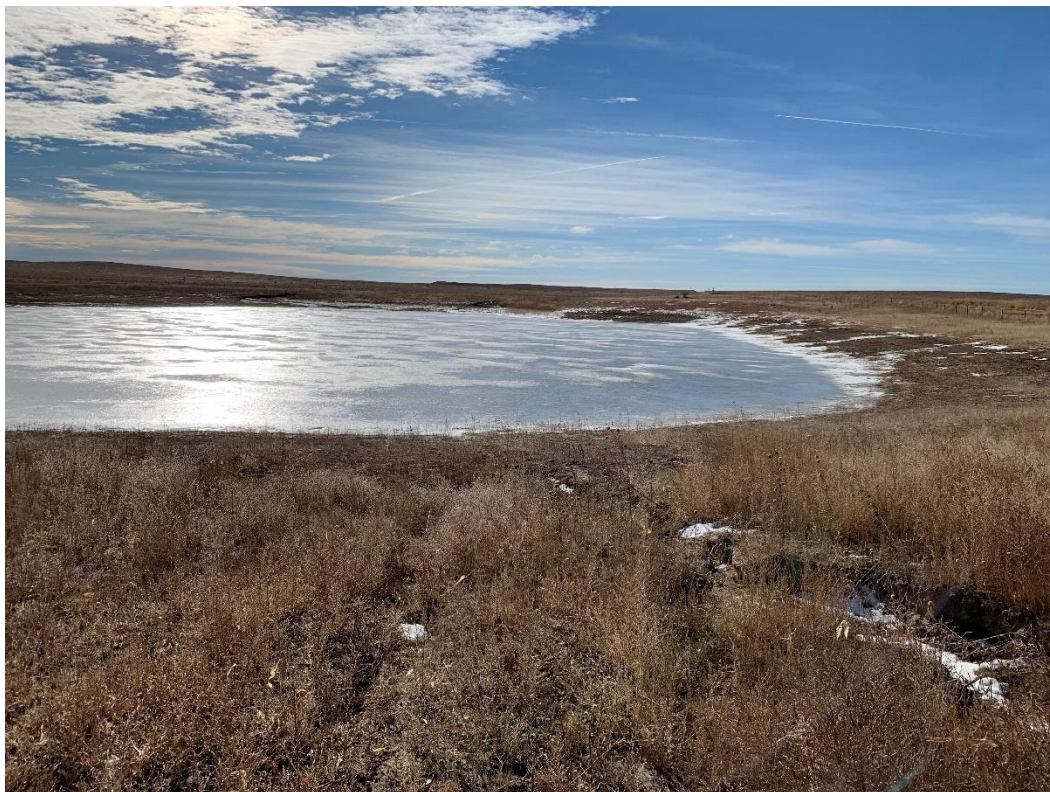
The slopes of the pit were graded to less than 3h:1v slopes (photo 2).

The pit contained water and was frozen at the time of the inspection (photo 2). The pit is located in a natural hydrological basin about 685 acres in size. The basin is not part of a larger drainage area and there is no natural drainage for the basin. The USGS Alvin NW Quadrangle, Colorado, 7.5 Minute Series Topo Map (1971) shows the basin area, and that water collected in the exact area of the Schneller Pit prior to mining activities. The major source of water in the pit is most likely tail water from a nearby irrigation pivot. The irrigation pivot is located within the same basin about 400 feet south of the pit area and is 185 acres in size. Mining activities did not impound the water in the pit.

Photo 2 – West side of pit area, facing south

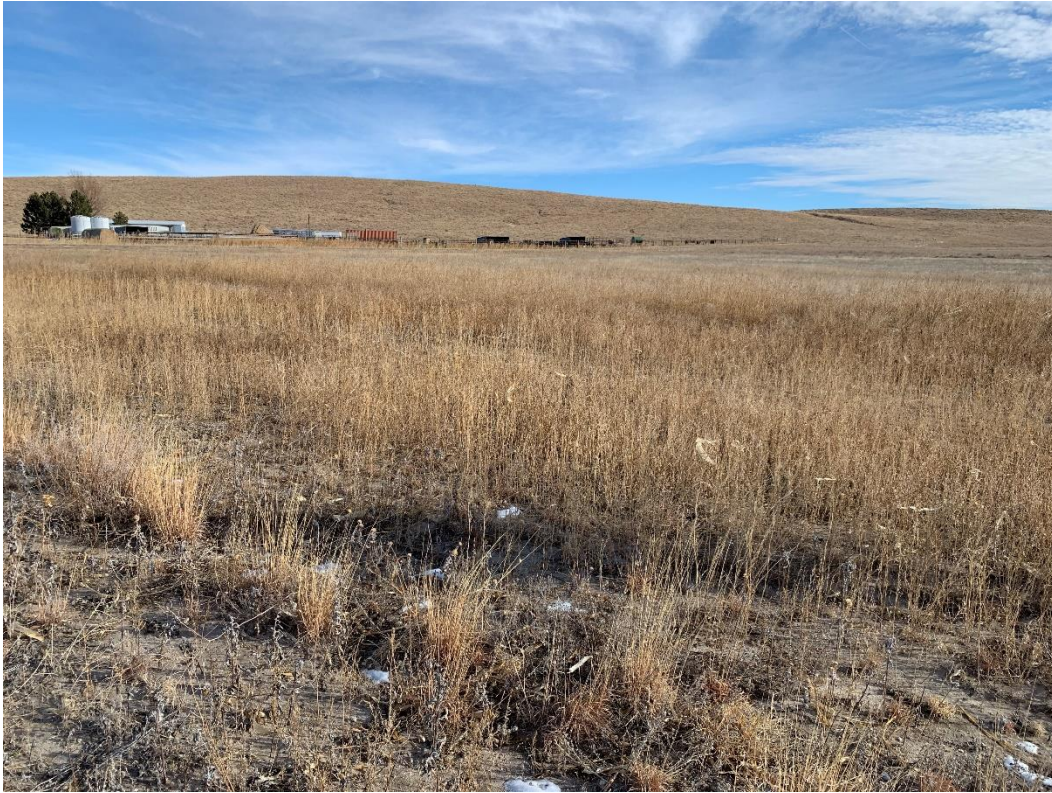
Photo 3 – Northern stockpile area

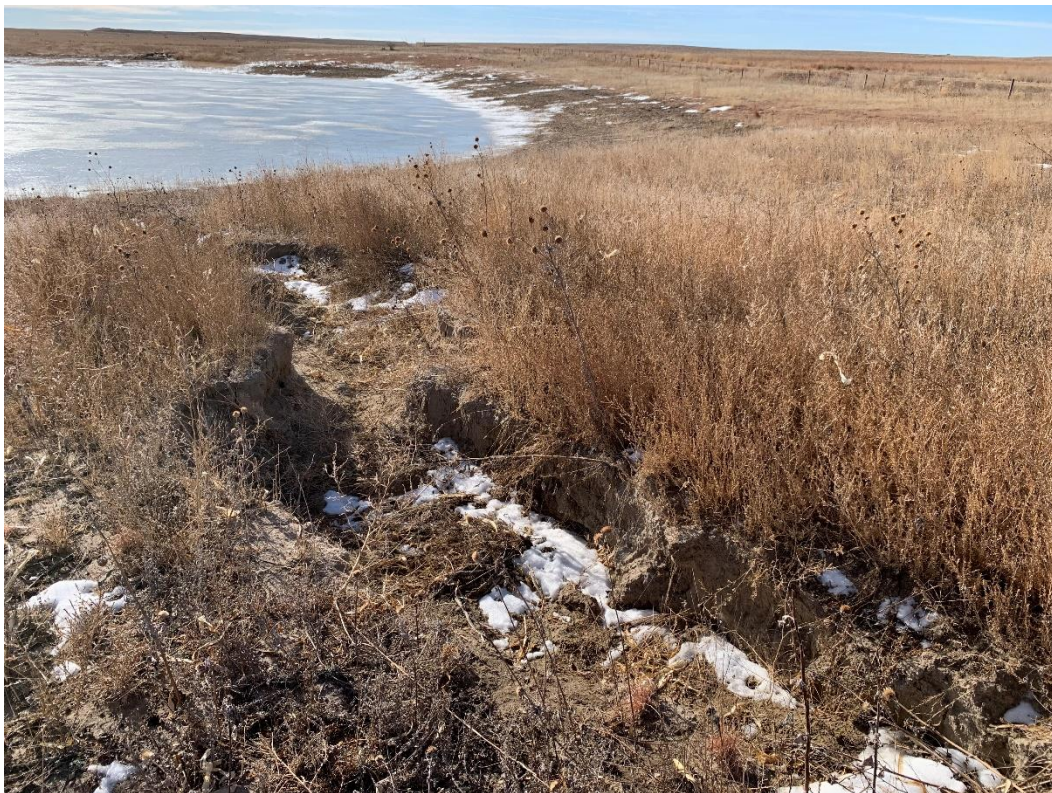
The north side of the pit area was the stockpile area during active mining. This area has been graded to slope toward the pit area (photo 3). The area is well vegetated and stable with the exception of one gully on the west side (photo 4). The gully needs to be repaired and seeded when the weather is appropriate in the spring.

Photo 4 – Gully in the northern stockpile area

The Division will deny approval of the SL-1 application because the gullies noted need to be repaired and seeded prior to the release of the site. The Division suggests to wait until after the ground thaws so that repairs can be made and then resubmit a release application.

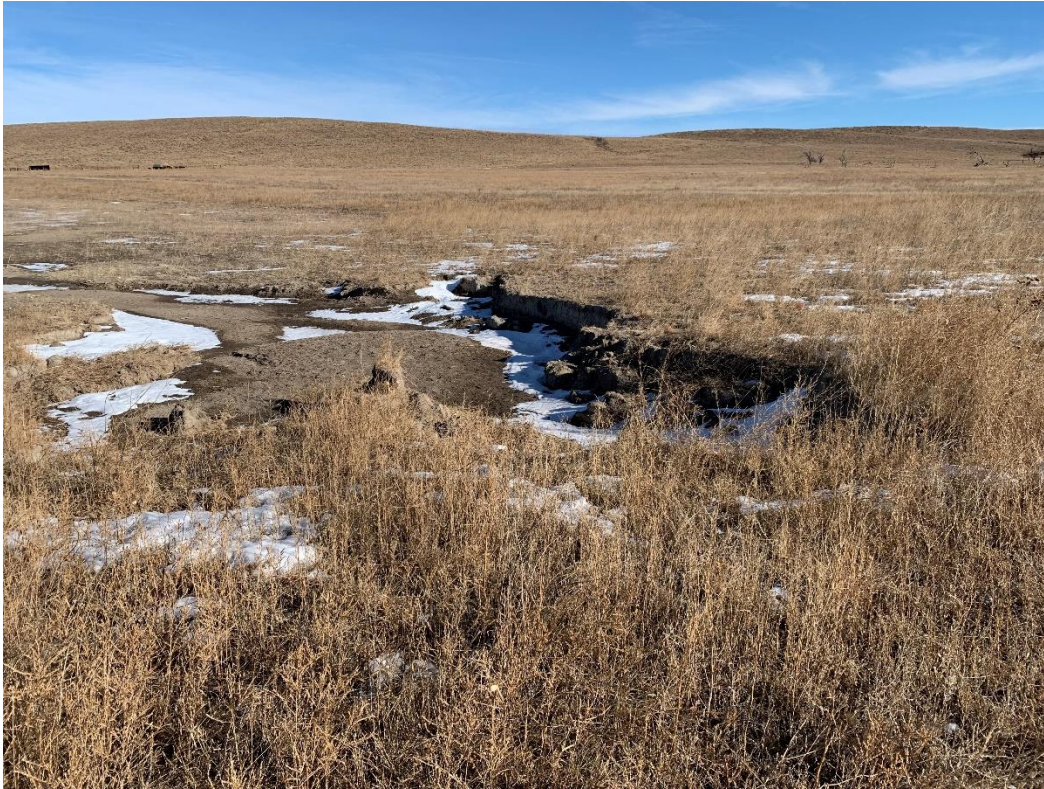
The south side of the pit area was the topsoil stockpile area. The topsoil has been replaced and the area has been graded and seeded. The area is well vegetated and stable with the exception of a couple of gullies (photo 5). The gullies are the result of tail water coming off the irrigation pivot. These gullies need to be repaired and seeded when the weather is appropriate in the spring.

Photo 5 – Gully in the southern stockpile area
