Huddleston-Berry
Engineering & Testing, LLC

January 25, 2022
Project#01349-0001

Subject: Summary of Instrumentation Monitoring
4th Quarter 2021
Bowie Coal Waste Disposal Area No. 2
Paonia, Colorado

SUBJECT: Summary Report, 4th Quarter 2021, Inclinator and Active Vibrating Wire Piezometer Data October – December 2021, Bowie Mine #2 Coal Waste Disposal Area (CWDA) #2

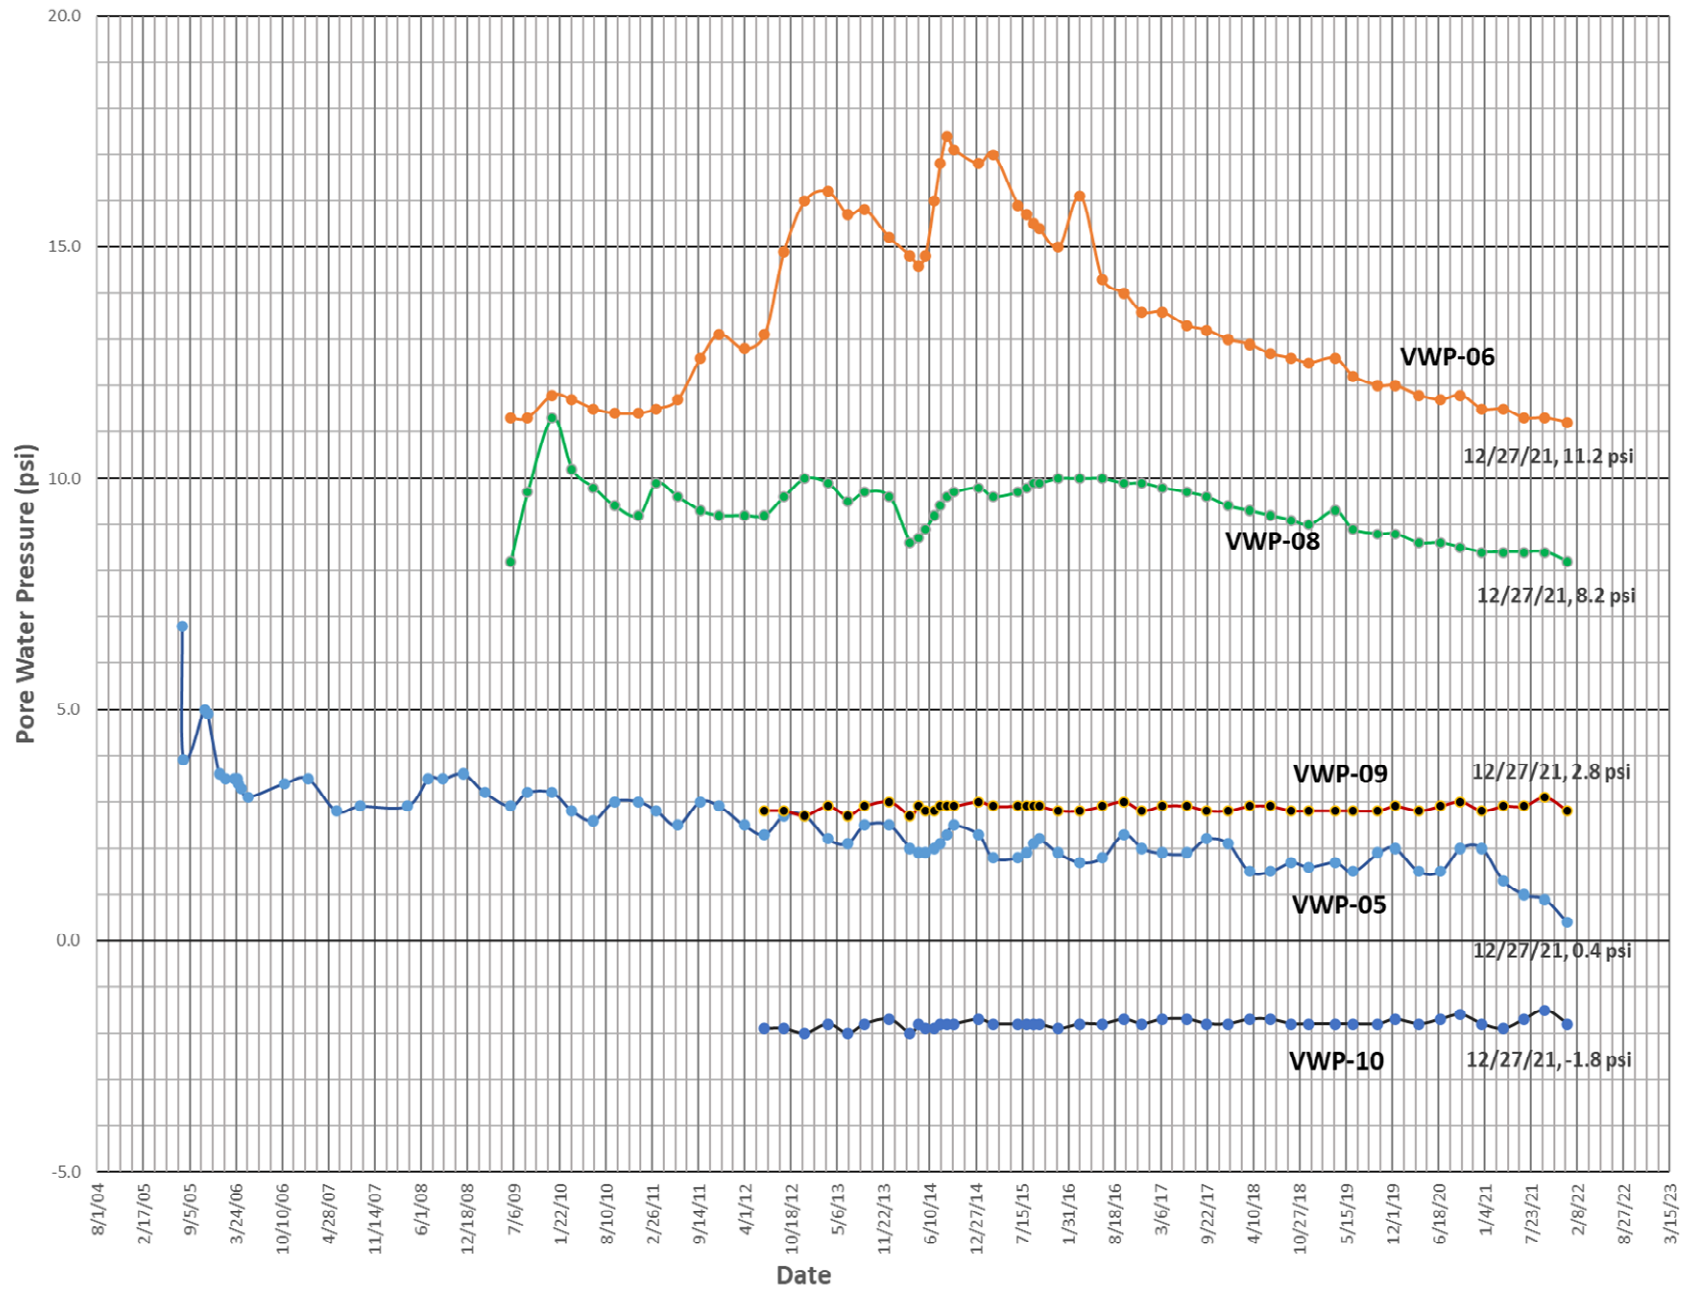
Figure 2 - Bowie Mine #2 - CWDA #2
Active Vibrating Wire Piezometer Data

As seen on Table 1 and Figure 2, the VWP readings and trends are consistent with recent and historic readings. Pore pressure readings changed by small amounts (0.0 to -0.3 psi) for four of the five VWP's since the readings one year ago (Q4 2020), while VWP-05 had a change of -1.6 psi from a year ago. When compared with a last quarter (Q3 2021), pore pressures also changed by relatively small amounts (-0.1 to -0.5 psi) in all five VWP's. Although four of the five VWP's remain steady or have general declining trends in pore pressure over the life of the VWP's, one of the piezometers (VWP-05) has exhibited pronounced seasonal cyclical behavior since installation. This piezometer generally (but not always) shows low pore pressures for Q1 and Q2 and higher pressures for Q3 and Q4, with a net loss of 6.4 psi over the lifetime of that VWP. The other four VWP's have experienced net changes of +/-0.1 psi or less since installation, meaning current readings are very similar to initial readings. For VWP-09 and VWP-10, pressures have been consistent throughout the lifetime of the piezometers; however, for VWP-06 and VWP-08, they experienced wild fluctuations in pore water pressure in the first half of their lifetimes, but have settled to pressures similar to the installation pressures in the past 1-2 years.

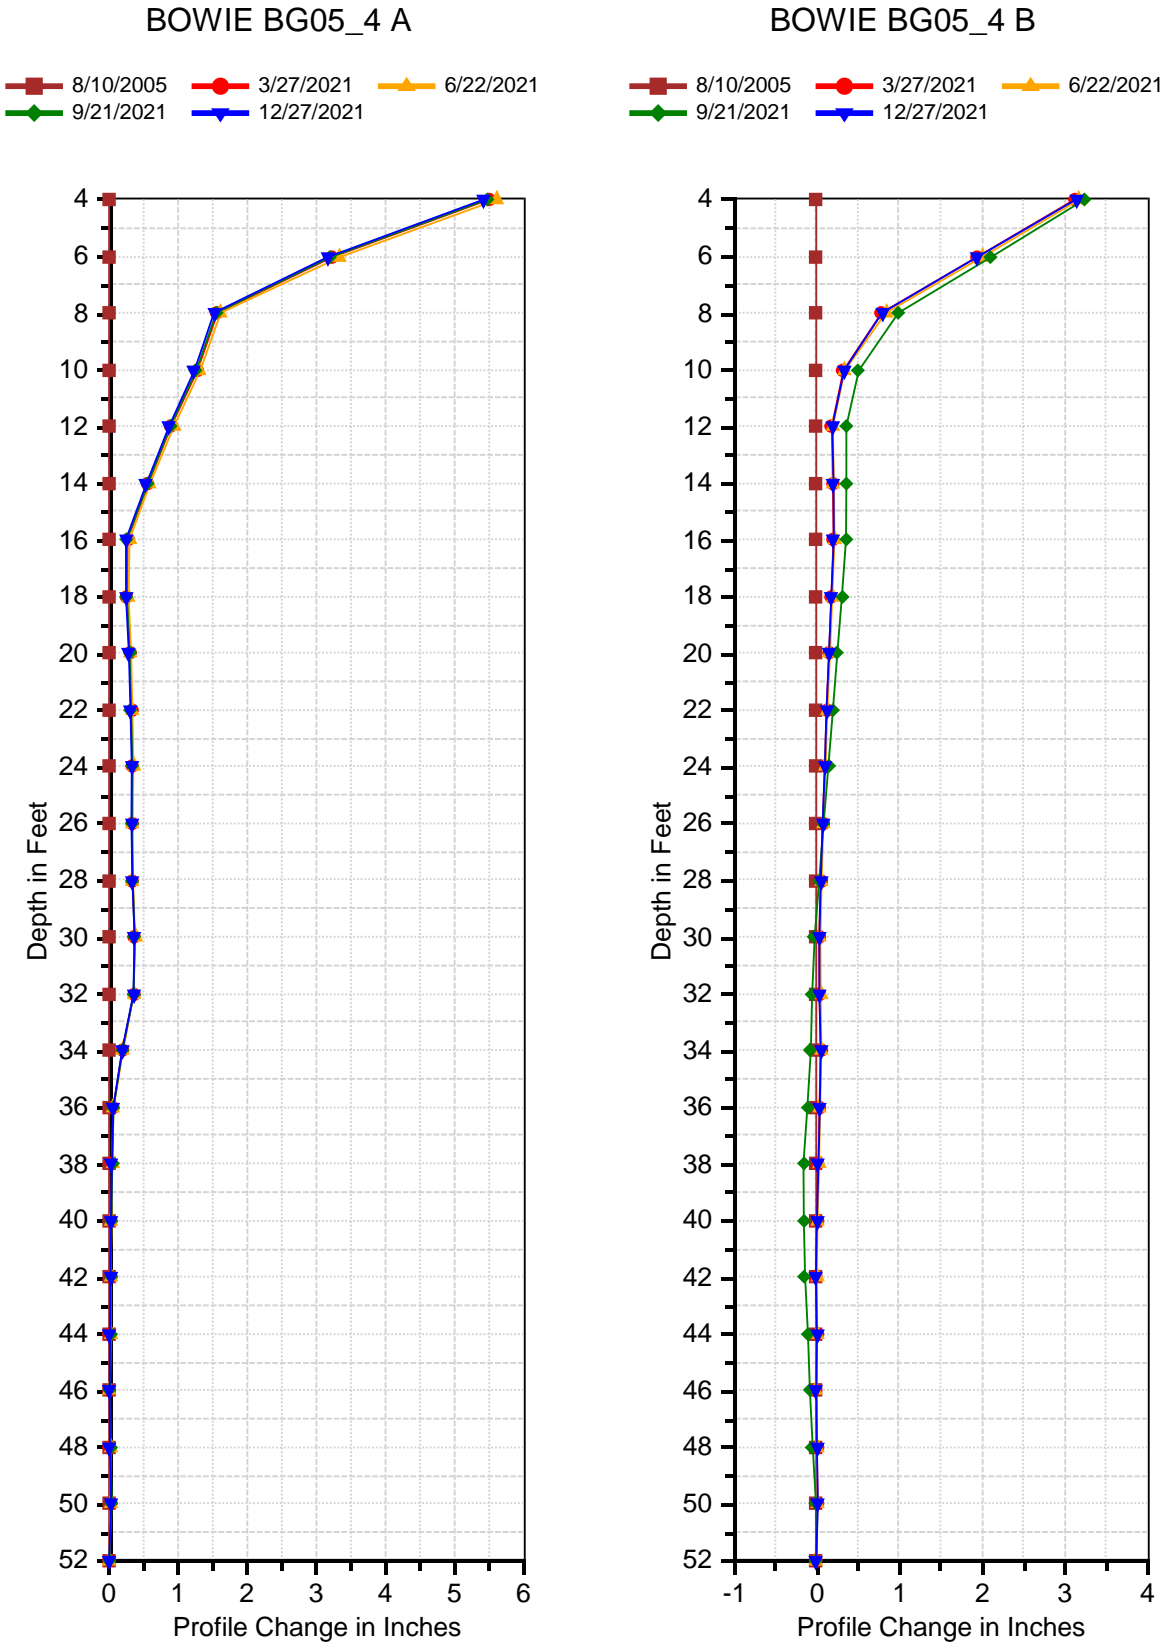
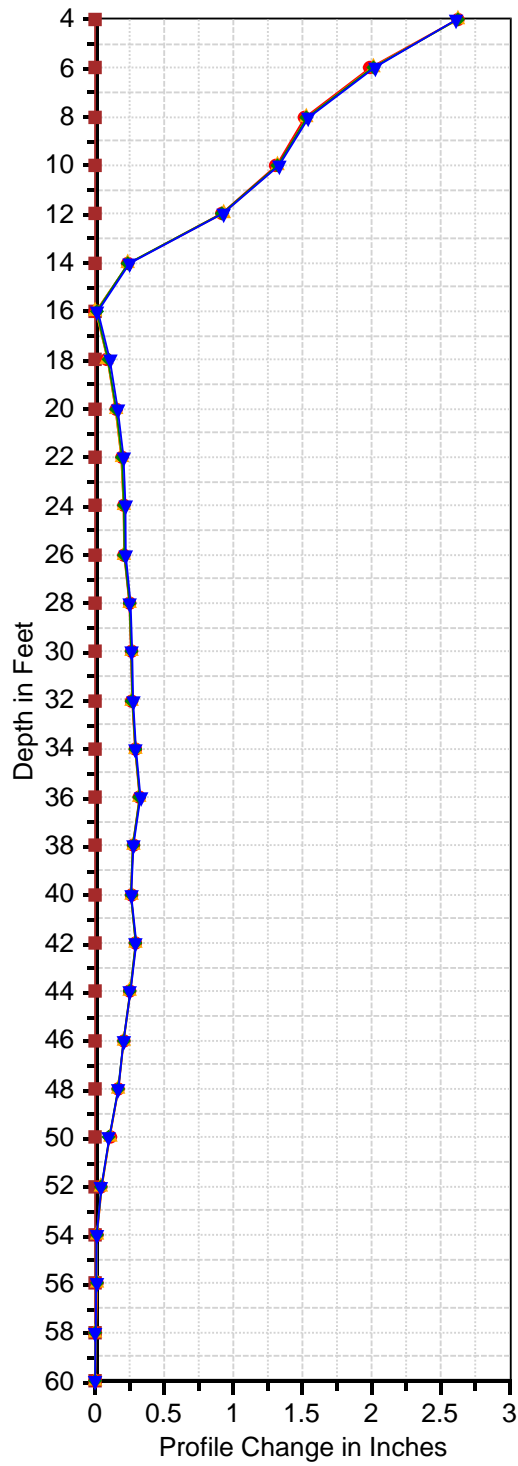
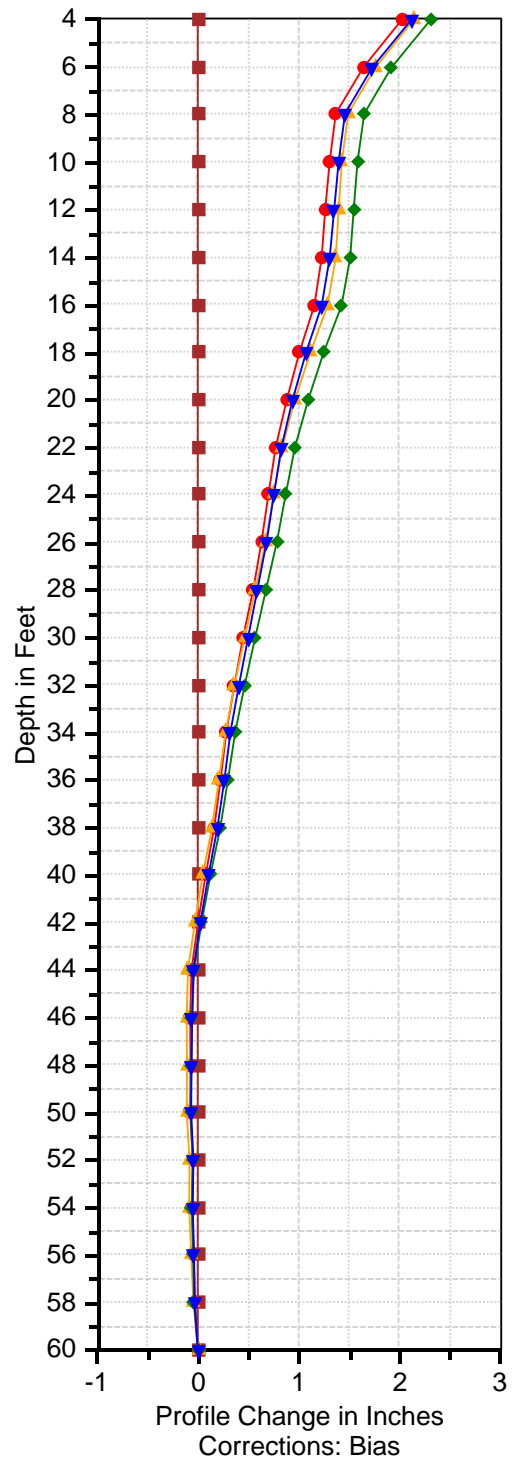
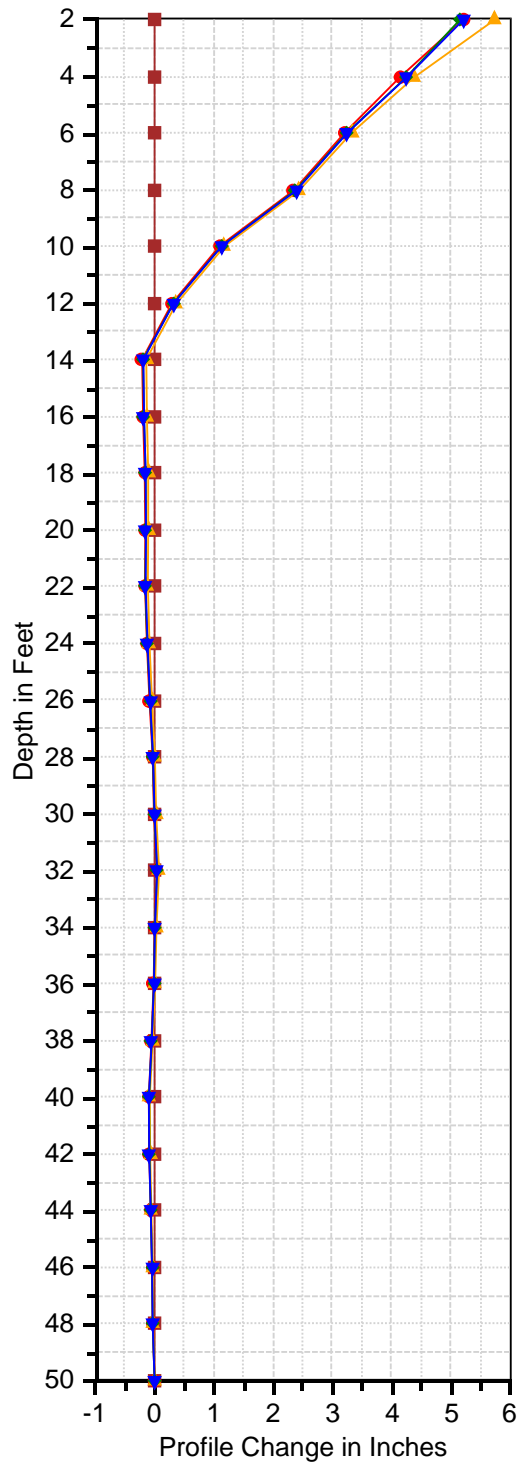
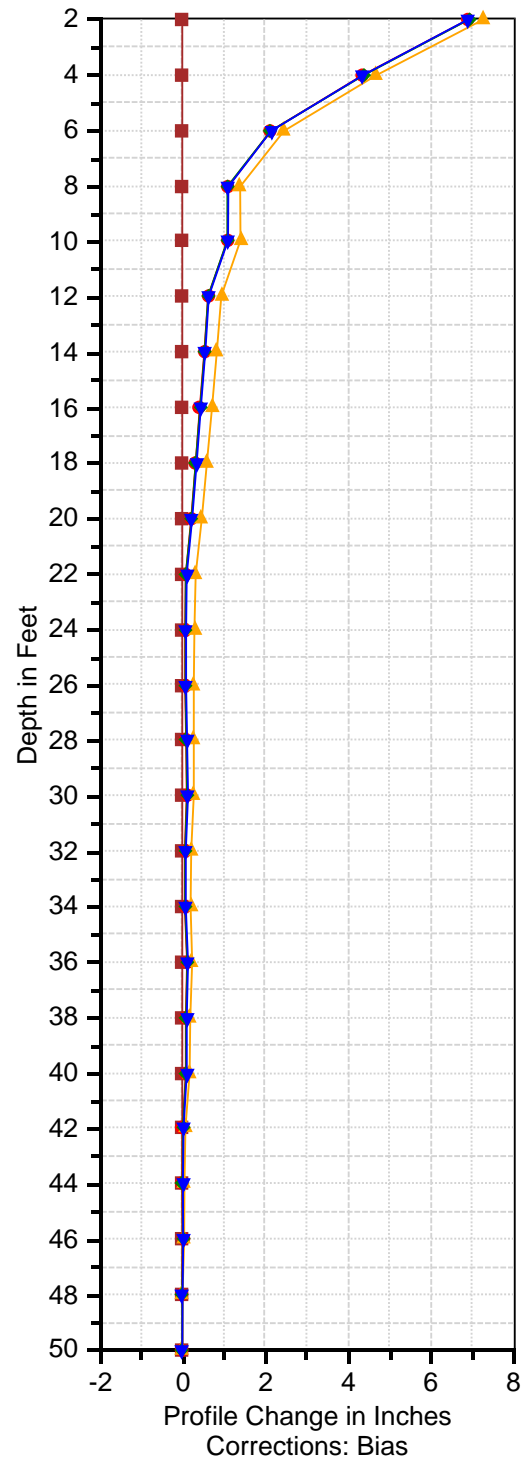
Figure 3 - Inclinator Displacement Curves

As described in previous reports, historic displacements indicated on the plots for the approximate upper 12-14 feet of the inclinometers since installation in 2005 are due to placement of cover soil on the face of the waste pile during revegetation operations in late 2006 and early 2007. This man-caused displacement is documented in a report by Buckhorn Geotech dated December 22, 2008 to Bowie Resources called *Revised Stability Evaluations for Coal Mine Waste Disposal Area No. 2, Bowie No. 2 Mine*.

Based on the current inclinometer readings, there has not been evidence of significant downslope movement (Axis A) in any of the inclinometers since 2007 and they are generally consistent with previous readings. Some "noise" which is understood to be relatively common in orthogonal direction (Axis B) readings, was observed over the past few years for all three inclinometers. This can be due to various mechanical or installation causes that are unrelated to slope movement. For example, grout voids, poor grout coverage, or soil settlement around the instrument can all contribute to vibrations and pipe movement that impacts inclinometer readings. Software bias adjustments were applied which filtered this noise. All readings were consistent with previous ones and the "displacement" error was within equipment tolerances and not deemed to be due to slope movement.
