MINERALS PROGRAM INSPECTION REPORT
PHONE: (303) 866-3567

MINE NAME: Red Canyon Quarry	MINE/PROSPECTING ID#: M-1985-043	MINERAL: Aggregate and sand and gravel	COUNTY: Fremont
INSPECTION TYPE: Monitoring	INSPECTOR(S): Timothy Cazier, P.E.	INSP. DATE: August 9, 2021	INSP. TIME: 14:00
OPERATOR: Rocky Mountain Materials and Asphalt, Inc.	OPERATOR REPRESENTATIVE: Phil Courtney, Wayne Stoughton	TYPE OF OPERATION: 112c - Construction Regular Operation	
REASON FOR INSPECTION: Normal I&E Program	BOND CALCULATION TYPE: Complete Bond	BOND AMOUNT: \$334,000.00	
DATE OF COMPLAINT: NA	POST INSP. CONTACTS: None	JOINT INSP. AGENCY: None	
WEATHER: Clear	INSPECTOR'S SIGNATURE:

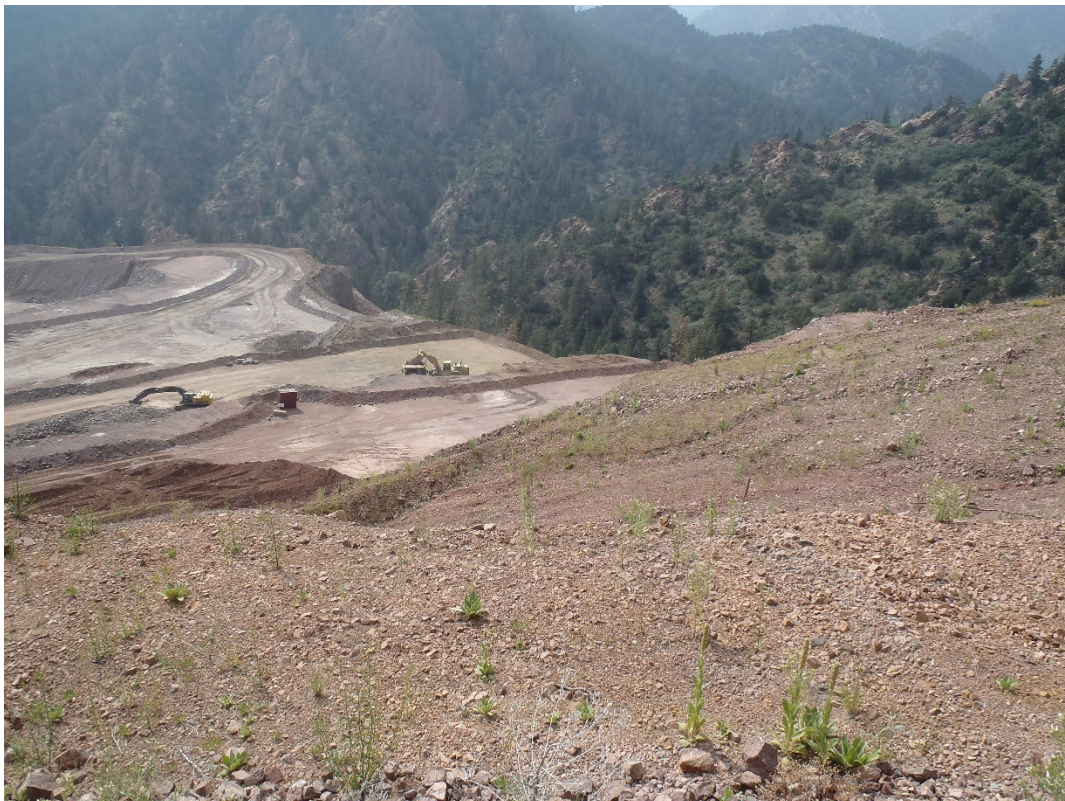
Backfilling and Grading: Concurrent reclamation was being performed as some of the upper benches were observed to have been backfilled and topsoiled (see **Photo 1**). Backfill material is overburden.

Photo 1. Backfilled & topsoiled upper bench area (looking west).

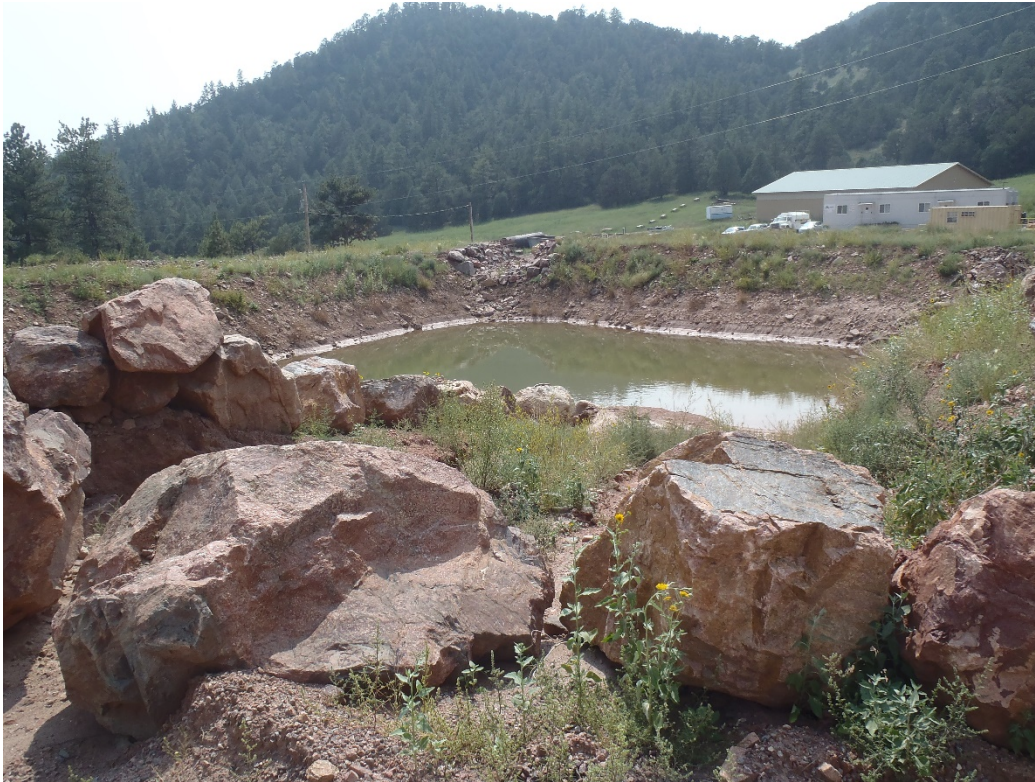
Hydrologic Balance: No standing water was observed in the pit. Groundwater is exposed in the sediment pond (see **Photo 2**). Evaporation losses are addressed in the site Substitute Water Supply Plan (SWSP).

Photo 2. Exposed groundwater in sediment pond (~150 ft. east of scale house).

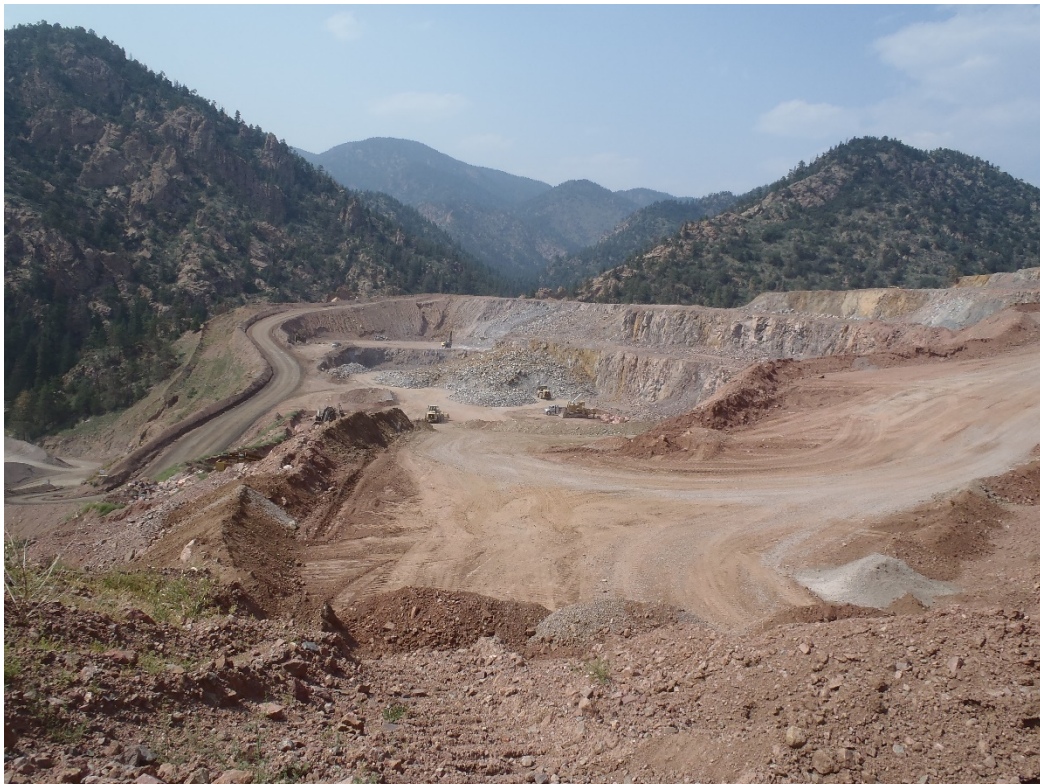
Gen. Compliance with Mine Plan: The operation appeared to be in compliance with the approved mine plan. The maximum allowed disturbed area is 110 acres. Google Earth was used to measure the disturbed area, which was measured to be approximately 62 acres, based on older 2019 imagery. Highwalls varied between 40 and 50 feet in height and appeared stable (see **Photo 3**).

Photo 3. Pit highwalls from SE side of working area (looking NW).

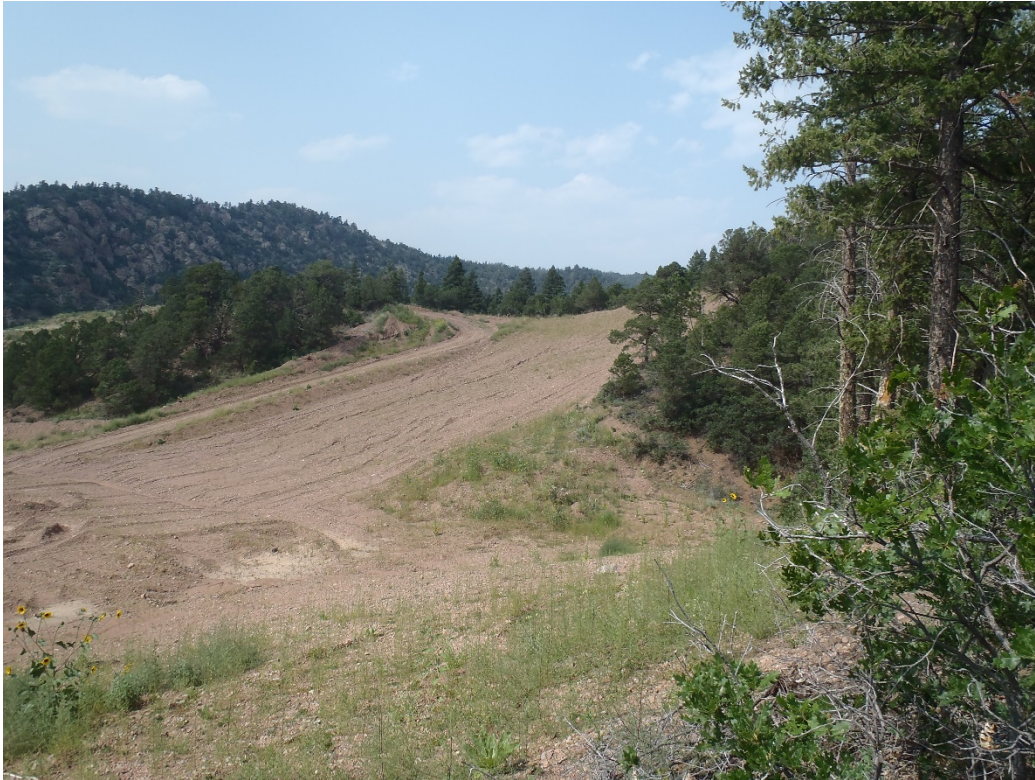
Reclamation Success: As stated above, some of the upper benches have been backfilled and topsoiled. The backfilled areas appeared to be sloped at 3H:1V or flatter. The upper access road in the northeast corner of the active area had been realigned and the older portion is being reclaimed (see **Photos 4 and 5**).

Sediment Control: Minor local erosion features were observed (see **Photo 4**) with no offsite impact. No BMPs were needed at the time of the inspection.

Photo 4. Realigned upper access road undergoing reclamation (Note small erosion rills).

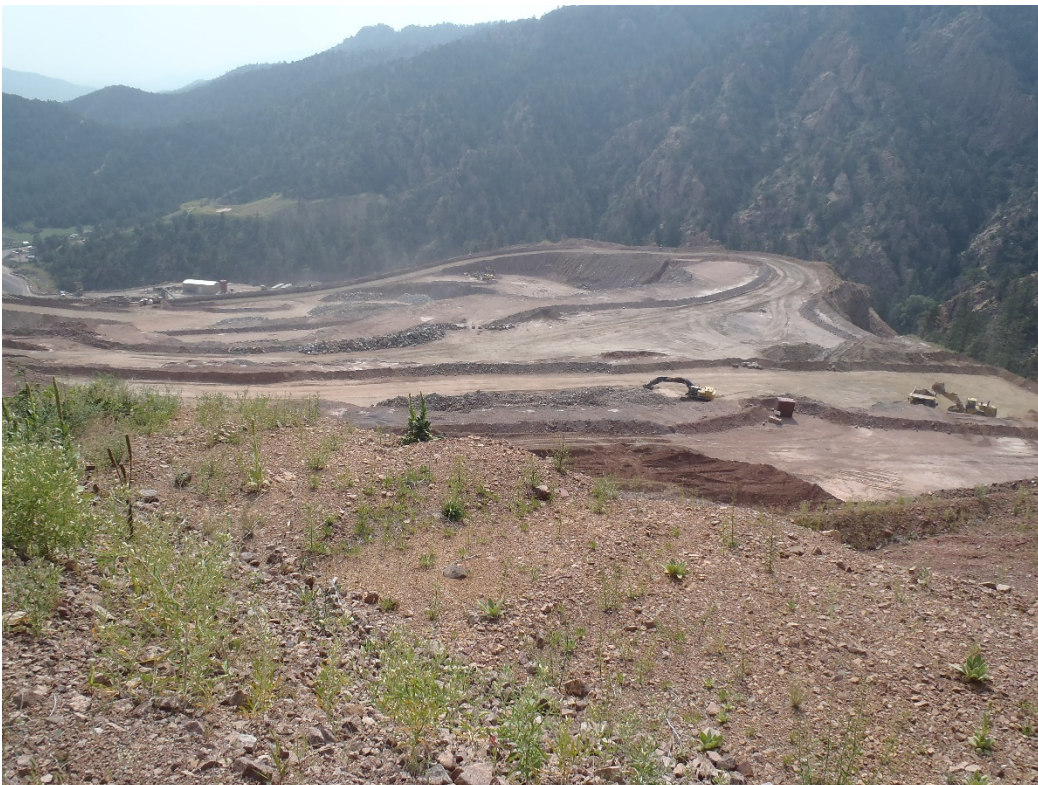
Support Facilities On-site: In addition to the screen plant, excavators, loaders and haul trucks were observed on site (see **Photo 5**).

Photo 5. Active pit and mining equipment (note concurrent upper bench reclamation in foreground).

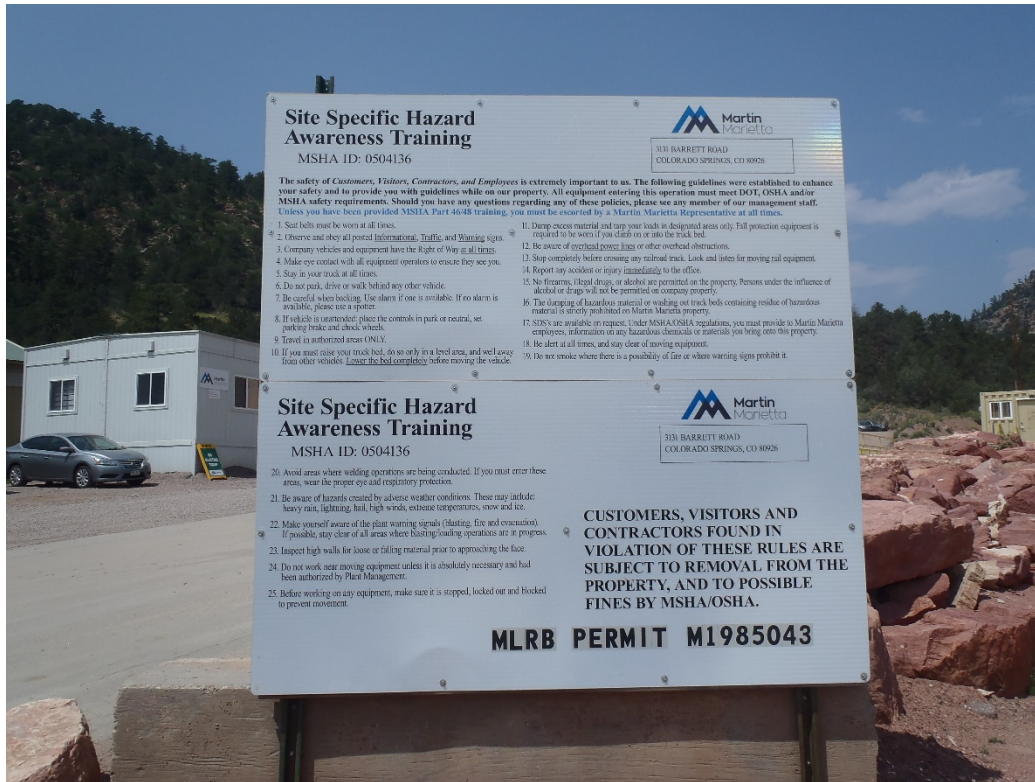
Photo 6. Permit sign near scale house.

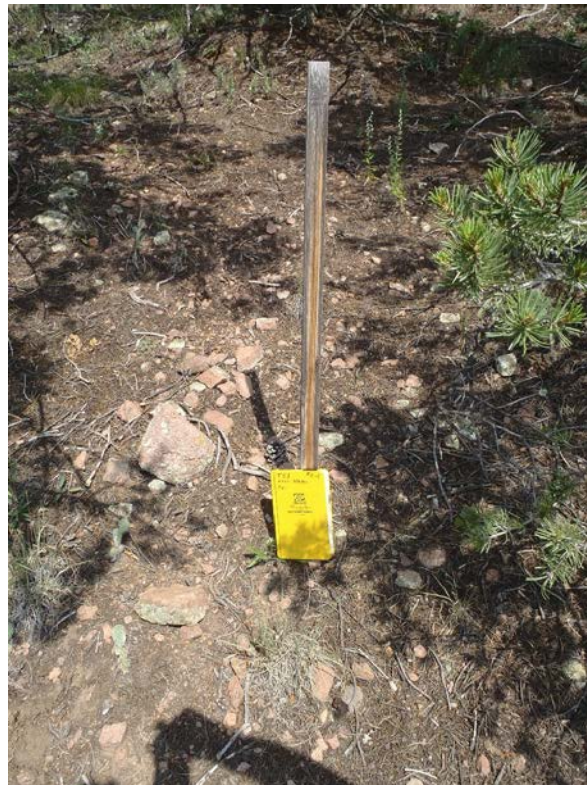
Signs and Markers: The permit sign was properly posted (see **Photo 6**) and boundary markers were observed in most areas to delineate the permit boundary (see **Photo 7**). However, a considerable amount of time was spent looking for a boundary marker in the wooded area on the northeast that could not be located. [The DRMS recommends boundary markers in heavily wooded areas be painted or replaced with highly visible material prior to advancing the mine in that direction.](#)

Photo 7. Typical boundary marker (NE area, hard to find in wooded areas).
