2022 ANNUAL REPORT STRUCTURAL GEOLOGY EVALUATION SPECIFICATIONS AGGREGATE QUARRY

**Martin Marietta Materials
Golden, Colorado**

21C64003.00
January 26, 2022

**Subject: Project 21C64003.00, 2022 Annual Report, Structural Geology Evaluation,
Specification Aggregates Quarry, Golden, Colorado**

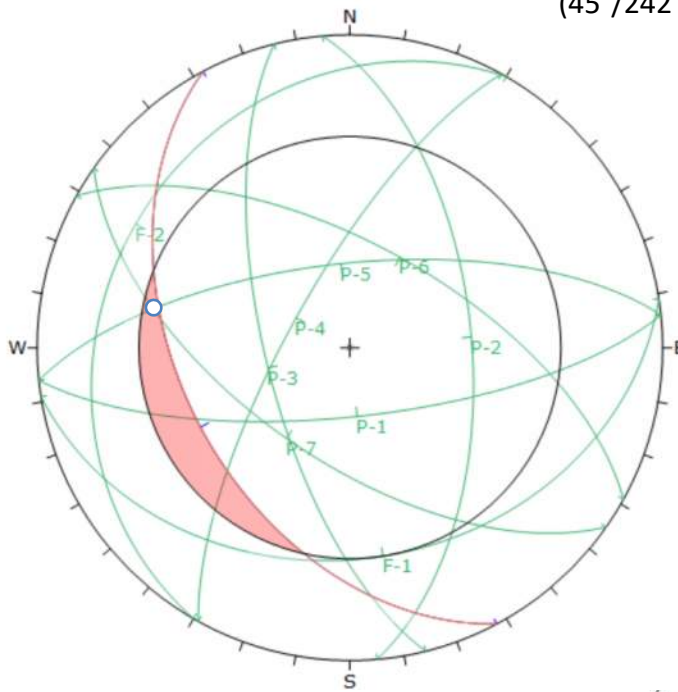
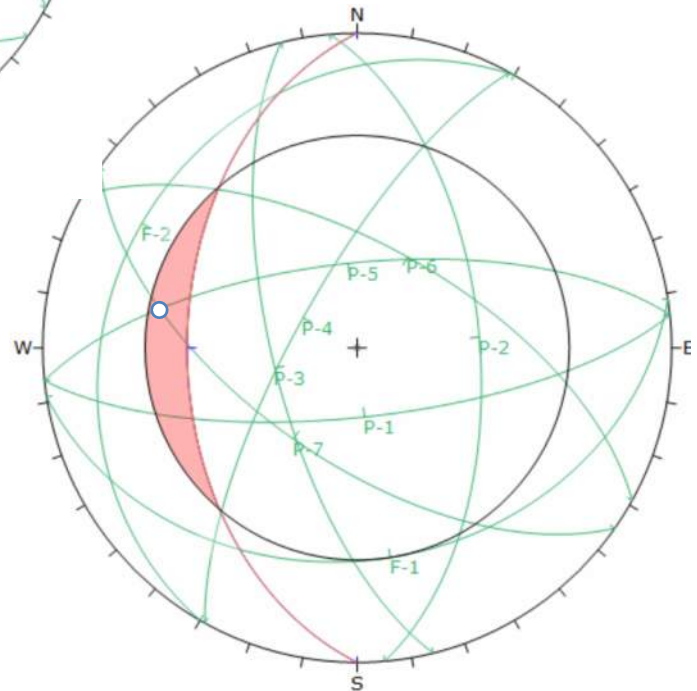
Figure 8

The stereonet plots for East Walls 1 and 2 each show one discontinuity intersection that falls within the failure envelope, suggesting that wedge failure is kinematically possible for these slope orientations (Figure 8). The intersecting set that may result in wedge failure are joint sets P-5 and joint P-7.

The development and size of these wedge failures will be controlled by the variability and limited lateral extent of the discontinuities. Based on the current and previous years’ data sets, these two joint sets (P-5 and P-7) have weak signatures represented by relatively few measured orientations and no measurements of P-5 this year (Figure 6). As excavation proceeds in the vicinity of the eastern walls, additional measurements are needed to refine the representative discontinuity orientations of these joint and foliation sets in this area to evaluate their potential to contribute to large-scale slope failure modes.

As shown in Figure 8, the stereonet plot for East Walls 1 and 2 do not indicate the possibility of planar failure.

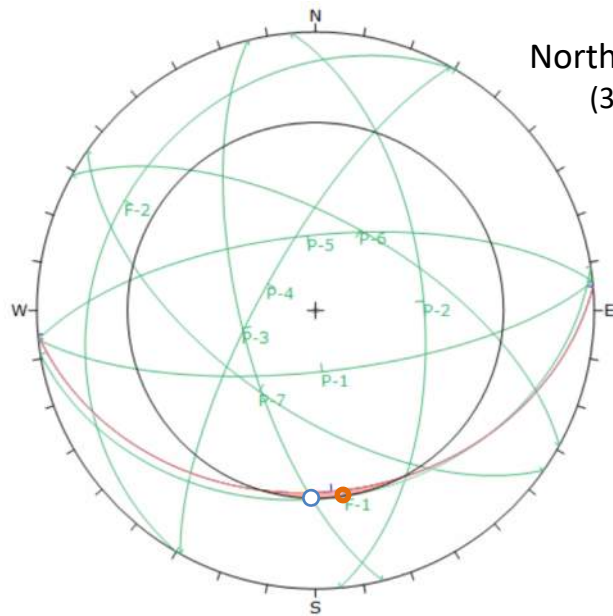
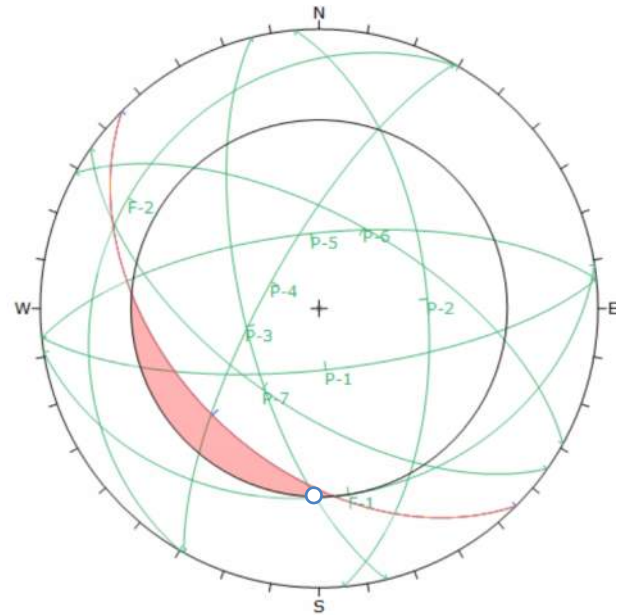
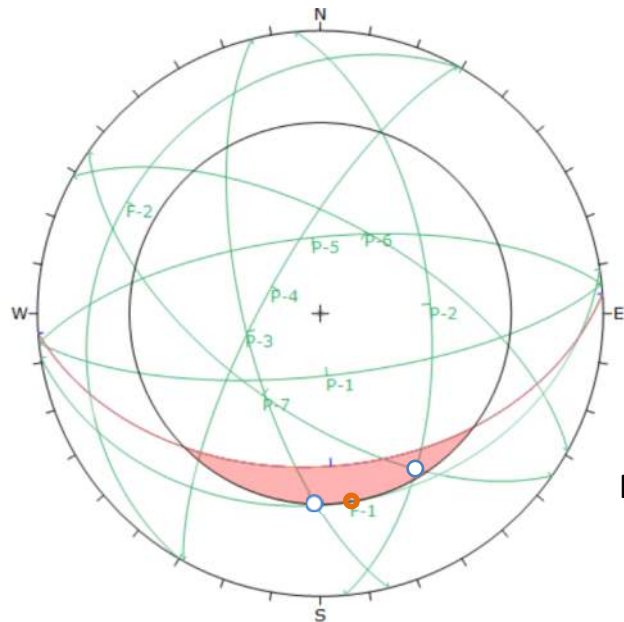
Figure 9

The stereonet plot for Northeast Wall 1 indicates a potential planar failure mode along foliation F-1 for this slope orientation (Figure 9). This is the same foliation orientation that was believed to contribute to the 1998 slope instability (Photo 5). The stereonet plot for Northeast Wall 1 also shows one discontinuity intersection that falls within the failure envelope, suggesting that wedge failure is kinematically possible for this slope orientation (Figure 9). The intersecting sets that may result in wedge failure include foliation F-1 and joint set P-3.

The stereonet plot for Northeast Wall 2 shows one discontinuity intersection that falls within the failure envelope, suggesting that wedge failure is kinematically possible for this slope orientation (Figure 9). The intersecting sets that may result in wedge failure are foliation F-1 and joint set P-3. As described above, the development and size of wedge failures will be controlled by the variability and limited lateral extent of the discontinuities. If excavation proceeds in the vicinity of the northeastern walls, additional measurements are needed to refine the representative discontinuity orientations of these joint and foliation sets in this area to evaluate their potential to contribute to large-scale slope failure modes. Currently there is no additional excavation planned near the northeastern wall. Planar failure is not indicated in the stereonet plot for Northeast Wall 2.

The stereonet plot for Northeast Wall 3 indicates a potential planar failure mode along foliation F-1 for this slope orientation (Figure 9). This is the same foliation orientation that was believed to contribute to the 1998 slope instability. The stereonet plot for Northeast Wall 3 shows two discontinuity intersections that fall within the failure envelope, suggesting that wedge failure is kinematically possible for this slope orientation (Figure 9). The intersecting sets that may result in wedge failure are foliation F-1 and joint set P-3, and joint sets P-2 and P-7. Based on the current and previous years' data sets, joint set P-7 has weak signatures represented by relatively few measured orientations representing these features (Figure 6). The Northeast Wall 3 was not accessible for direct measurements or observations during our site visits. Additional measurements and observations are needed to assess the potential for large scale planar sliding along foliation F-1 as excavation continues to extend below Northeast Wall 3 in the future (there is currently no mining activity in this area).

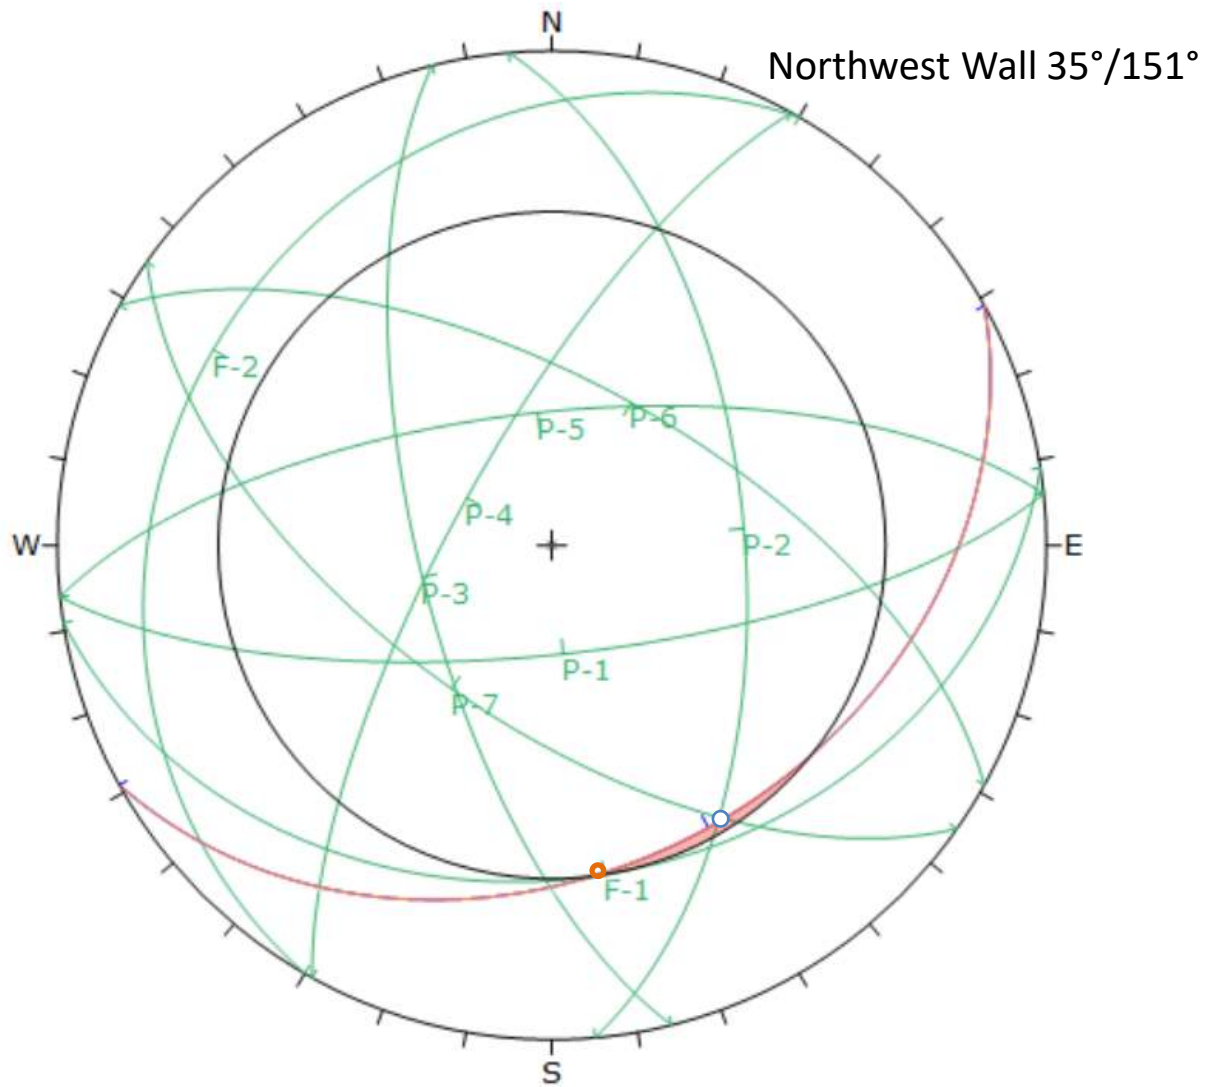
Figure 10

The stereonet plot for the Northwest Wall shows a potential planar failure mode along foliation F-1 for this slope orientation and one discontinuity intersection that falls within the failure envelope, suggesting that wedge failure is kinematically possible for this slope orientation (Figure 10). The intersecting sets that may result in wedge failure are joint sets P-2 and P-7. Based on the current and previous years' data sets, joint set P-7 has weak signatures represented by relatively few measured orientations representing these features (Figure 6). Furthermore, even a slight variability of the orientation of joint sets P-2, P-7 and foliation F-1 would create the potential to form wedges within the critical zone for this wall.

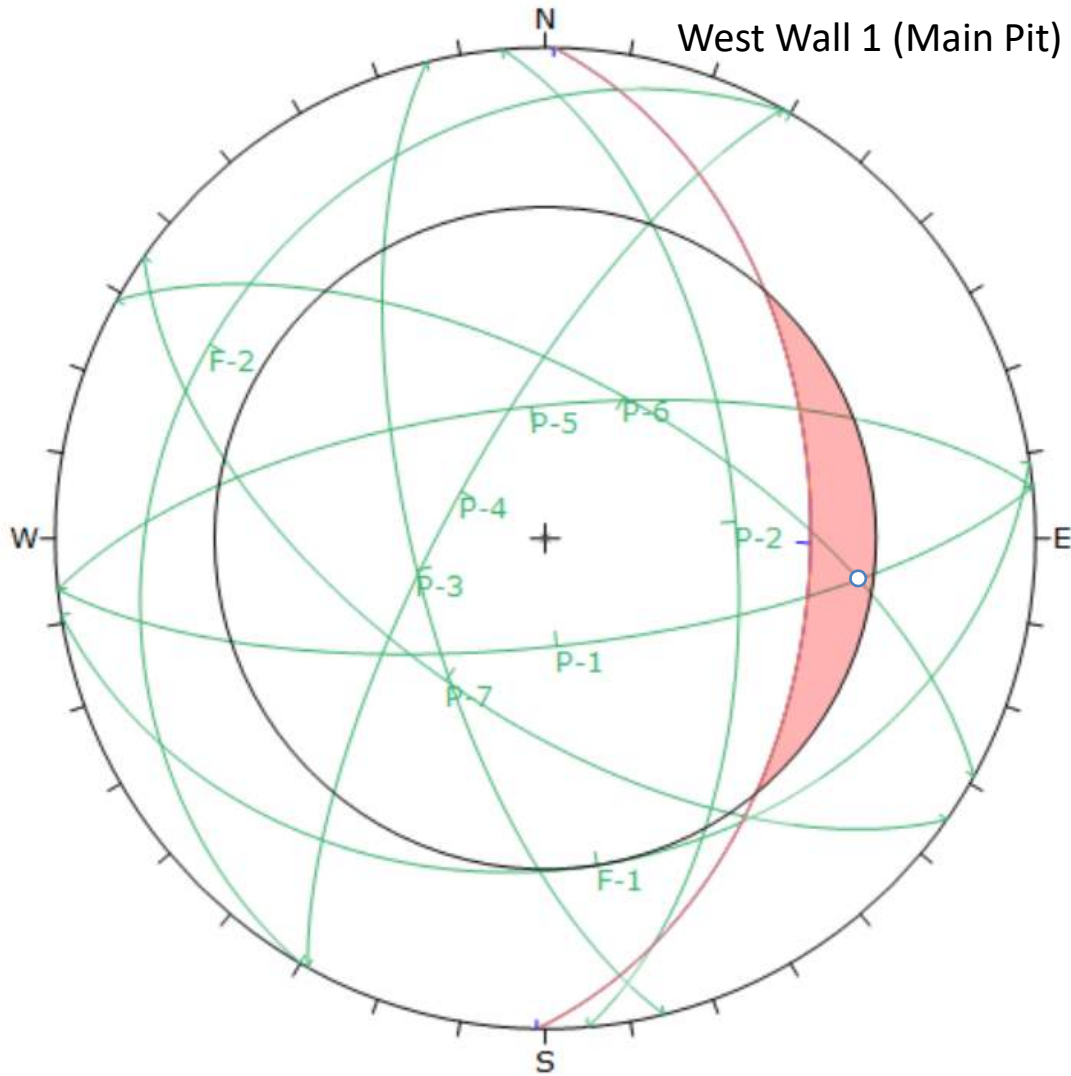
Figure 11

The stereonet plot for West Wall 1 (Figure 11), adjacent to the Main Pit area, shows a discontinuity intersection that falls within the failure envelope, suggesting that wedge failure is kinematically possible for this slope orientation (Figure 11). The intersecting sets that may result in wedge failure are joint sets P-1 and P-6. Based on the current and previous years' data sets, joint sets P-1, P-2, and P-3 are the dominant joint sets observed in the Southern Expansion Area (Figure 6) in the recent years. Joint set P-6 has a weak signature represented by relatively few measured orientations representing this feature (Figure 6). Planar failure is not indicated in the stereonet plot for the West Wall 1 (Figure 11).

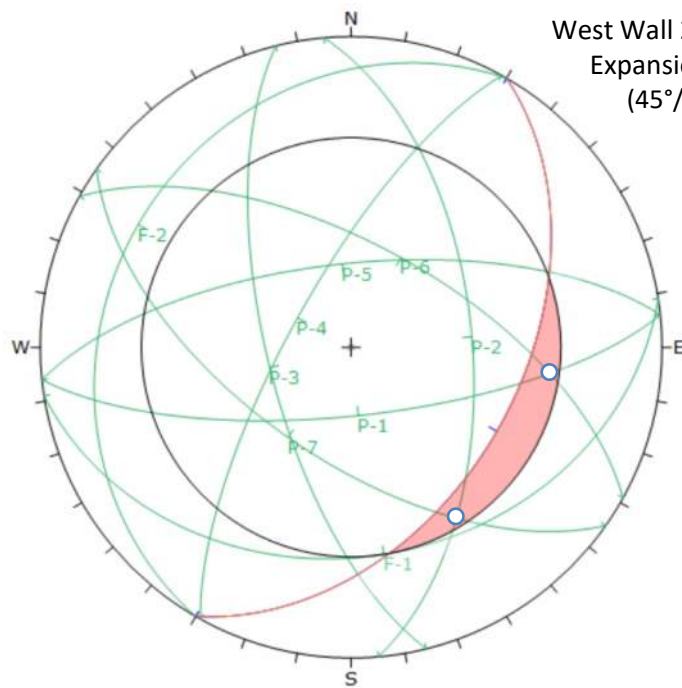
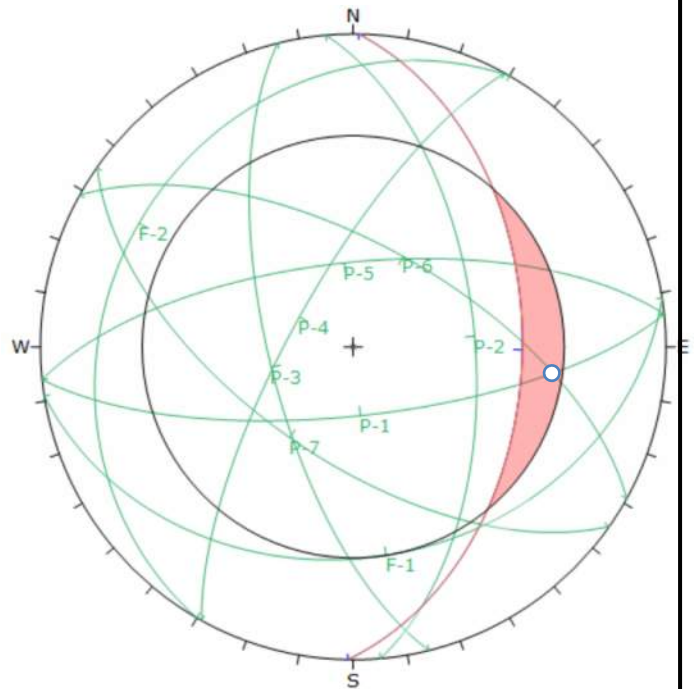
Figure 12

The stereonet plot for West Wall 2, adjacent to the access road in the Southern Expansion Area, shows two discontinuity intersections that fall within the failure envelope, suggesting that wedge failure is kinematically possible for this slope orientation (Figure 12). The intersecting sets that may result in wedge failure include joint sets P-2 and P-7 and joint sets P-1 and P-6. Based on the current and previous years' data sets, joint set P-7 has a weak signature represented by relatively few measured orientations representing this feature (Figure 6). Planar failure is not indicated in the stereonet plot for West Wall 2 (Figure 12).

The stereonet plot for West Wall 3 shows a discontinuity intersection that falls within the failure envelope, suggesting that wedge failure is kinematically possible for this slope orientation (Figure 12). The intersecting sets that may result in wedge failure are joint sets P-1 and P-6. Planar failure is not indicated in the stereonet plot for the West Wall 3 (Figure 12).

The development and size of wedge failures will be controlled by the variability and limited lateral extent of the discontinuities. As excavation proceeds in the west walls area, additional measurements are

needed to refine the representative discontinuity orientations of these joint and foliation sets in this area to evaluate their potential contribute to large-scale slope failure modes.

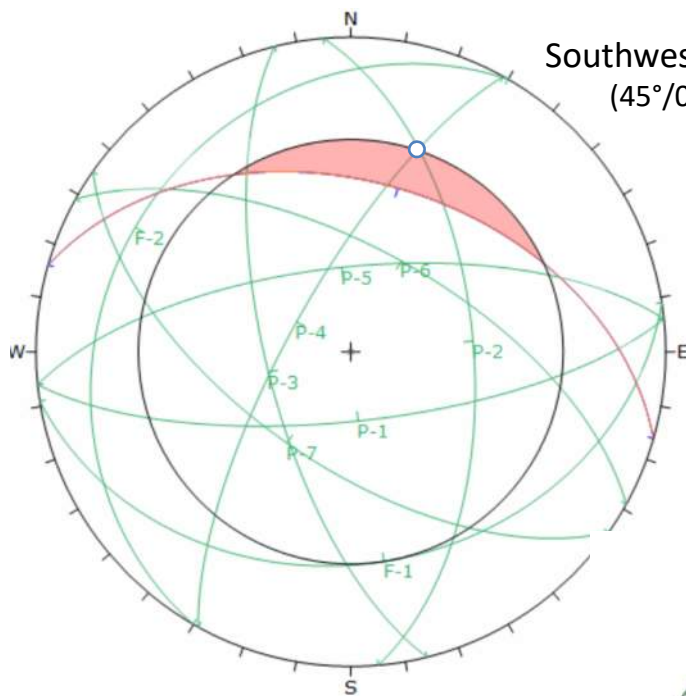
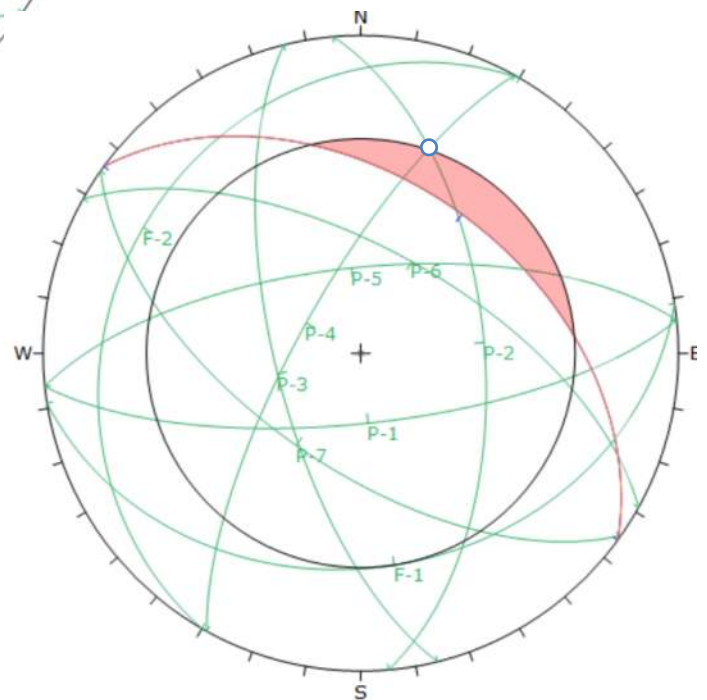
Figure 13

The stereonet plots for the Southwest Wall 1, Southwest Wall 2, and South Wall show one discontinuity intersection that falls within the failure envelope, suggesting that wedge failure is kinematically possible for this slope orientation (Figures 13 and 14). The intersecting sets that may result in wedge failure are joint sets P-2 and P-4. Based on the current as well as previous year's data set, joint set P-4 has a weak signature represented by relatively few measured orientations representing this feature (Figure 6). Planar failure is not indicated in the stereonet plot for these three walls (Figures 13 and 14).

As described above, the development and size of wedge failures will be controlled by the variability and limited lateral extent of the discontinuities. As excavation proceeds in the vicinity of the southern walls, additional measurements are needed to refine the representative discontinuity orientations of these joint and foliation sets in this area to evaluate their potential contribute to large-scale slope failure modes.

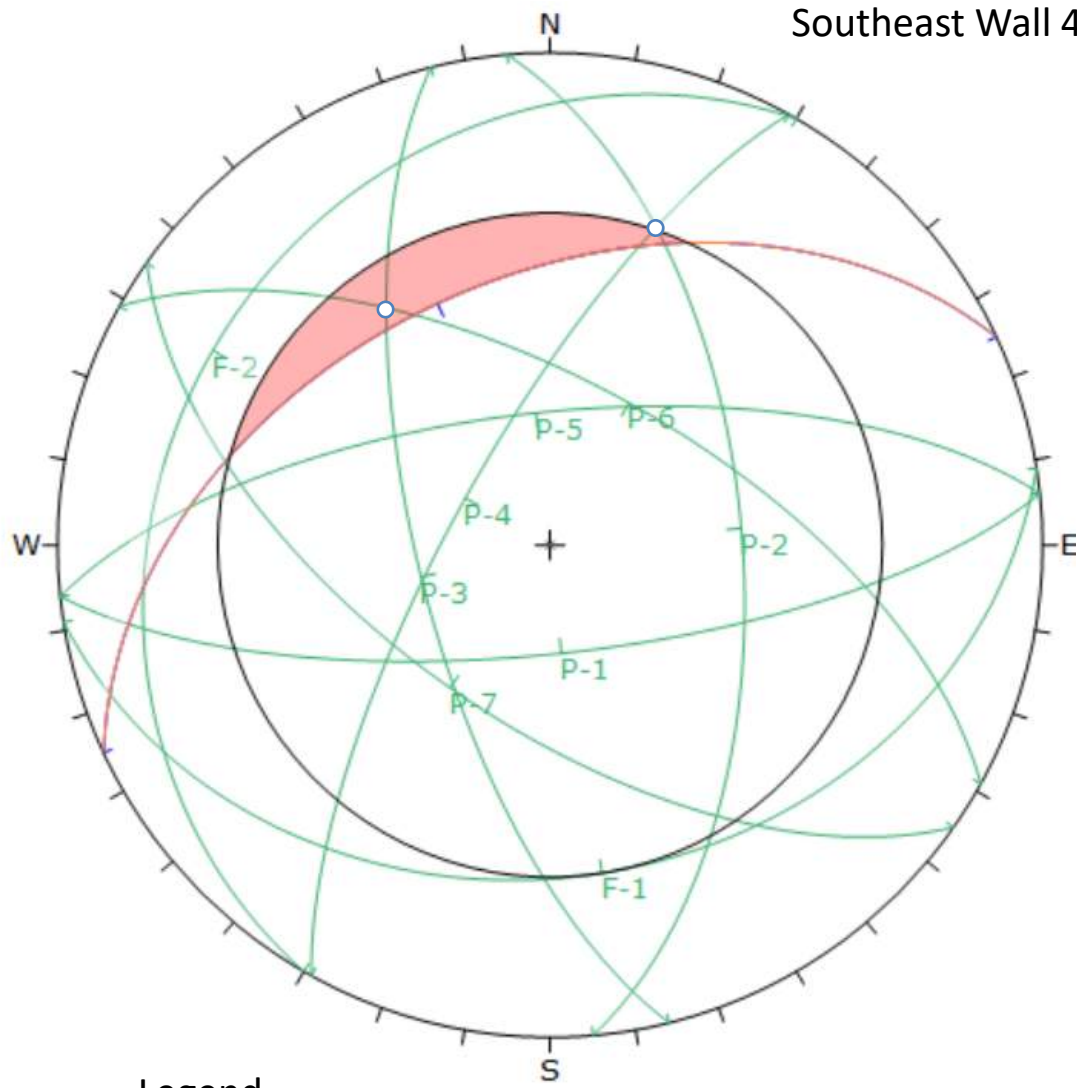
Figure 15

The stereonet plot for Southeast Wall shows two discontinuity intersections that fall within the failure envelope, suggesting that wedge failure is kinematically possible for this slope orientation (Figure 15). The intersecting sets that may result in wedge failure are joint sets P-2 and P-4 and joint sets P-3 and P-6. Based on the current and previous years' data sets, joint sets P-4 and P-6 have weak signatures represented by relatively few measured orientations representing these features (Figure 6). Additional measurements and observations are needed to assess the potential wedge formed by joint sets P-3 and P-6 as excavation continues to extend below Southeast Wall in the future.

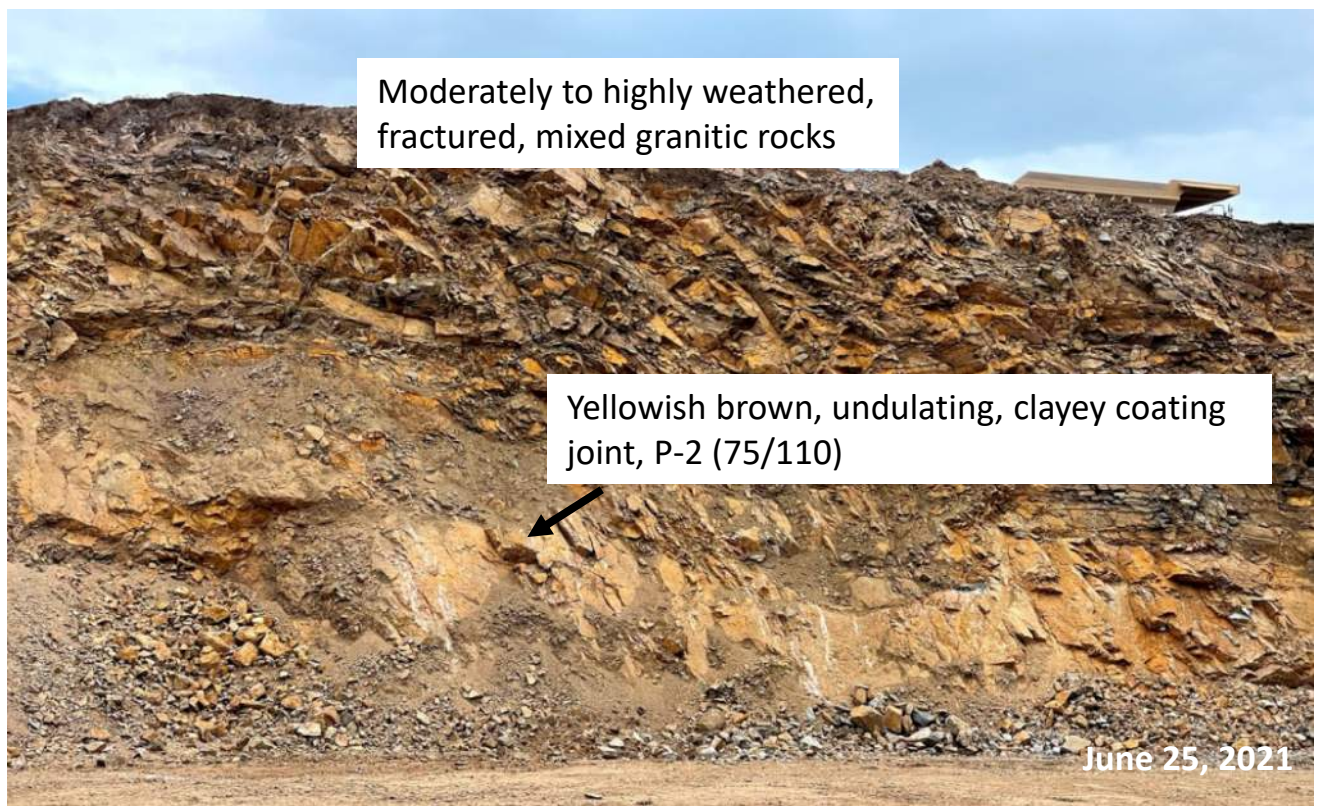
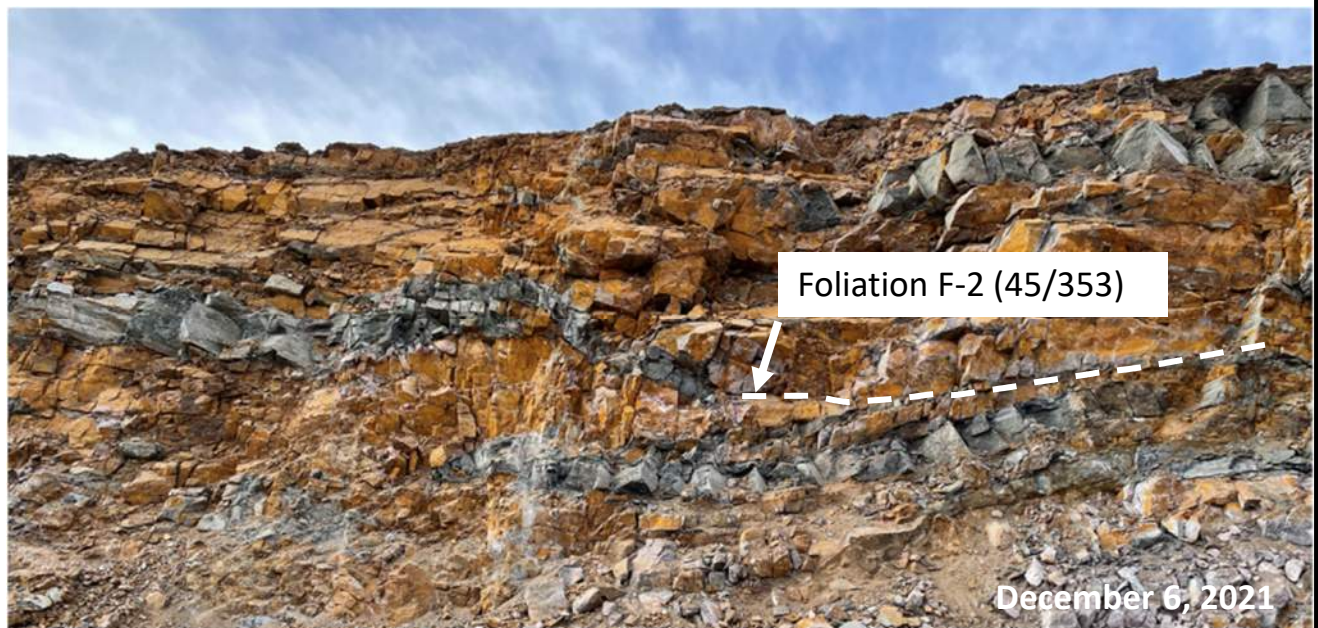
Photo 1

Looking North in an newly active mine area (middle bench, ~Elevation 6510 msl) of the Southern Expansion Area near Station 22-05 (Figure 2).

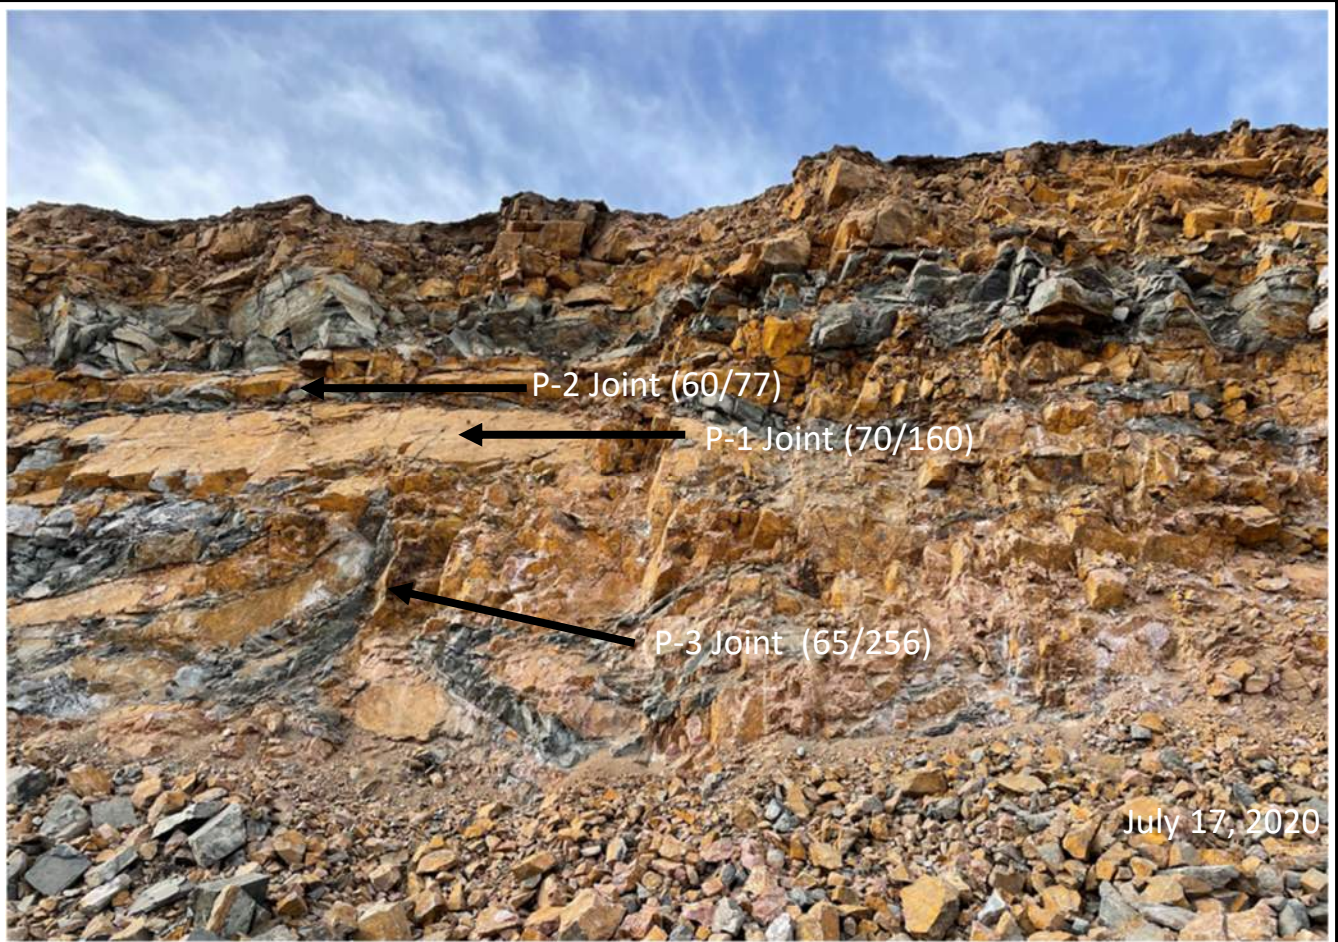
Photo 2

Looking North - P-1, P-3 and P-3 joints are the dominant joint sets in the lower temporary working bench area the Southern Expansion area (~Elevation 6475 ft msl).

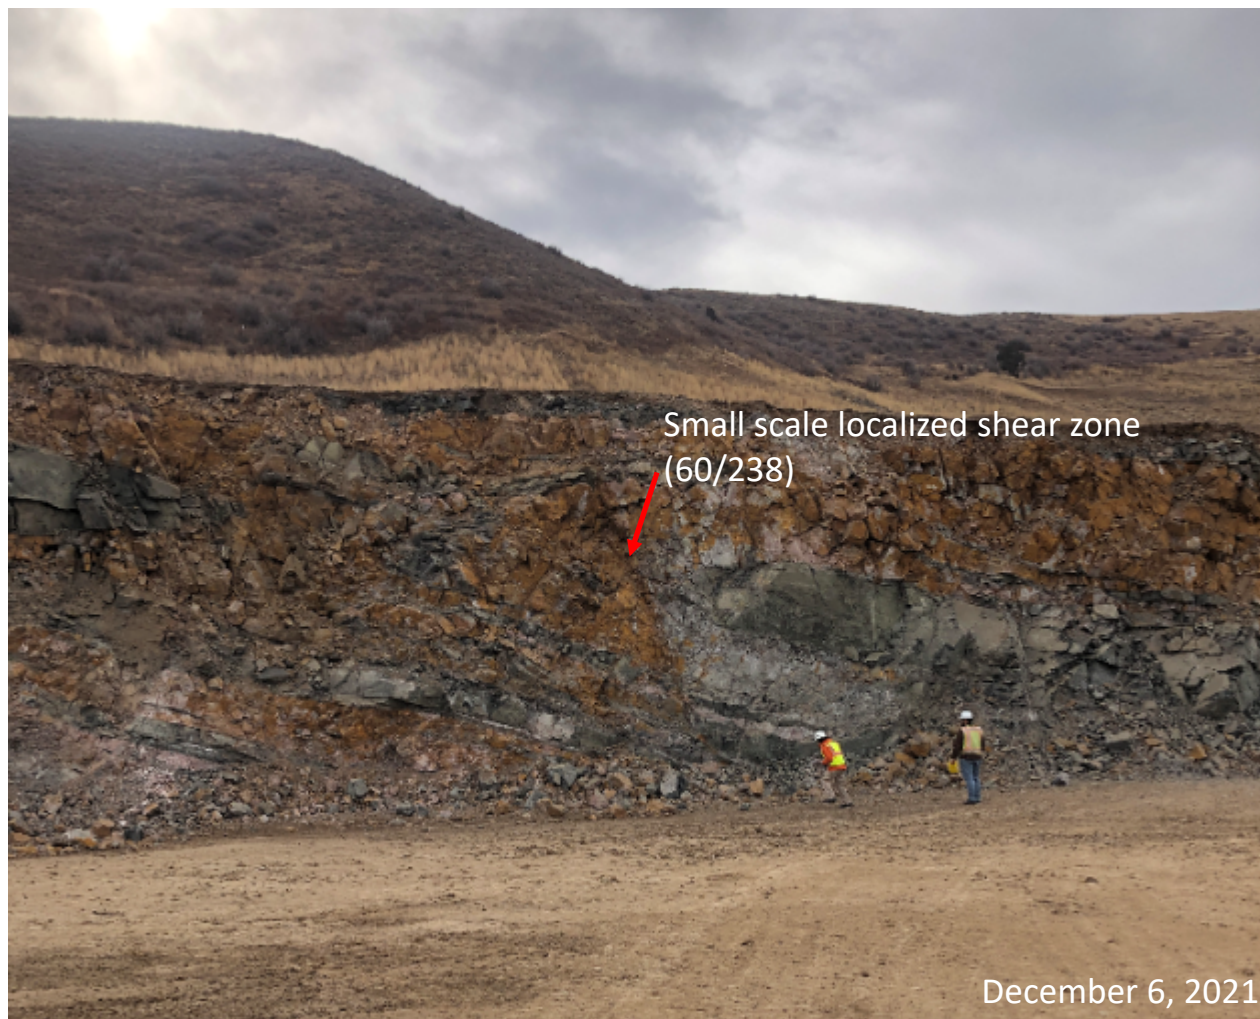
During our 2021 site visits, no major shear zone or fault exposure along the temporary excavation walls in the Southern Expansion Area were observed. Localized small scale shear zones were observed at approximately Station 22-05 and Station 22-06. The localized shear zones at Station 22-05 were oriented approximately north-south with a high angle dip to the west and were exposed in the north to northwest facing temporary wall of the Expansion Area. The localized shear zone consisted of yellowish-brownish weathered, broken granitic rock, with parallel close spaced fractures. The localized shear zone near approximately Station 22-06 (Figure 2, and Photo 3) was observed in a southwest-southeast orientation with a high angle dipping to the north along the southwest-west temporary excavation wall. These shear zones are likely localized and not associated with previously reported faults. Previous fault measurements are shown in Figure 4.

Looking Southwest near Station 22-06.
 No major shear zone was observed during this report year (in both June and December 2021 field activities).

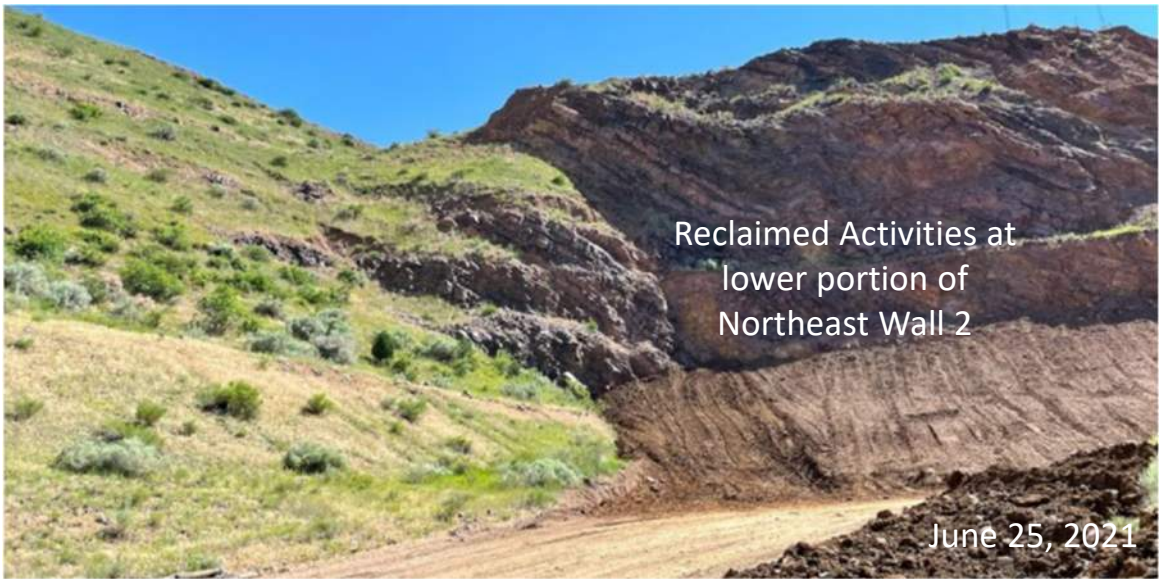
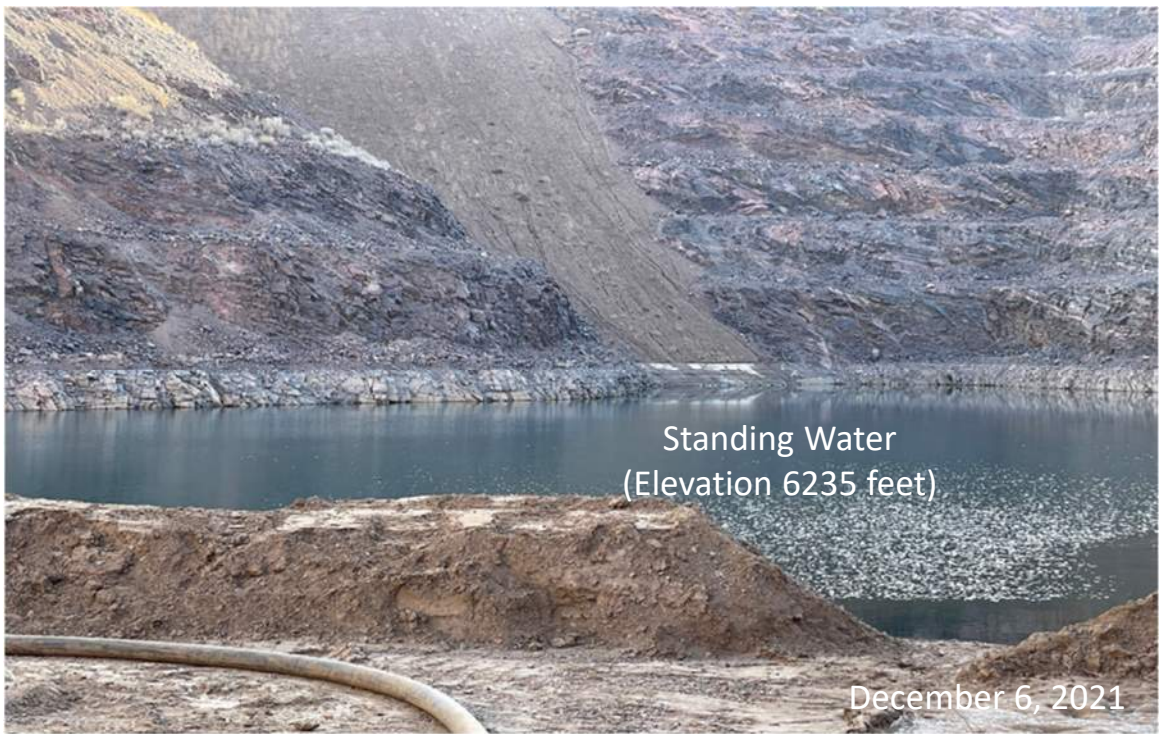
Photo 4

Looking East (Northeast Walls 1-2)

Looking East (access road temporary walls)

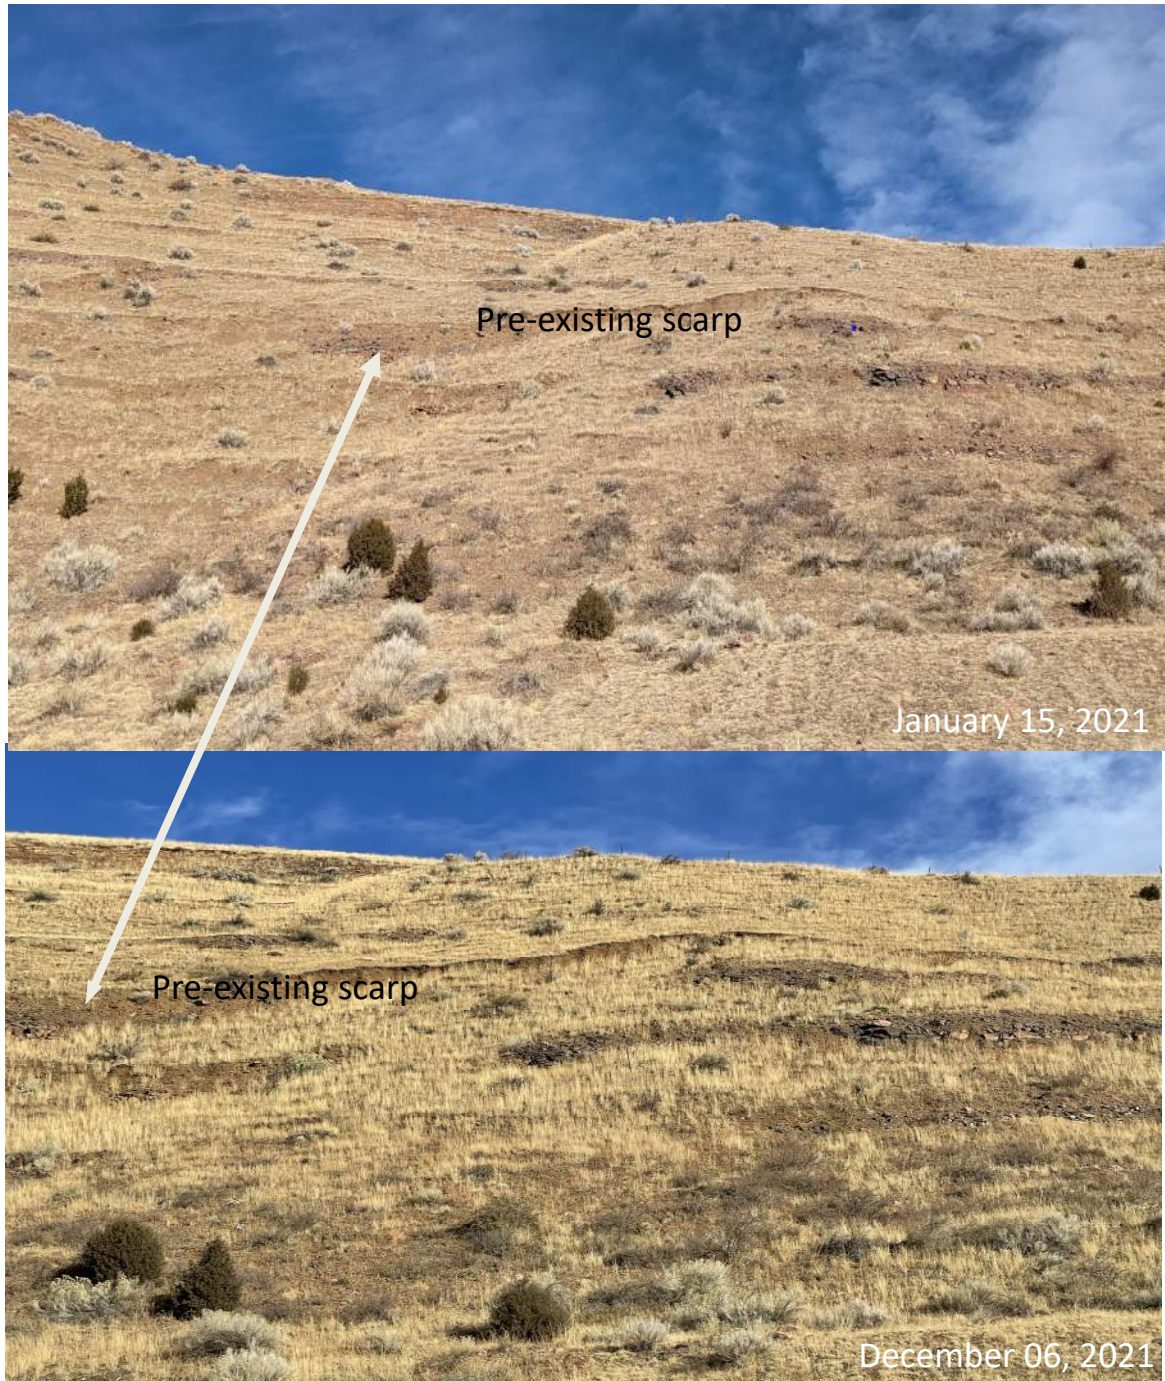
After planar failure along foliation planes in 1998 and 1999, the overall effective angle of the last three benches of the Northeast Wall 1 and the Northwest Wall were reduced to an overall angle of 35°, which is consistent with the 2003 Lachel geotechnical evaluation (Lachel, 2003). The failure surfaces (i.e., the

surfaces along which movement has occurred) remain at a “residual strength” and therefore are less resistant to additional loading. Based on visual inspection from the access road and bottom of the pit, these slopes did not appear to show signs of additional movement during the site visits for this study (Photo 5). Although the slope configuration is currently stable, the failure mechanism could potentially be reactivated, resulting in movement of additional material. The Northwest Wall, Northeast Wall 1, and Northeast Wall 3 (Figure 2) should continue to be visually monitored for indications of instability.

Looking north from the Main Pit Area showing pre-existing scarp feature on the Northeast Wall 1. Area appears unchanged since January 2021.
