**MINERALS PROGRAM INSPECTION REPORT**  
**PHONE: (303) 866-3567**

<b>MINE NAME:</b> Western Slope Flagstone Quarry No. 2	<b>MINE/PROSPECTING ID#:</b> M-1996-076	<b>MINERAL:</b> Gravel	<b>COUNTY:</b> Mesa
<b>INSPECTION TYPE:</b> Surety-Related Inspection	<b>INSPECTOR(S):</b> Lucas West	<b>INSP. DATE:</b> January 24, 2022	<b>INSP. TIME:</b> 13:55
<b>OPERATOR:</b> Rudolph Fontanari	<b>OPERATOR REPRESENTATIVE:</b> Rudolph and Brett Fontanari	<b>TYPE OF OPERATION:</b> 112c - Construction Regular Operation	
<b>REASON FOR INSPECTION:</b> High Priority	<b>BOND CALCULATION TYPE:</b> None	<b>BOND AMOUNT:</b> \$163,251.00	
<b>DATE OF COMPLAINT:</b> NA	<b>POST INSP. CONTACTS:</b> None	<b>JOINT INSP. AGENCY:</b> None	
<b>WEATHER:</b> Clear	<b>INSPECTOR'S SIGNATURE:</b>

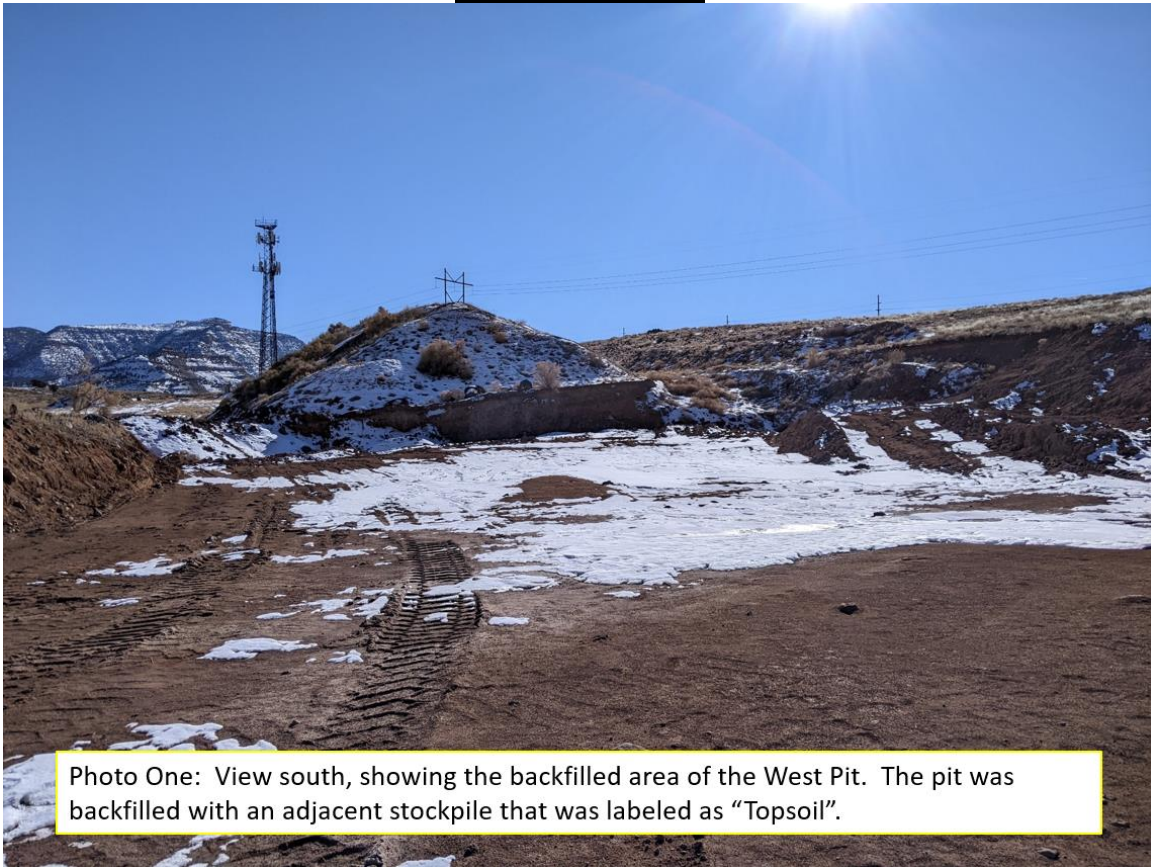
**Northern Mining Area:** The Northwest Pit area is located in the northern section of the Permit Area, near where the east access road reaches the top of the Mesa. Utilizing the marked "Topsoil" stockpile located adjacent to the pit, the Operator has mostly backfilled the pit, sloping the pit floor to the north. The backfilled pit floor can be seen in Photo One and Two. Along the west edge of the pit, approximately 50 linear feet of the backfilled area has been graded (sloped) to match the adjacent undisturbed topography. In that 50 foot area additional topdressing will be required to make the slope sufficiently blend and achieve the final grade. This area has been graded at approximately a 3H: 1V slope. This area can be seen in Photo Three. Just south of the blended area, approximately 75 linear feet of the backfill is at a 2H: 1V slope and requires minor grading and blending to achieve the final reclamation topography. This area can be seen in Photo Four. The southwest corner of the pit was left at a near vertical highwall to allow for future mining to proceed to the south. There are two highwalls in this area, one on the south face and one on the west. The south highwall increases from east to west, and ranges in height from 6 feet to 12 feet at its highest point, and is approximately 50 linear feet. The highwall on the west face is approximately 20 feet tall at its highest point, and 30 feet long. The south highwall can be seen in Photo Five, and the west highwall in Photo Six. On site discussions with the Operator indicate that no additional topsoil was placed on the backfilled or sloped areas and no seeding had been done.

Photo One: View south, showing the backfilled area of the West Pit. The pit was backfilled with an adjacent stockpile that was labeled as "Topsoil".

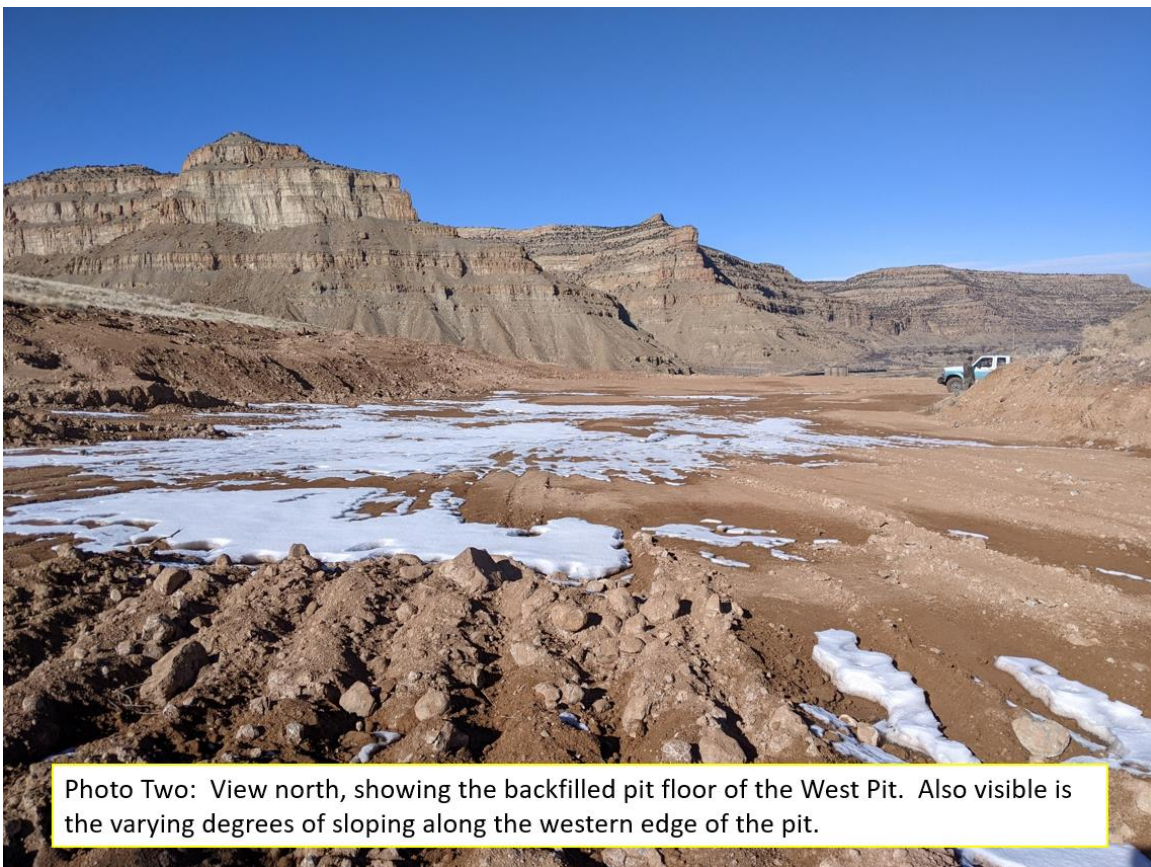
Photo Two: View north, showing the backfilled pit floor of the West Pit. Also visible is the varying degrees of sloping along the western edge of the pit.

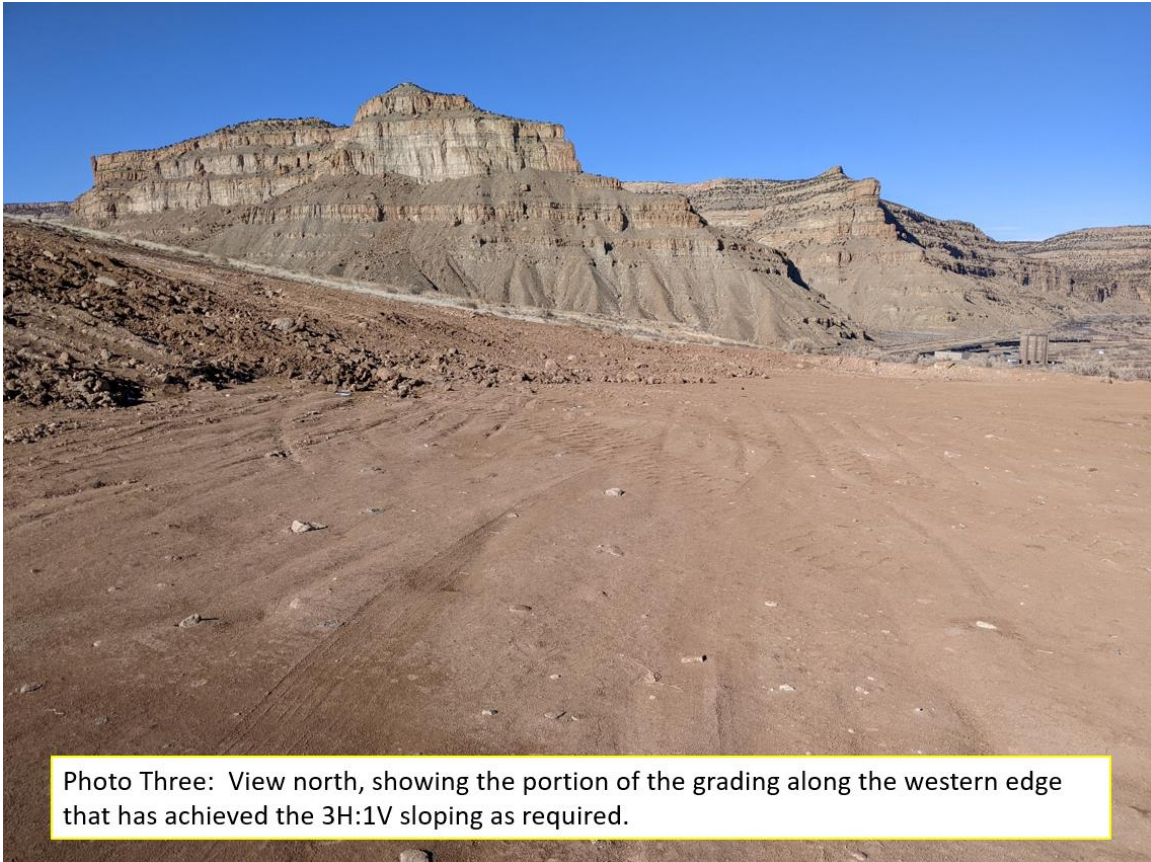
Photo Three: View north, showing the portion of the grading along the western edge that has achieved the 3H:1V sloping as required.

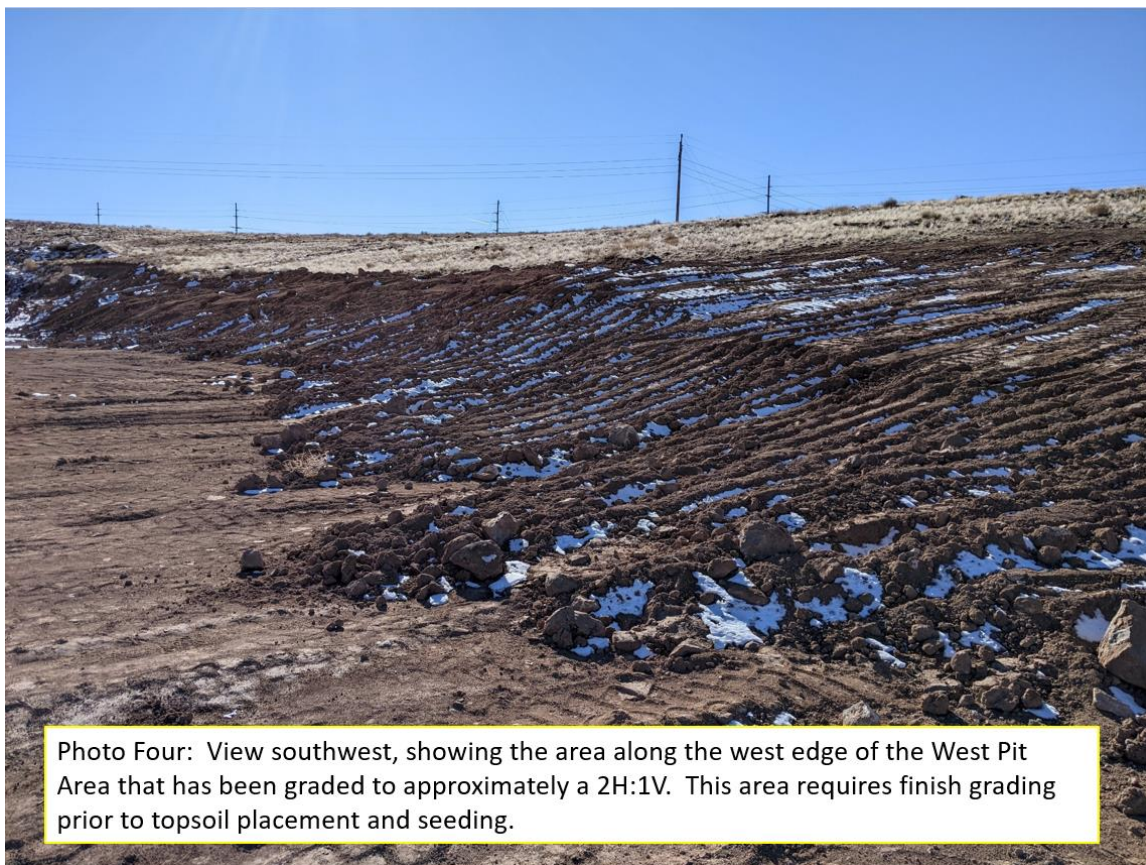
Photo Four: View southwest, showing the area along the west edge of the West Pit Area that has been graded to approximately a 2H:1V. This area requires finish grading prior to topsoil placement and seeding.

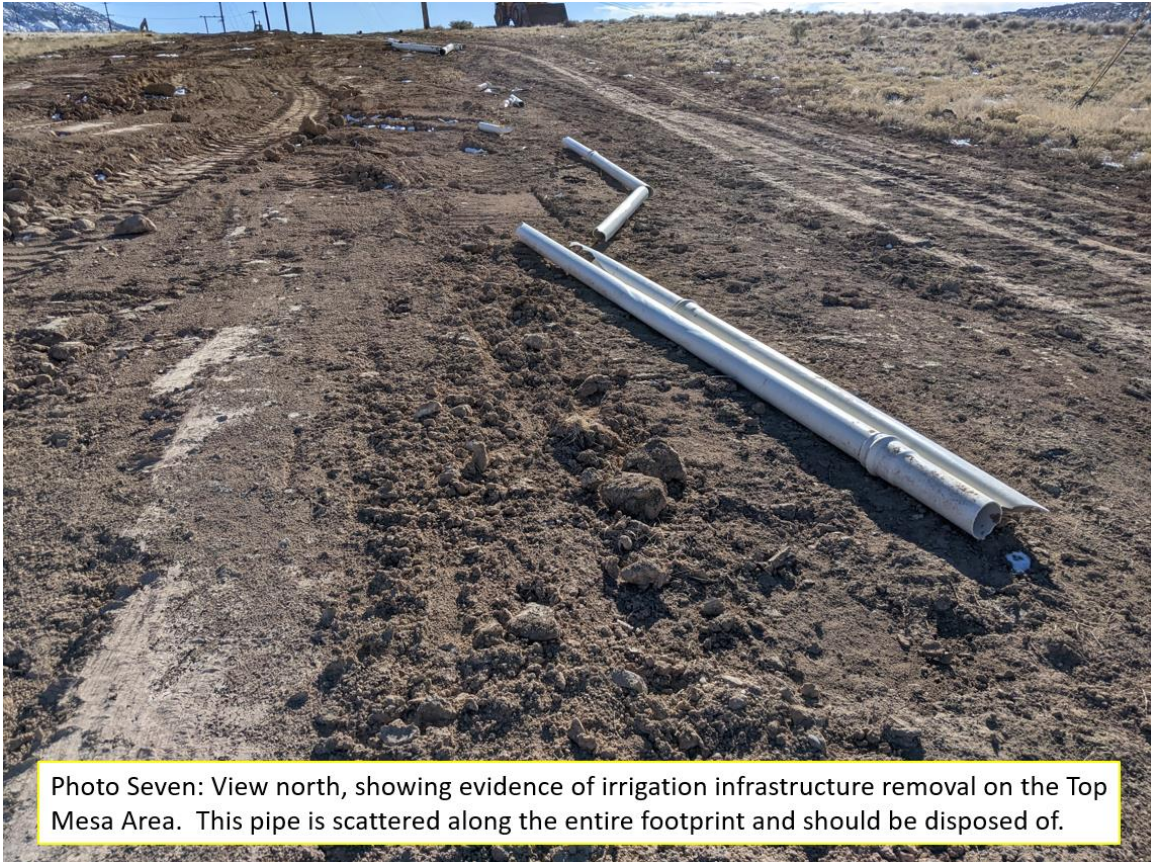
Photo Seven: View north, showing evidence of irrigation infrastructure removal on the Top Mesa Area. This pipe is scattered along the entire footprint and should be disposed of.

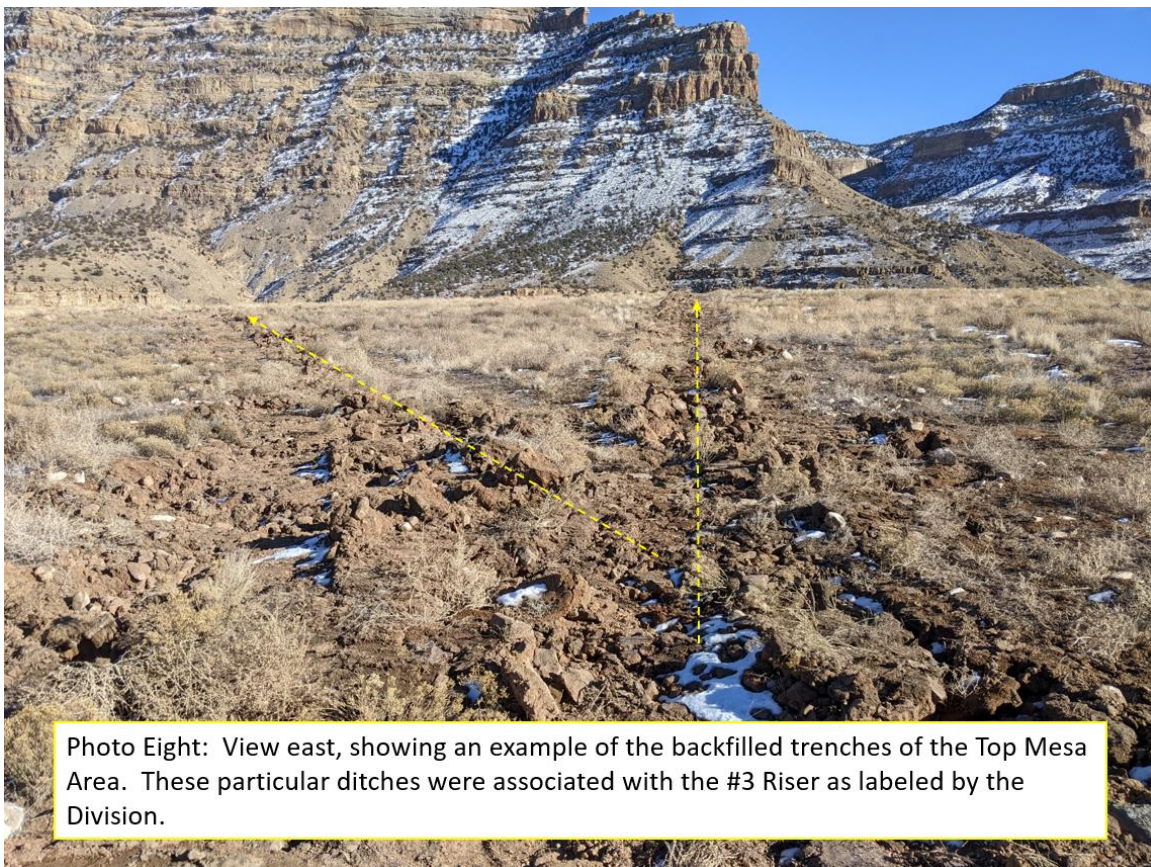
**Northern Irrigation Area:** In the Northern Irrigation Area, there were a series of five irrigation risers installed on an underground main line that were within the Permit Area. Leading away from the risers in a generally easterly direction were a series of ditches used as water conveyances. All irrigation infrastructure including the main line and risers, north of the #8 riser, as identified by the Division has been removed. The approximate linear foot of main line that was removed is around 1200 feet within the Permit Boundary. Evidence of the removal by way of pipe segments laid on the ground can be seen in Photo Seven. All of the ditches associated with the risers have been backfilled, examples of the backfilled ditches can be seen in Photos Eight and Nine. The footprint of the mainline was observed as it passes through the Permit Area. The

Photo Eight: View east, showing an example of the backfilled trenches of the Top Mesa Area. These particular ditches were associated with the #3 Riser as labeled by the Division.

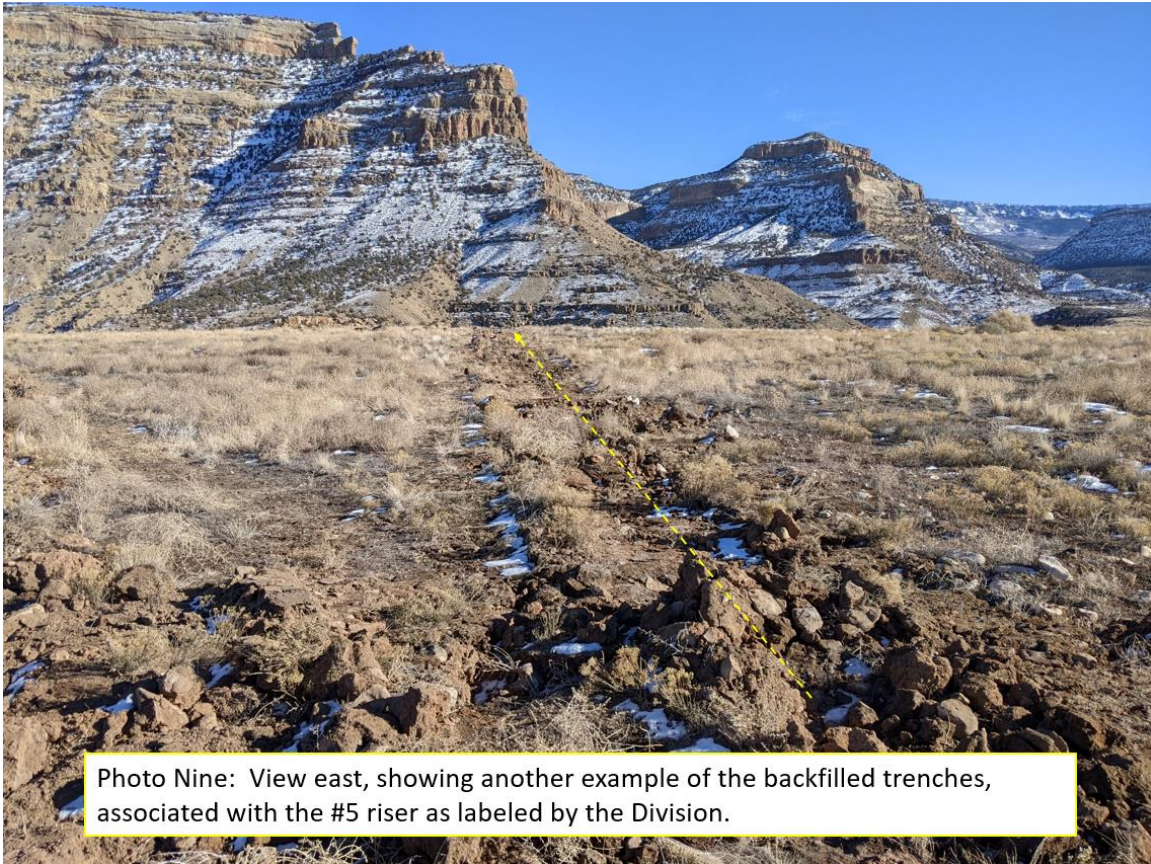
Photo Nine: View east, showing another example of the backfilled trenches, associated with the #5 riser as labeled by the Division.

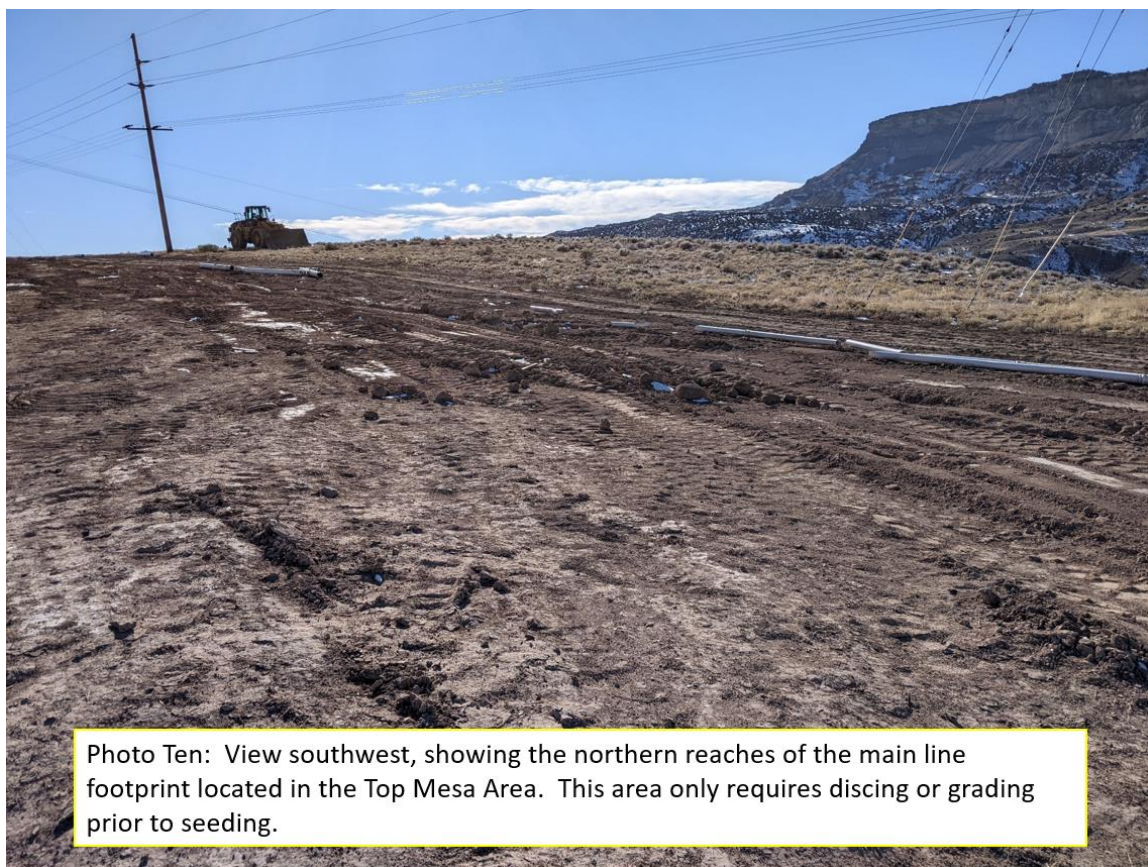
northern reaches of the footprint have been graded, with minimal excess material left on the surface. Approximately 250 – 300 linear feet of the area requires no finish grading or additional dirt work. An example of this area can be seen in Photo Ten. The remaining 900 – 950 linear feet of the footprint of the mainline has resulted in backfill material and large rocks remaining on the surface. The approximate depth of this material ranges from 6 to 18 inches deep moving from the north to the south of the footprint. This area can be seen in Photo Eleven. On site discussions with the Operator indicate the rocky material will be pushed from its current location, to the west, to create a small berm along the edge of the mesa. The remaining work to be done in the Top Mesa Area includes pushing the material to create the berm, finish grading of the footprint of the irrigation mainline and seeding of the appropriate areas.

Photo Ten: View southwest, showing the northern reaches of the main line footprint located in the Top Mesa Area. This area only requires discing or grading prior to seeding.

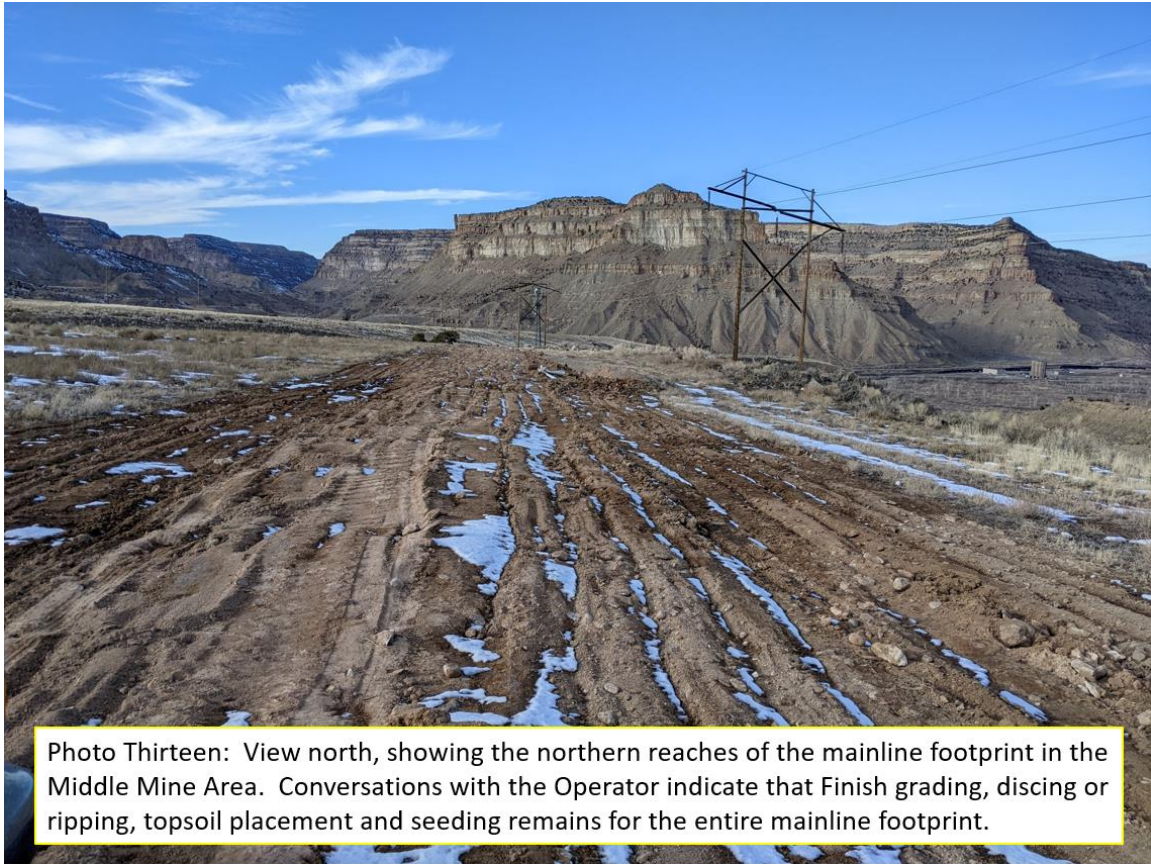
Photo Thirteen: View north, showing the northern reaches of the mainline footprint in the Middle Mine Area. Conversations with the Operator indicate that Finish grading, discing or ripping, topsoil placement and seeding remains for the entire mainline footprint.
