Keenesburg Mine Site Inspection Report

4th Quarter

12/14/2021

COORS ENERGY KEENESBURG MINE

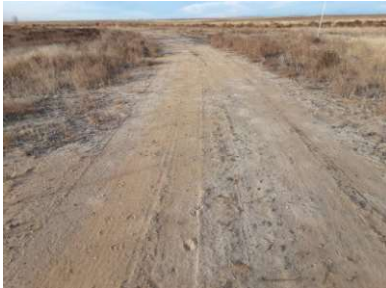
Gate access road still been utilized. Close road once revegetation has been completed.

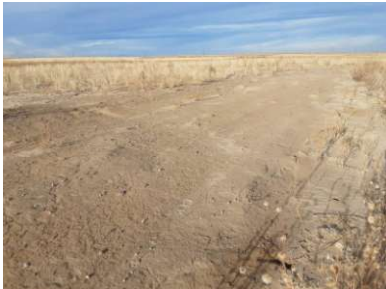
Included small isolated bare patches in revegetation

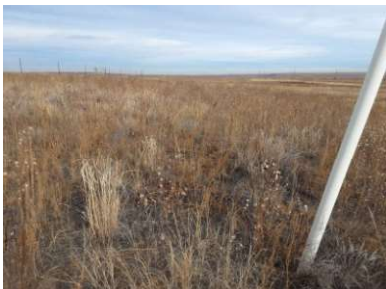
Inspected far northwest corner of property. Vegetation well established. Markers in place.

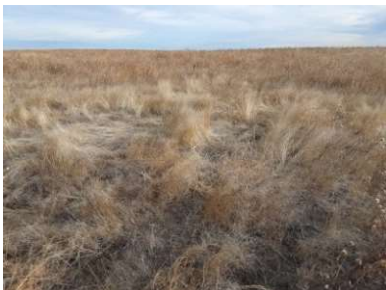
Species: Cheatgrass/Downy brome - *Bromus tectorum* - List C

Isolated patches of cheatgrass inside of west boundary markers

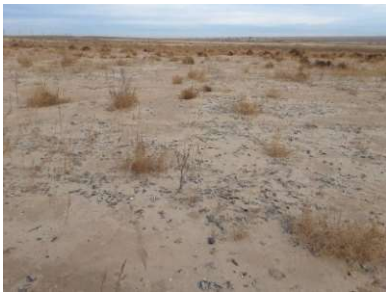
Minimal vegetation in Area 35. Monitor and consider implementing Area into future revegetation plans.

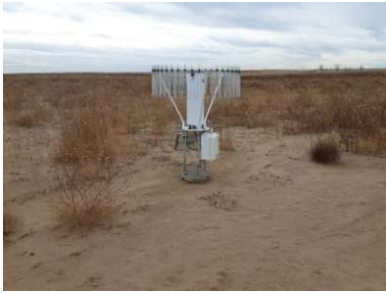
Weather station inspected. Minor erosion around concrete base. Divert sheet flows during revegetation cross ripping.

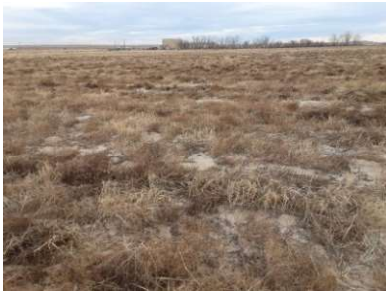
Debris naturally breaking down in 2021 mowed area.

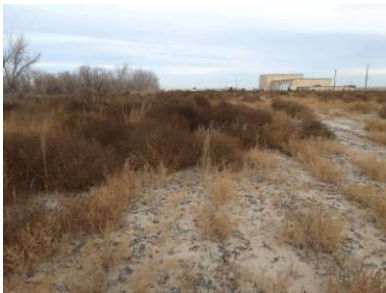
Species: Sunflower stocks are dense in some areas. *Salsola* is also dense in some areas. Consider spot mowing areas in early summer to help desirable vegetation establish

Area 36 and Area 39 (see photo #8)

Dense Salsola in pending revegetation area. Monitor area post revegetation and mow if necessary to control.
