February 3, 2022

**Re: Loveland Ready-Mix Concrete, Inc., Green/Croissant Property Sand and Gravel Mine, File No. M-2001-022, Cell 4 Reclamation Slope Evaluation Review**

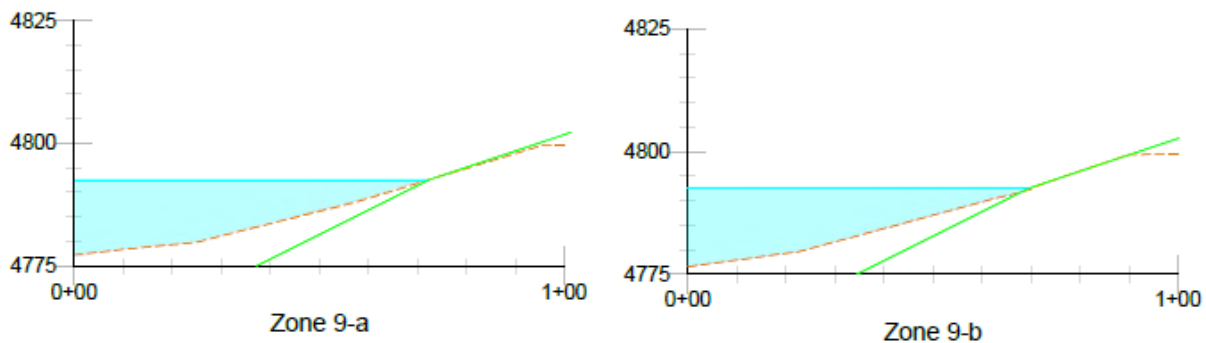
6. For Zones 9, 20, 25, 26 and part of 27 the report states the following:
  - a. Zone 9: Both sections (Zone 9a and Zone 9b) show slopes at or shallower than 3H:1V for 15 feet horizontally from water’s edge, and flatter below the water surface.

The Division agrees the slope appears to be 3H:1V and in compliance above the waterline. The Division does not agree the slope below the waterline complies with the requirements of the approved Reclamation Plan. Please explain the comment that the slopes below the waterline are flatter.

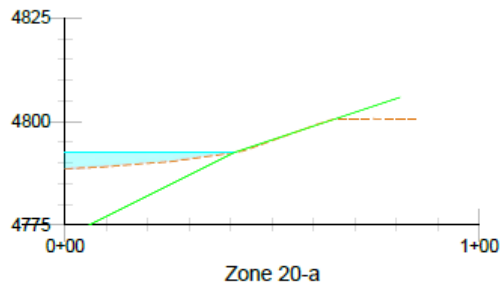
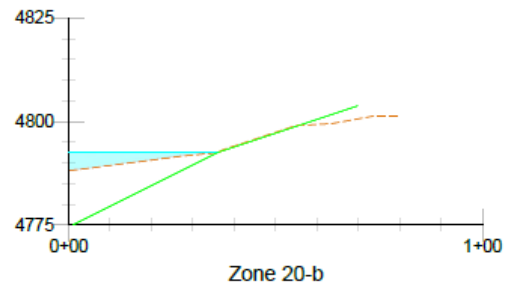
- b. Zone 20: Both sections (Zone 20a and 20b) show slope compliance because the average slopes 15 feet and 20 feet horizontally from water’s edge (above and below water level, respectively) are shallower than Rule 3.1.5(7) requirements.

The Division agrees the slope appears to be 3H:1V and in compliance above the waterline. The Division does not agree the slope below the waterline complies with the requirements of the approved Reclamation Plan.

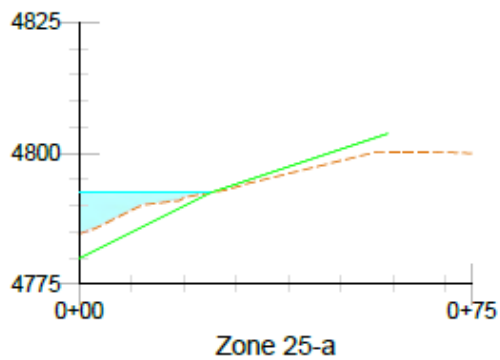
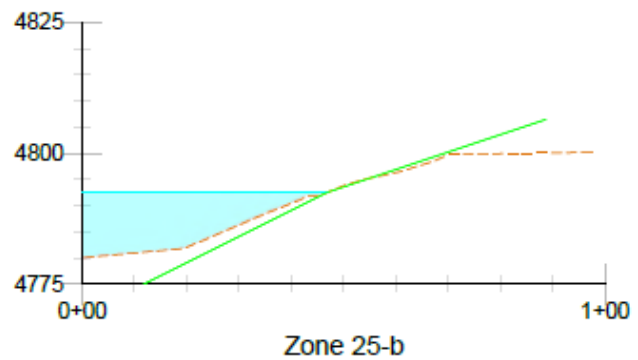
- c. Zone 25: Section Zone 25a is shallower than the Rule requirement. Section Zone 25b averages 3H:1V for 15 feet from the water's edge

The Division agrees the slope appears to be 3H:1V and in compliance above the waterline. The Division does not agree the slope below the waterline complies with the requirements of the approved Reclamation Plan.

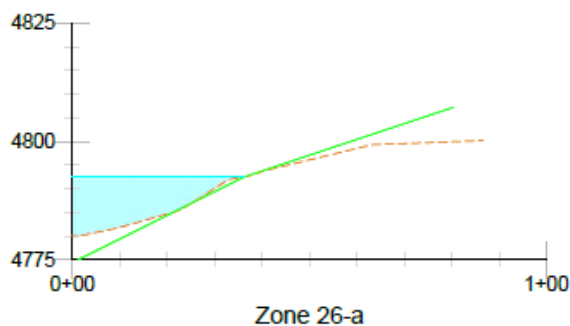
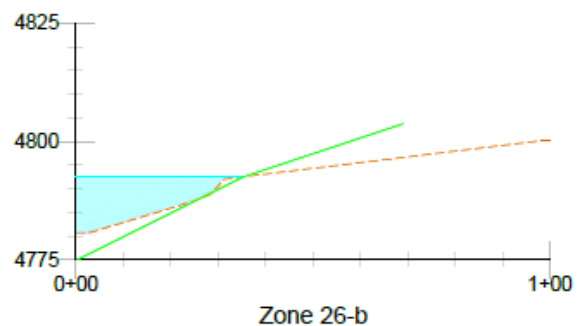
- d. Zone 26: Above the water level, both sections show the slopes are gentler than Rule requirements. Below the water level, the average slopes are at the requirement.

The Division agrees the slope appears to be 3H:1V and in compliance above the waterline with the exception of the typical shoreline erosion area. The Division does not agree the slope below the waterline complies with the requirements of the approved Reclamation Plan.

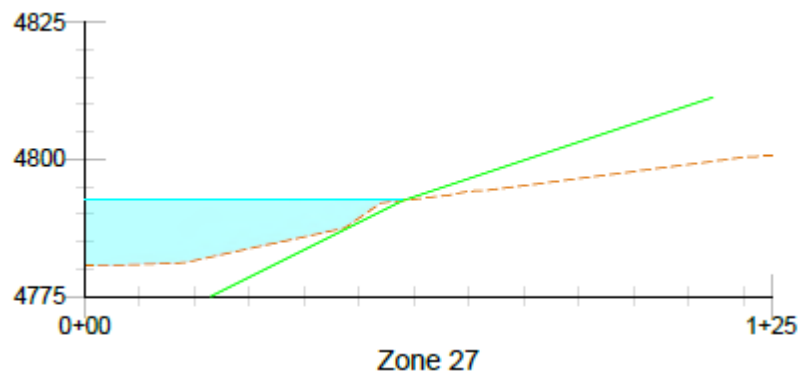
e. Part of Zone 27: Meets average reclamation slopes

The Division agrees the slope appears to be 3H:1V and in compliance above the waterline with the exception of the typical shoreline erosion area. The Division does not agree the slope below the waterline complies with the requirements of the approved Reclamation Plan.

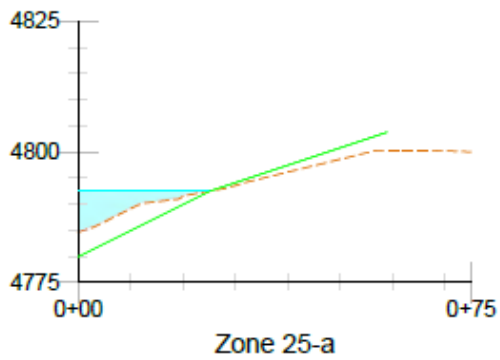
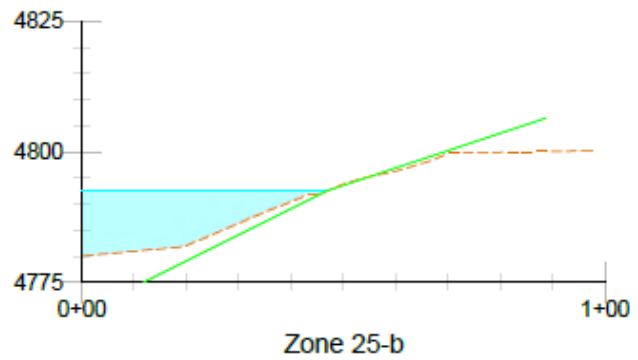
## Sheet 1

9. The cross sections for Zone 25 on Sheet 1 and Sheet 2 are different. Please explain this discrepancy and revise the maps accordingly.
