Attachment D

SPCC C-1 Diesel and Gas Storage & Filling Station

Date of Inspection	2021-01-28
Inspection Frequency	Monthly

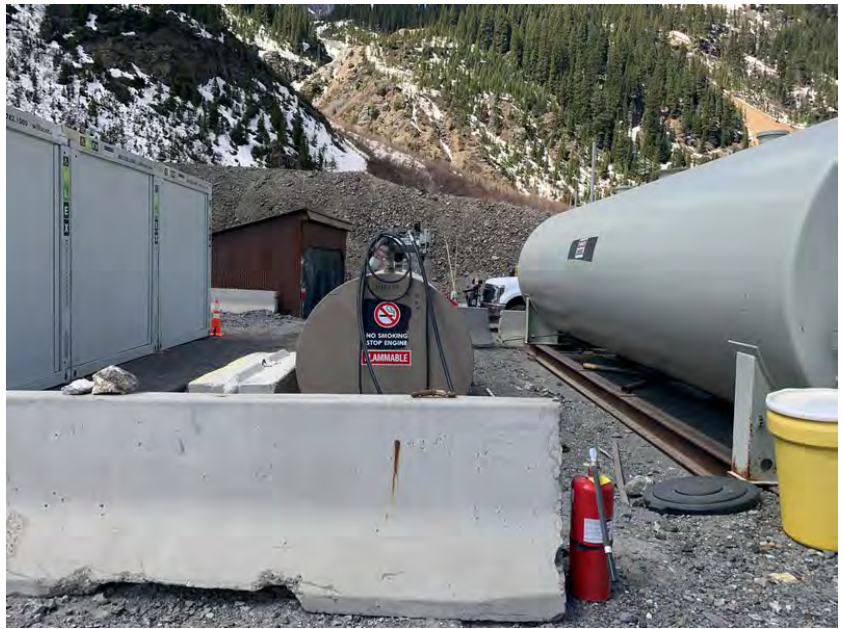
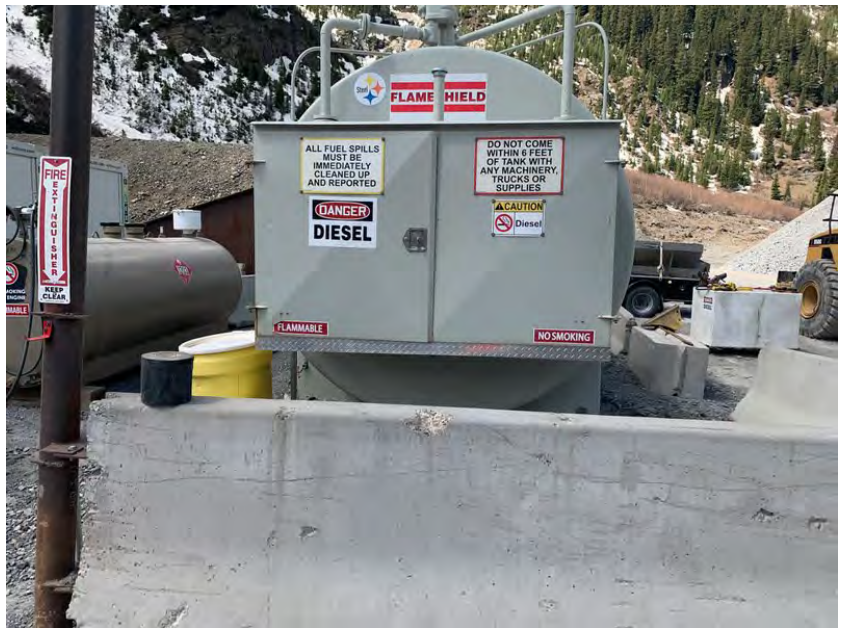
Tank photos (both tanks)

Are diesel pipelines or supports damaged, rusted or otherwise deteriorating?	No
Do diesel joints, valves, valve seals, gaskets or other appurtenances show signs of leakage?	Yes
Loading/unloading deisel connections are capped or blank flanged?	Yes
Is any maintenance required on diesel connections?	Yes
Note corrective action needed for diesel transfer and connections	Check for leaks or confirm it's spill

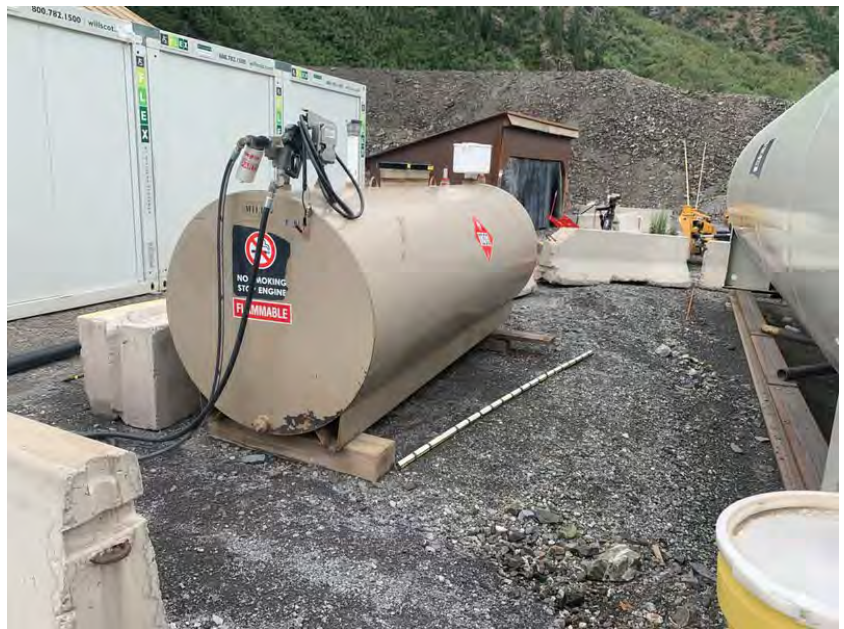
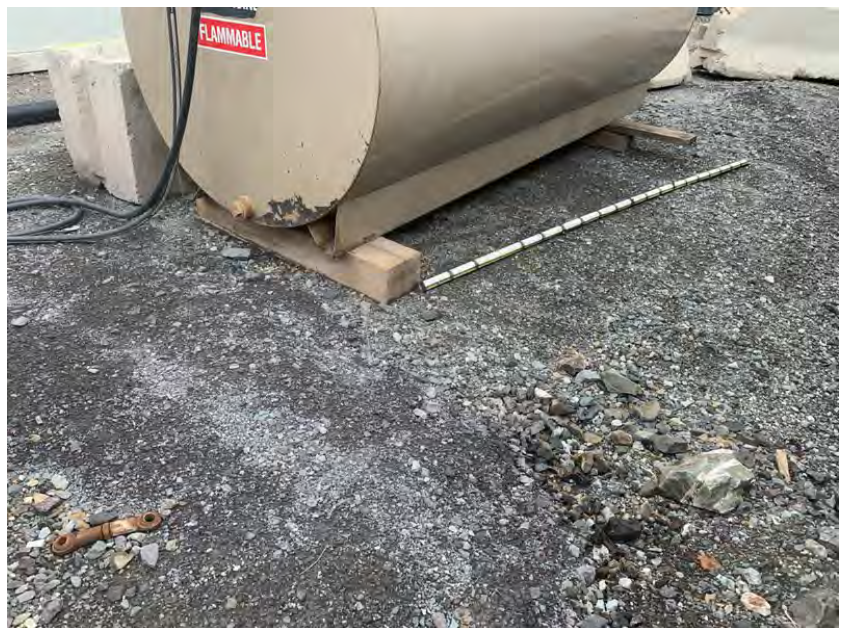
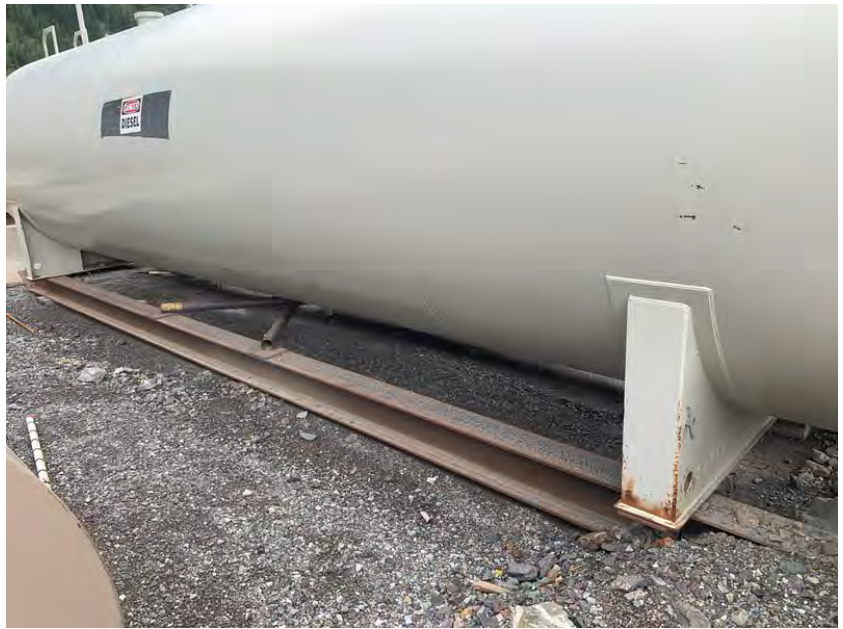
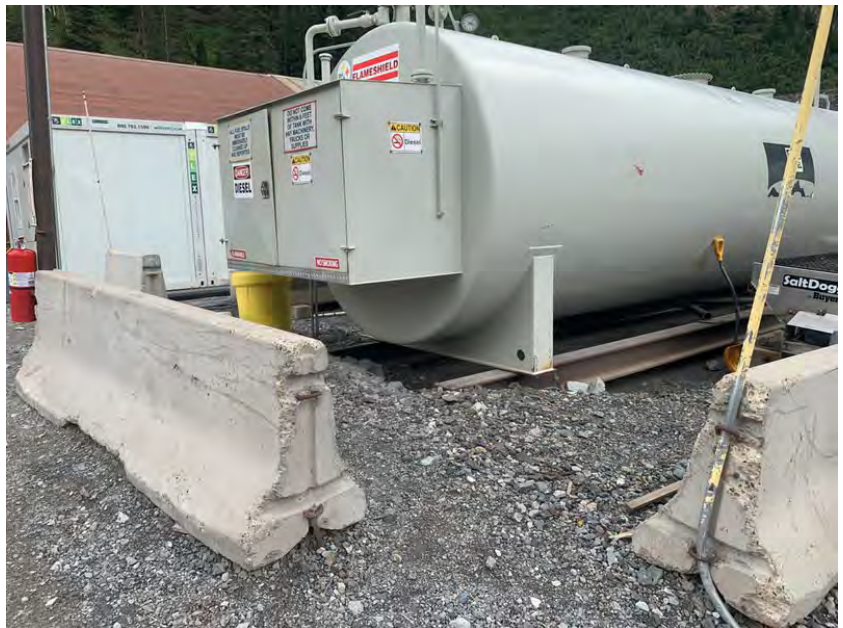
Tank photos (both tanks)

Are diesel pipelines or supports damaged, rusted or otherwise deteriorating?	No
Do diesel joints, valves, valve seals, gaskets or other appurtenances show signs of leakage?	No
Loading/unloading deisel connections are capped or blank flanged?	Yes
Is any maintenance required on diesel connections?	Yes
Note corrective action needed for diesel transfer and connections	Swap spill pads.

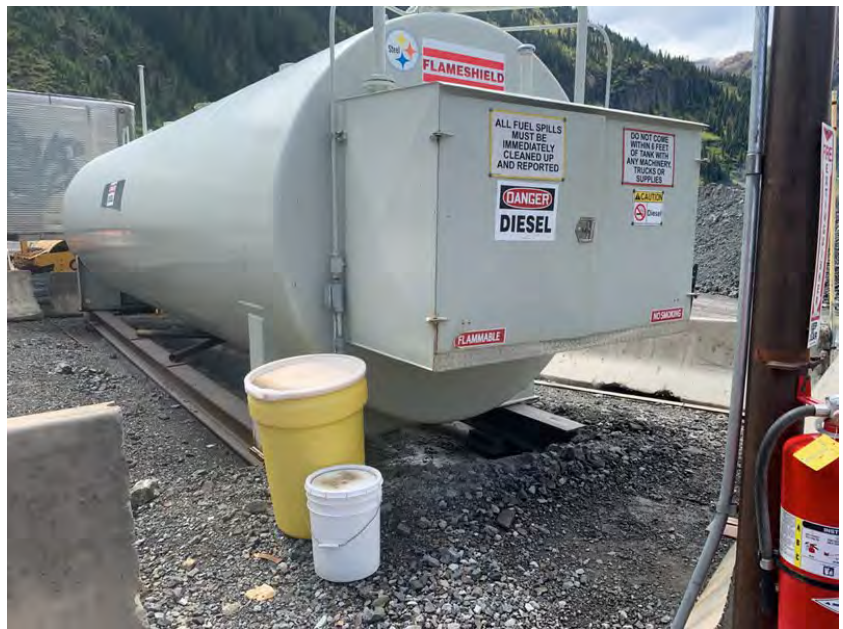
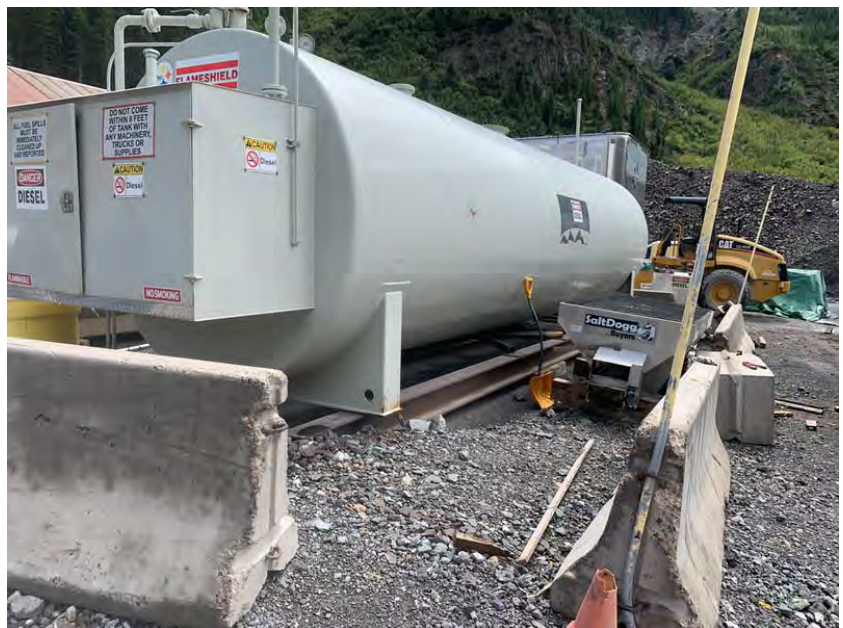
Tank photos (both tanks)

Do diesel tank surfaces show signs of leakage?	No
Is diesel tank damaged, rusted or otherwise deteriorating?	No
Are diesel tank supports damaged, rusted or otherwise deteriorating?	No
Are diesel tank foundations eroded or settled?	No
Diesel fill level gauge functional?	Yes
Note diesel fill level (inches)	43
Are diesel tank vents free of obstruction?	Yes
Is diesel secondary containment damaged?	No
Is any maintenance required for diesel tank?	Yes
Note corrective action needed for diesel tank	Clean up within the diesel storage tank. Used gasoline rags need to go to the waste storage pad.

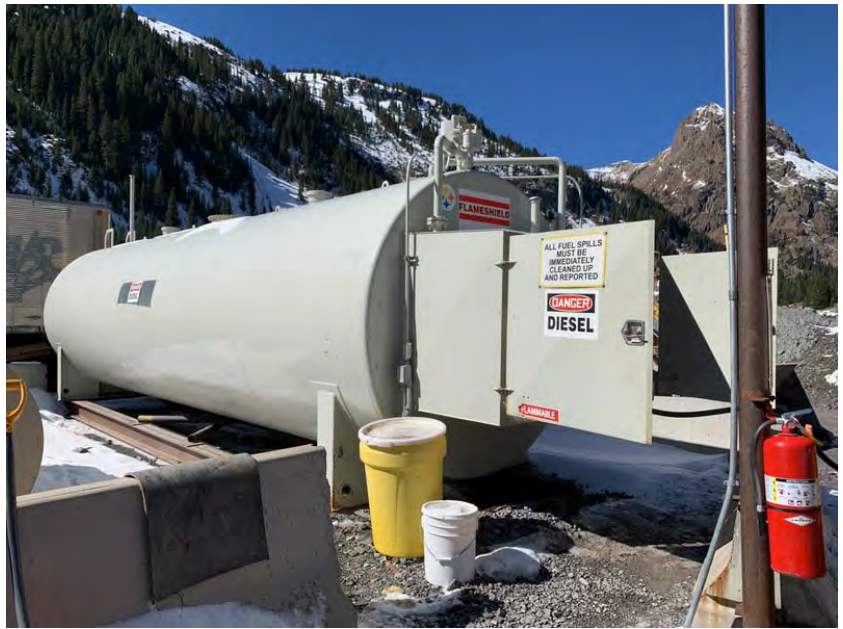
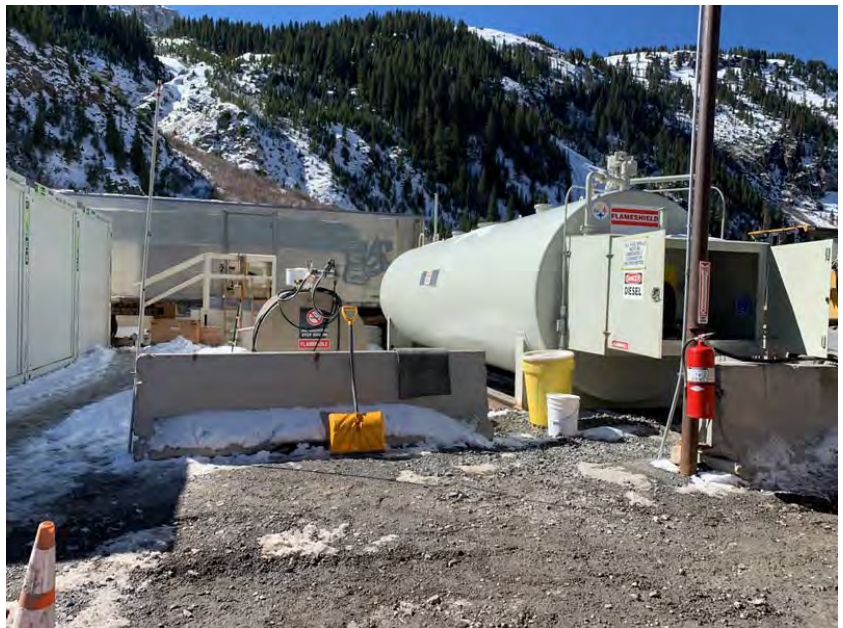
Tank photos (both tanks)

Do diesel tank surfaces show signs of leakage?	No
Is diesel tank damaged, rusted or otherwise deteriorating?	No
Are diesel tank supports damaged, rusted or otherwise deteriorating?	No
Are diesel tank foundations eroded or settled?	No
Diesel fill level gauge functional?	Yes
Note diesel fill level (inches)	32
Are diesel tank vents free of obstruction?	Yes
Is diesel secondary containment damaged?	No
Is any maintenance required for diesel tank?	Yes
Note corrective action needed for diesel tank	Clean up inside door. Light spillage on the inside

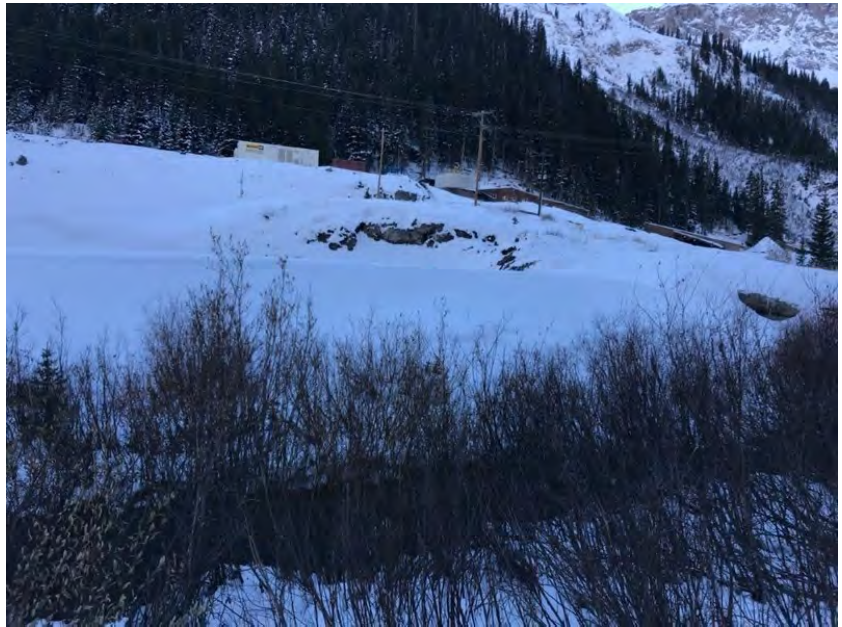
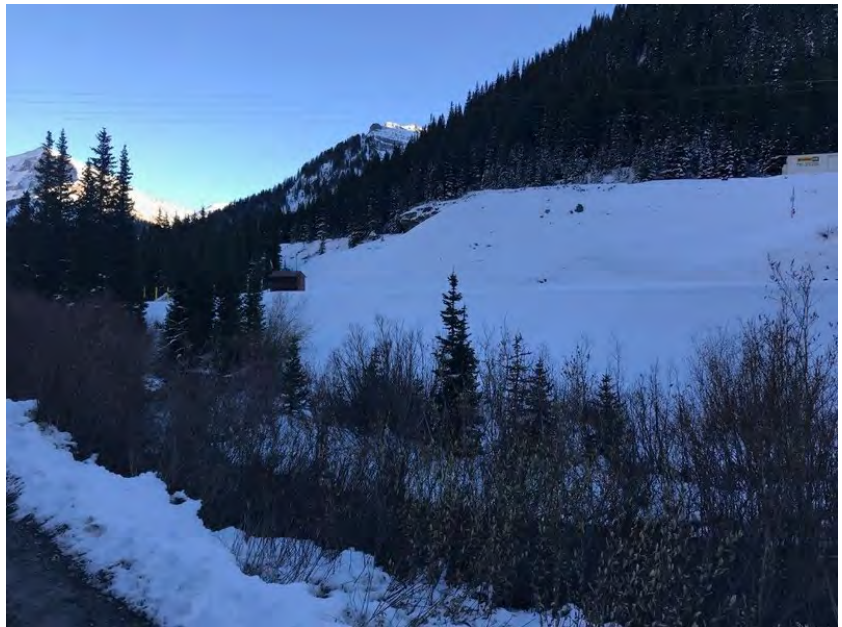
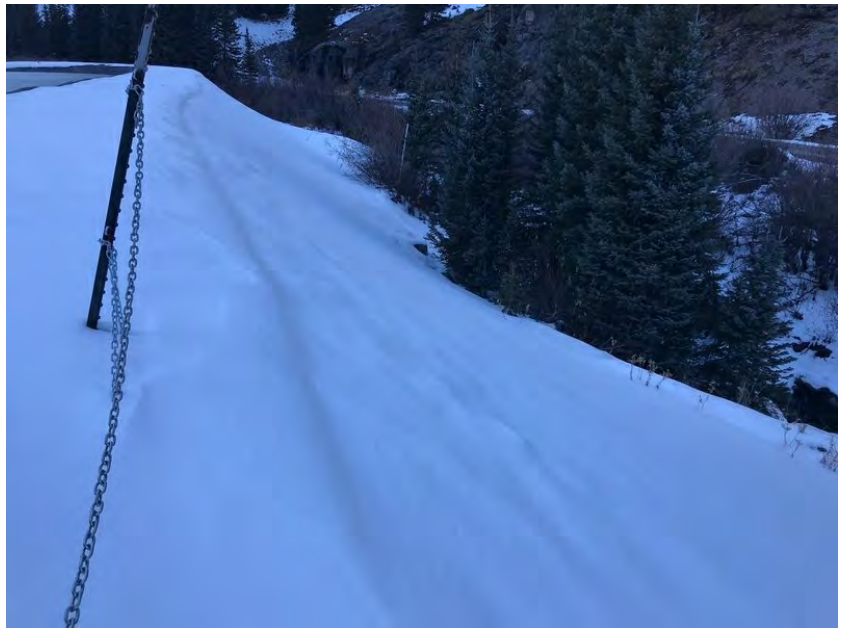
Containers & Containment

Created	2021-10-31 10:40:30 MDT by Environmental Department
Updated	2021-10-31 10:43:59 MDT by Environmental Department
Location	37.9739932, -107.7507483
Date	2021-10-31
Time	10:40
Weather Conditions	Sunny, but snow-covered
Water Present?	No
Notes	Area snow covered.

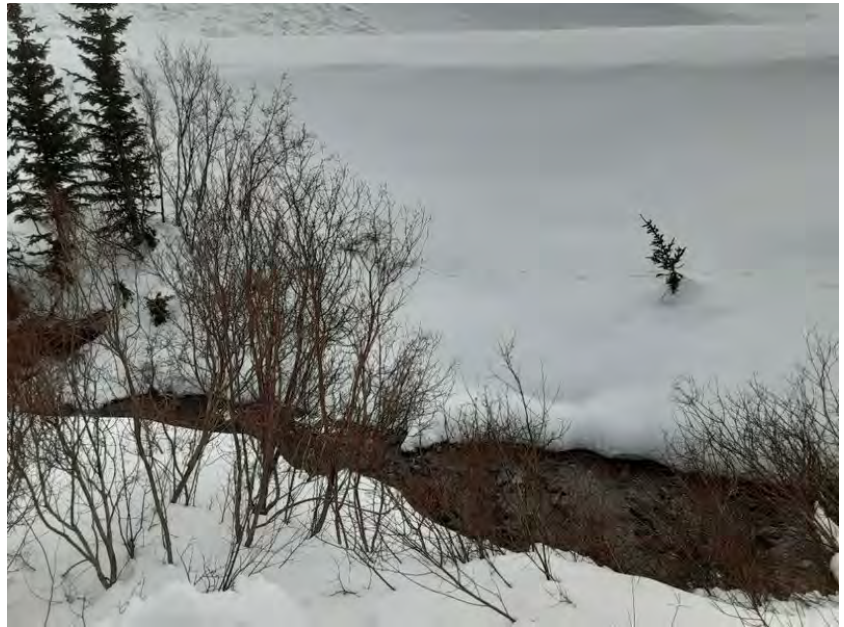
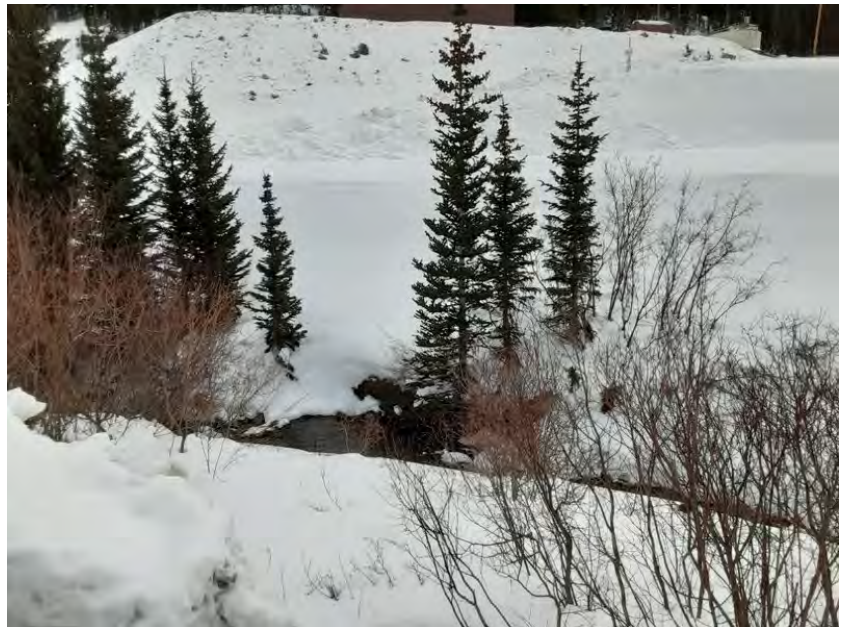
Photos

Created	2022-01-19 14:17:50 MST by Environmental Department
Updated	2022-01-19 14:29:28 MST by Environmental Department
Location	37.9739417, -107.7507733
Date	2022-01-19
Time	14:17
Weather Conditions	Cloudy. Ground snow covered
Water Present?	No
Notes	Ground snow covered.
