MINERALS PROGRAM INSPECTION REPORT
PHONE: (303) 866-3567

MINE NAME: Bennett Pit	MINE/PROSPECTING ID#: M-2016-085	MINERAL: Sand and gravel	COUNTY: Weld
INSPECTION TYPE: Monitoring	INSPECTOR(S): Peter Hays	INSP. DATE: November 30, 2021	INSP. TIME: 12:00
OPERATOR: Northern Colorado Constructors	OPERATOR REPRESENTATIVE: Chris Zadel	TYPE OF OPERATION: 112c - Construction Regular Operation	
REASON FOR INSPECTION: Normal I&E Program	BOND CALCULATION TYPE: None	BOND AMOUNT: \$1,556,607.00	
DATE OF COMPLAINT: NA	POST INSP. CONTACTS: None	JOINT INSP. AGENCY: None	
WEATHER: Clear	INSPECTOR'S SIGNATURE:

SIGNATURE DATE: February 4, 2022

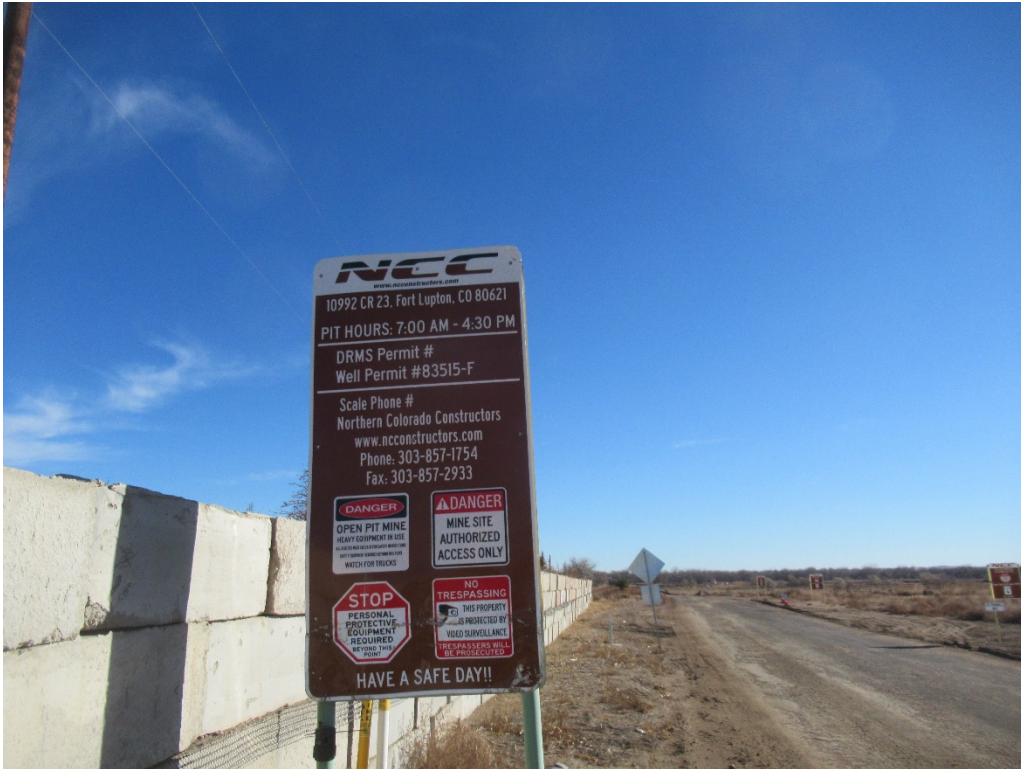
The mine sign and boundary markers were observed as required by Rule 3.1.12. The Division currently holds a reclamation bond in the amount of \$1,556,607.00, which is adequate to reclaim the site based on the observations from this inspection.

Bennett Pit mine sign

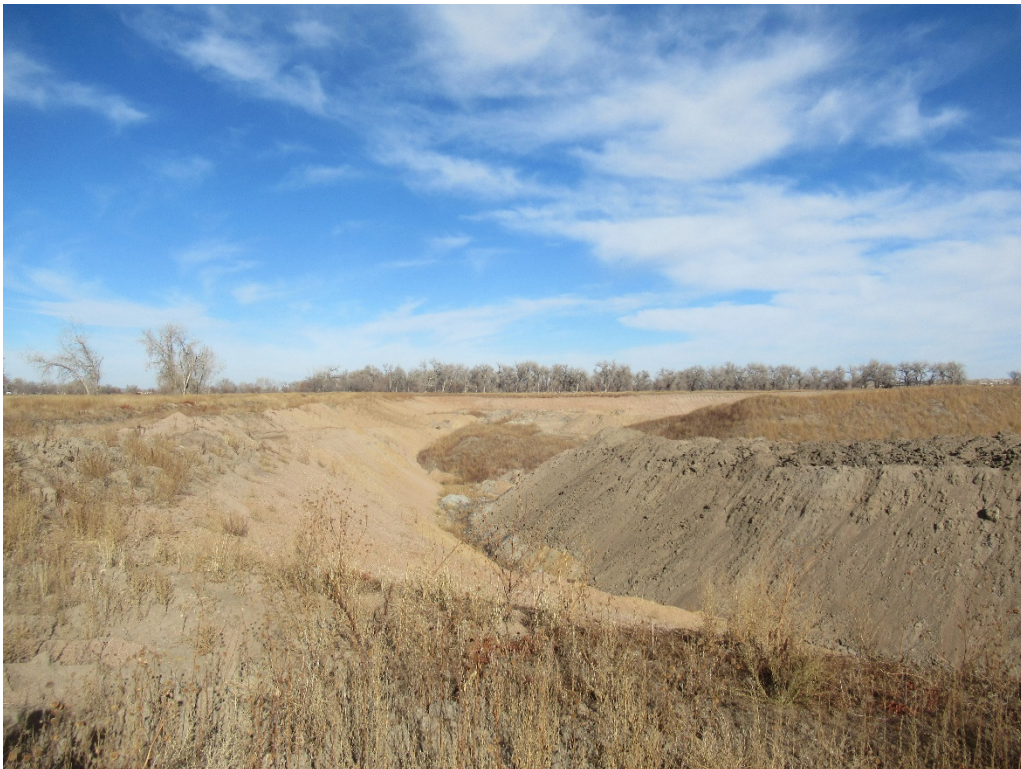
The excavation of the north cell is mostly complete. The depth of the cell was estimated at 25 feet. The southwest corner of the cell including the access ramp remain to be mined by the Operator. The north, east and south slopes of the cell have been rough graded to the required 3H:1V slope. The topsoil and overburden stockpiles required to complete reclamation of the cell were observed on the pit floor. The approved post-mining land use for the cell is developed water resource. The cell will be reclaimed to a 33.01 acre reservoir. The Operator stated the leak test for the slurry wall was complete. The Division will require proof of the slurry wall approval from the Division of Water Resources prior to any future release requests by the Operator.

View of the North Cell from the southwest corner looking north

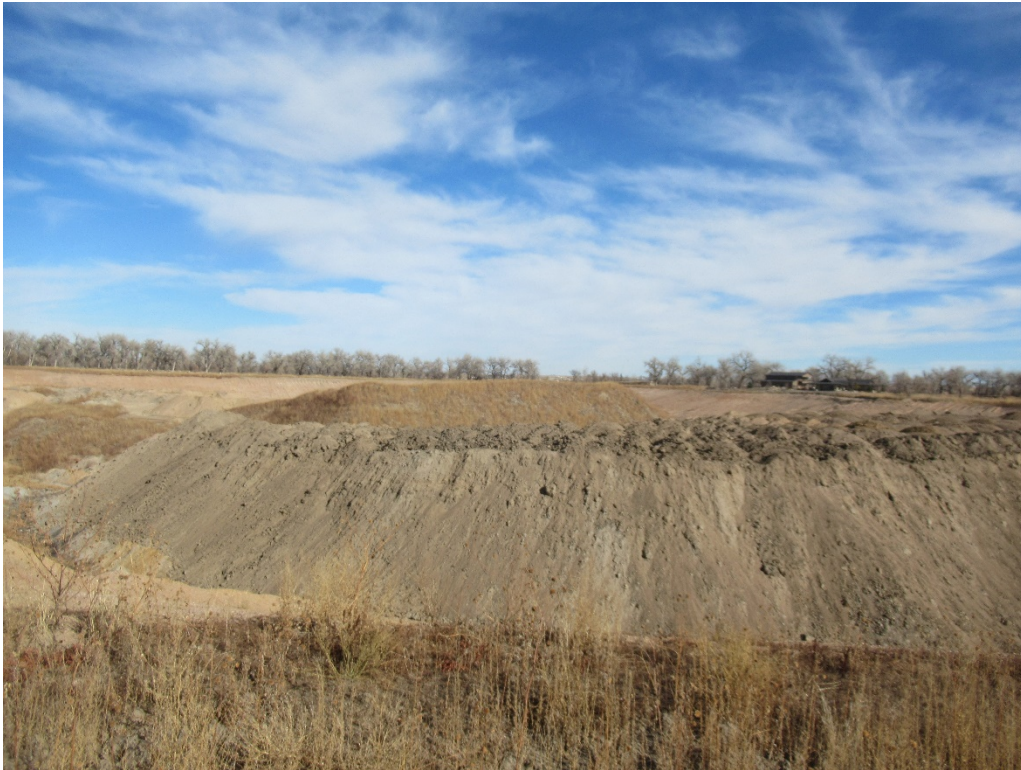
View of the North Cell from the southwest corner looking northeast

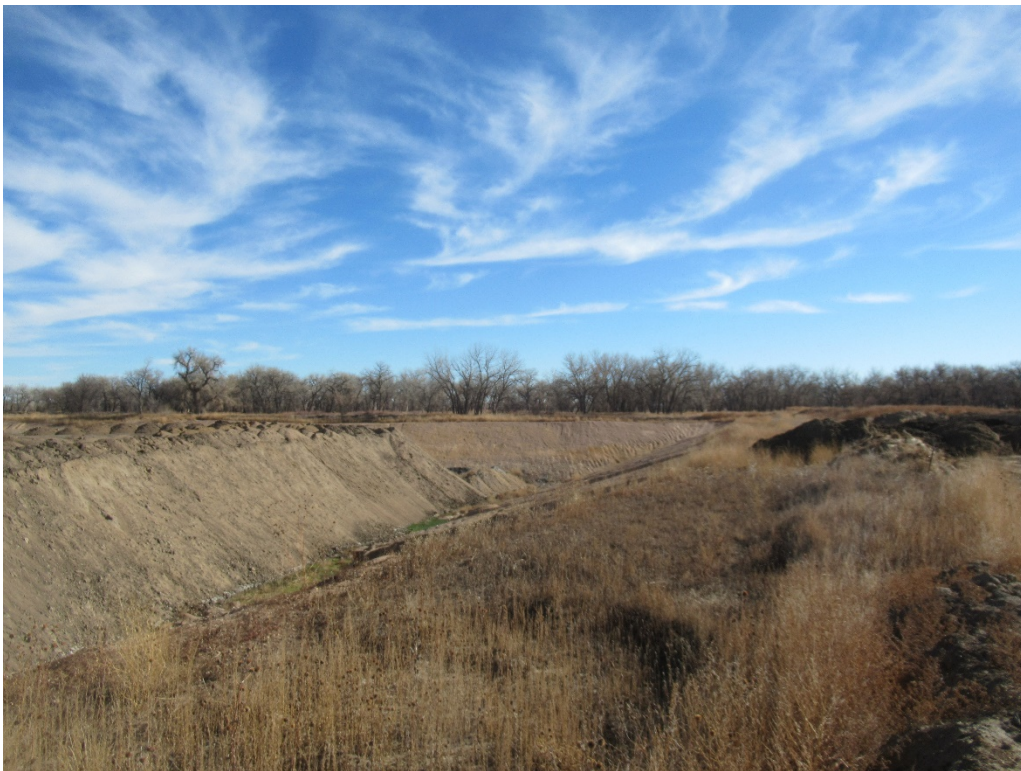
View of the North Cell from the southwest corner looking east

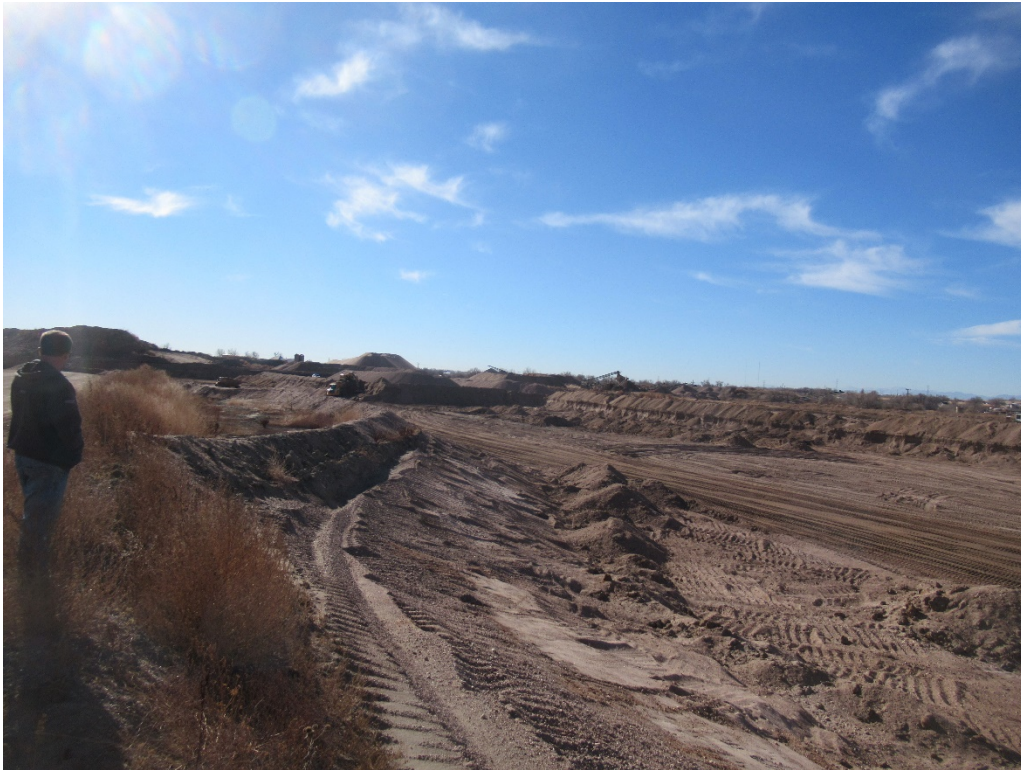
The excavation of the south cell was observed during the inspection. Material was being mined by an excavator and hauled by trucks to the processing plant or off-site. The cell is being mined roughly from south to north. The depth of the cell in the southern portion was estimated at 25 feet and the depth of the northern portion was estimated at 10 feet. A dewatering pond was located in the southeast corner of the cell. The Operator reported dewatering to the Platte River has not been required for a while. Three (3) settling ponds were observed along the west side of the current excavation in the cell. The processing plant is located in the southwest corner of the cell. A large topsoil stockpile was located in the southern portion of the cell. Groundwater is pumped from the cell to the fresh water pond. The water is used at the processing plant and pumped to the settling ponds for recycling. The approved post-mining land use for the cell is developed water resource. The cell will be reclaimed to a 65.05 acre reservoir. The Operator stated the leak test for the slurry wall was complete. The Division will require proof of the slurry wall approval from the Division of Water Resources prior to any future release requests by the Operator.

View of the South Cell from the northeast corner looking south
