**COLORADO**  
Division of Reclamation,  
Mining and Safety  
Department of Natural Resources

<b>Permit Number:</b> C-1981-018 <b>Mine Name:</b> Deserado Mine <b>Operator:</b> Blue Mountain Energy, Inc. <b>Operator Address:</b> Mr. Kurtis Blunt 3607 County Road 65 Rangely, CO, 81648	<b>County:</b> Moffat, Rio Blanco <b>Operation Type:</b> Underground <b>Permit Status:</b> Active <b>Ownership:</b> Private
	<b>Operator Representative Present:</b>  Kurt Blunt
<b>Operator Representative Signature: (Field Issuance Only)</b>

<b>Inspection Start Date:</b> January 31, 2022 <b>Inspection Start Time:</b> 11:30 <b>Inspection End Date:</b> January 31, 2022 <b>Inspection End Time:</b> 13:10		<b>Inspection Type:</b> Coal Partial Inspection <b>Inspection Reason:</b> Normal I&E Program <b>Weather:</b> Clear	
<b>Joint Inspection Agency:</b>  None		<b>Joint Inspection Contacts:</b>  None	
<b>Post Inspection Agency:</b>  None		<b>Post Inspection Contacts:</b>  None	
<b>Inspector(s):</b>  Clayton Wein	<b>Inspector's Signature:</b>  <i>Clayton Wein</i>		<b>Signature Date:</b>  2/4/2022

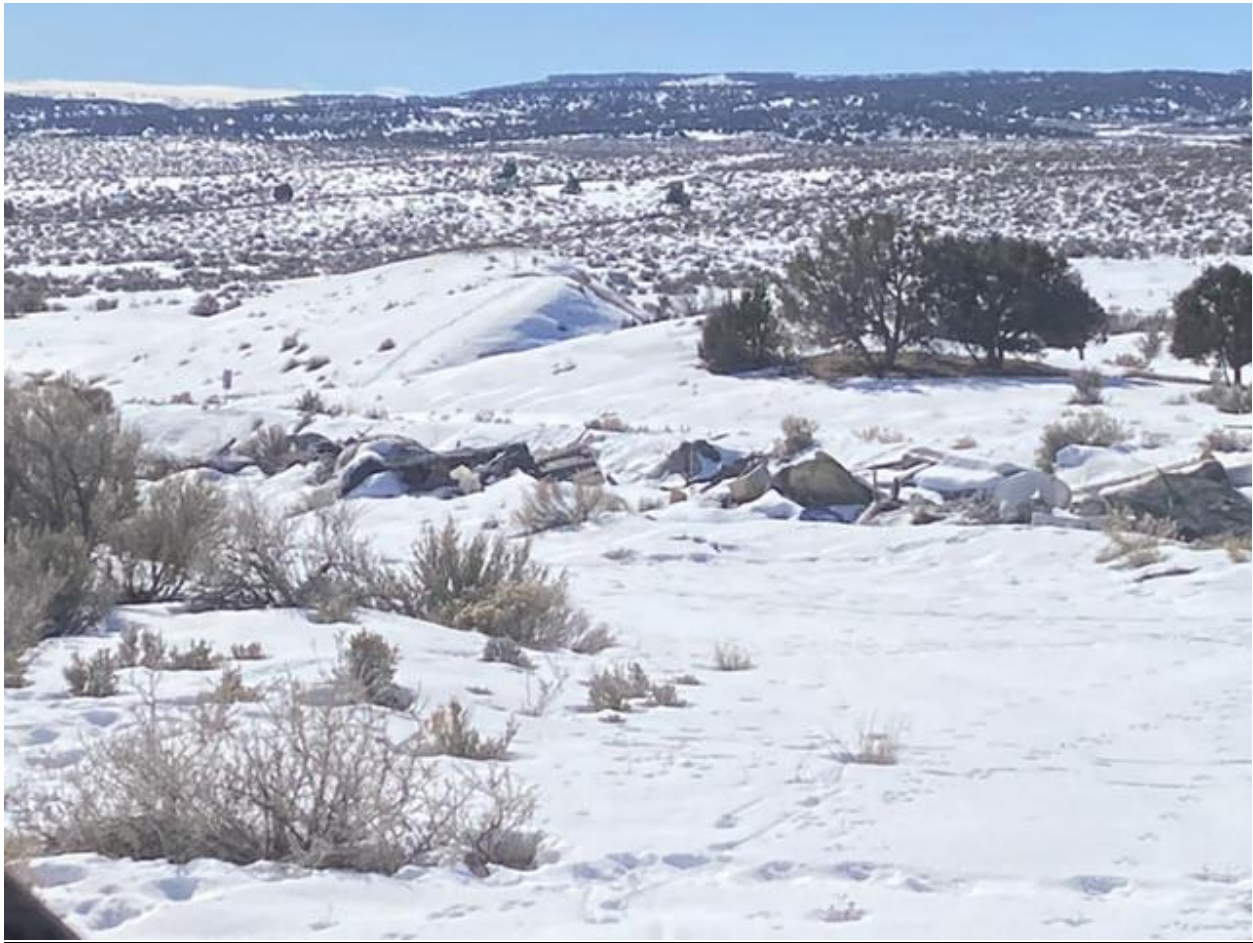
The Halandras landfill was covered with snow (Photo 1). Waste material was observed to be placed in the pits and there were no debris outside of the pits. No off site impacts were observed.

**Photo 1:** The northern end of the Halandras Landfill.

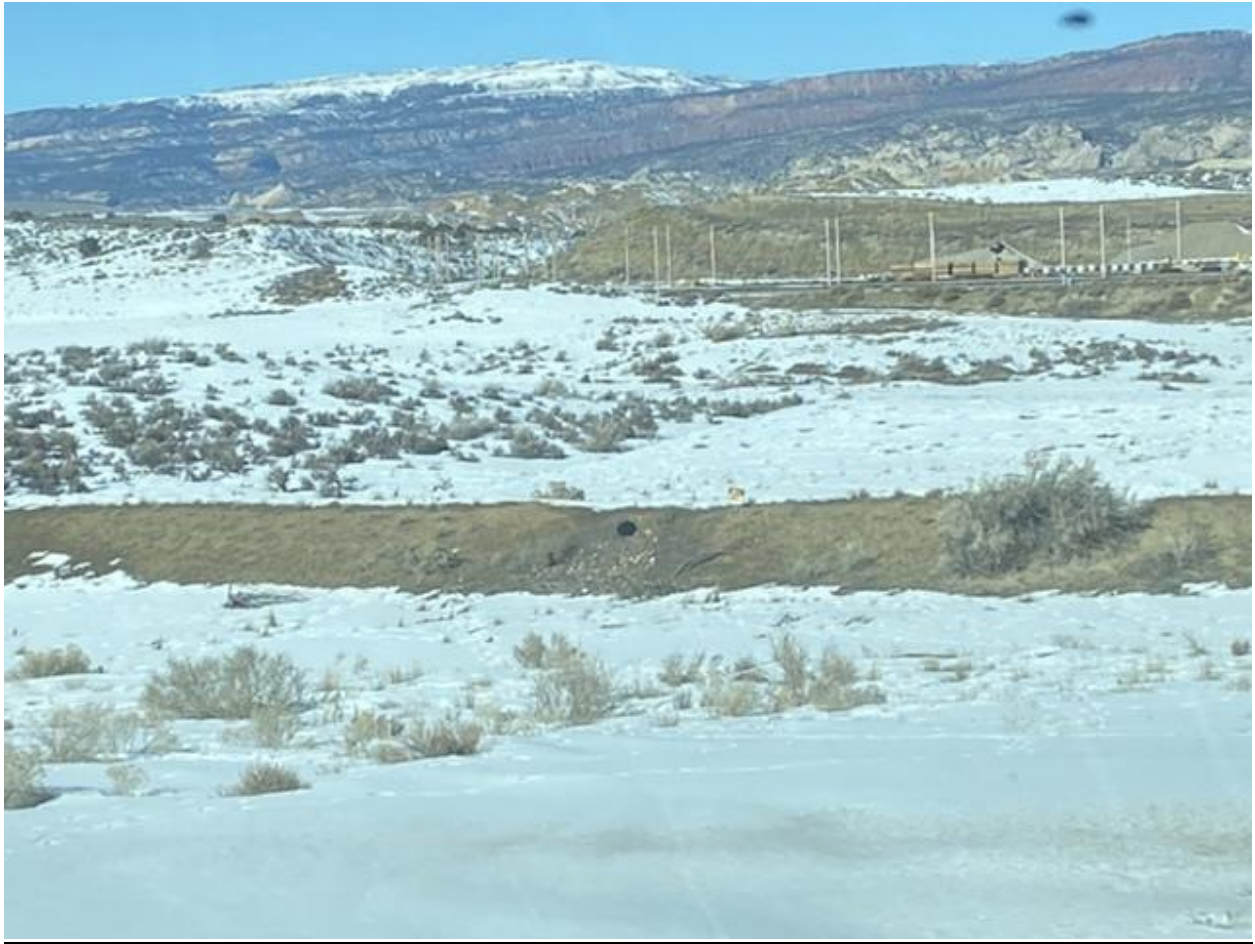
The SS-2 pond at the Slot Storage was covered with snow. The embankment was partly covered with snow (Photo 2). The embankment was stable and there were no indications of erosion. The primary outlet was clear of debris.

**Photo 2:** The SS-2 pond and embankment.

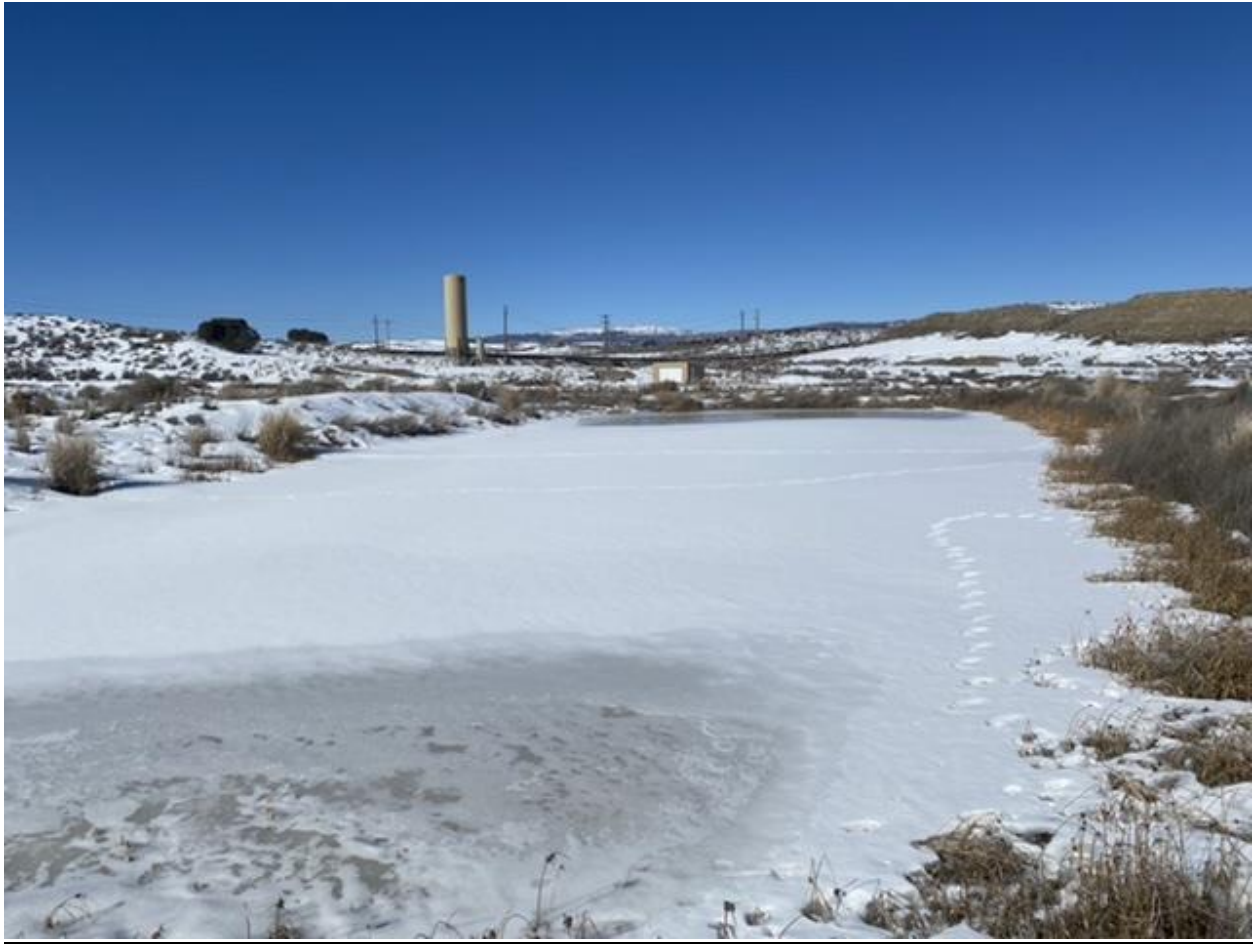
The B Seam Dewatering System No. 1 was holding water in all of its cells at the time of the inspection. All but the first couple of cells were frozen over (Photo 3). The embankments of the system were covered with snow. There were no erosional features observed. The outlet at the Last Chance Pond was clear and discharging.

**Photo 3:** The Last Chance Pond of the B Seam No. 1 Dewatering System.

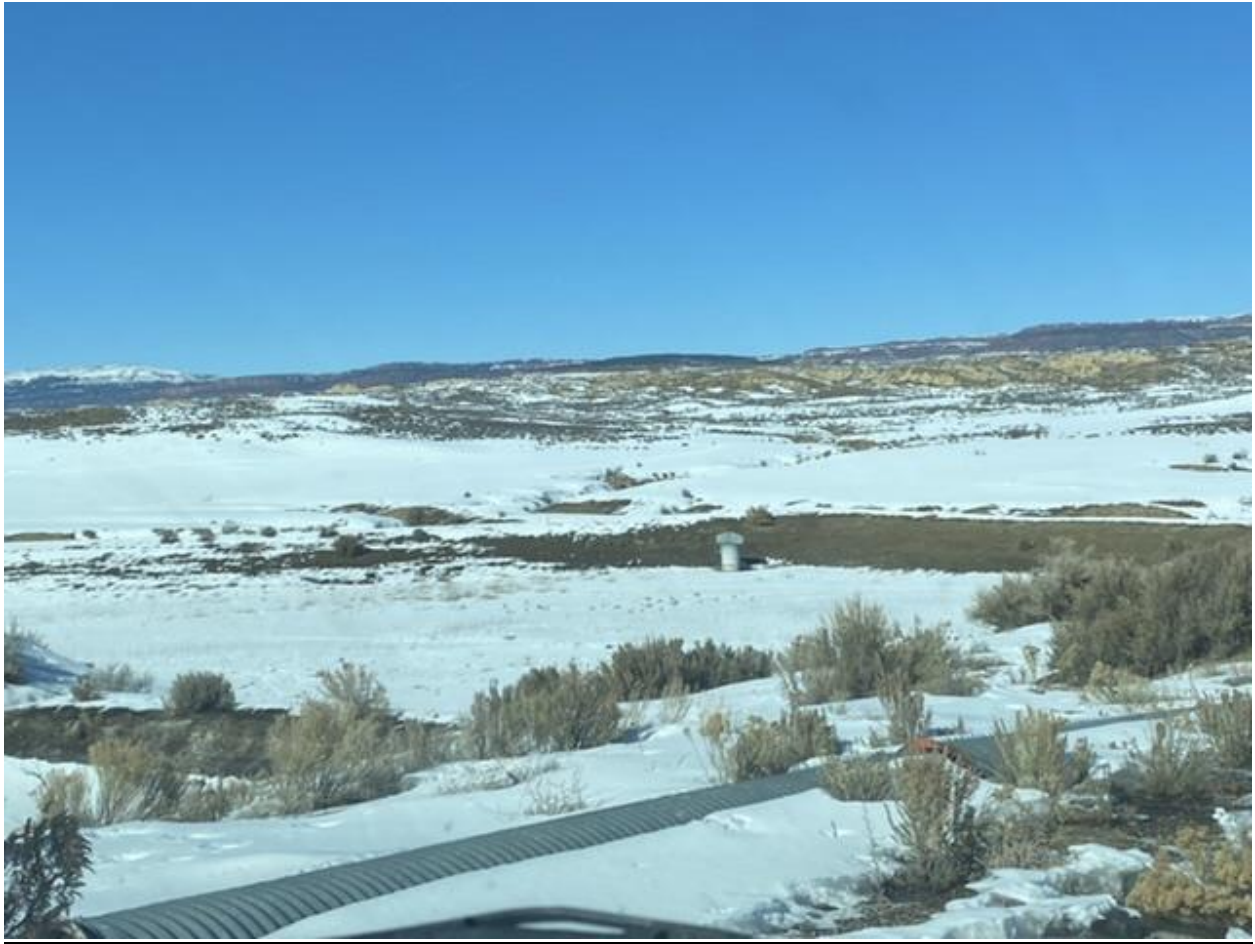
The RP-2/3 pond is located at the northeastern base of the RP-2/3/4 refuse pile (Photo 4). The pond consists of three cells. All three cells were covered with snow during the inspection. The main embankment on the pond was clear of snow. The embankments were observed to be stable with no erosional features. The trash rack on the primary spillway was clear of debris.

**Photo 4:** The RP-2/3 pond's main cell and embankment.
