MINERALS PROGRAM INSPECTION REPORT
PHONE: (303) 866-3567

MINE NAME: Betz Borrow Pit	MINE/PROSPECTING ID#: M-2018-048	MINERAL: Borrow material	COUNTY: Weld
INSPECTION TYPE: Monitoring	INSPECTOR(S): Peter Hays	INSP. DATE: December 16, 2021	INSP. TIME: 11:30
OPERATOR: SEMA Construction, Inc.	OPERATOR REPRESENTATIVE: Gavin Madsen	TYPE OF OPERATION: 111 - Construction by Government Agency	
REASON FOR INSPECTION: Normal I&E Program	BOND CALCULATION TYPE:	BOND AMOUNT: \$74,925.00	
DATE OF COMPLAINT: NA	POST INSP. CONTACTS: None	JOINT INSP. AGENCY: None	
WEATHER: Clear	INSPECTOR'S SIGNATURE:

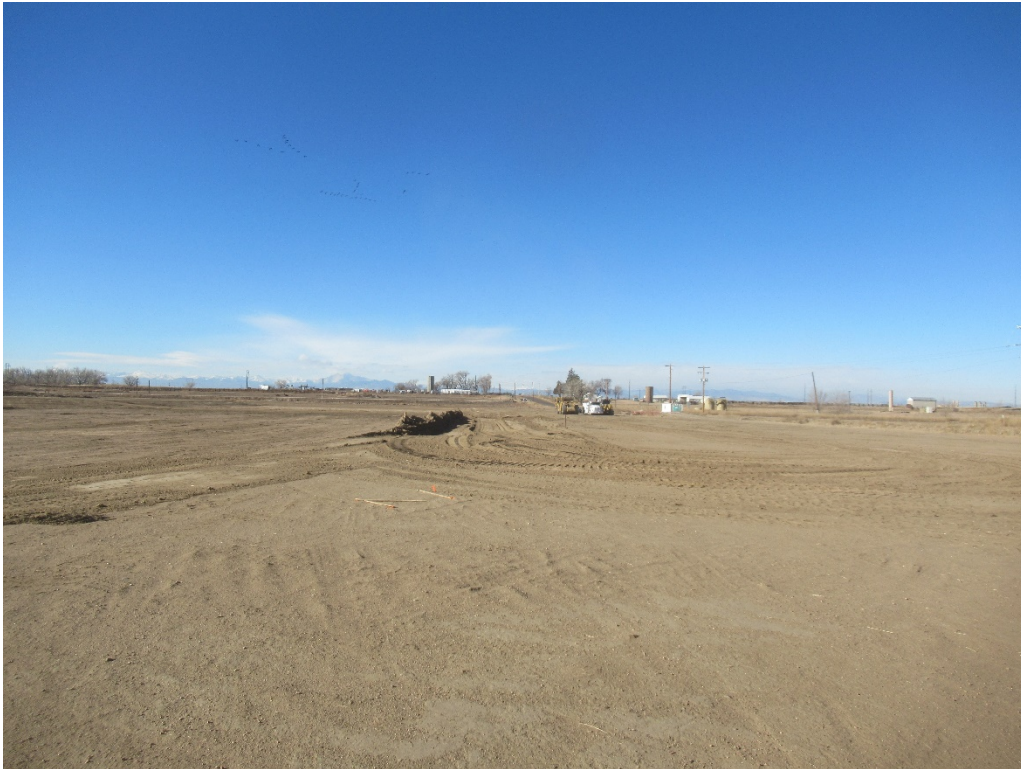
View of the site from the northeast corner looking west

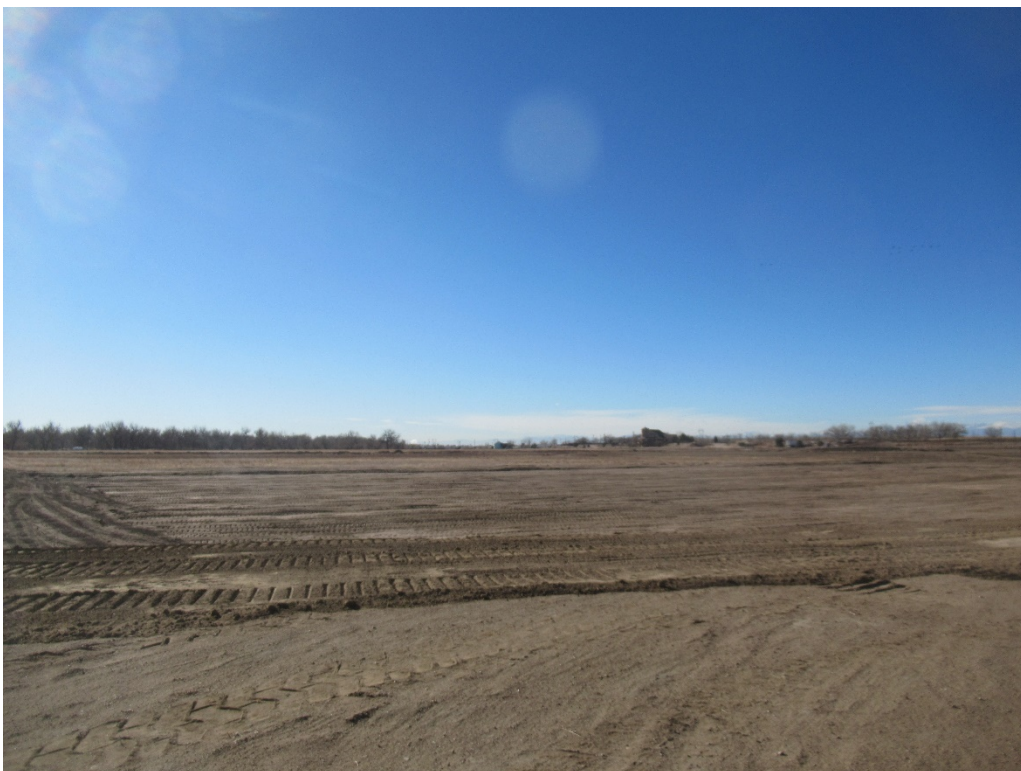
View of the site from the northeast corner looking southwest

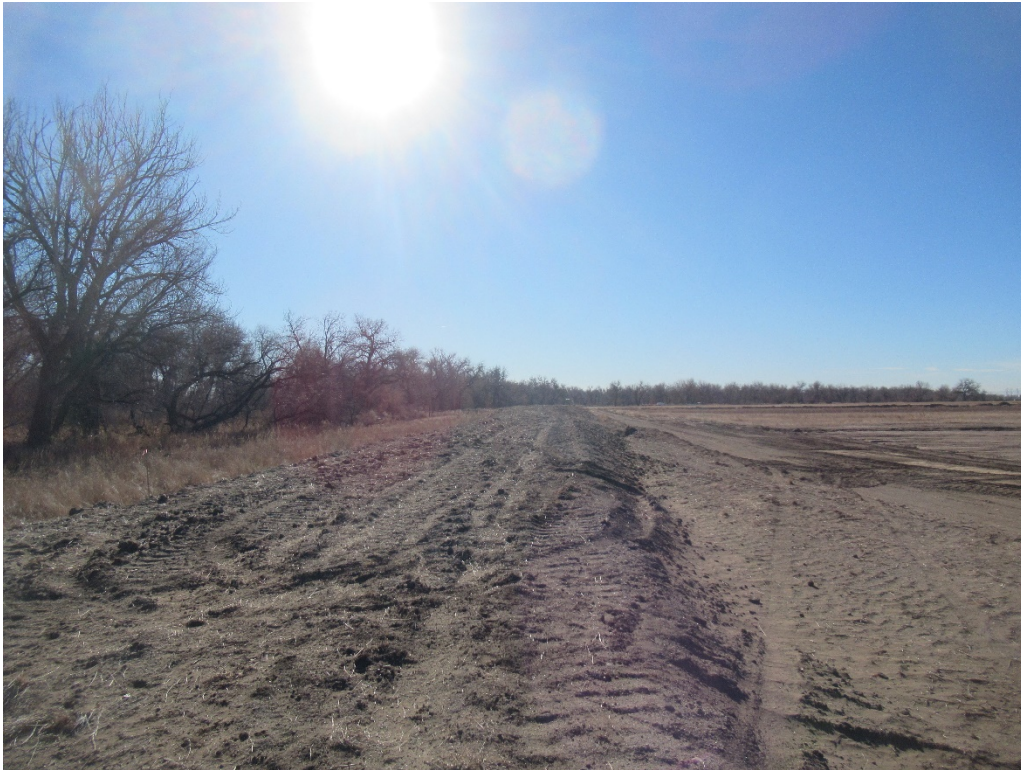
View of the site from the northeast corner looking south at topsoil stockpile

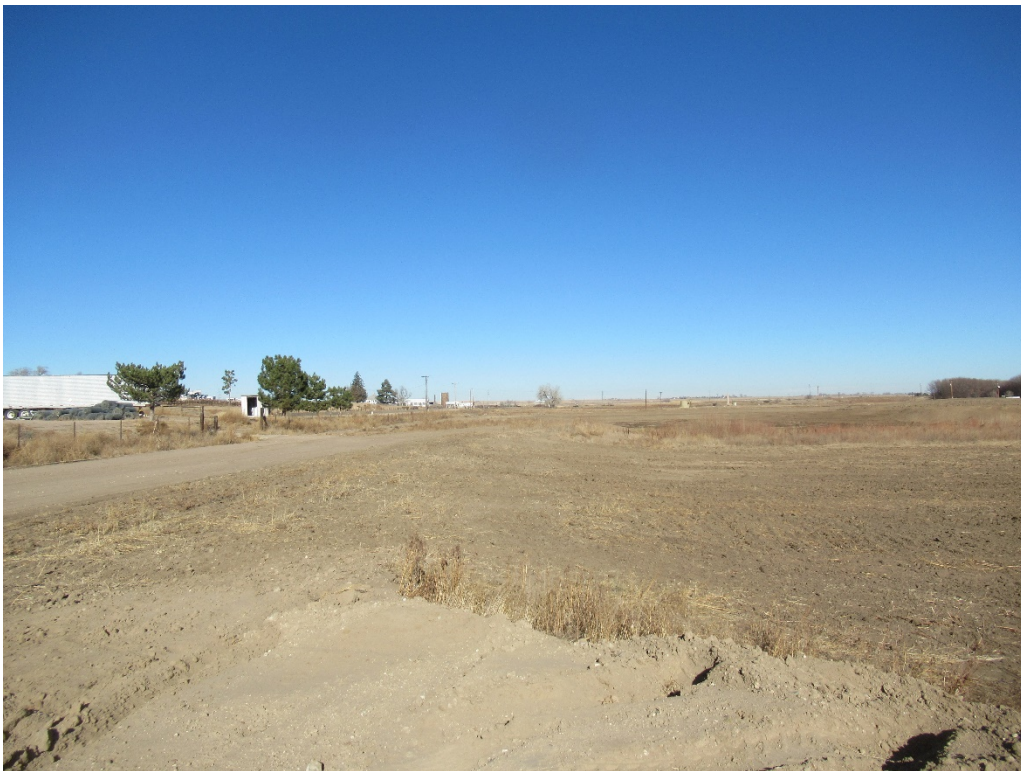
View of the site from the southwest corner looking north

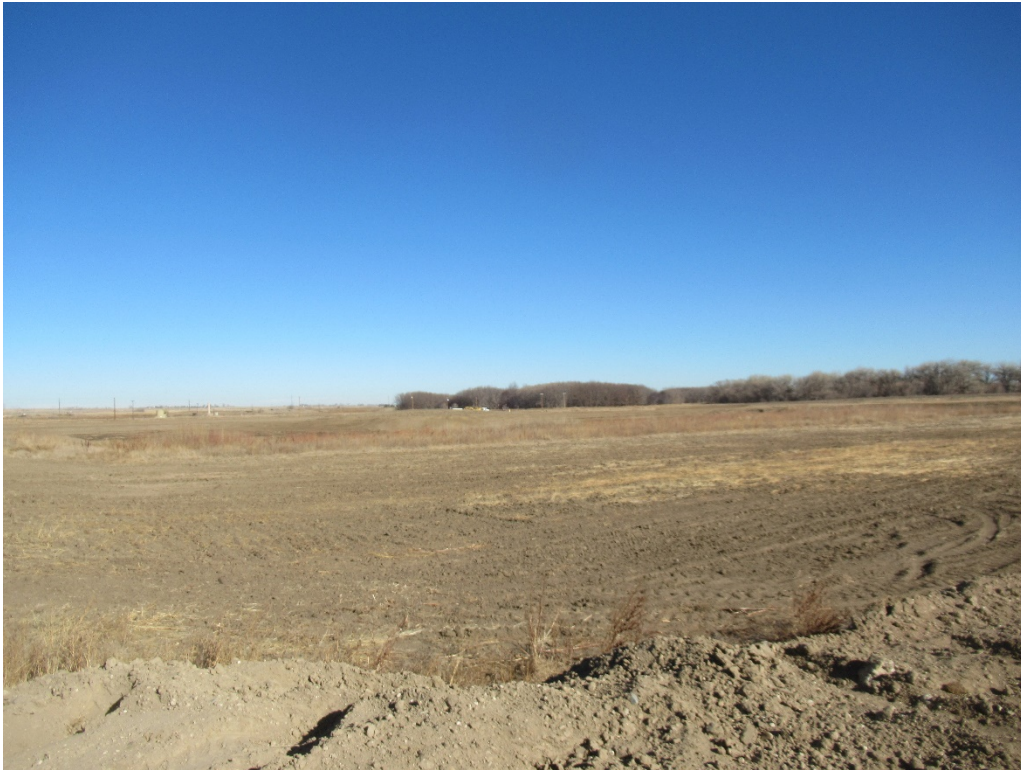
View of the site from the southwest corner looking northeast

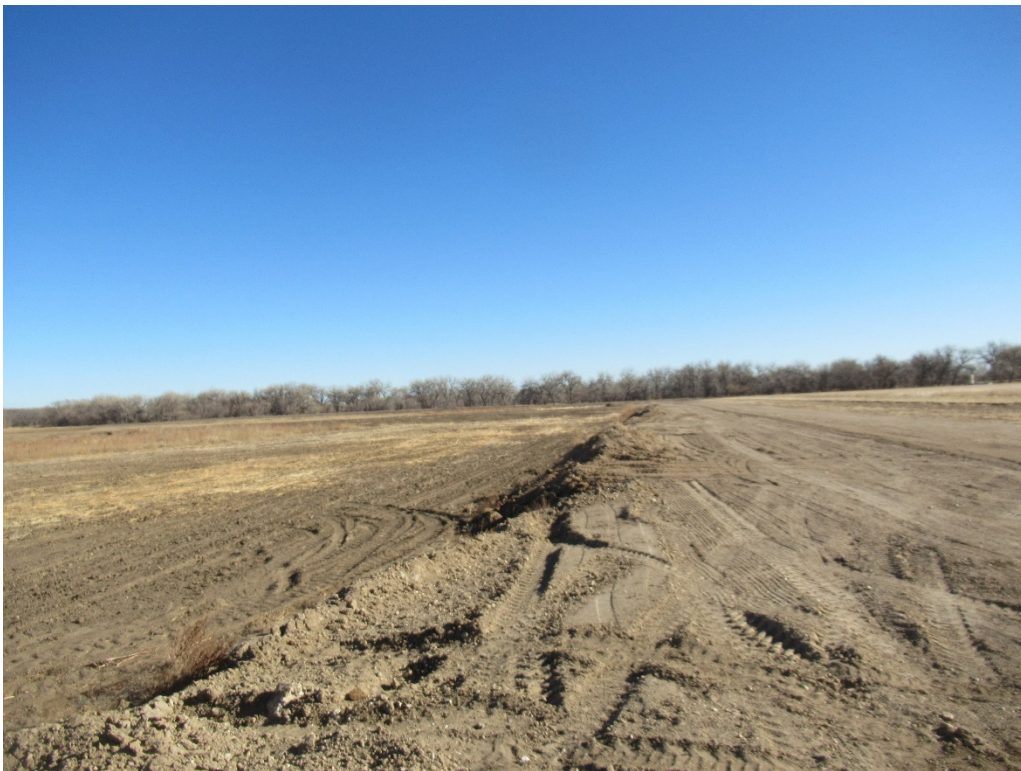
View of the site from the southwest corner looking east
