**MINERALS PROGRAM INSPECTION REPORT**  
**PHONE: (303) 866-3567**

<b>MINE NAME:</b> Williams Pit No. 1	<b>MINE/PROSPECTING ID#:</b> M-2010-054	<b>MINERAL:</b> Borrow material	<b>COUNTY:</b> Huerfano
<b>INSPECTION TYPE:</b> Surety-Related Inspection	<b>INSPECTOR(S):</b> Patrick Lennberg	<b>INSP. DATE:</b> February 1, 2022	<b>INSP. TIME:</b> 11:00
<b>OPERATOR:</b> Timothy D. Williams & Betty J. Williams	<b>OPERATOR REPRESENTATIVE:</b> Paul Bottini	<b>TYPE OF OPERATION:</b> 110c - Construction Limited Impact	
<b>REASON FOR INSPECTION:</b> Surety Related	<b>BOND CALCULATION TYPE:</b> Complete Bond	<b>BOND AMOUNT:</b> \$26,600	
<b>DATE OF COMPLAINT:</b> NA	<b>POST INSP. CONTACTS:</b> None	<b>JOINT INSP. AGENCY:</b> None	
<b>WEATHER:</b> Cloudy	<b>INSPECTOR'S SIGNATURE:</b>

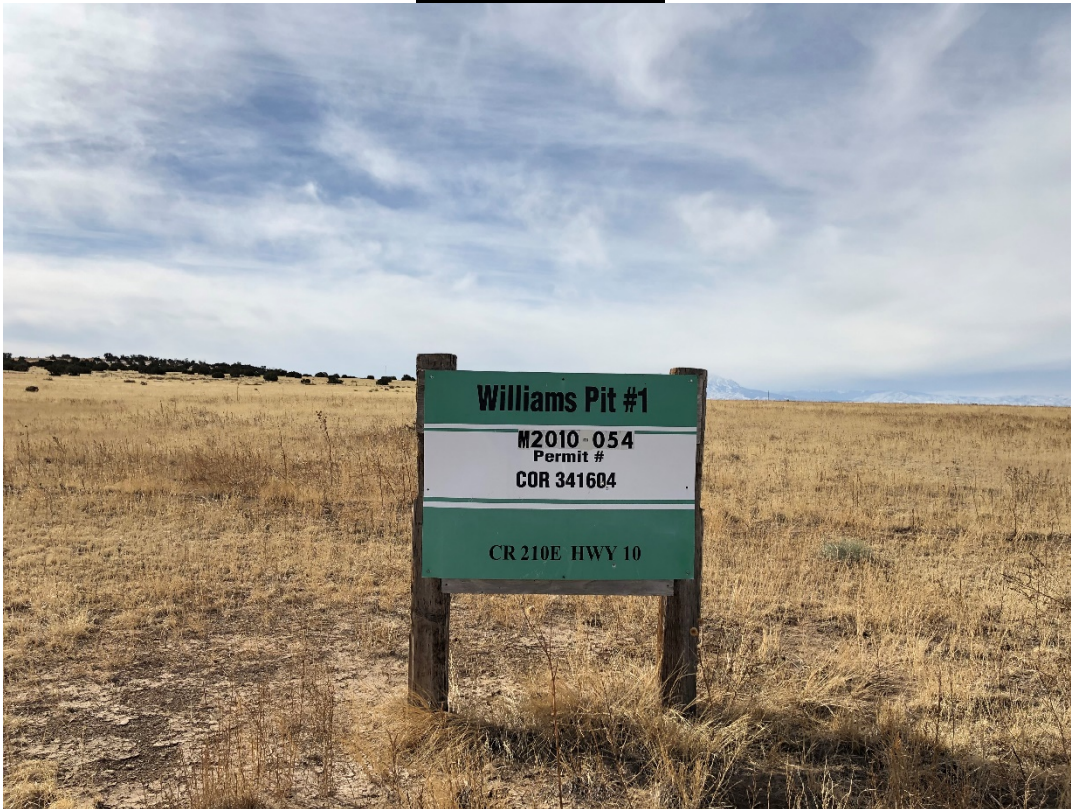
**Photo 1:** Mine sign at the intersection of haul road and County Road 210

The mine sign at the mine entrance will have to be updated to reflect the new permittee, Southway Construction Company. The Division was able to locate and GPS the permit boundary corners around the pit area.

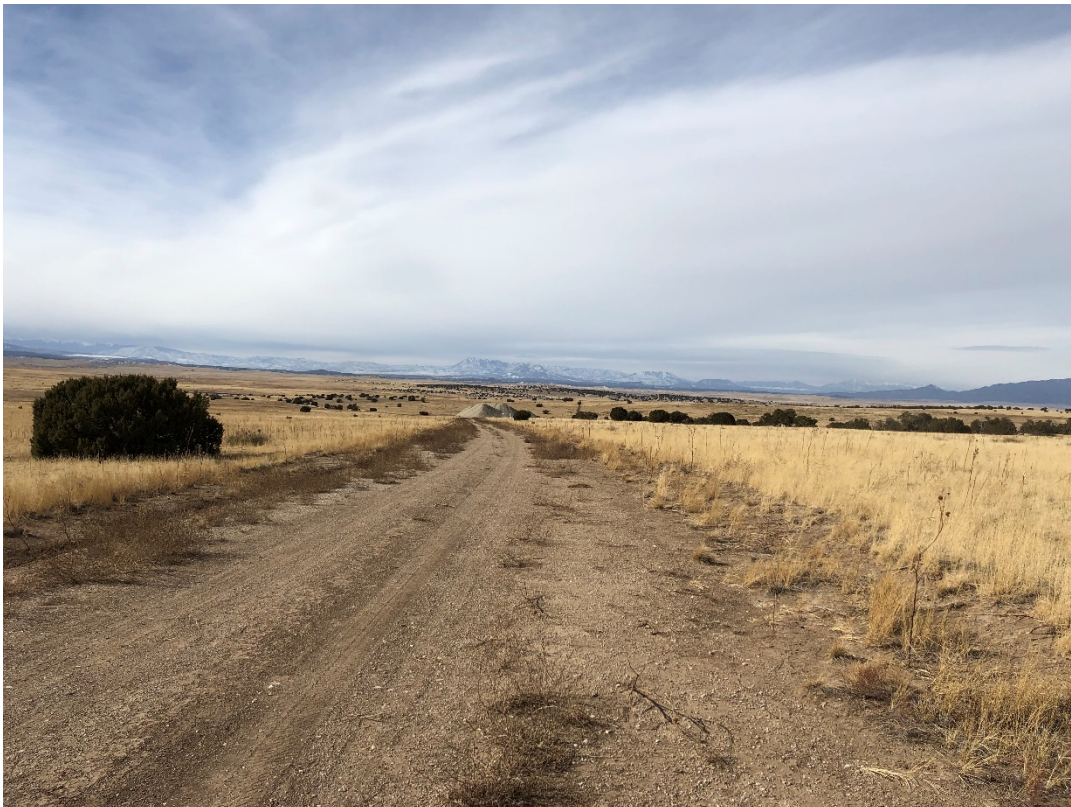
The site was not active at the time of inspection and for the most part was in the same condition as it was in during the 2020 inspection. However, a significant amount of reclamation has taken place to grade all slopes to approximately 3H:1V. There were several large stockpiles of material, as noted in the previous inspection report, however Paul stated the material had been sold to Las Animas County and would be removed in the near future for county purposes.

**Photo 2:** Looking west along the haul road leading to the pit, note stockpiles of material center of photo

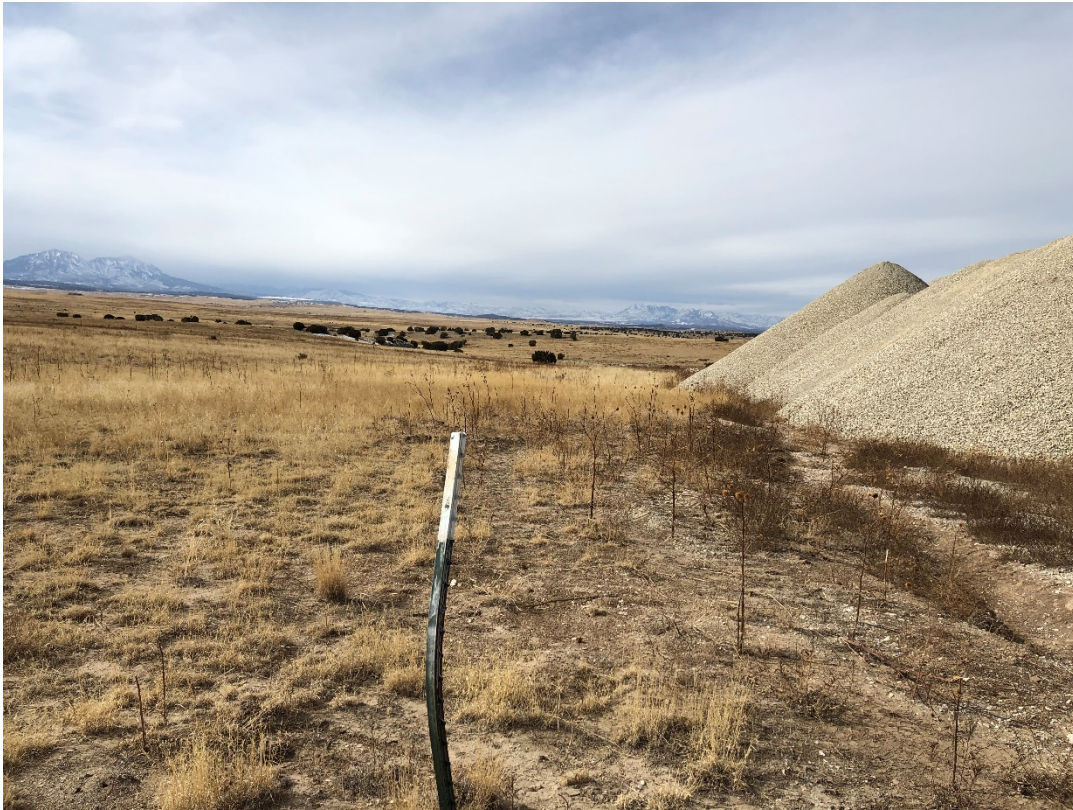
**Photo 3:** Typical permit boundary marker

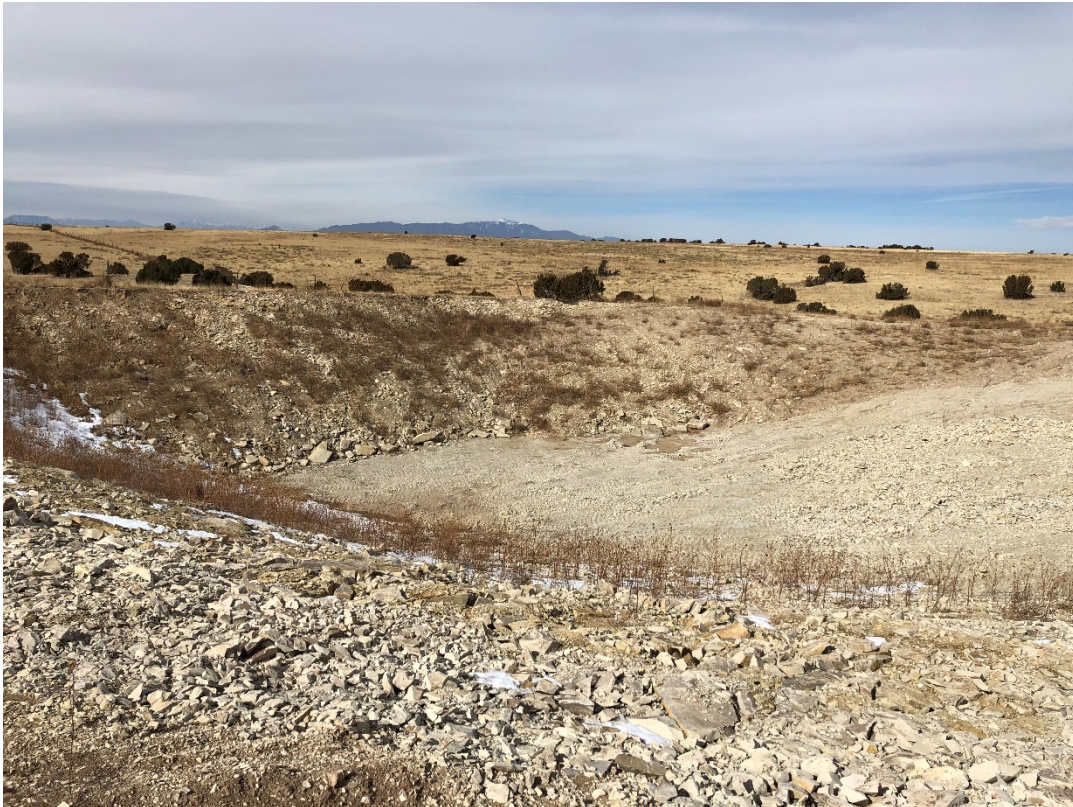
**Photo 4:** Graded box-cut area, looking northwest

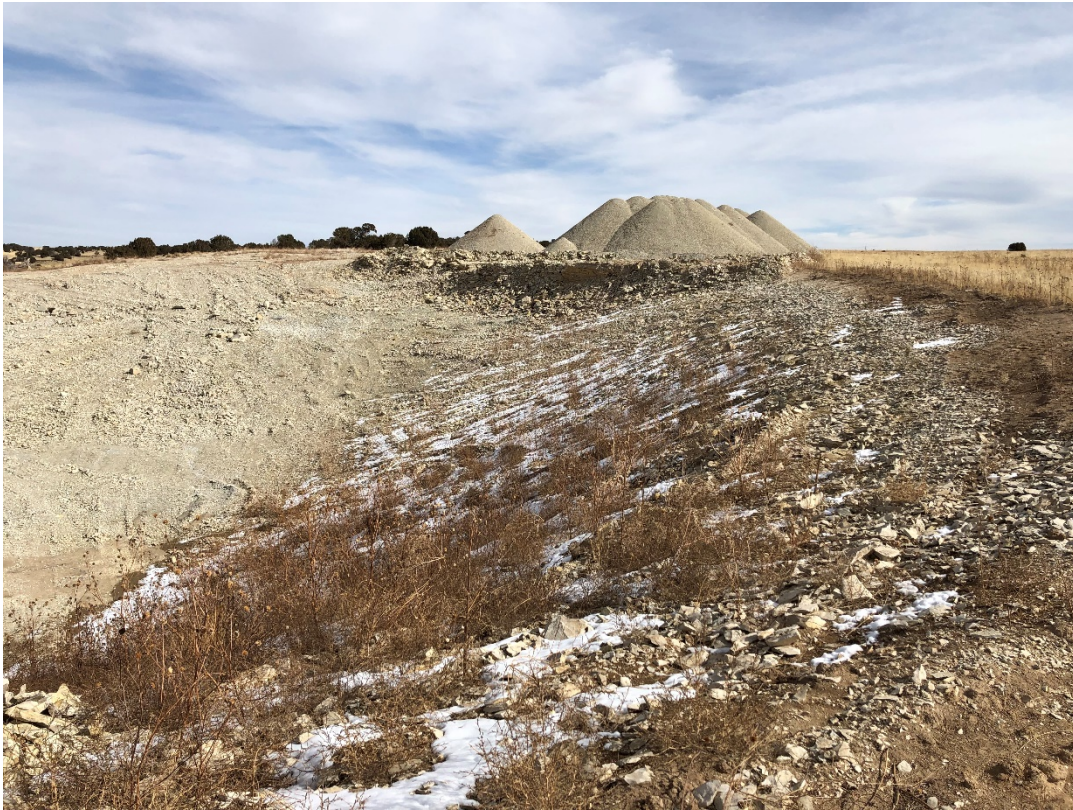
**Photo 5:** Graded box-cut area, looking east

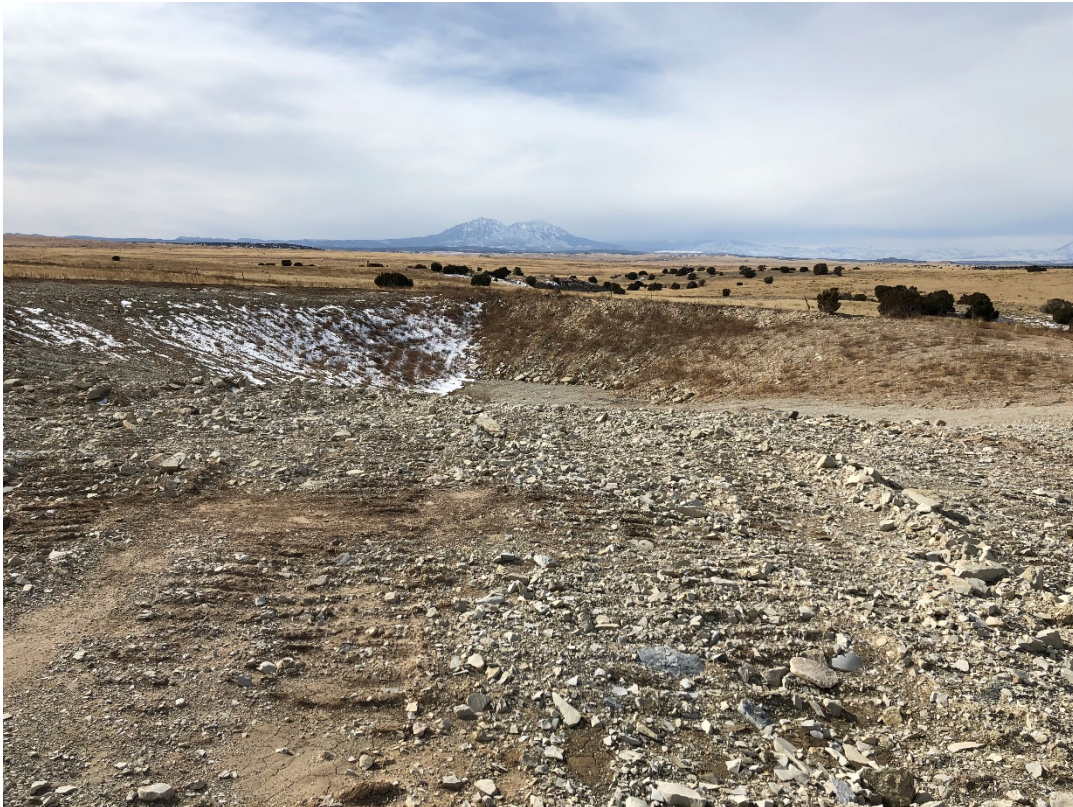
**Photo 6:** Graded box-cut area, looking southwest

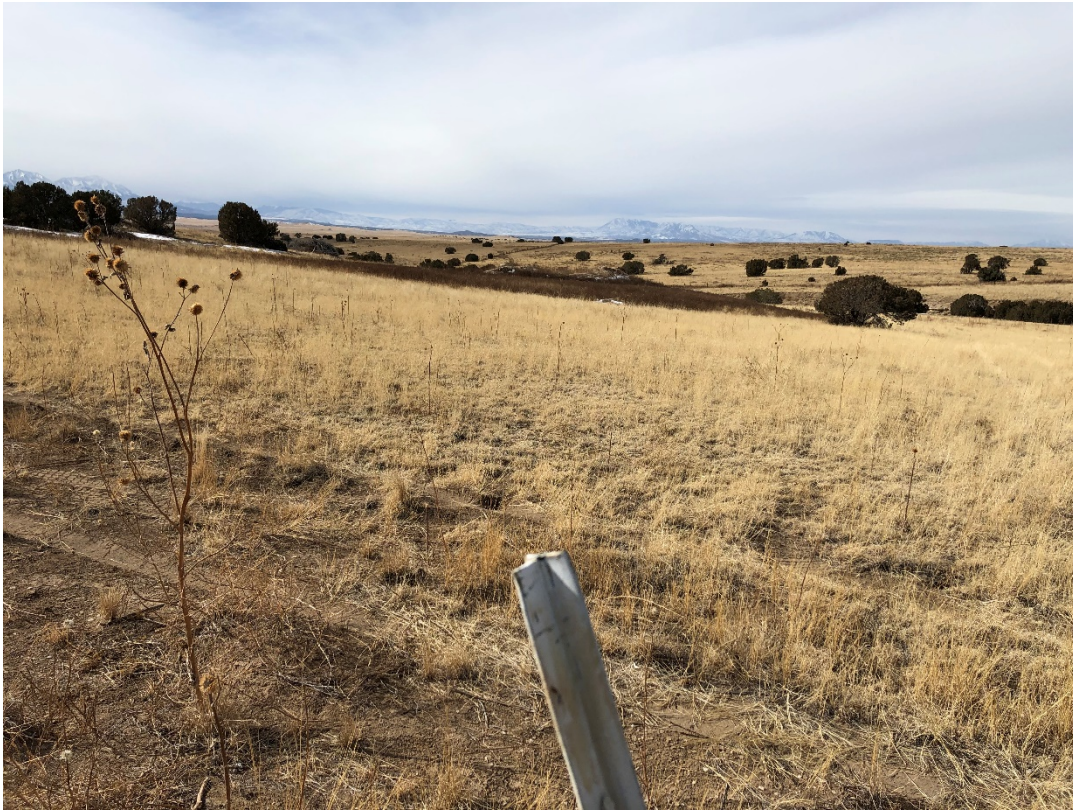
**Photo 7:** Looking southwest from northeastern permit corner, topsoil stockpile center of photo

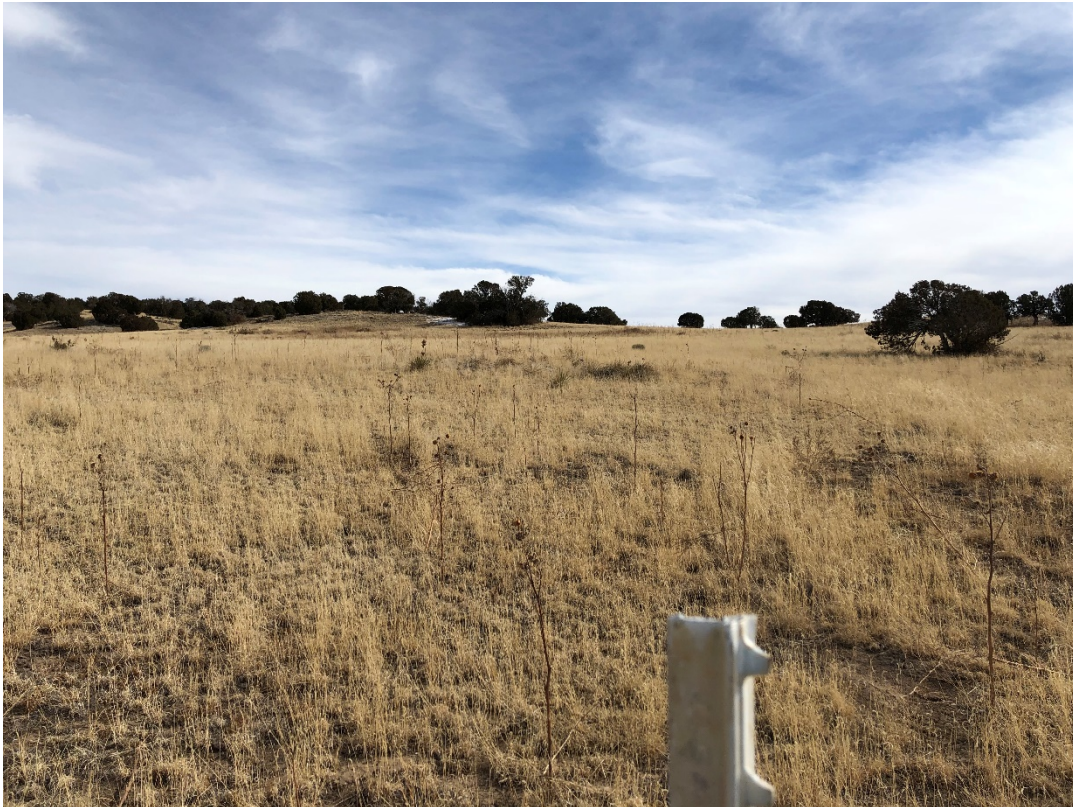
**Photo 8:** Undisturbed area of the permit
