UPDATED MINERALS PROGRAM INSPECTION REPORT PHONE: (303) 866-3567

MINE NAME:		MINE/PROSPECTING ID#:	MINERAL:	COUNTY:
Hokestra Gravel Pit		M-1980-149	Sand and gravel	Weld
INSPECTION TYPE:		INSPECTOR(S):	INSP. DATE:	INSP. TIME:
Monitoring		Peter Hays	December 16, 2021	13:00
OPERATOR:		OPERATOR REPRESENTATIVE:	TYPE OF OPERATION:	
Weld County Public Works		Jeff York	112c - Construction Regular Operation	
REASON FOR INSPECTION:		BOND CALCULATION TYPE:	BOND AMOUNT:	
Normal I&E Program		None	\$0.00	
DATE OF COMPLAINT:		POST INSP. CONTACTS:	JOINT INSP. AGENCY:	
NA		None	None	
WEATHER:	INSPECTOR'S SIGNATURE:		SIGNATURE DATE:	
Clear	f.A.m.		February 7, 2022

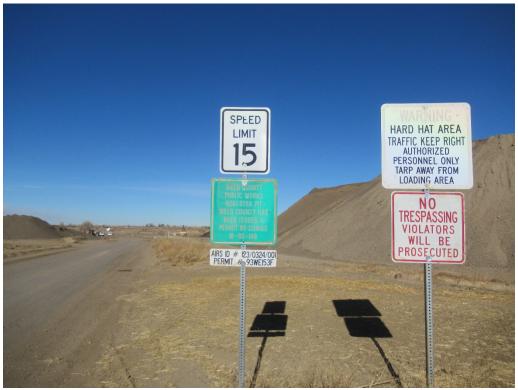
The mine sign and boundary markers were observed as required by Rule 3.1.12. A financial warranty is not held by the Division for the site.

Hokestra Gravel Pit mine sign

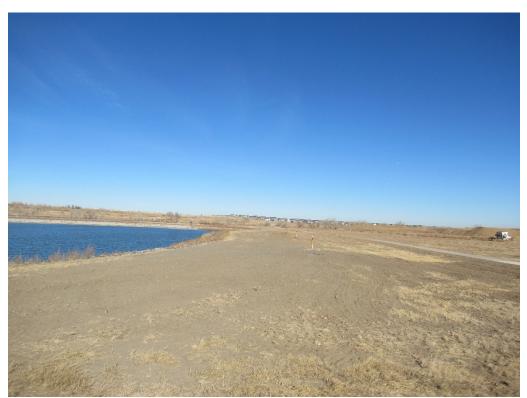
Phase 2 is located in the northwest corner of the site and consists of a clay lined reservoir. The Operator has not submitted the Office of the State Engineer (SEO) approval letter for the clay liner to the Division. The reservoir was partially filled at the time of the inspection. The perimeter of the reservoir has been riprapped with the exception of the eastern shoreline. The riprap is required as part of the flood mitigation measures for the site. The required spillways between Phase 2 and 4 and Phase 4 and the St. Vrain River have not been constructed to date. The upland areas around the reservoir are vegetated with reclamation grasses. The vegetation on the north and south sides of the reservoir appeared to be well-established in the current dormant and recently mowed status. The vegetation on the east and west side of the reservoir consisted of poorly established grasses with bare areas. The Operator reported the areas were reseeded three weeks ago. The perimeter drain along the western side of the phase is installed as indicated in construction report by Brierley Associates dated October 30, 2014.

View of the Phase 2 eastern upland area from the southeast corner looking north

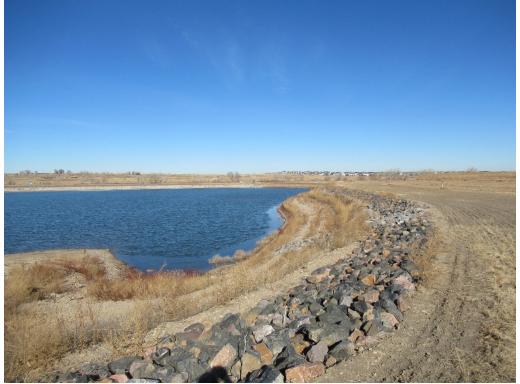
View of the Phase 2 shoreline from the southeast corner looking north

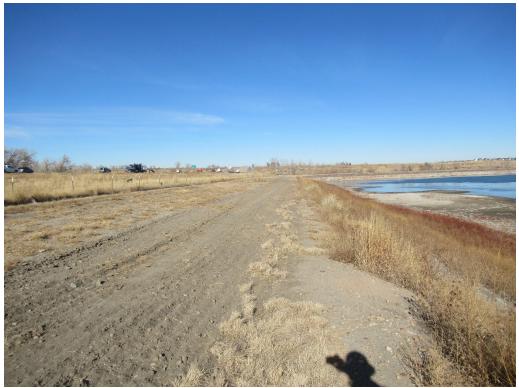
View of the Phase 2 western upland area from the southwest corner looking north

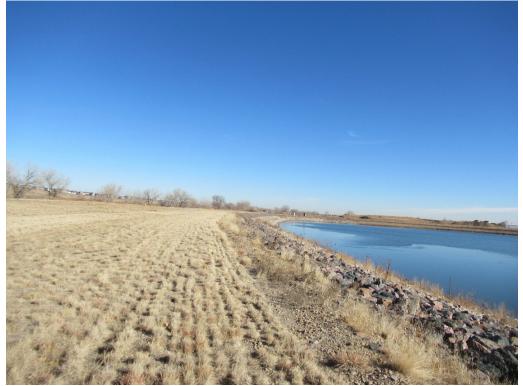
View of the Phase 2 northern upland area from the northwest corner looking east

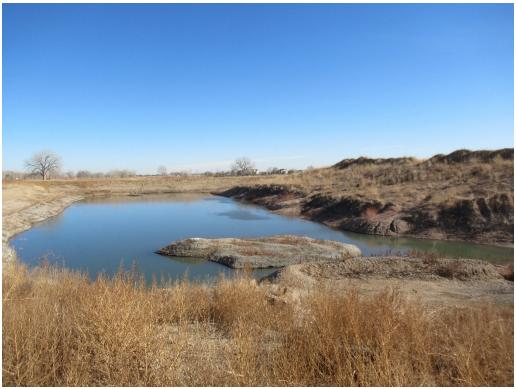
Phase 4 is located east of Phase 2 and north of Phase 3 in the northeast corner of the site and consists of a slurry wall lined reservoir. The Operator has not submitted the SEO approval letter for the slurry wall to the Division. The location of the slurry wall centerline was marked on all sides with white posts. The phase was inactive at the time of the inspection. The northern portion of the phase is partially mined and was partially filled with water. The current pit floor contained a stockpile of imported material for another Weld County mine site. A topsoil stockpile was observed in the southwest corner of the phase.

View of Phase 4 from the northwest corner looking east

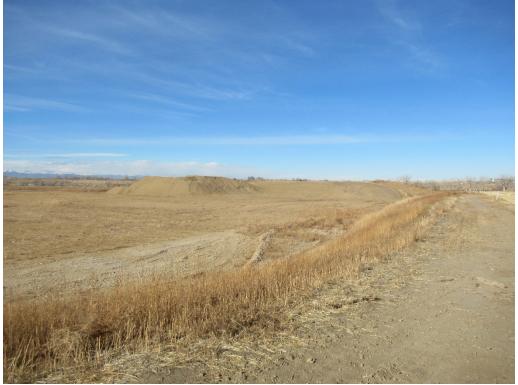
View of Phase 4 from the southeast corner looking northwest

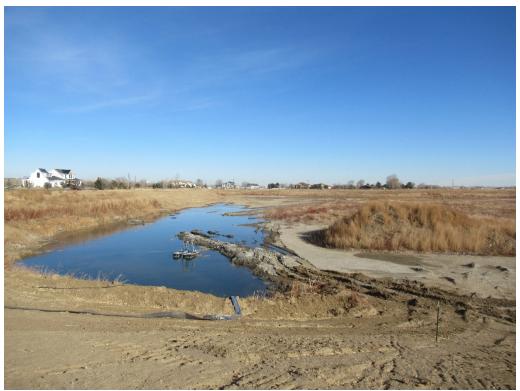
The parcel east of Phase 3 (Phases 5 and 6) was mined and reclaimed to slurry lined reservoir several years ago. The Operator has not submitted the SEO approval letter for the slurry wall to the Division. The Division will require proof of SEO approval for the slurry wall prior to consideration of any future release requests. The area has been re-mined to create a single reservoir instead of two separate reservoirs. The reservoir was dewatered at the time of the inspection to allow the reservoir owner to complete repair to the leaking slurry wall along the southern portion of the reservoir. The upland areas around the reservoir were recently seeded by the Operator.

View of Phases 5 and 6 from the northwest corner looking east

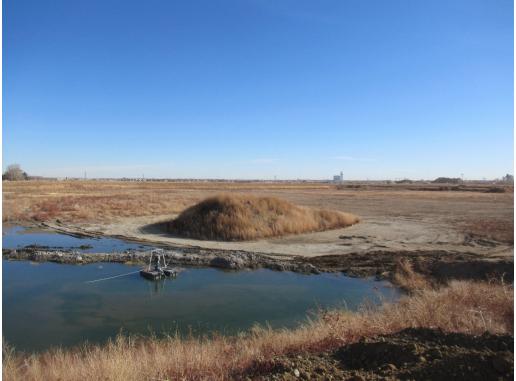
View of Phases 5 and 6 from the northwest corner looking southeast

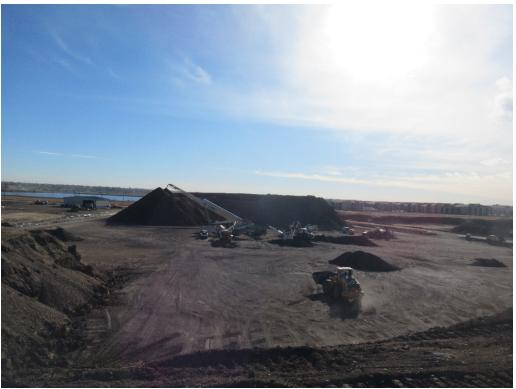
Phase 3 is located in the southeast corner of the site and consists of a slurry wall lined reservoir. The Operator has not submitted the SEO approval letter for the slurry wall to the Division. The location of the slurry wall centerline was marked on all sides with white posts. The phase has been stripped of topsoil and overburden, however mining excavation has not started in the phase. The phase is currently being utilized as a stockpile and processing area by the Operator. The stockpiles consisted of imported and native materials. The reservoir to the east of the phase will need to be dewatered before Phase 3 is mined, since the two areas are surrounded by a single slurry wall.

View of Phase 3 from the stockpile looking south
