MINERALS PROGRAM INSPECTION REPORT
PHONE: (303) 866-3567

MINE NAME: Ghost River Gravel Pit	MINE/PROSPECTING ID#: M-2003-002	MINERAL: Sand and gravel	COUNTY: Huerfano
INSPECTION TYPE: Monitoring	INSPECTOR(S): Patrick Lennberg	INSP. DATE: February 1, 2022	INSP. TIME: 09:45
OPERATOR: HCR High Country Repair	OPERATOR REPRESENTATIVE: Natasha Branch	TYPE OF OPERATION: 110c - Construction Limited Impact	
REASON FOR INSPECTION: Priority	BOND CALCULATION TYPE: Partial Bond	BOND AMOUNT: \$19,112.00	
DATE OF COMPLAINT: NA	POST INSP. CONTACTS: None	JOINT INSP. AGENCY: None	
WEATHER: Cloudy	INSPECTOR'S SIGNATURE:

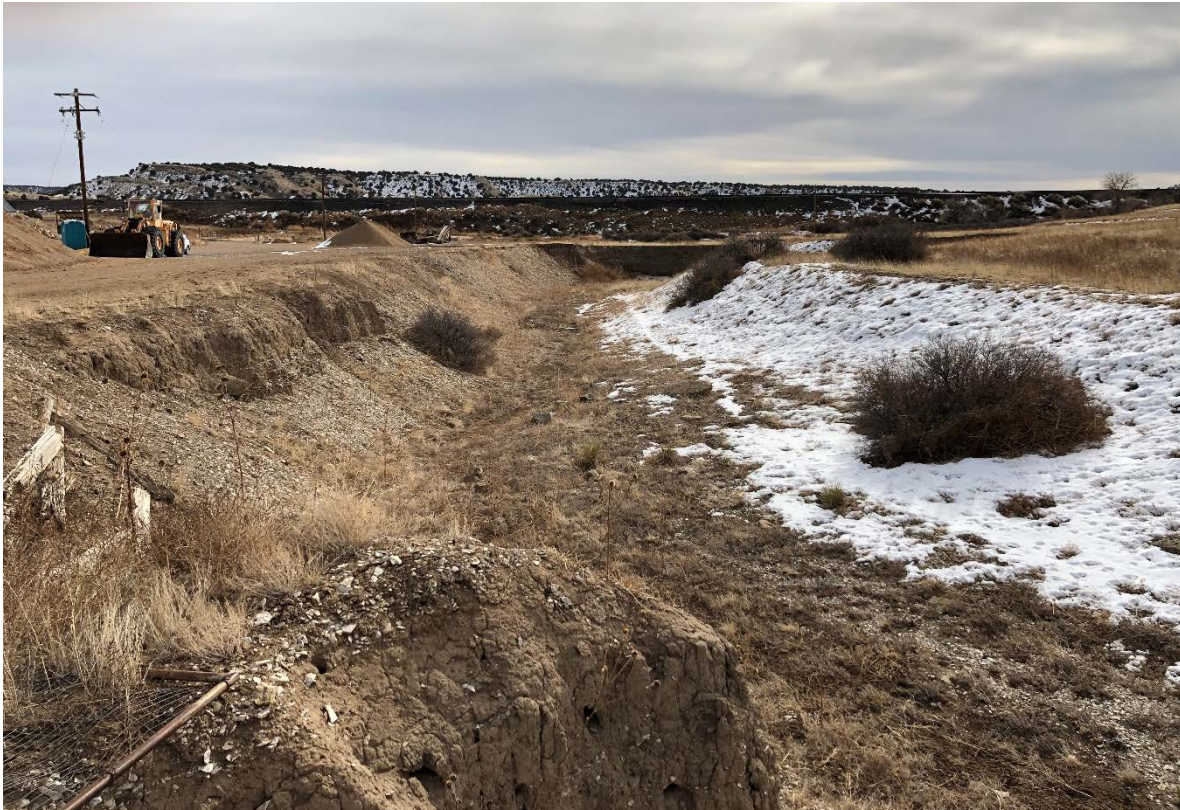
The site was not active at the time of inspection. However there has been some activity at the site since the last inspection. Trash and refuse has been removed from the site including the concrete pipes and 55-gal drum that were located in the dry drainage to the south of the site. The Division will abate this problem. The other problem cited, missing a structure agreement for the powerline is still active. The area to the west of the permit boundary where material had been placed beyond the permit boundary has had that material removed and the area seeded. Also the southern area has also been cleaned up and seeded. A pothole located north of the permit boundary has been filled in graded and seeded.

Photo 3: Looking east along the drainage where the concrete pipes were located

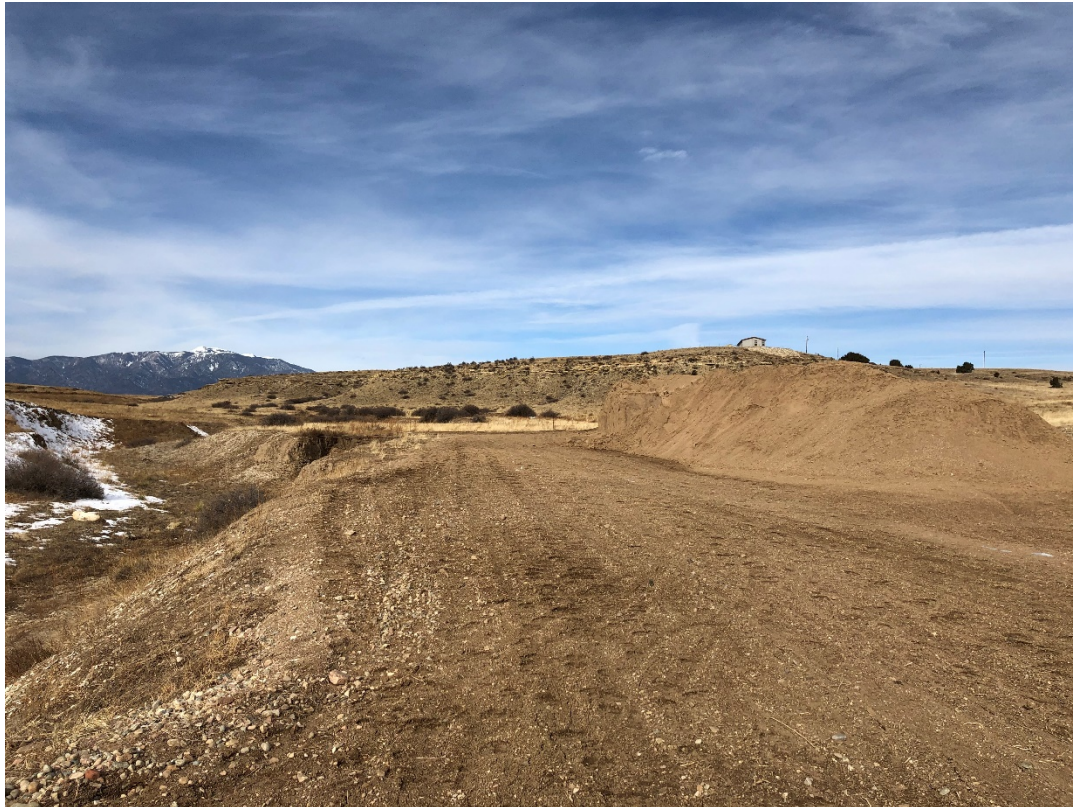
Photo 4: Looking west towards the sw permit corner note trash piles have been removed

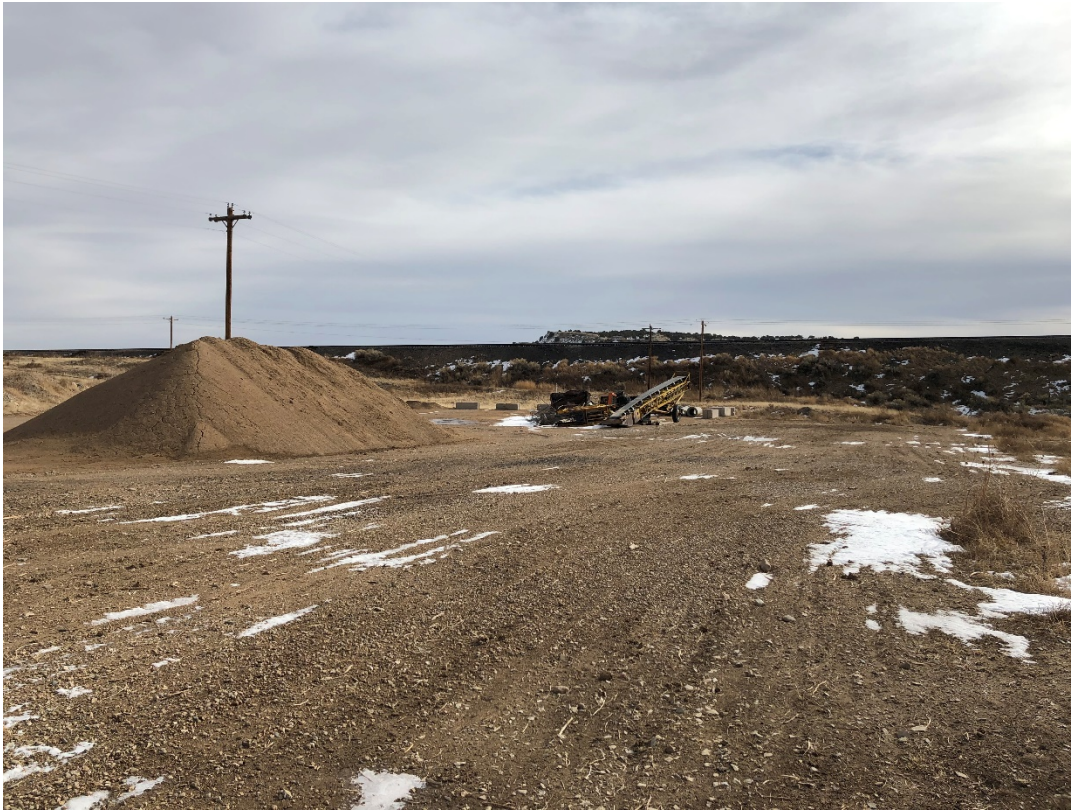
Photo 5: Old equipment has been moved towards the mine entrance and the southern permit area has been cleaned and seeded

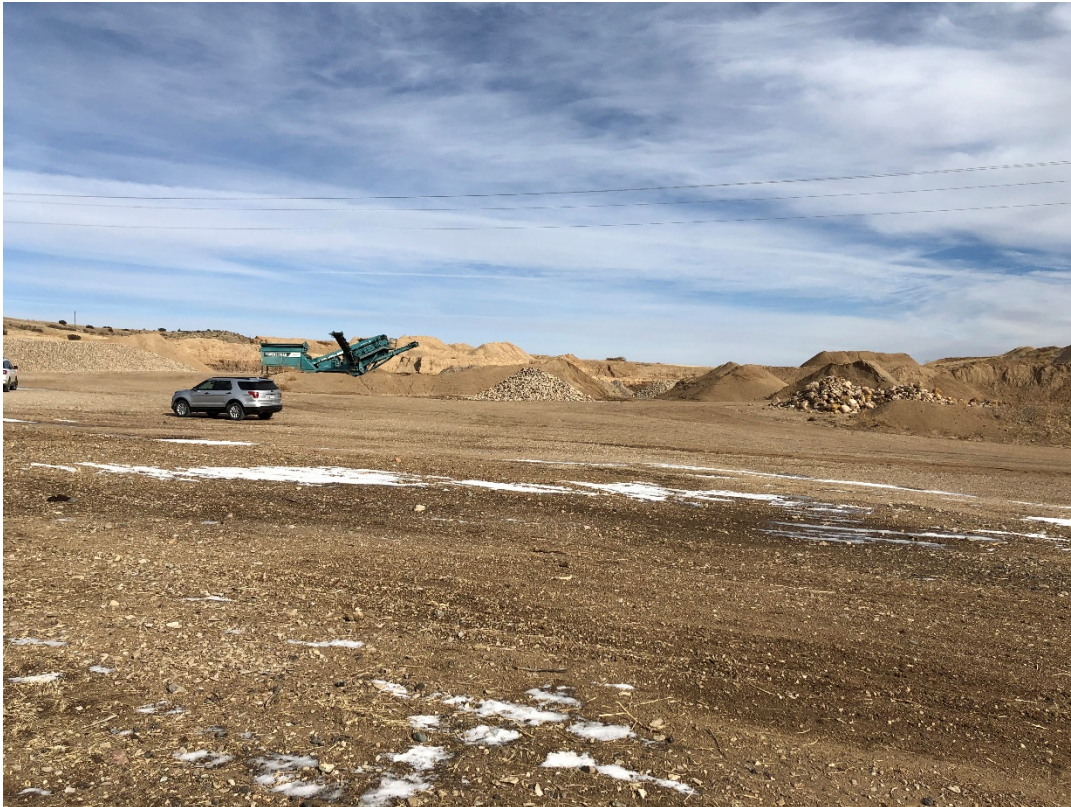
Photo 6: Mining area and mine equipment remaining at the site

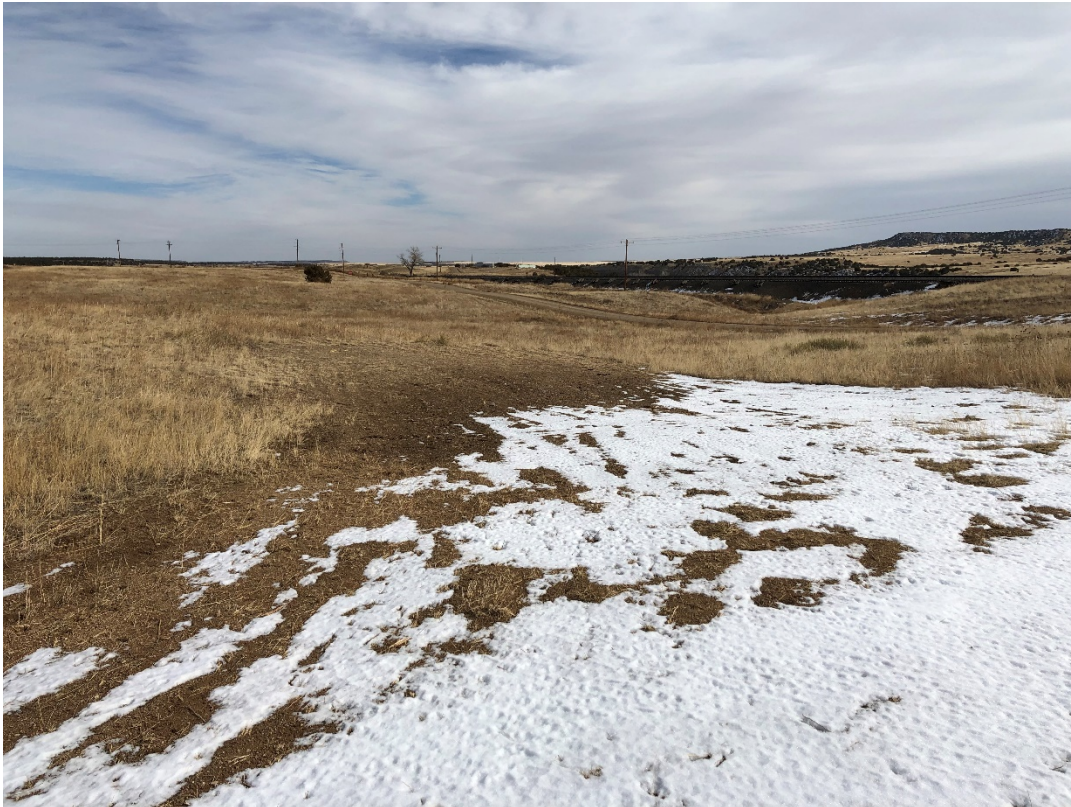
Photo 10: Reclaimed pothole area near the NE permit corner
