MINERALS PROGRAM INSPECTION REPORT

| MINE NAME: Dawson Gold Mine | MINE/PROSPECTING ID#: M-2021-046 | MINERAL: Gold | COUNTY: Fremont |
| INSPECTION TYPE: Preoperation Inspection | INSPECTOR(S): Timothy Cazier, P.E. | INSP. DATE: September 15, 2021 | INSP. TIME: 12:30 |

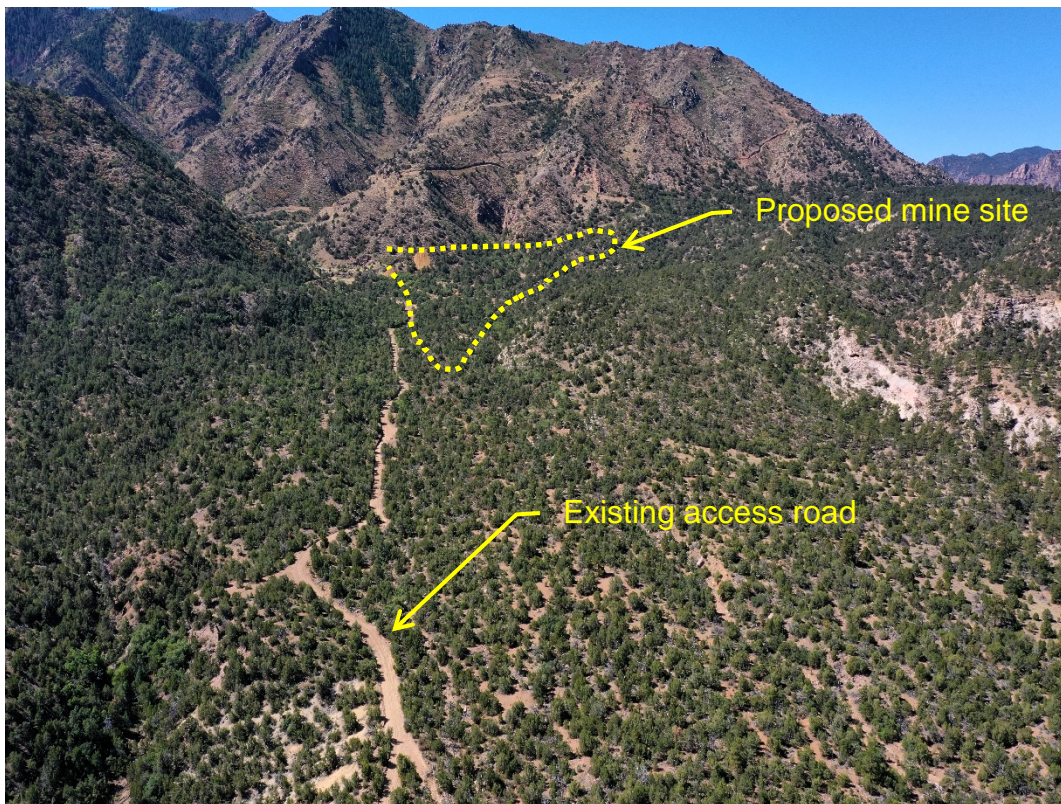
This was a pre-operation inspection conducted by the DRMS for a new permit. Present for the DRMS were Tim Cazier, Russ Means, Michael Cunningham, Lucas West and Patrick Lennberg. Angela Bellantoni, Tim Crawford, and Diana Sollner were also present representing the Applicant. The Dawson Gold Mine site is located approximately 4.5 miles southwest of Cañon City. The proposed site is restricted to private land with no federally managed land involved. The site was accessed from Temple Canyon Road/CR 3. The site was flown by the DRMS using a UAV (drone) to provide an aerial perspective of the site (see **Photos 1** and **2**).

Roads: Images of the existing access road were captured using the drone (see **Photos 1** and **6**) for comparison with future improvements. A new entrance off FCR 3/Temple Canyon Road is proposed roughly 450 feet west of the existing road (see **Photo 6**).

Photo 1. Access road and mine site from near FCR3 (looking SW).

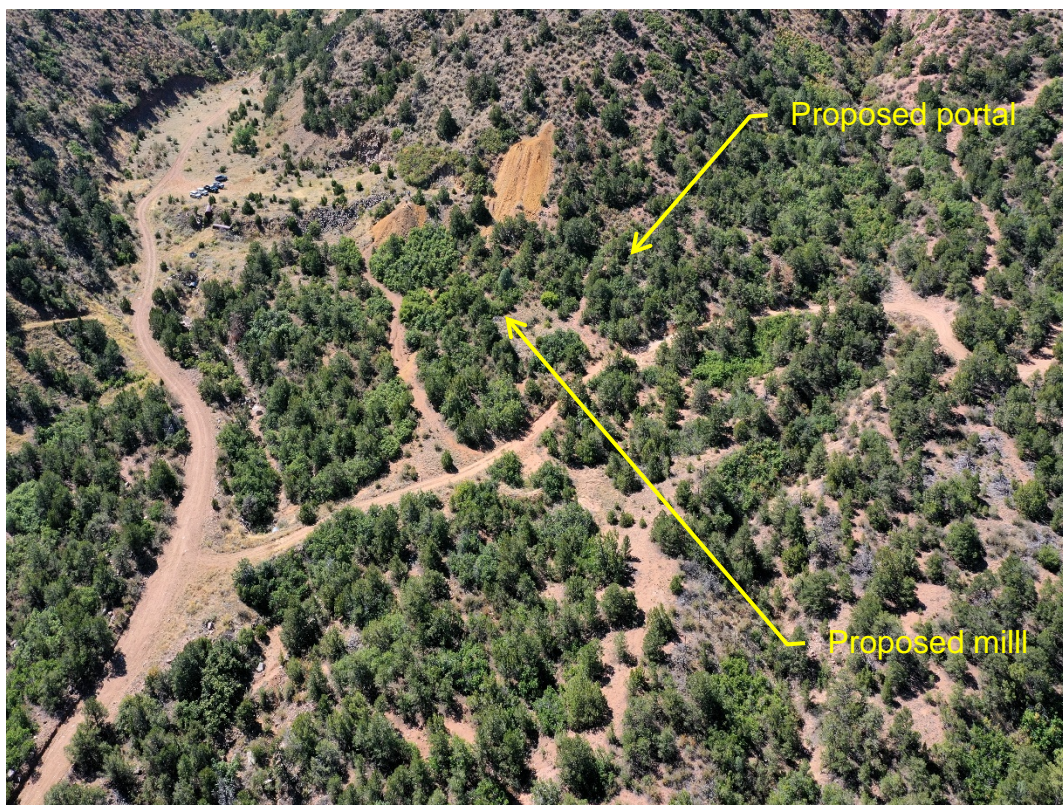
Photo 2. Proposed mine site (looking SW).

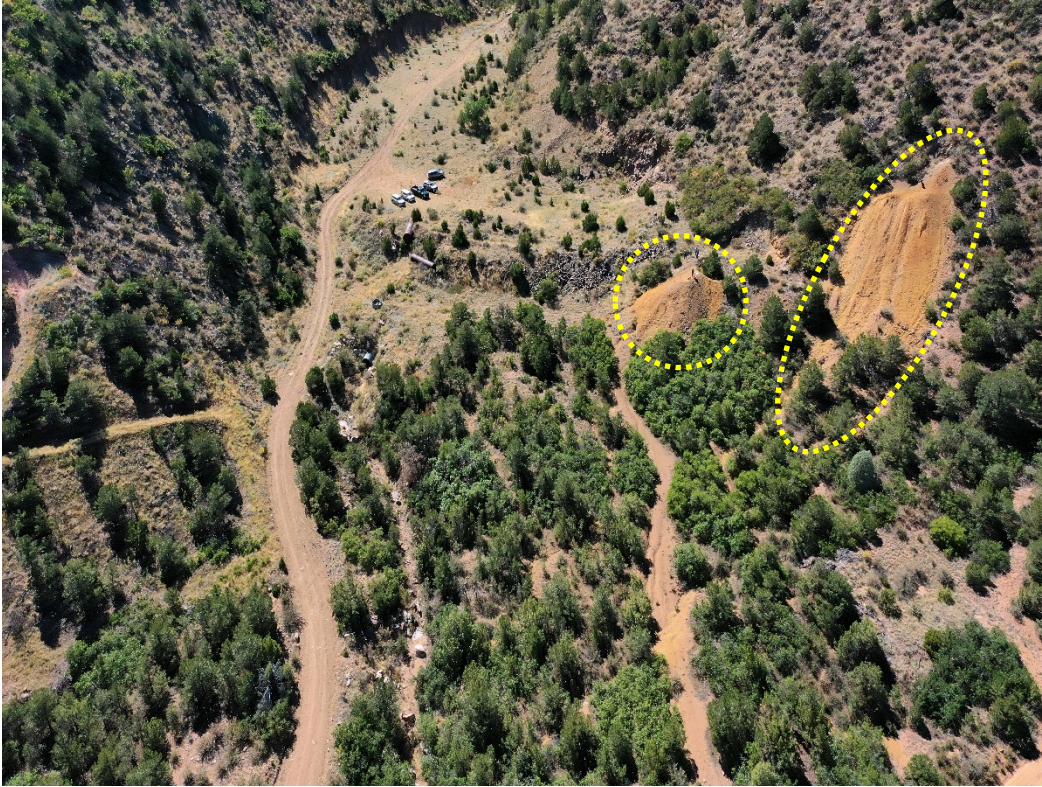
Existing disturbances within the proposed permit area include the access road and historic/pre-law excavated mine development waste piles (see **Photo 3**). The site can be characterized as rugged terrain with rock outcrops, vegetated with a mixture of pinyon pine and juniper trees, oak brush, and grasses in open areas.

Photos 4 and **5** show the proposed filtered tailings storage facility (FTSF) location. **Photo 3** shows the proposed portal and mill locations.

Photo 3. Pre-law existing mine development waste piles (looking south).

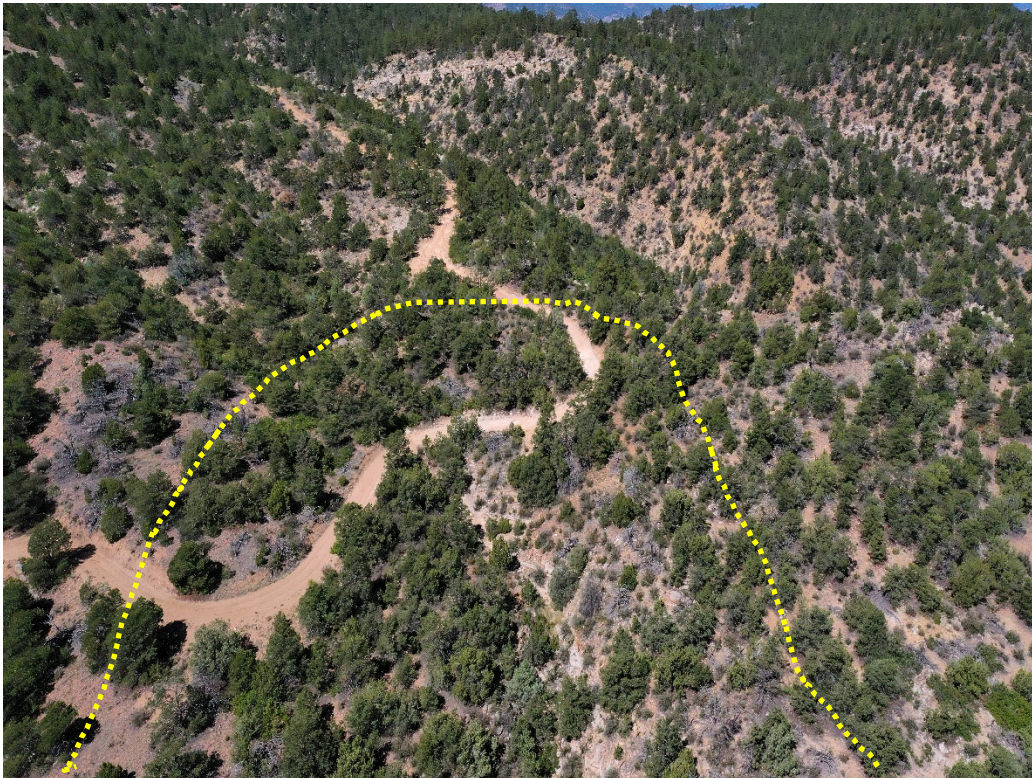
Photo 4. West end of proposed FTSF (looking west from near center of FTSF).

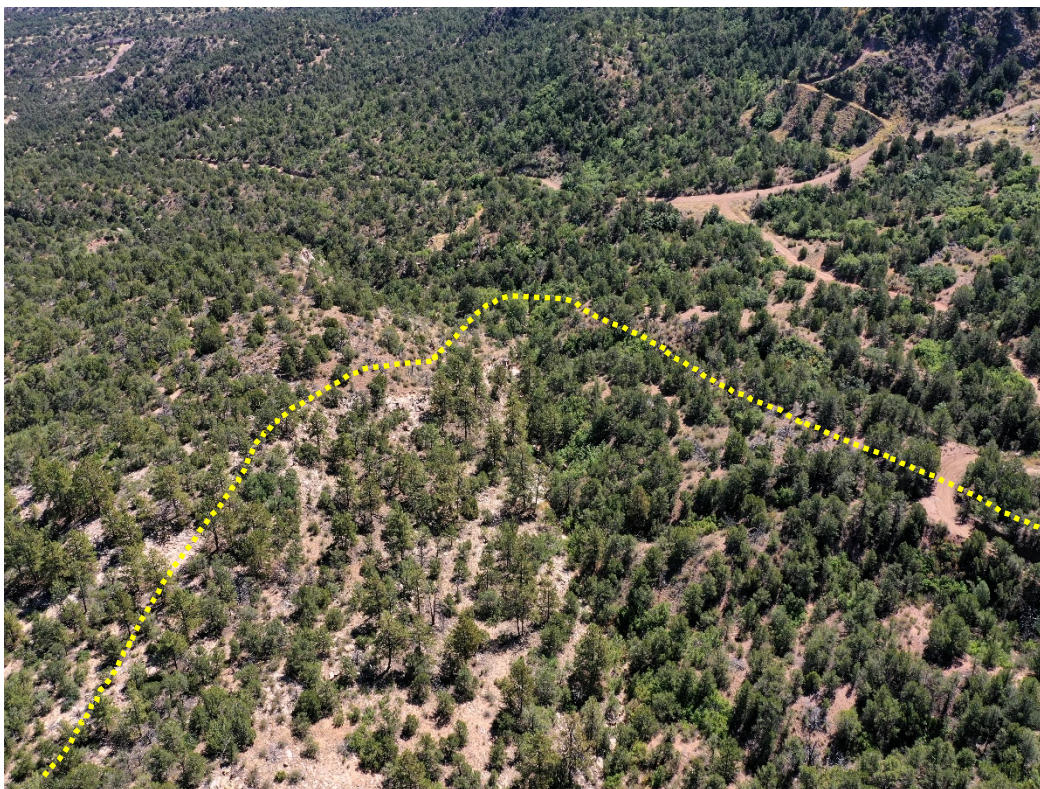
Photo 5. East end of proposed FTSF (looking east from near center of FTSF).

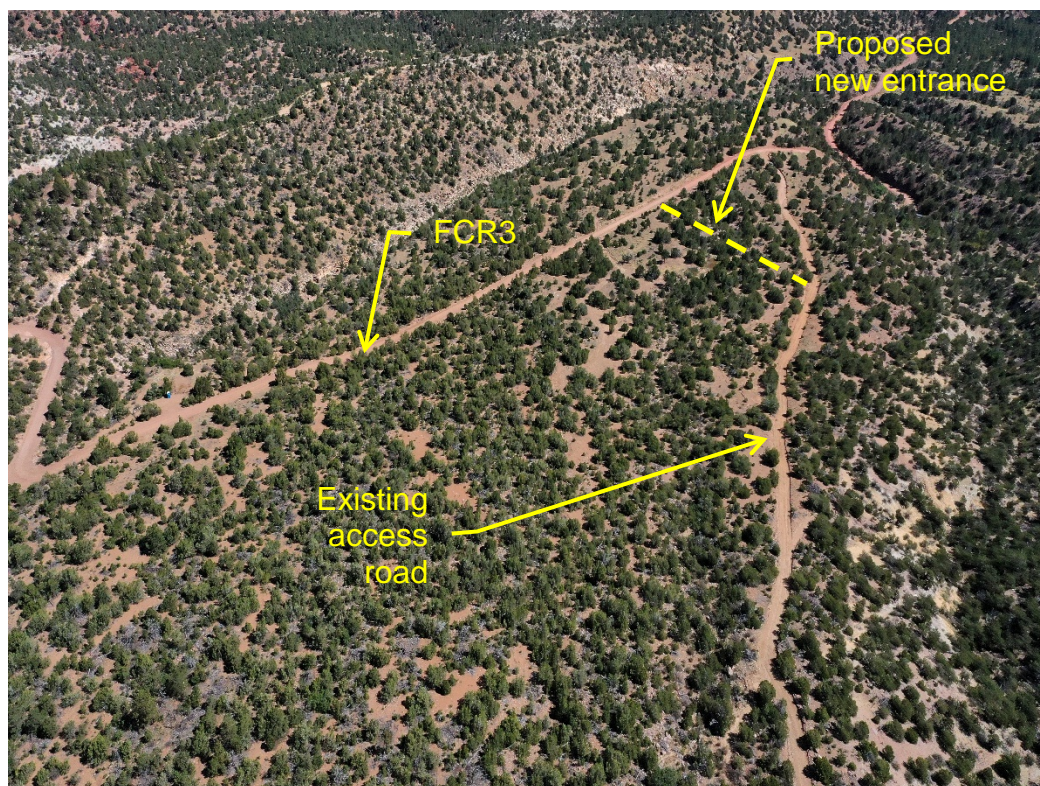
Photo 6. Existing access road from FCR3 and approximate location of proposed new entrance road (looking NE).
