Daniels Sand Pit 2, Permit No. M-1973-007-SG: Monthly Monitoring Report

February 9, 2022
Project No.: 19125

Regarding: Daniels Sand Pit 2, Permit No. M-1973-007-SG
Slope Stability Monthly Monitoring Report

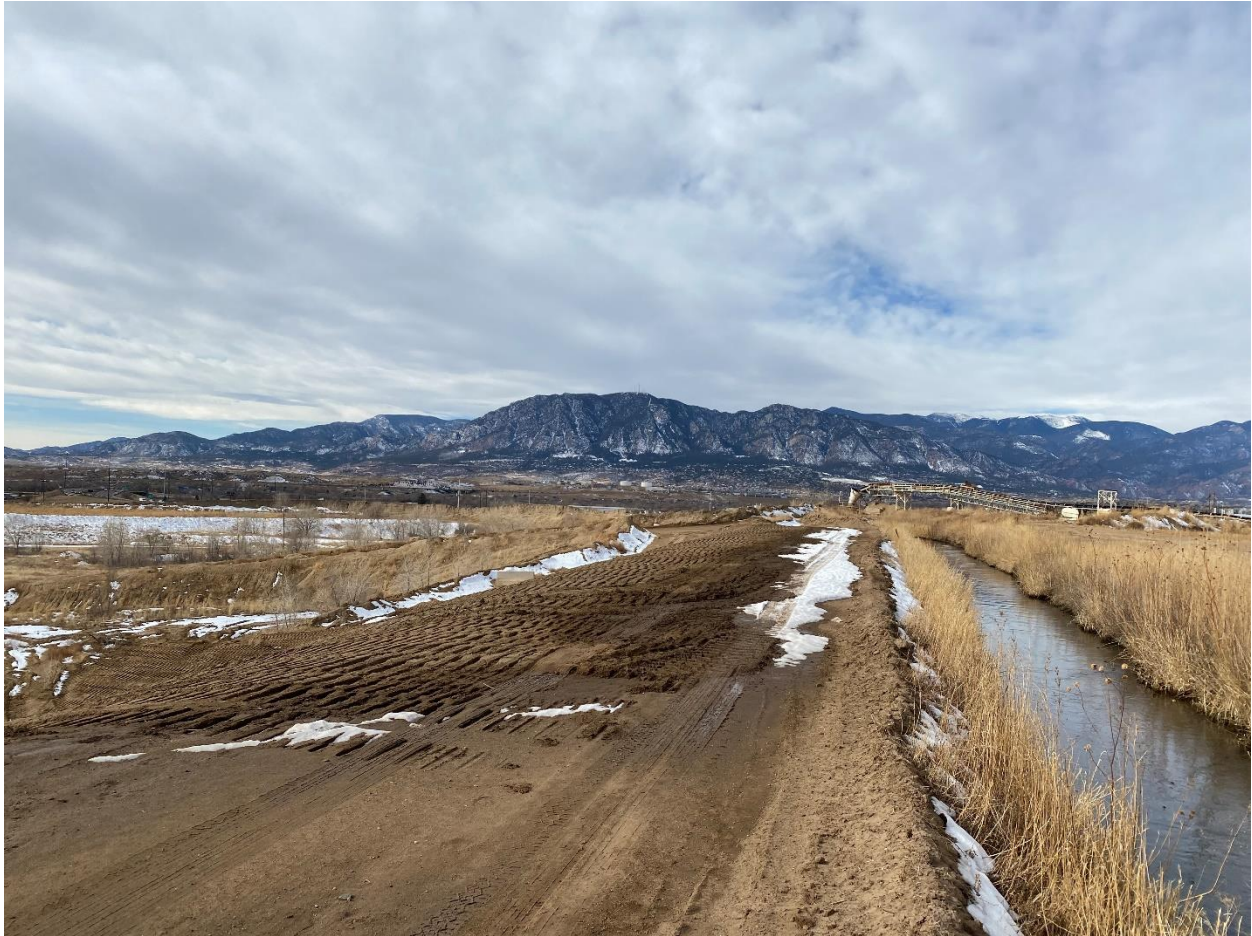
Photo 1. Fountain Mutual Ditch looking west with buttress slope

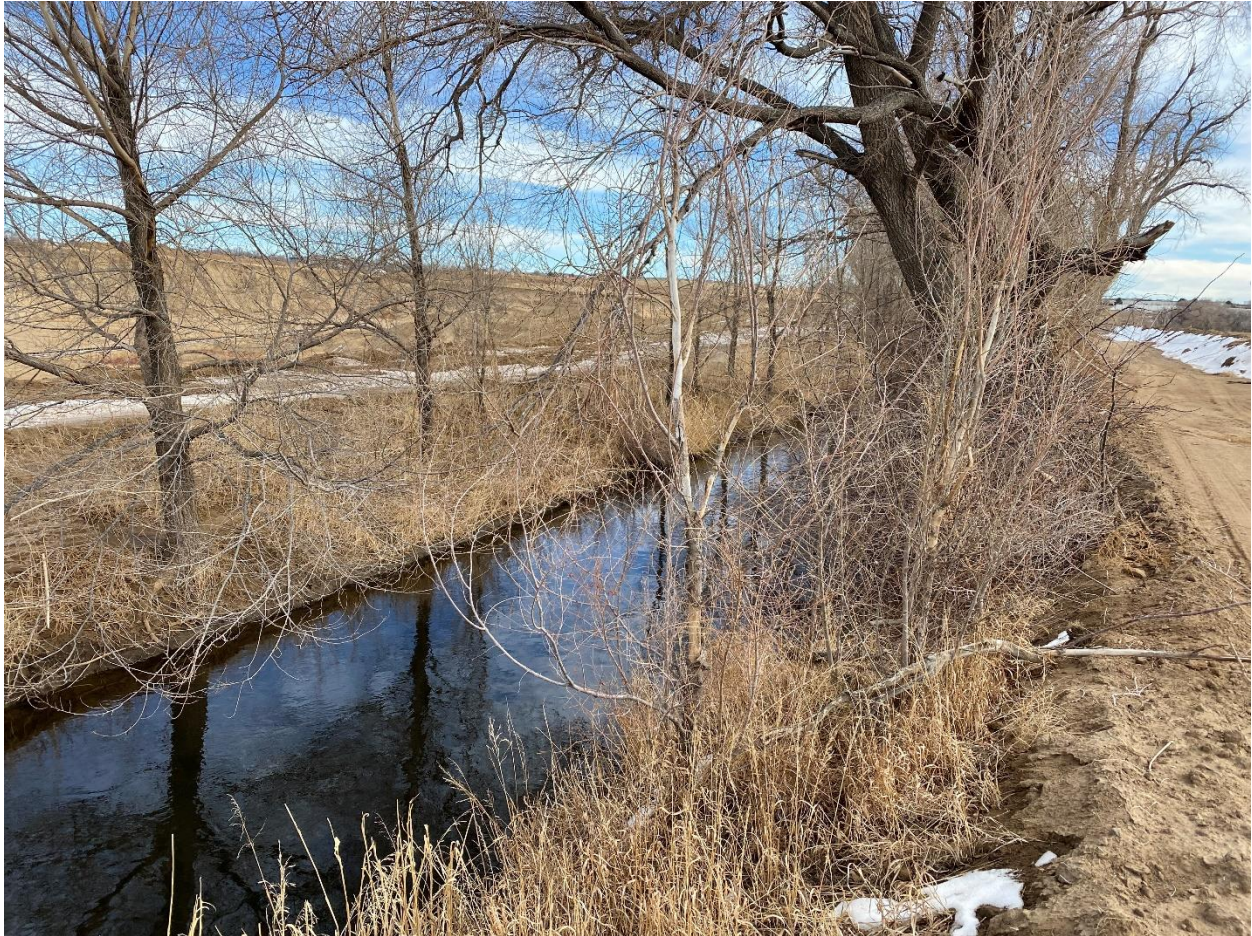
Photo 2. Fountain Mutual Ditch looking east

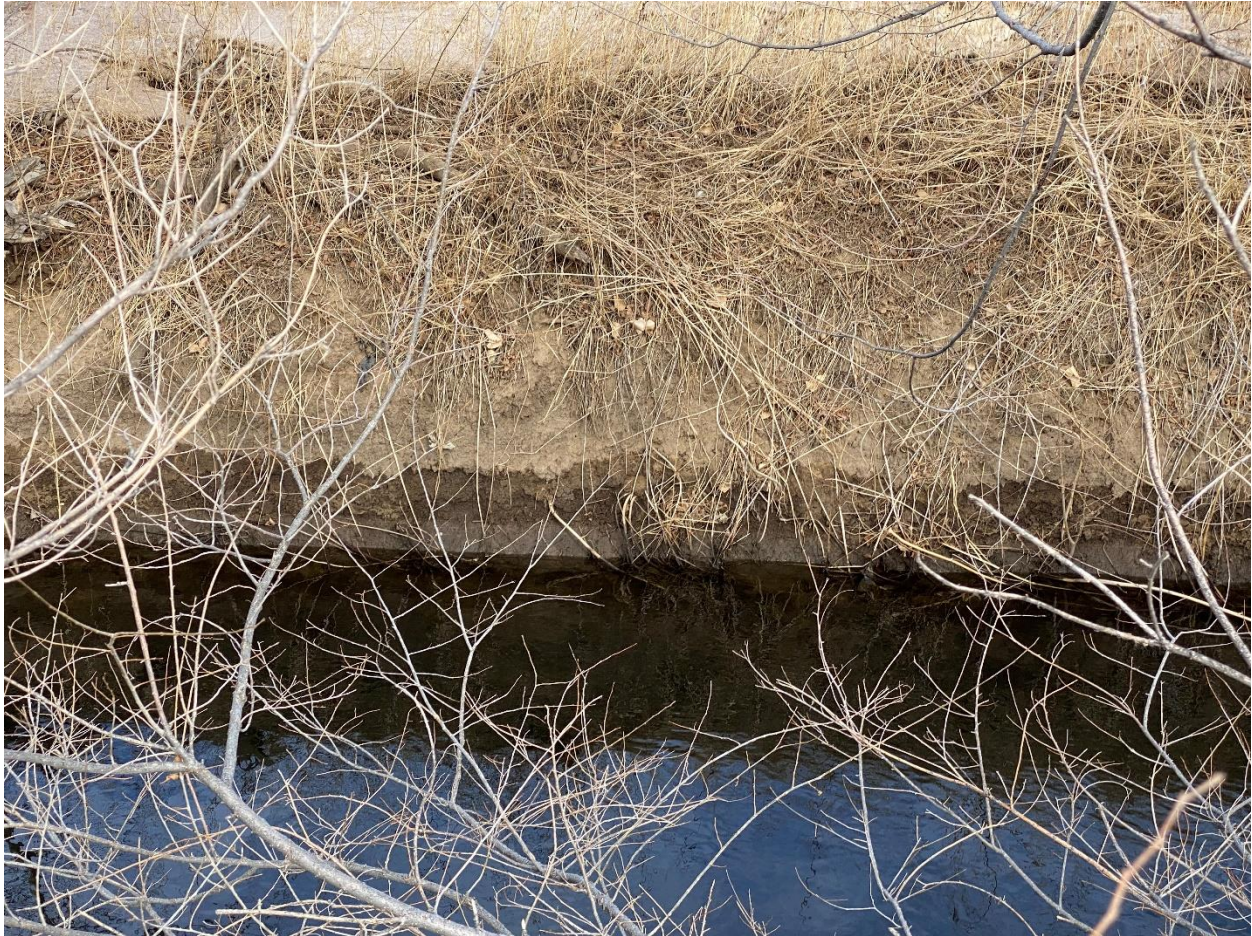
Photo 3. Fountain Mutual Ditch looking north (note change in water level on bank)

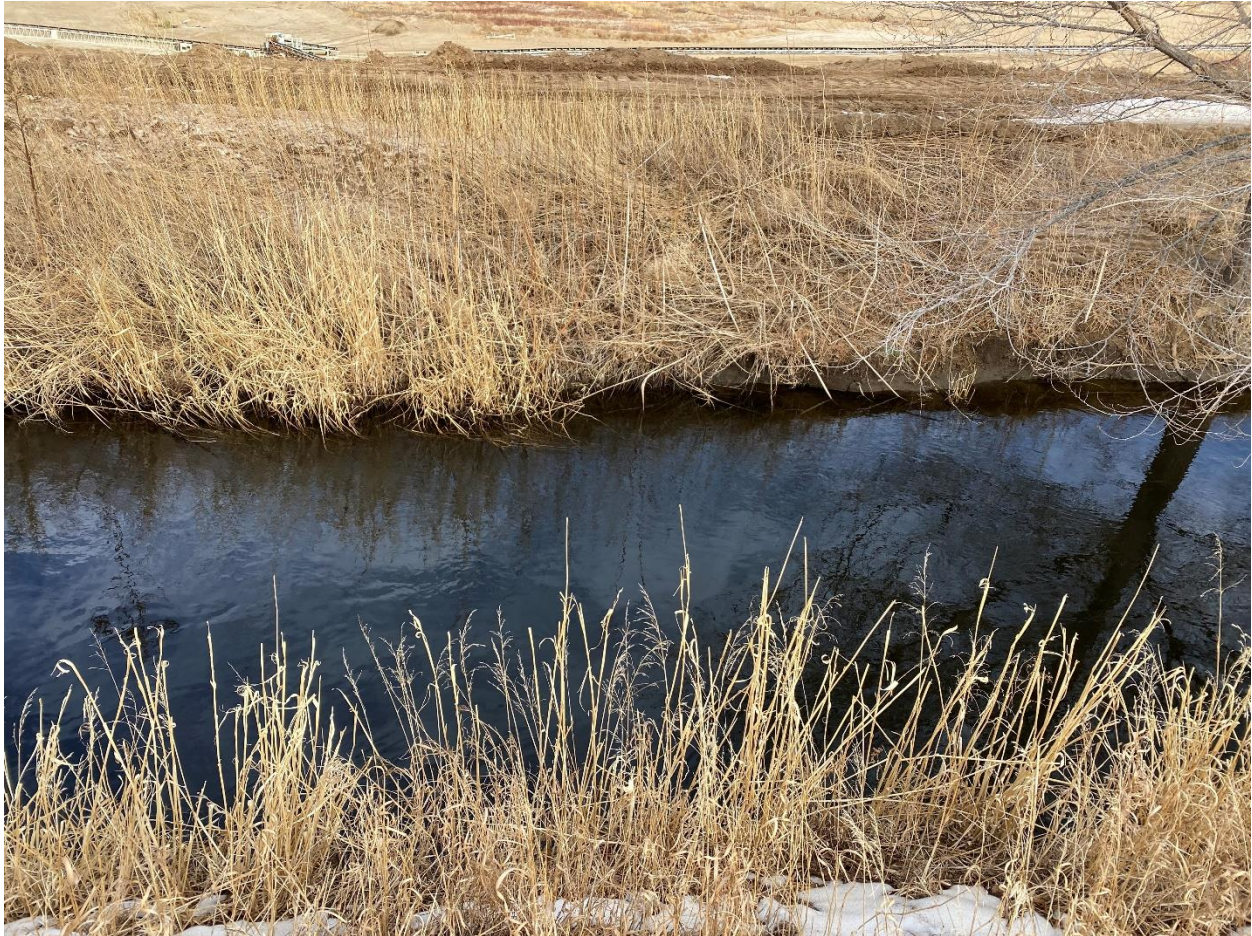
Photo 4. Fountain Mutual Ditch invert with water

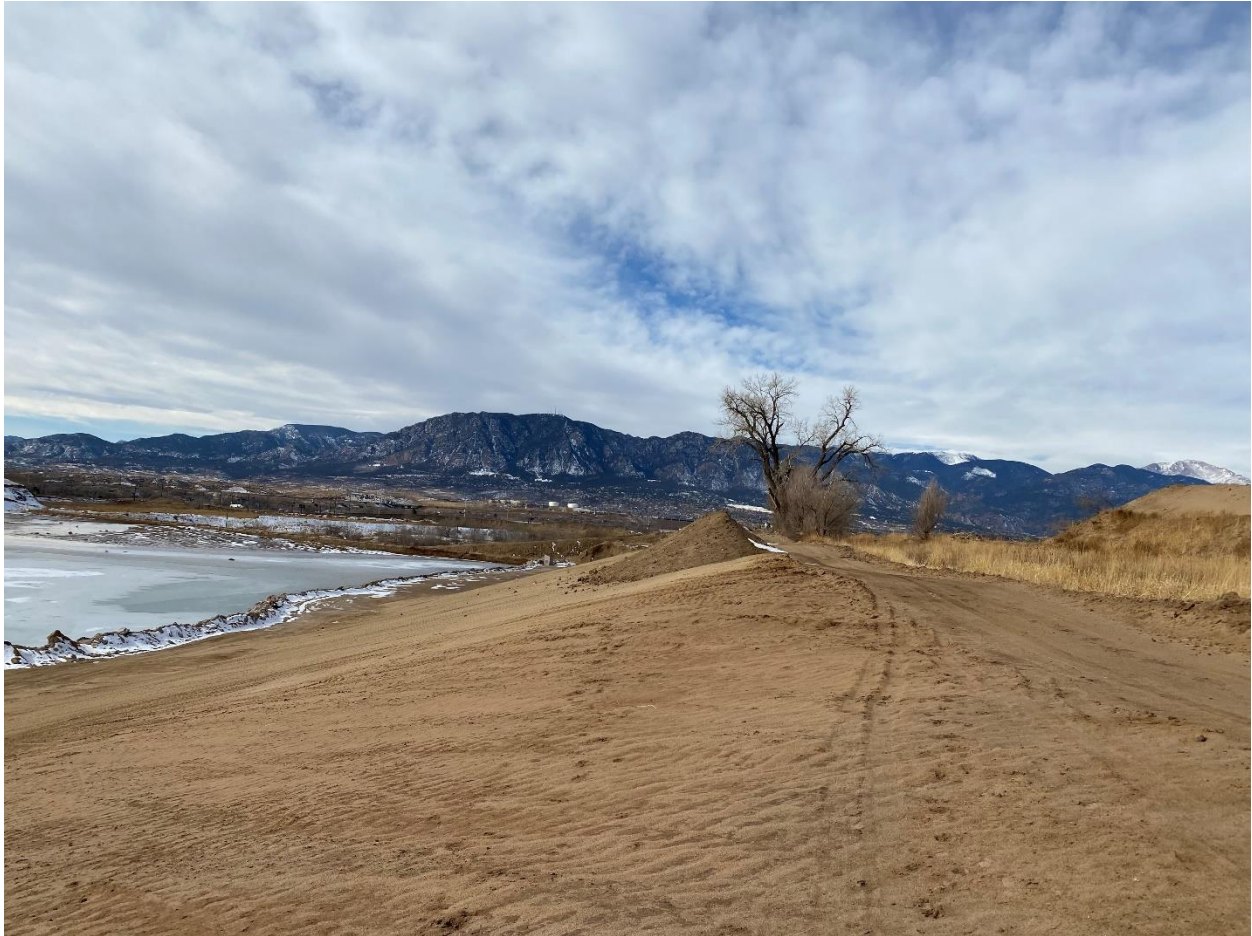
Photo 5. Stockpiled sand for final lift, access road and ditch (looking west)

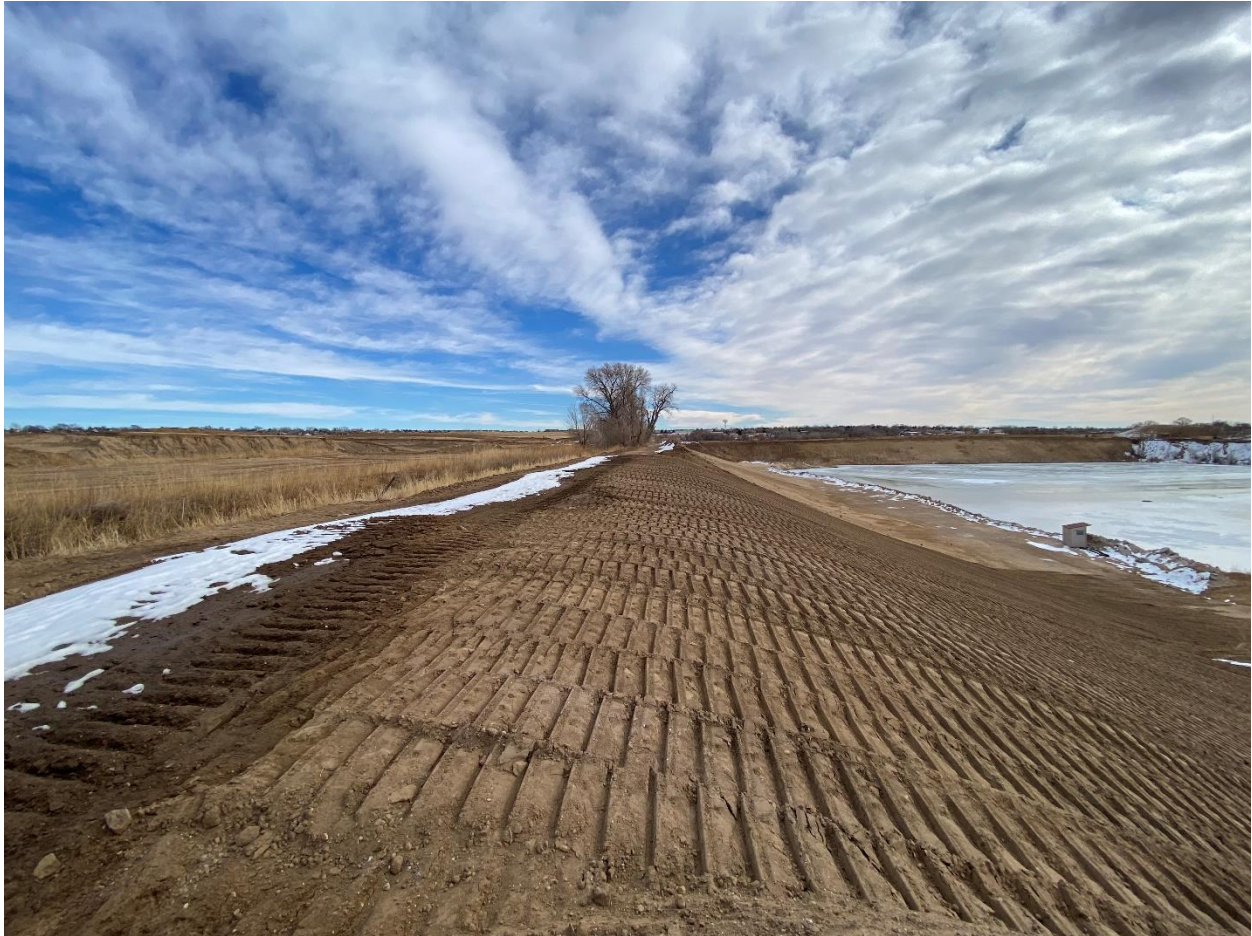
Photo 6. Buttress slope looking east

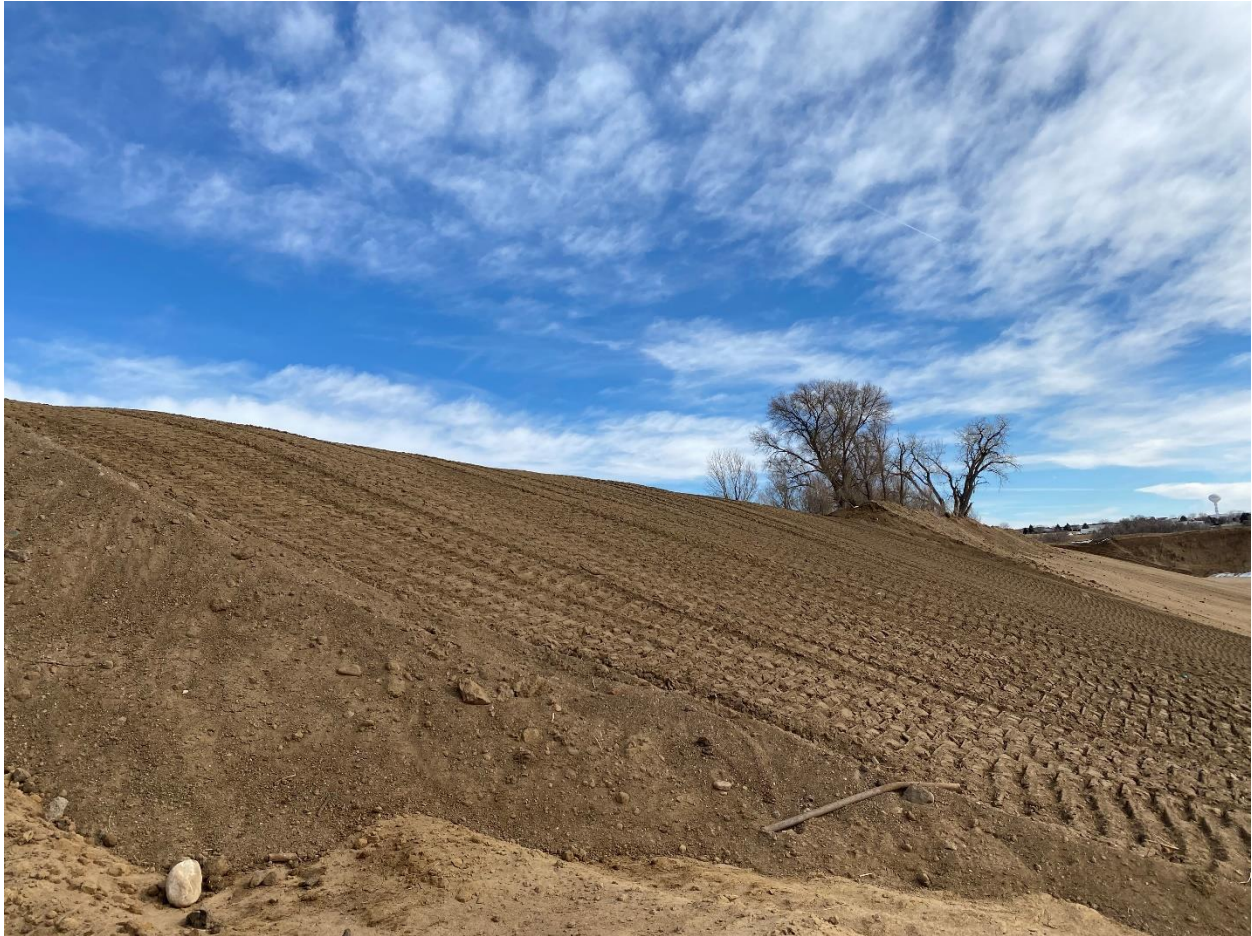
Photo 7. Buttress slope looking northeast

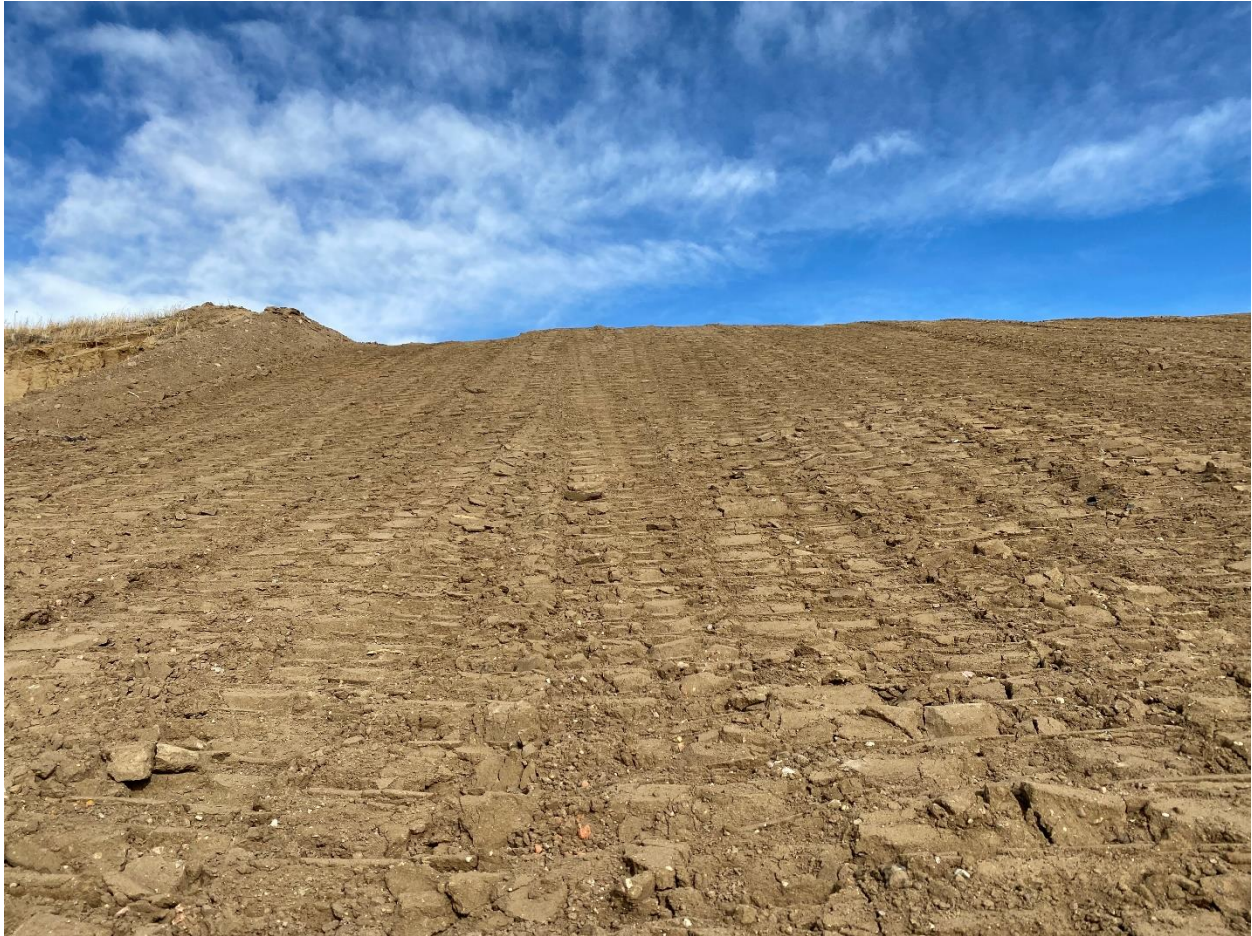
Photo 8. Buttress slope looking north

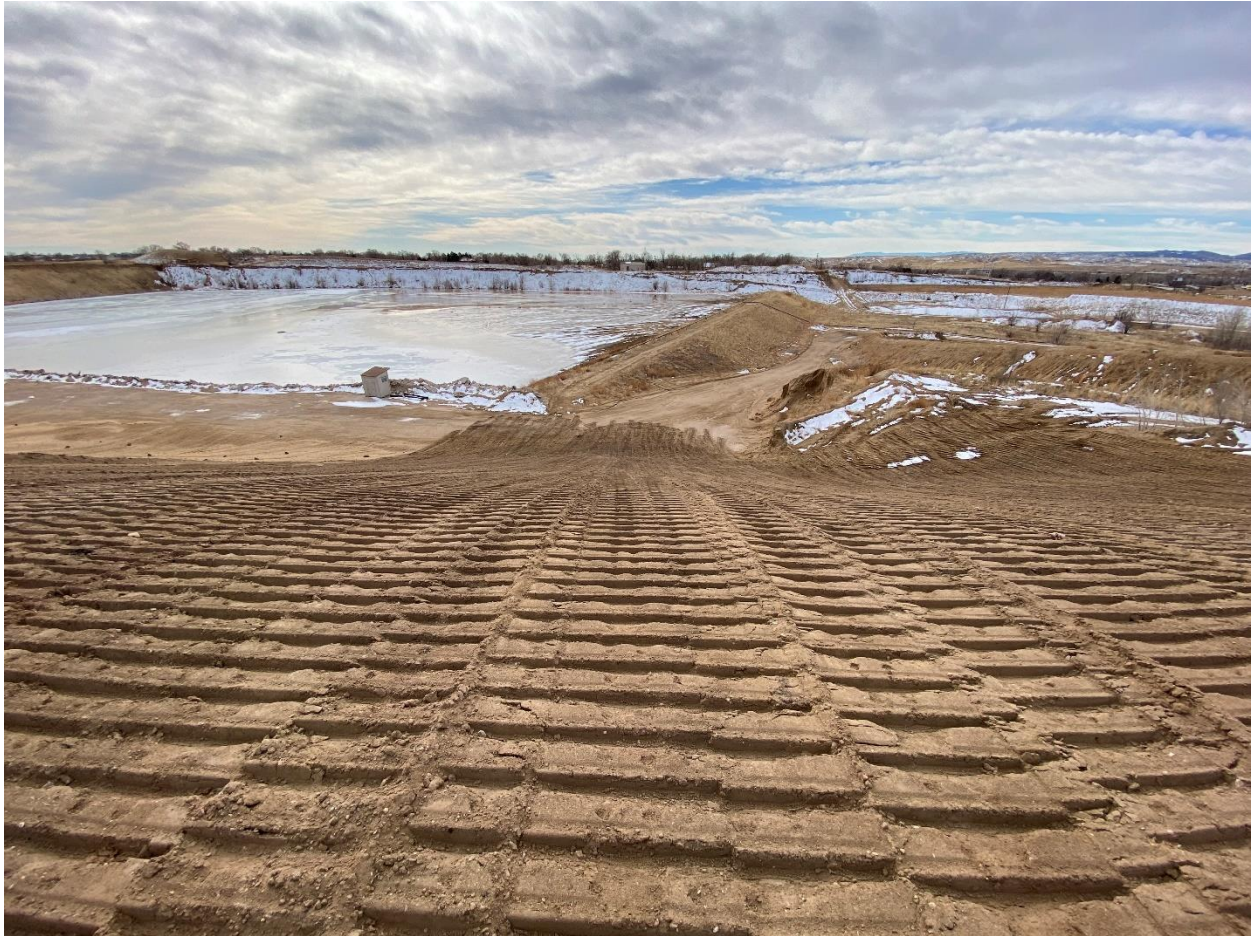
Photo 9. Buttress slope looking south
