MINERALS PROGRAM INSPECTION REPORT**PHONE: (303) 866-3567**

MINE NAME: Providence Mine	MINE/PROSPECTING ID#: M-2012-052	MINERAL: Silver and gold	COUNTY: Teller
INSPECTION TYPE: Monitoring	INSPECTOR(S): Elliott R. Russell	INSP. DATE: August 28, 2019	INSP. TIME: 12:00
OPERATOR: Cripple Creek & Victor Gold Mining Company	OPERATOR REPRESENTATIVE: Justin Bills and Katie Blake	TYPE OF OPERATION: 110d - Designated Limited Impact

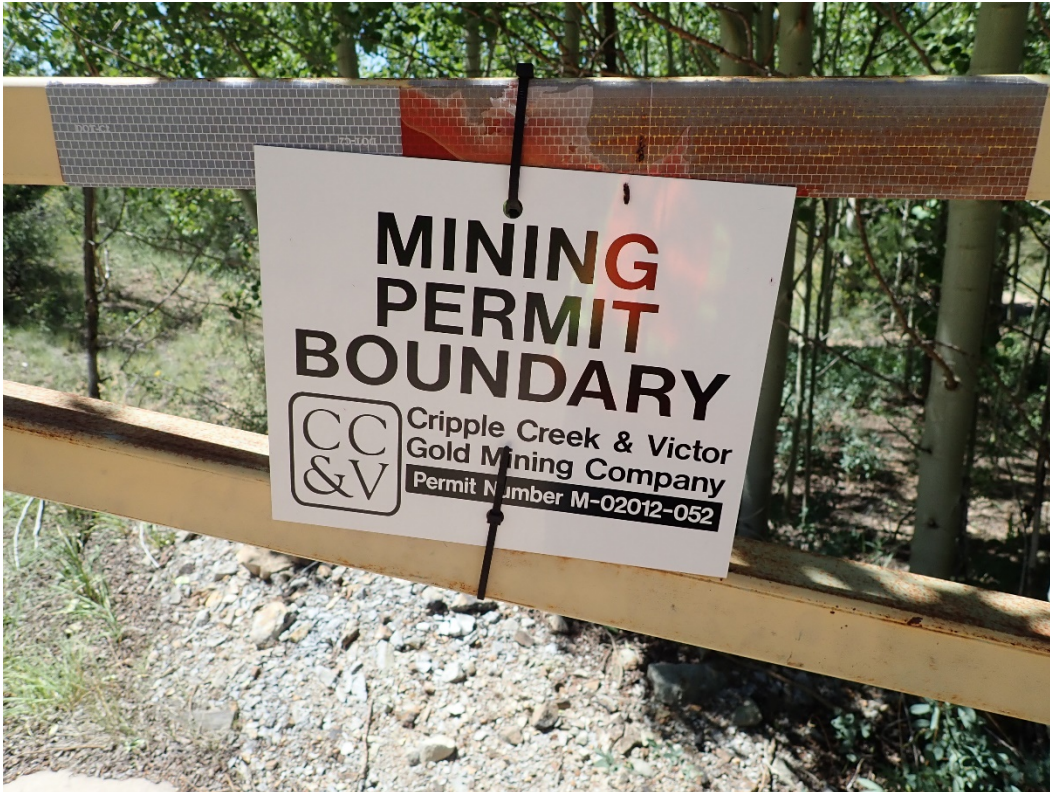
COMPLIANCE PROBLEM #1: The mine identification sign posted at the entrance of the mine site listed the wrong permit number. This is a problem for failure to post a mine identification sign in accordance with Rule 3.1.12(1).

Signs and Markers: The permit signed listed an incorrect permit number which will need to be corrected. This was cited as Compliance Problem #1, however, the Operator resolved this problem by submitted photo documentation of the corrective action after the inspection but prior to the date of this report on September 27, 2019.

Photo 1. Mine sign with an extra "0" in the permit number; looking west.

CORRECTIVE ACTIONS: The operator shall, at the entrance of the mine site, post a sign which shall be clearly visible from the access road with the following: the name of the operator, a statement that a reclamation permit for the operation has been issued by the Colorado Mined Land Reclamation Board; and the permit number. The operator shall submit photo documentation that a proper sign has been posted by the corrective action date.

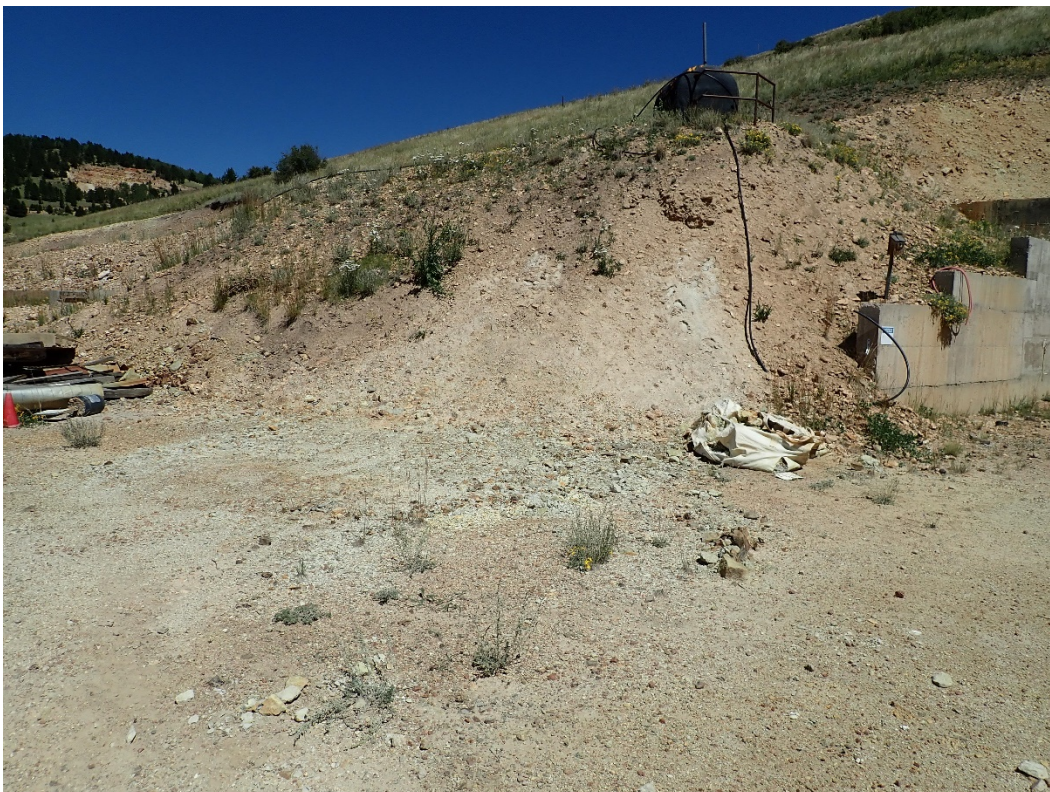
COMPLIANCE PROBLEM #2: A super sack of ore or waste rock was observed on the surface of the mine site near the Sangre de Christo Tunnel portal. The Division has no record of a geochemical analysis for this material in accordance with Stipulation No. 1 of the approved permit.

Permit Stipulations: The Division observed a small super-sack of ore or waste rock near the entrance to the Sangre de Christo Tunnel portal. Stipulation No. 1 of the approved permit states: *The permittee will commit to performing annual testing of ore and waste rock if removed to the surface of the permit area. Results to be included with Annual Report.* The permit file doesn't contain any information regarding the results of any Meteoric Water Mobility Procedure (MWMP) characterization of the geochemistry and leaching potential of this stockpiled material. This has been cited as Compliance Problem #2 requiring corrective action; please see the second page of this report for more information. The Operator stated this sack was accidentally left behind during the corrective action of the previous inspection report of the same cited problem. The Operator resolved this problem by submitted photo documentation of the corrective action after the inspection but prior to the date of this report on September 27, 2019.

Photo 2. Sack of ore or waste rock near tunnel entrance; looking north.

CORRECTIVE ACTIONS: The Operator shall conduct testing on the stockpiled material in accordance with the approved permit OR remove this material from the surface of the site and dispose of it appropriately.

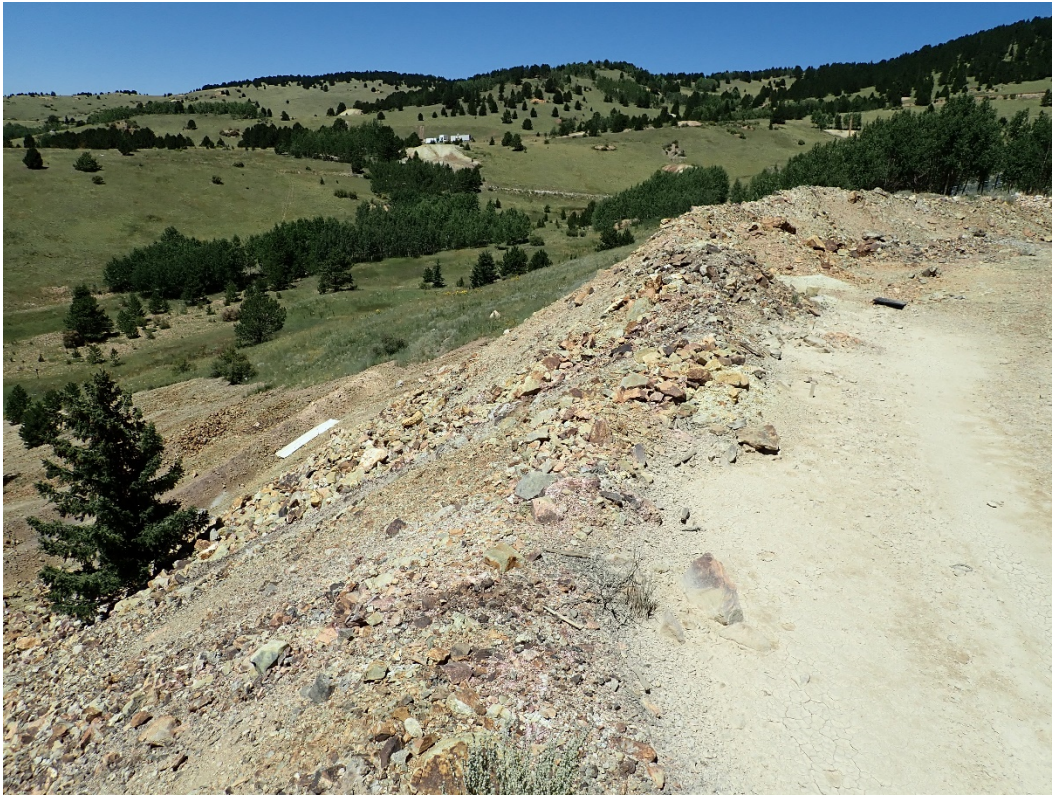
Sediment Control: The Division observed the repair work previously completed on the storm water containment berm around the crest of the Sangre de Christo Tunnel area. There are no issues of sediment control at this time.

Photo 3. Repaired storm water berm; looking northwest.

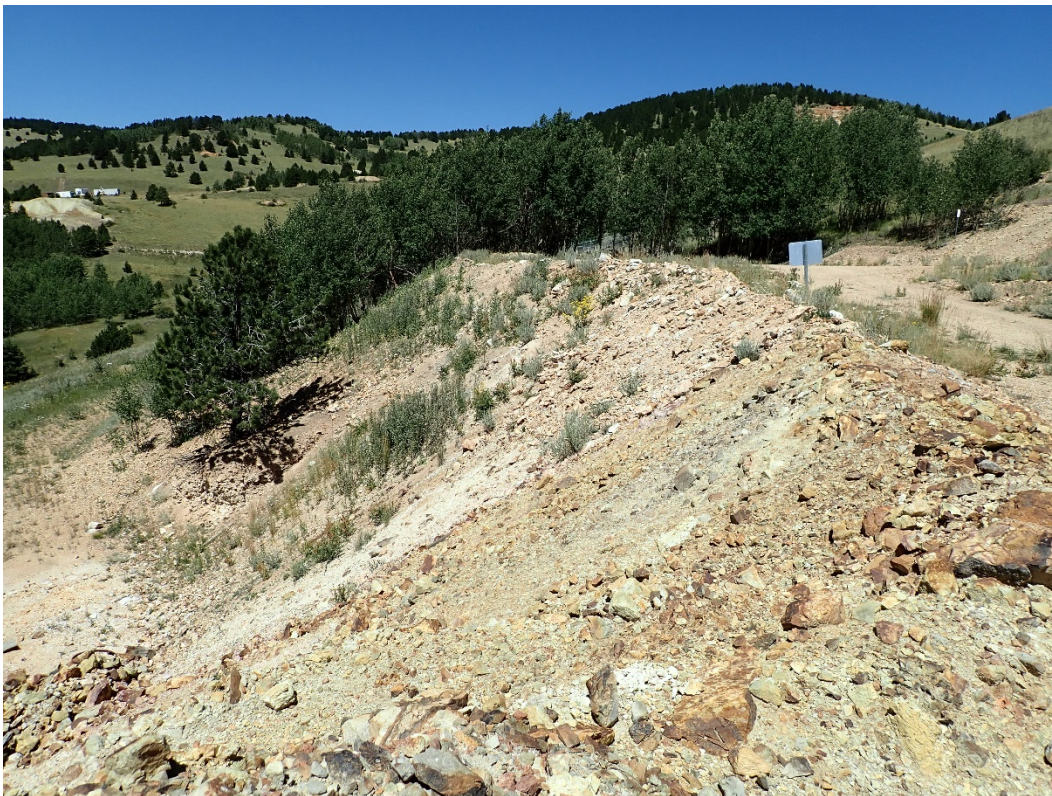
Photo 4. Waste rock dump; looking north.

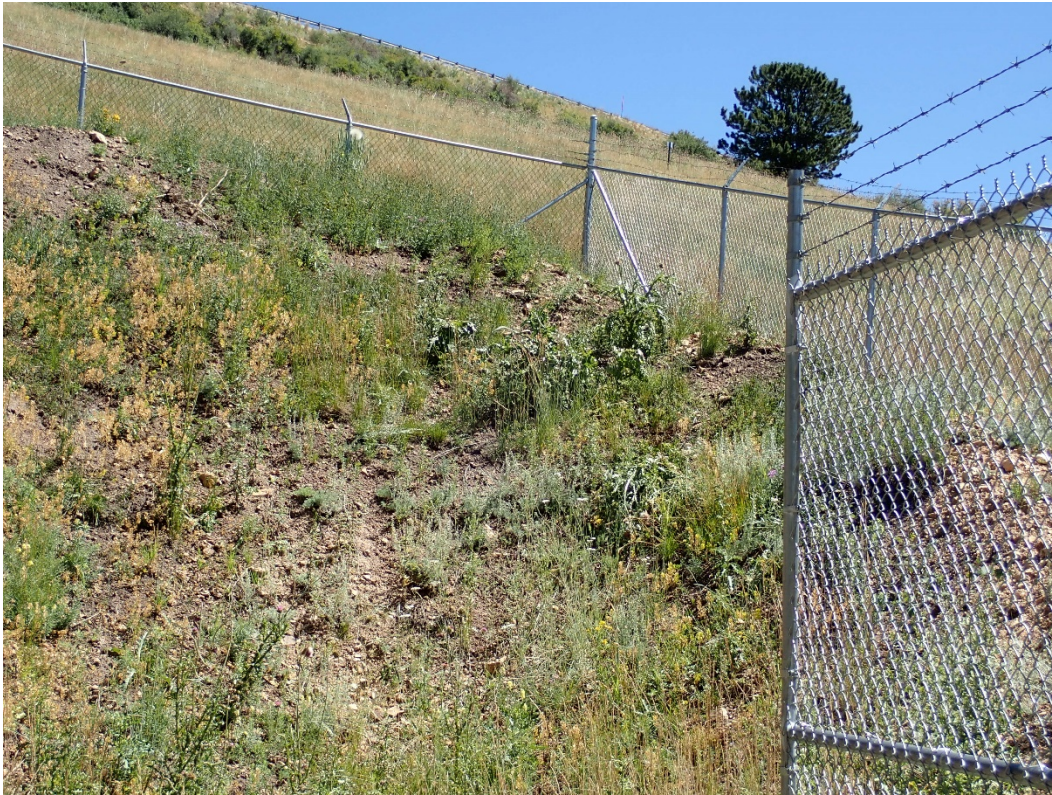
Revegetation: An infestation of musk thistle, a List B noxious weed, was observed the previous inspection. The Operator treated the weeds following that inspection. More musk thistle was observed during this inspection, however, the Division observed evidence that these weeds had recently been sprayed. The Operator should monitoring the site to ensure the treatment was effective at eradicating the musk thistle.

Photo 5. Musk Thistle showing signs of recent treatment; looking southeast.
