MINERALS PROGRAM INSPECTION REPORT
PHONE: (303) 866-3567

MINE NAME: Providence Mine	MINE/PROSPECTING ID#: M-2012-052	MINERAL: Silver and gold	COUNTY: Teller
INSPECTION TYPE: Monitoring	INSPECTOR(S): Elliott Russell	INSP. DATE: May 27, 2021	INSP. TIME: 13:30
OPERATOR: Cripple Creek & Victor Gold Mining Company	OPERATOR REPRESENTATIVE: Jeana Ratcliff	TYPE OF OPERATION: 110d - Designated Limited Impact	
REASON FOR INSPECTION: Normal I&E Program	BOND CALCULATION TYPE: None	BOND AMOUNT: \$17,200.00	
DATE OF COMPLAINT: NA	POST INSP. CONTACTS: None	JOINT INSP. AGENCY: None	
WEATHER: Clear	INSPECTOR'S SIGNATURE:

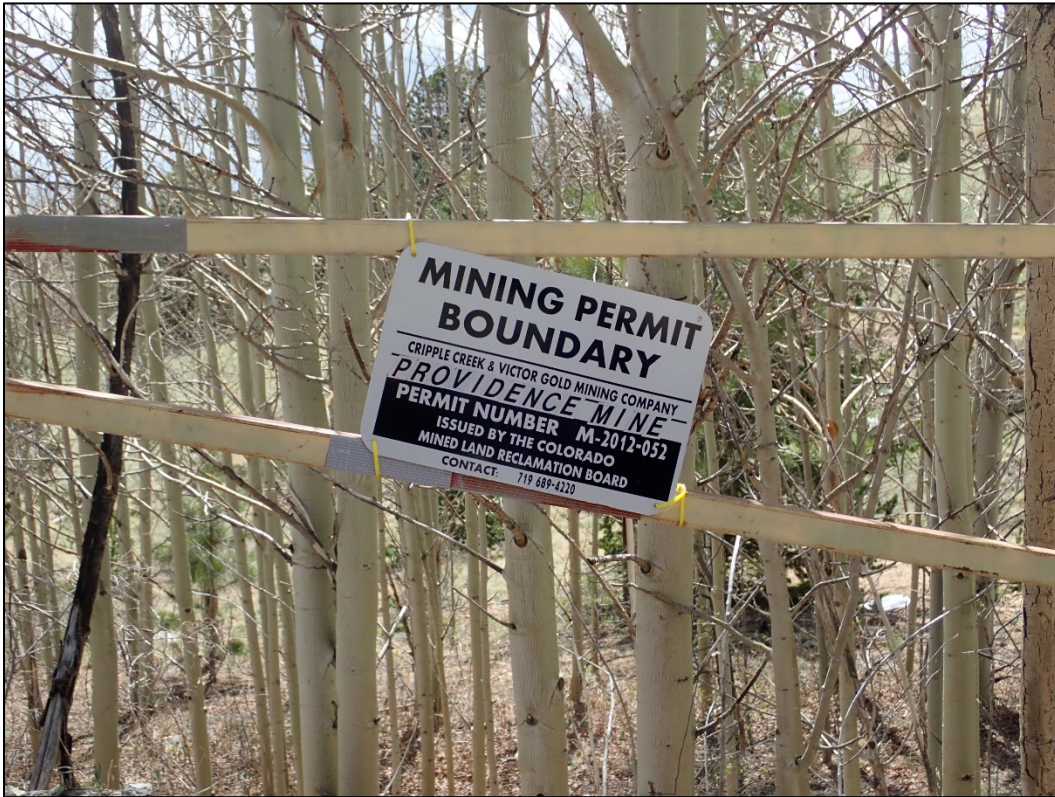
Signs and Markers: The permit sign was properly posted and permit boundary was marked.

Photo 1. Mine site identification sign at the entrance to the permit boundary; looking west.

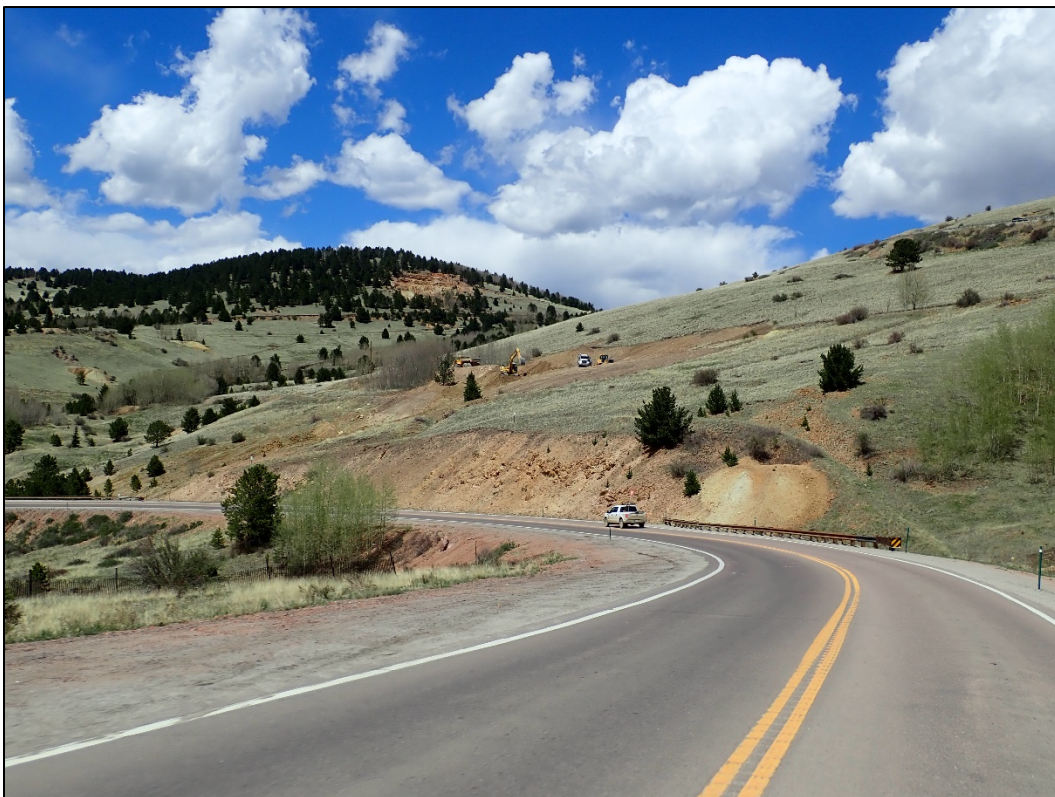
Photo 2. Site overview (Sangre de Cristo Tunnel area) from Highway 67; looking north.

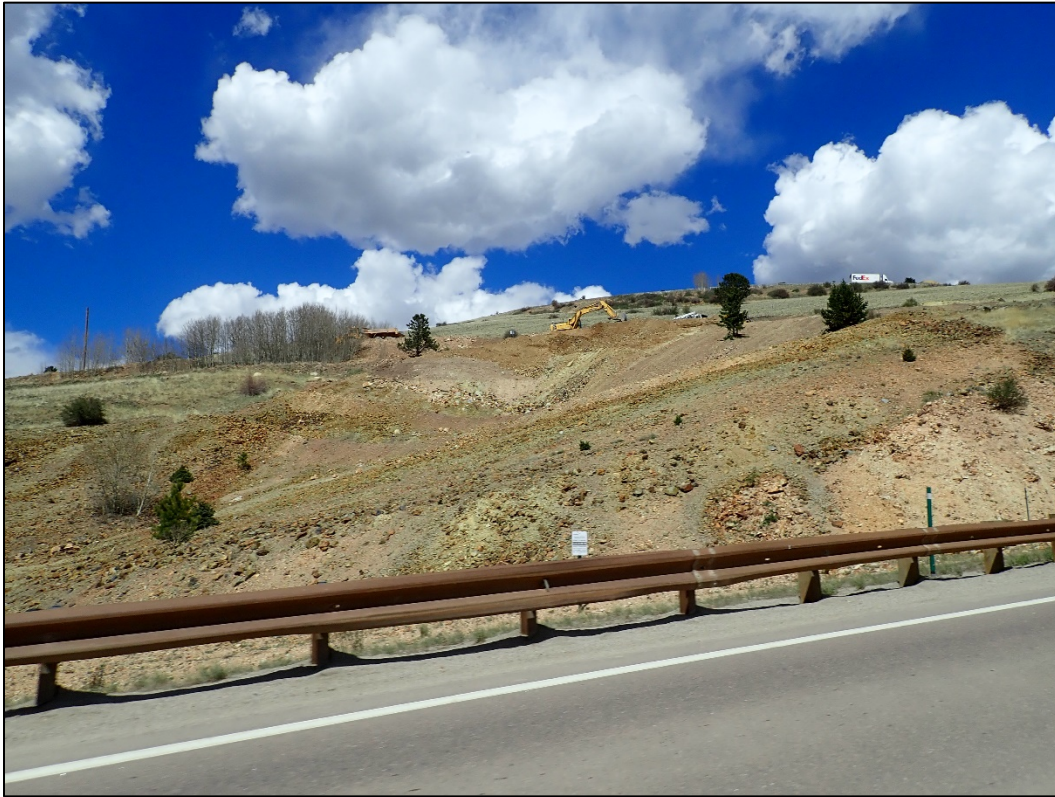
Photo 3. Site overview (Sangre de Cristo Tunnel area) from Highway 67; looking northeast.

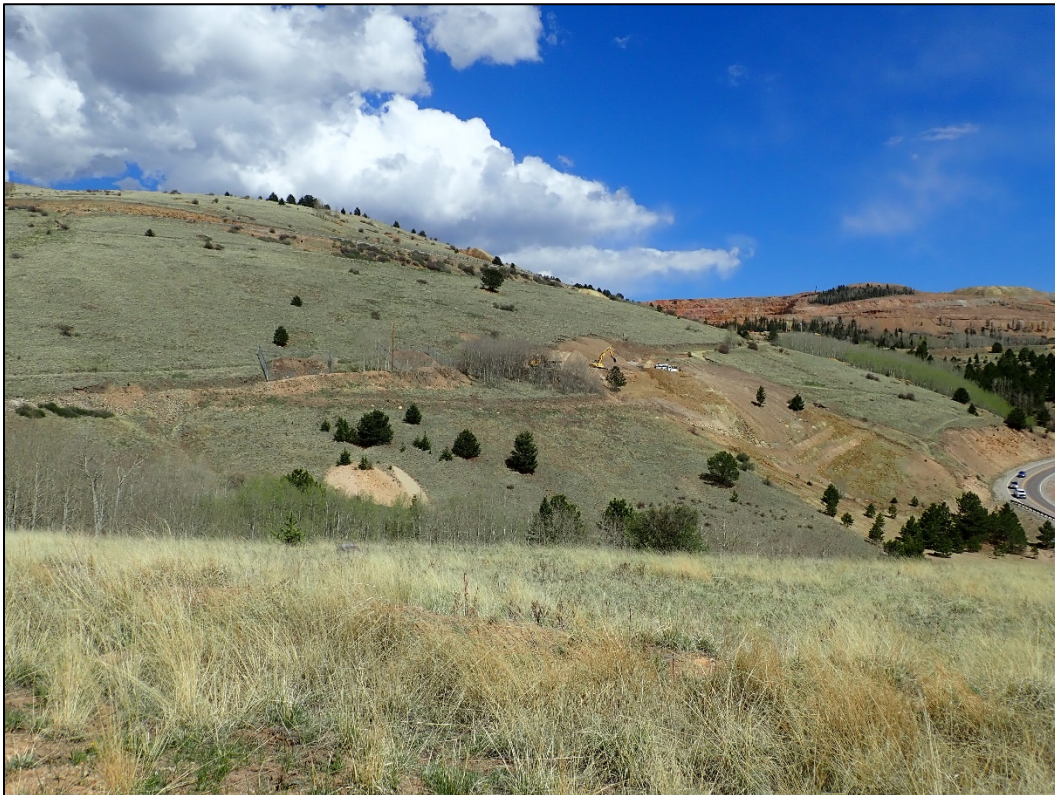
Photo 4. Site overview (Sangre de Cristo Tunnel area) from access road; looking east.

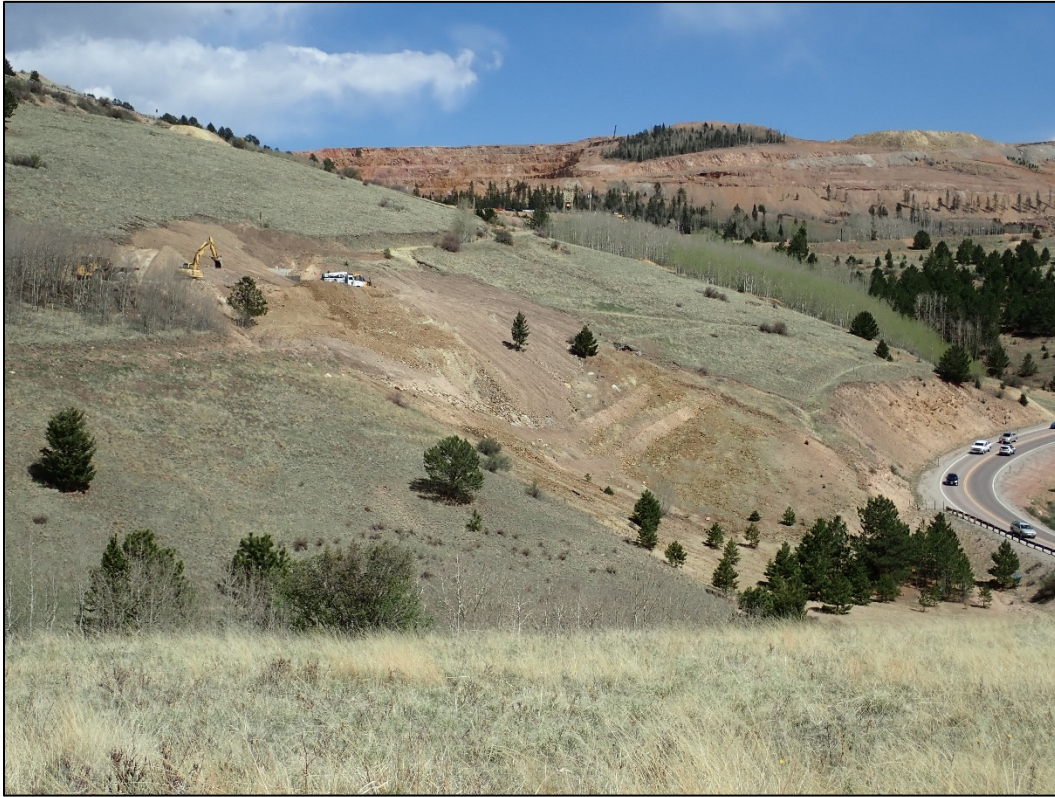
Photo 5. Site overview (Sangre de Cristo Tunnel area) from access road; looking southeast.

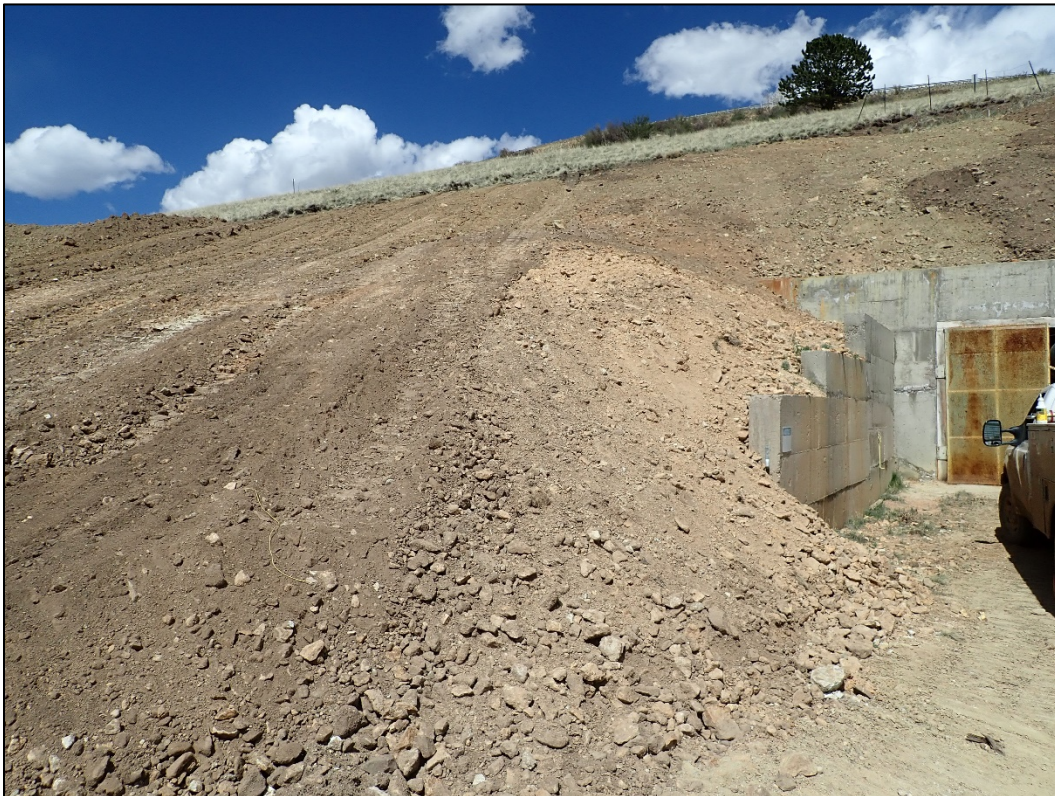
Photo 6. Graded area north of the Sangre de Cristo Tunnel; looking northeast.

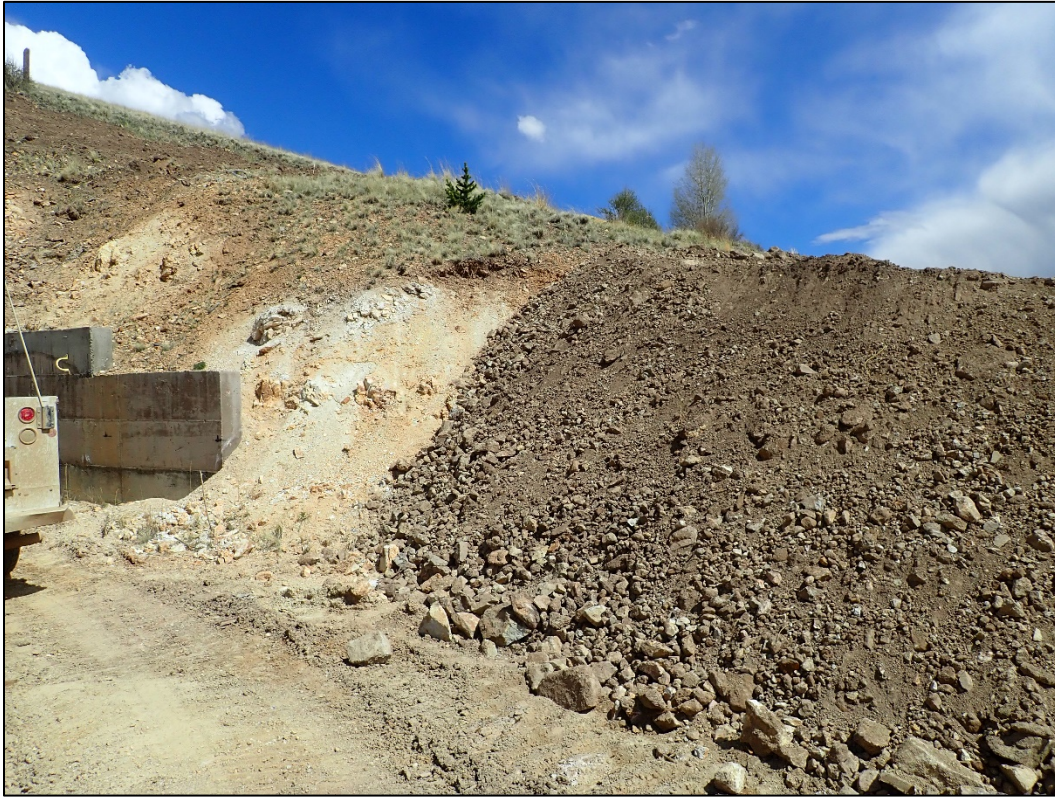
Photo 7. Backfilled area south of the Sangre de Christo Tunnel; looking southeast.

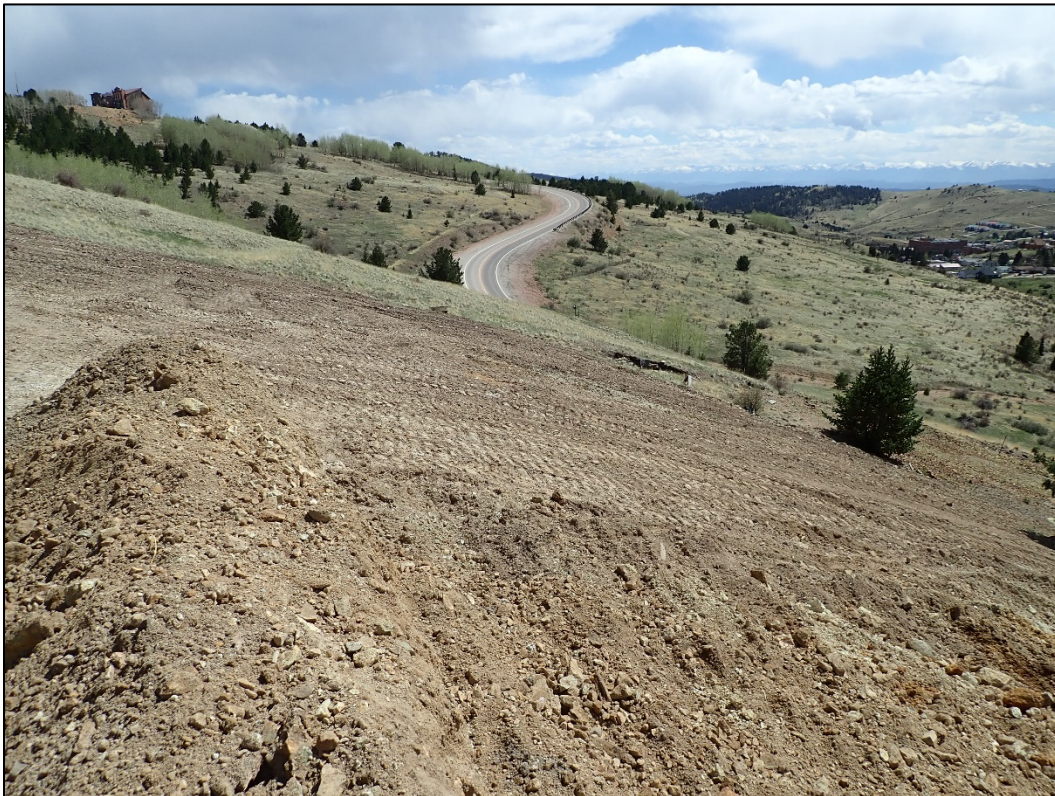
Photo 8. Graded waste rock dump; looking south.

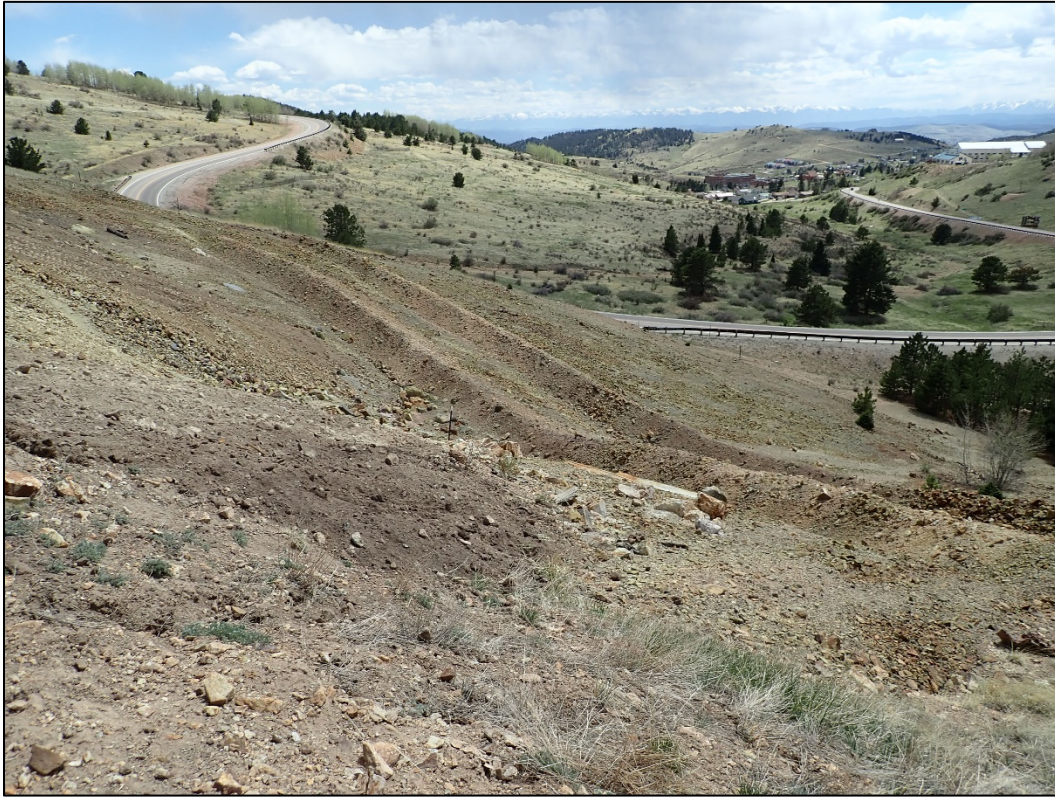
Sediment Control: During the inspection the Division, the Operator, and the reclamation contractor discussed sediment control following reclamation activities. Currently, there were two silt retention trenches at the base of the waste rock dump which could be temporarily left in place to help control off-site sedimentation while the site becomes revegetated. After vegetation is appropriately established on the reclaimed lands, these trenches/berms could be flattened out prior to final release. The Operator may choose to reclaim the trenches now, but will need to install other sediment controls (silt fencing, straw wattles, etc.).

Photo 9. Silt retention trenches at the base of the waste rock dump; looking south.
