MINERALS PROGRAM INSPECTION REPORT
PHONE: (303) 866-3567

MINE NAME: OakBrush Hill Gravel	MINE/PROSPECTING ID#: M-2021-064	MINERAL: Aggregate, gravel and sand	COUNTY: Archuleta
INSPECTION TYPE: Preoperation Inspection	INSPECTOR(S): Lucas West	INSP. DATE: January 25, 2022	INSP. TIME: 11:50
OPERATOR: C & J Gravel Products, Inc.	OPERATOR REPRESENTATIVE: Hank Boeschert	TYPE OF OPERATION: 112c - Construction Regular Operation	
REASON FOR INSPECTION: Pre-operation Inspection	BOND CALCULATION TYPE:	BOND AMOUNT: No Bond Held	
DATE OF COMPLAINT: NA	POST INSP. CONTACTS: None	JOINT INSP. AGENCY: None	
WEATHER: Clear	INSPECTOR'S SIGNATURE:

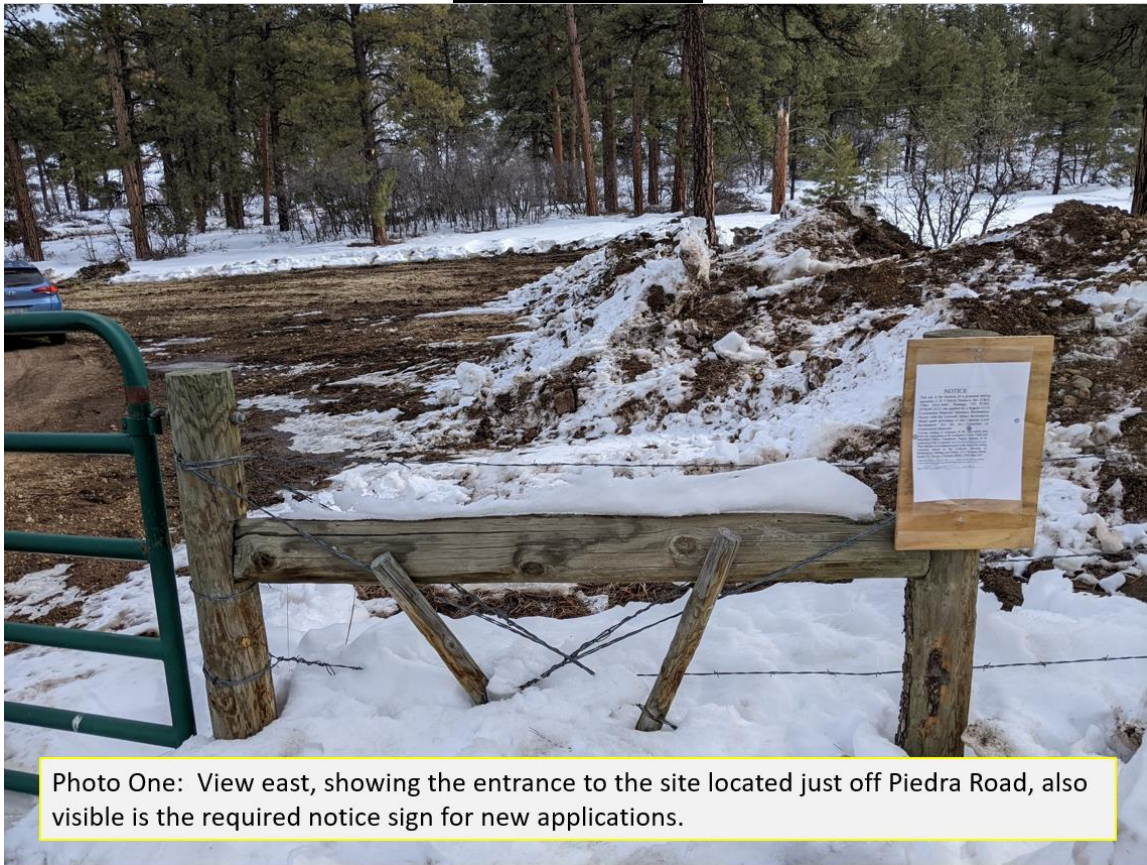
Photo One: View east, showing the entrance to the site located just off Piedra Road, also visible is the required notice sign for new applications.

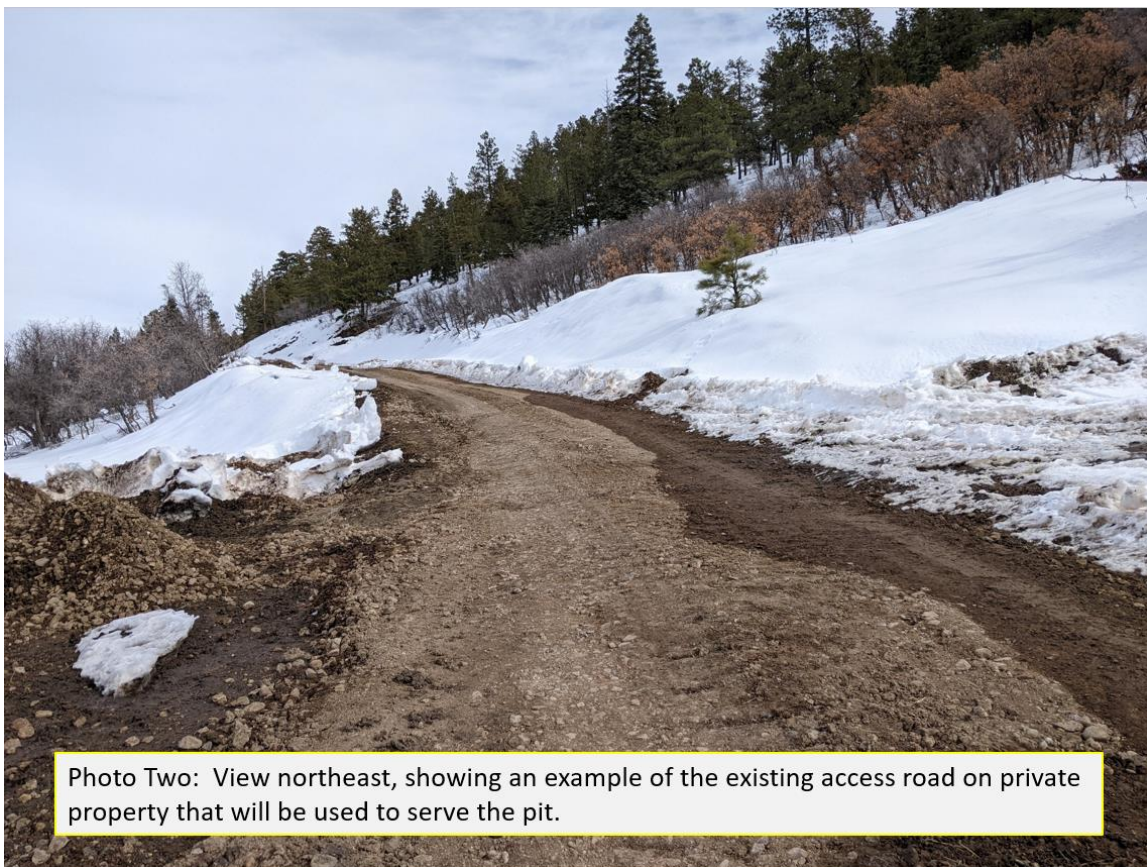
Access to the site is a locked gate off Piedra Road providing access to the private property. The access road leads approximately 2,500 feet into the property leading to the area of excavation. Evidence of material being placed on the road to mitigate muddy conditions was observed. During the inspection, conversations with the Applicant confirm that approximately 600 tons of material had been laid on the road, using the front end loader on site. The proper notice signs for the pending application were posted on the gate and can be seen in Photo One. The access road winds along the base of the ridge, turning south leading to the area of excavation. An example of the access road can be seen in Photo Two.

Photo Two: View northeast, showing an example of the existing access road on private property that will be used to serve the pit.

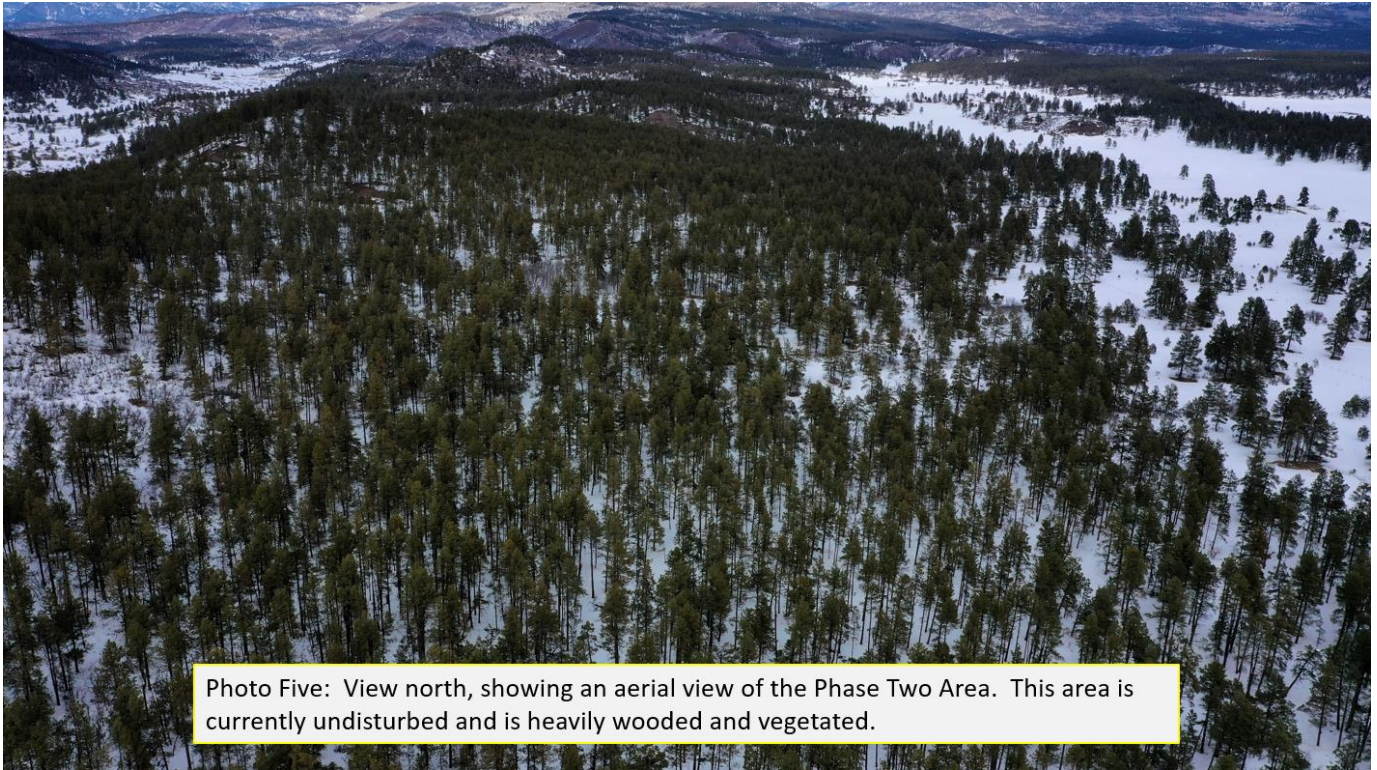
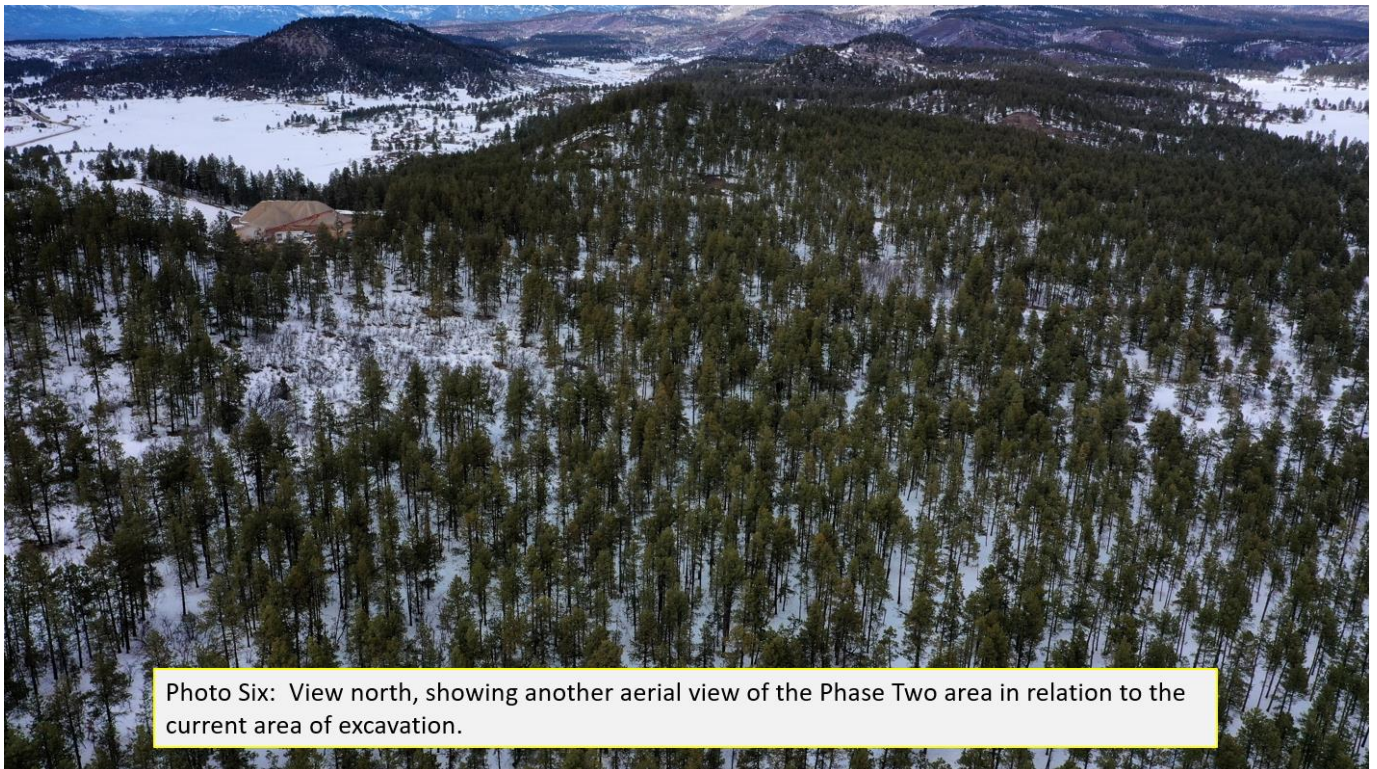
The application details a phased mining operation consisting of four separate phases, the most extensive being phases one and two. Phase one of the operation will be located to the south of the current excavation area, and is currently undisturbed with the exception of a small, 5.5 acre area that historically used as a Forest Service pit, when the property was administered by the US Forest Service years ago. An aerial view of the phase one area can be seen in Photos Three and Four. Phase two of the mining operation will be located to the northeast of the current area of excavation and includes approximately 39.7 acres of the permit area. This phase can be seen in Photos Five and Six.

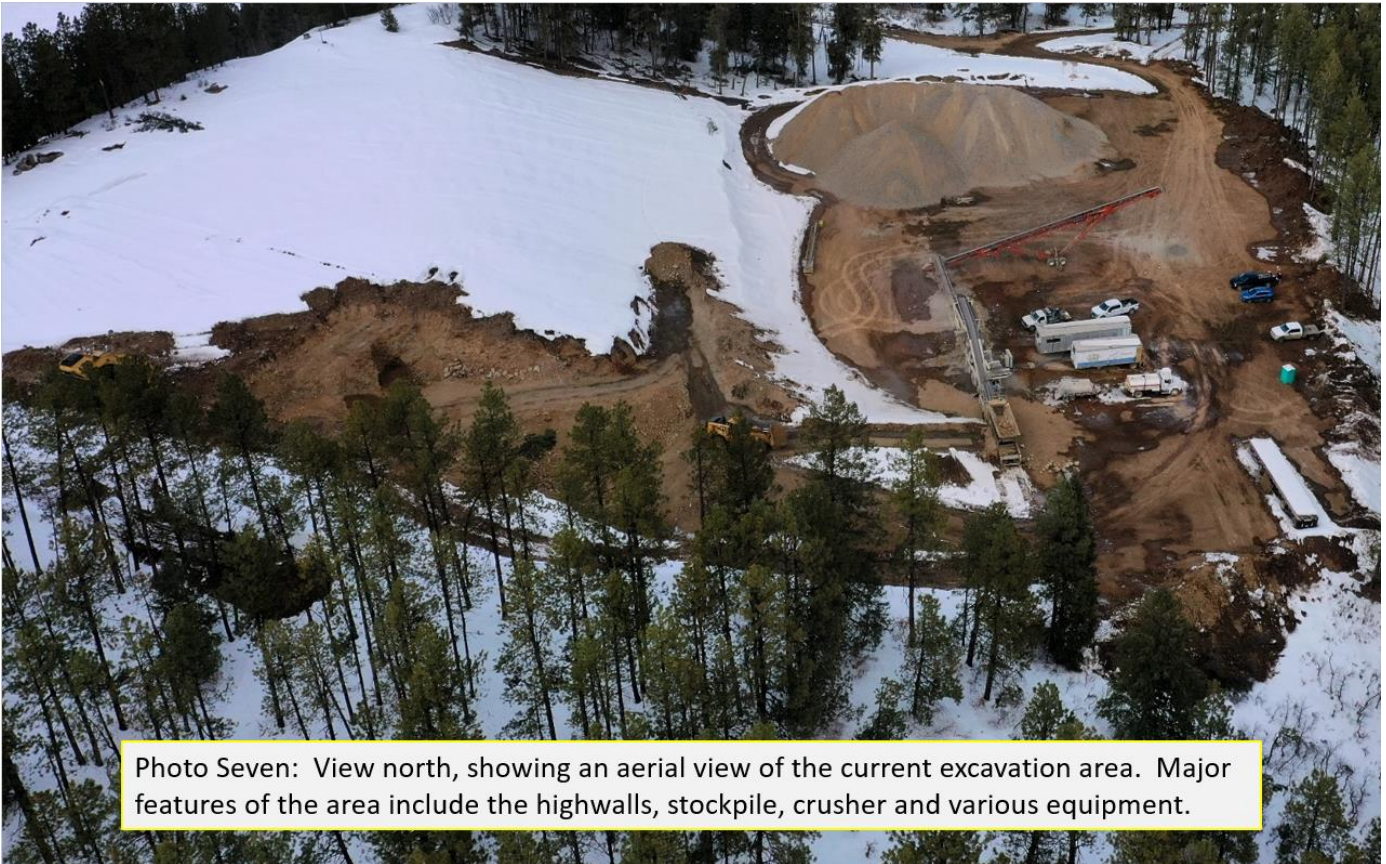
The current area of excavation was observed and found to be in good condition. An aerial image of the whole area can be seen in Photo Seven. Equipment present included an excavator, front end loader, crusher with conveyors and stackers, support trailers including a self-contained diesel gen-set, skid steer and other equipment. Examples of the equipment present can also be seen in Photo Seven. The area being excavated is currently a small footprint, containing two "benches" referred to as the upper and lower highwalls respectively. The highwalls are approximately 20 feet tall, with a length of approximately 60 linear feet in a general crescent shape. The area of excavation can be seen in Photos Eight and Nine. The highwalls appeared stable at the time of the inspection and no evidence of settling, slumping or erosion was noted. Just up gradient from the highwall, native soil material has been stripped back and stockpiled. The stockpiles were covered in snow, but appeared stable and in good condition at the time of the inspection. A larger area of approximately 2-3 acres had trees and vegetation removed in preparation for excavation. The harvested trees have been stockpiled on the property for later use.

Photo Seven: View north, showing an aerial view of the current excavation area. Major features of the area include the highwalls, stockpile, crusher and various equipment.

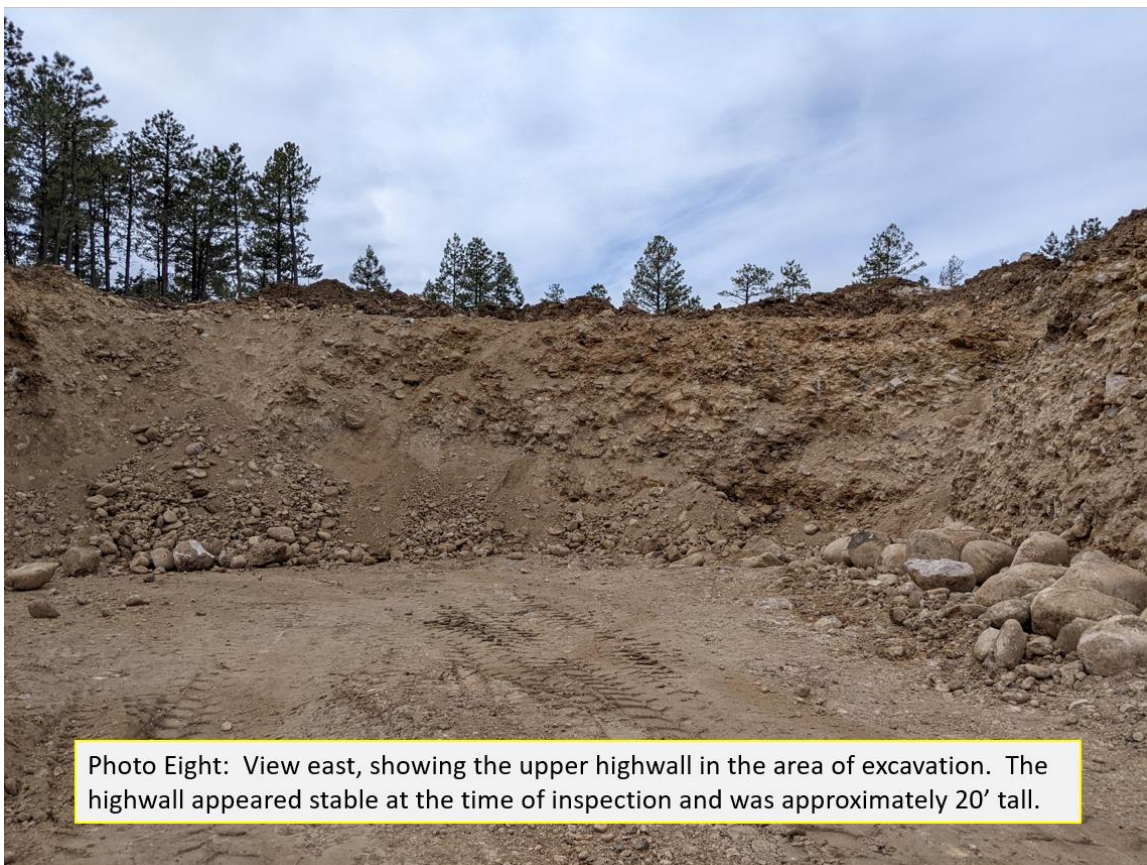
Photo Eight: View east, showing the upper highwall in the area of excavation. The highwall appeared stable at the time of inspection and was approximately 20' tall.

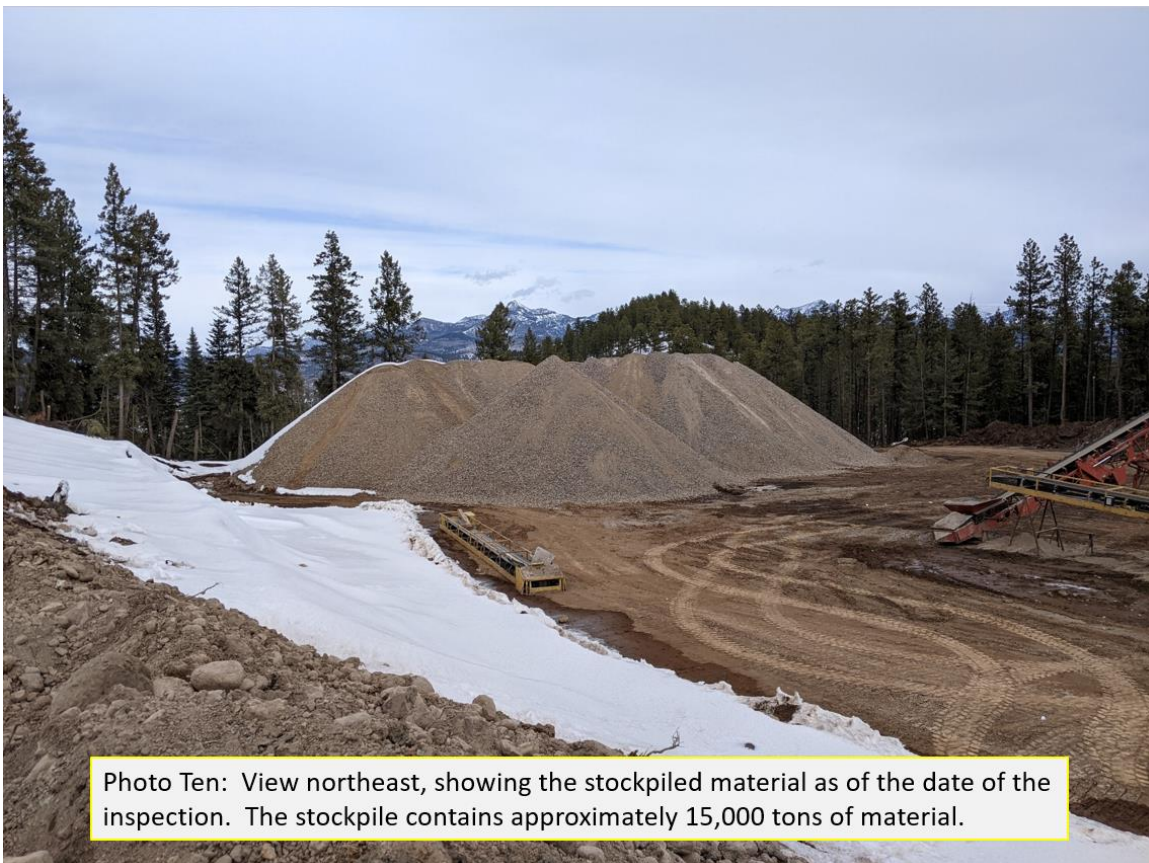
stockpile of crushed three inch material. Based on visual observations and conversations with the Applicant the estimated volume of material crushed is approximately 15,000 tons. The stockpile can be seen in Photo Ten. The volume of stockpiled material appeared to be consistent with the void volume of the area of excavation. The stockpile appeared stable at the time of the inspection and was in good condition. The pit floor contained some standing water from melting snow, and no evidence of groundwater, seeps or springs being encountered was noted.
