MINERALS PROGRAM INSPECTION REPORT
PHONE: (303) 866-3567

MINE NAME: Cresson Project	MINE/PROSPECTING ID#: M-1980-244	MINERAL: Gold	COUNTY: Teller
INSPECTION TYPE: Monitoring	INSPECTOR(S): Timothy Cazier, P.E.	INSP. DATE: December 21, 2021	INSP. TIME: 09:30
OPERATOR: Cripple Creek & Victor Gold Mining Company	OPERATOR REPRESENTATIVE: Katie Blake	TYPE OF OPERATION: 112d-3 - Designated Mining Operation	
REASON FOR INSPECTION: Normal I&E Program	BOND CALCULATION TYPE: None	BOND AMOUNT: \$209,491,188.00	
DATE OF COMPLAINT: NA	POST INSP. CONTACTS: None	JOINT INSP. AGENCY: None	
WEATHER: Clear	INSPECTOR'S SIGNATURE:

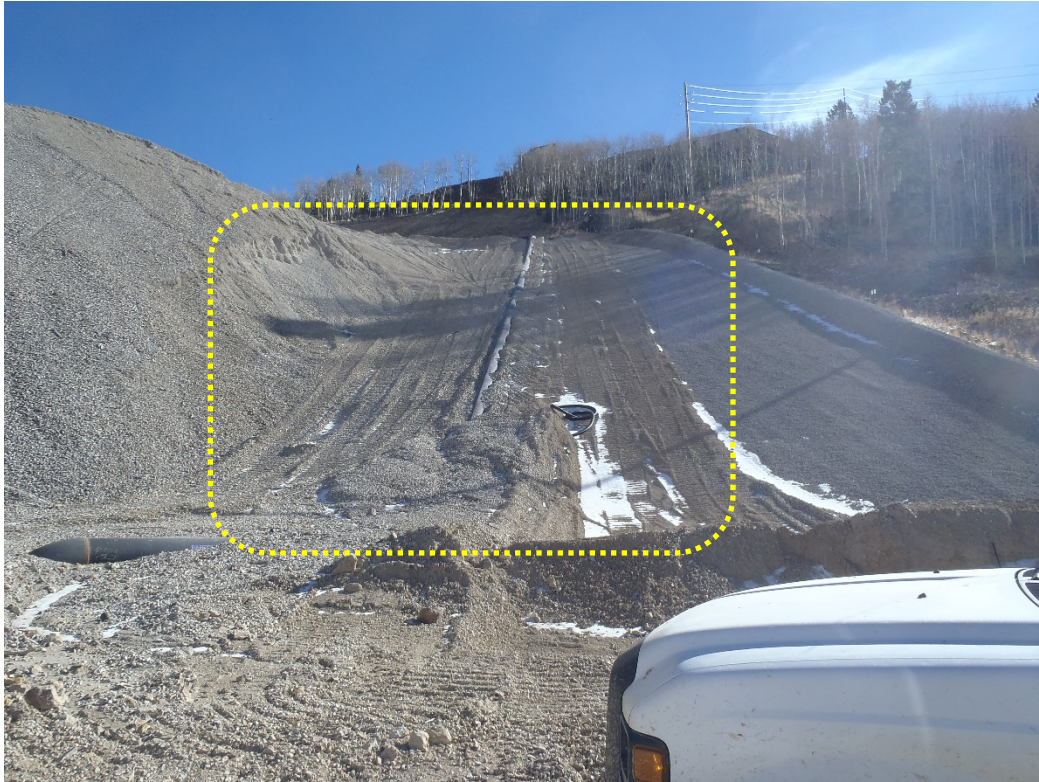
DCF damaged areas: The repairs to the eroded DCF south of VLF 2, near ADR 2 (resulting from the 3rd quarter rains referenced in our September 2021 inspection report) were observed (see **Photo 1**). The DCF had been replaced and appeared satisfactory. The DRMS received the recertification report on December 13, 2021 and was reviewing it at the time of this inspection. A review letter from the DRMS is expected to be issued to CC&V in the very near future.

Photo 1. Repaired DCF on the southeast corner of VLF2 (looking east from near ADR 2).
(compare with Photo 3 from the DRMS September 2021 inspection report)

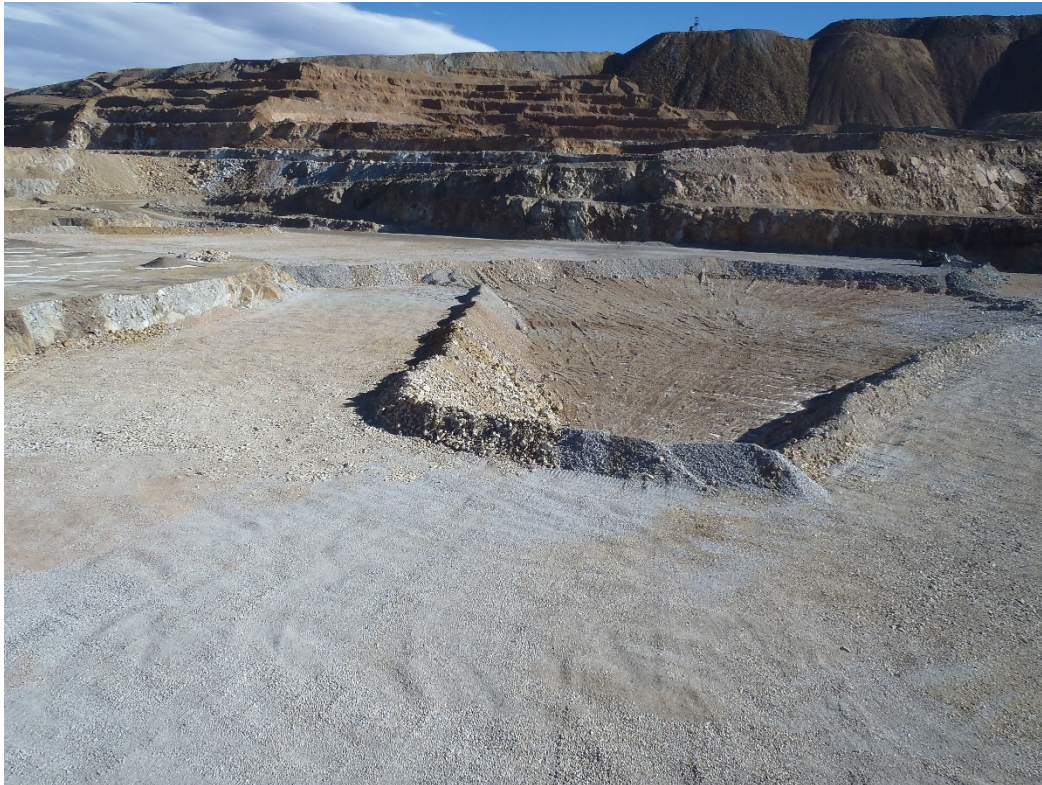
Schist Island backfill: Ms. Blake and Messrs. Tsibu Avenson, George Fry and Jeff Gaul accompanied the DRMS to an area above the west highwall to observe material placement in the Schist Island Pit high compaction zone. Crews were working on the 9960 bench level at the time of the inspection (see **Photo 2**). Site representatives stated GPS units on the dozer (see **Photo 3**) were used to control the lift height and ground survey was used check for compaction rebound. Placed material appeared to be less than the maximum allowed 24 inches.

Photo 2. Schist Island Pit high-compaction/5-foot lift backfill (looking east).

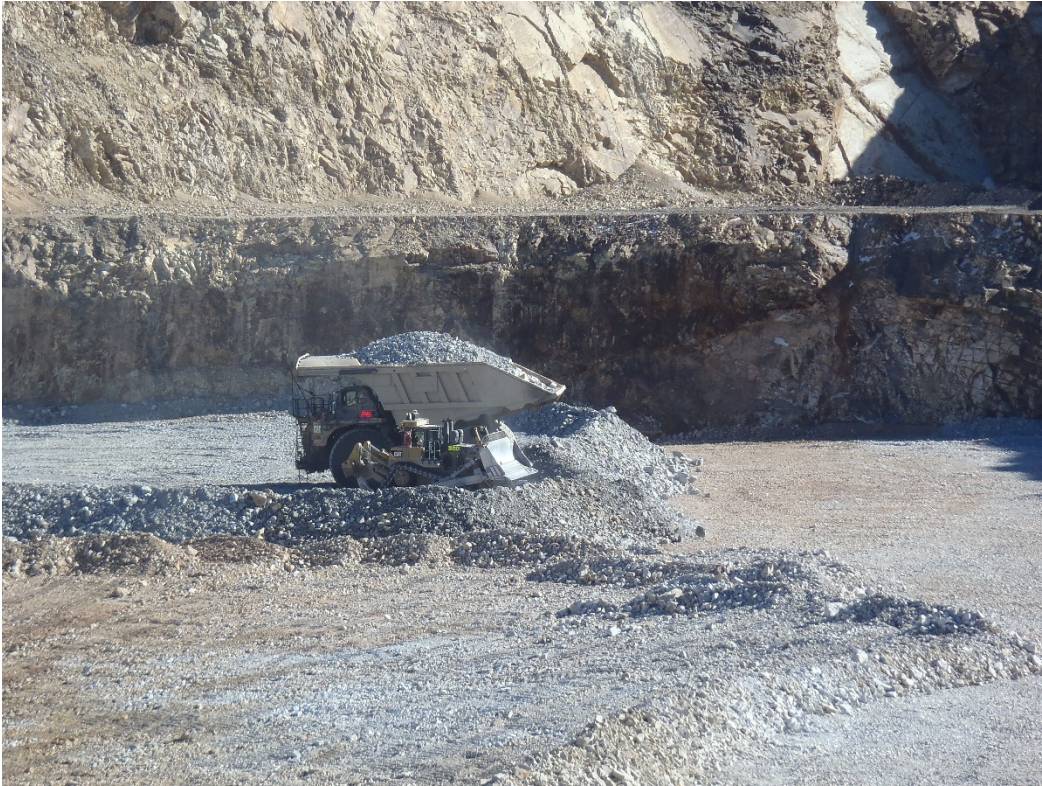
Photo 3. Actively placing Schist Island Pit high-compaction/5-foot lift backfill with dozer & haul truck.

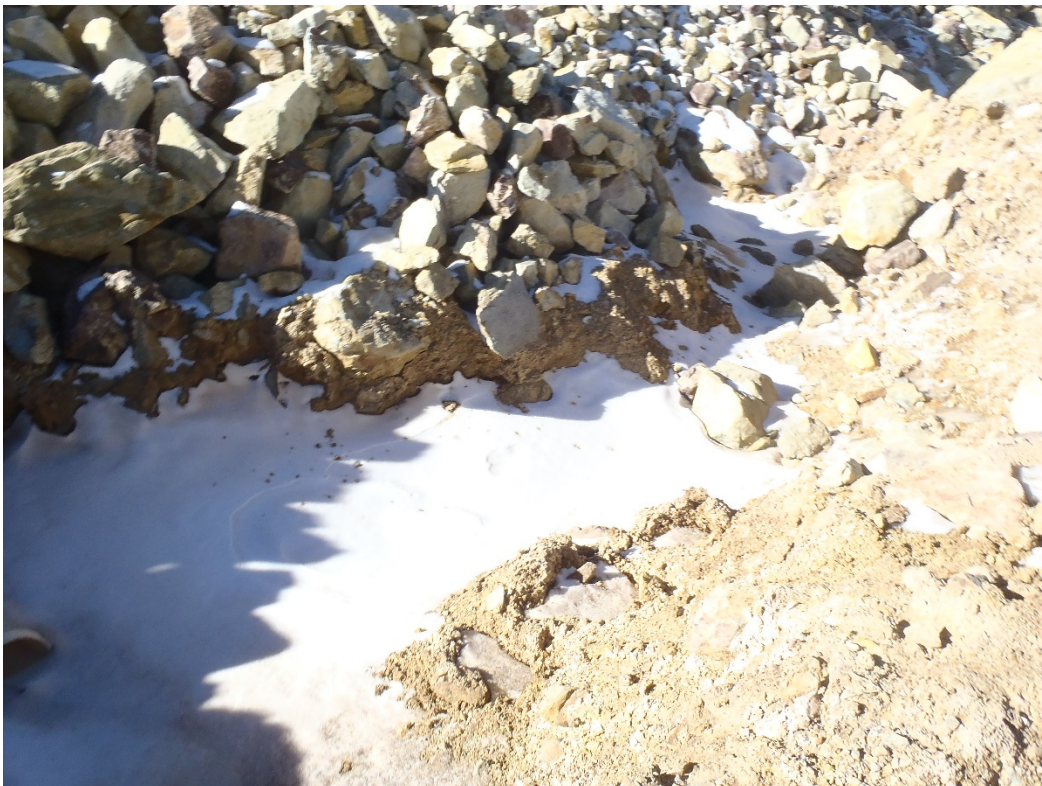
ECOSA Seeps: Ms. Blake and Ms. Maria Bujenovic accompanied the DRMS to the ECOSA toe to observe the status of two seeps. The north ECOSA seeps, designated as #2A & #2B, were both observed to be dry, with snow only in the sumps (see **Photos 4** and **5**). The south ECOSA seep, designated ECOSA Seep #1 was observed to no inflow and was frozen (see **Photo 6**). Ms. Bujenovic stated they had not pumped any water from the seeps since the week of November 7th.

Photo 4. ECOSA Seep #2A (looking west from ECOSA toe access road)

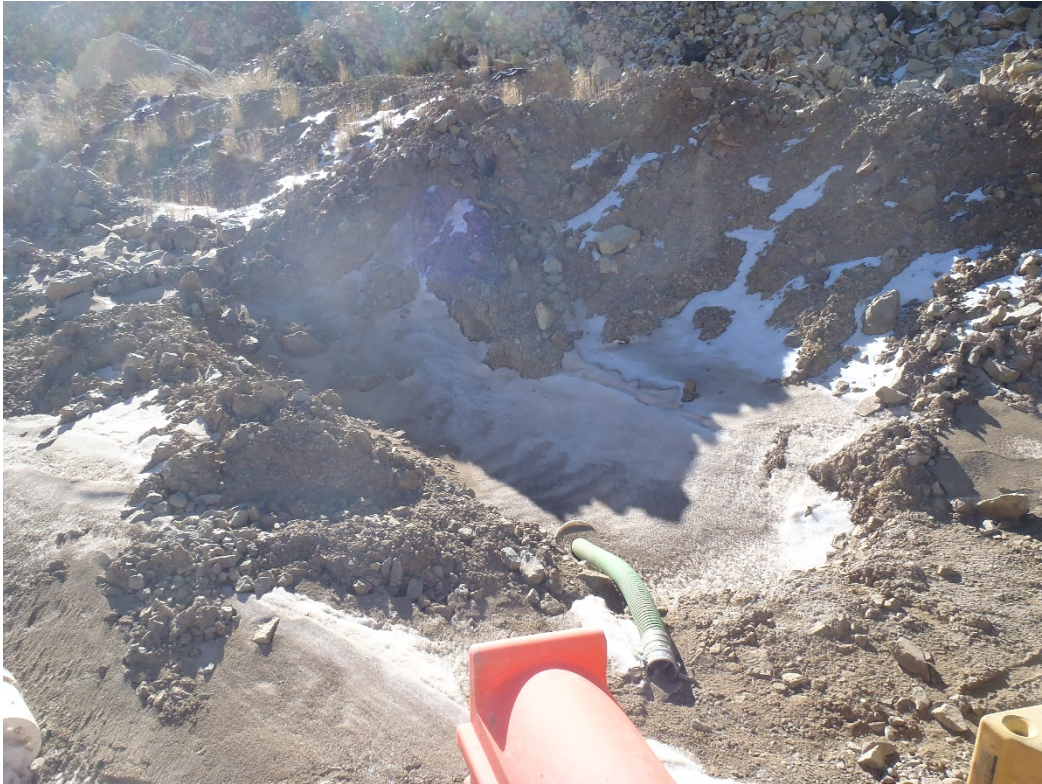
Photo 5. ECOSA Seep #2B (looking SE from ECOSA toe berm separating Seep 2A from 2B).

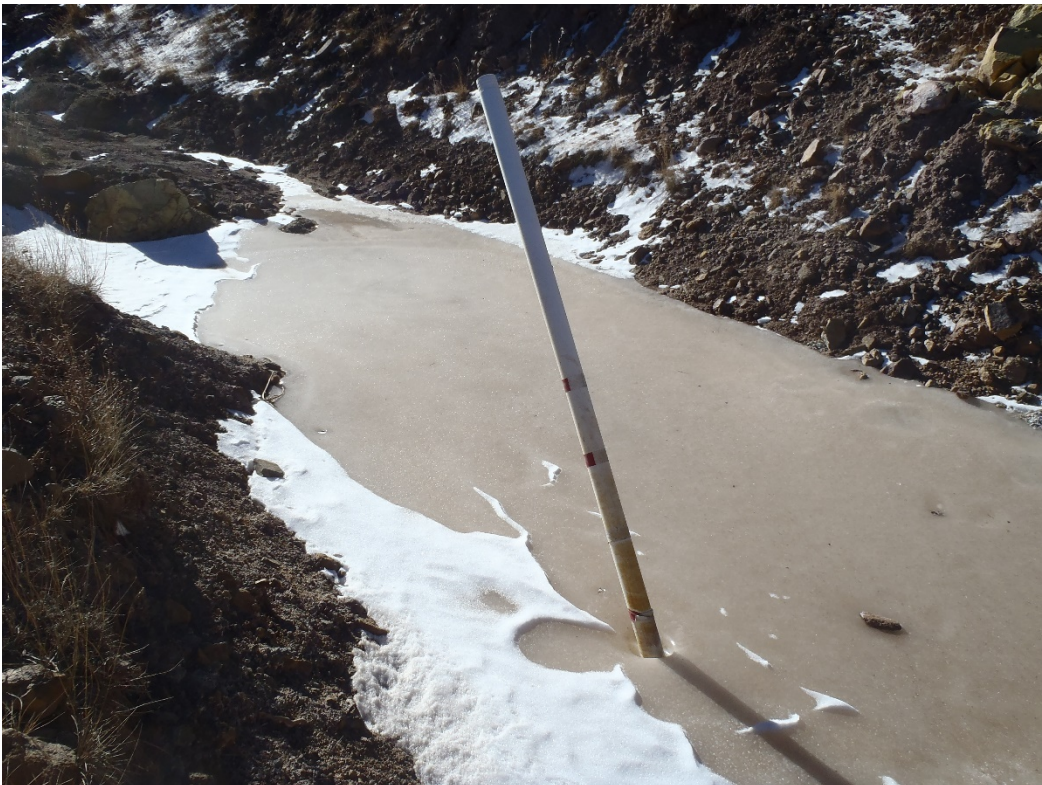
Photo 6. ECOSA Seep #1 (no inflow, frozen).

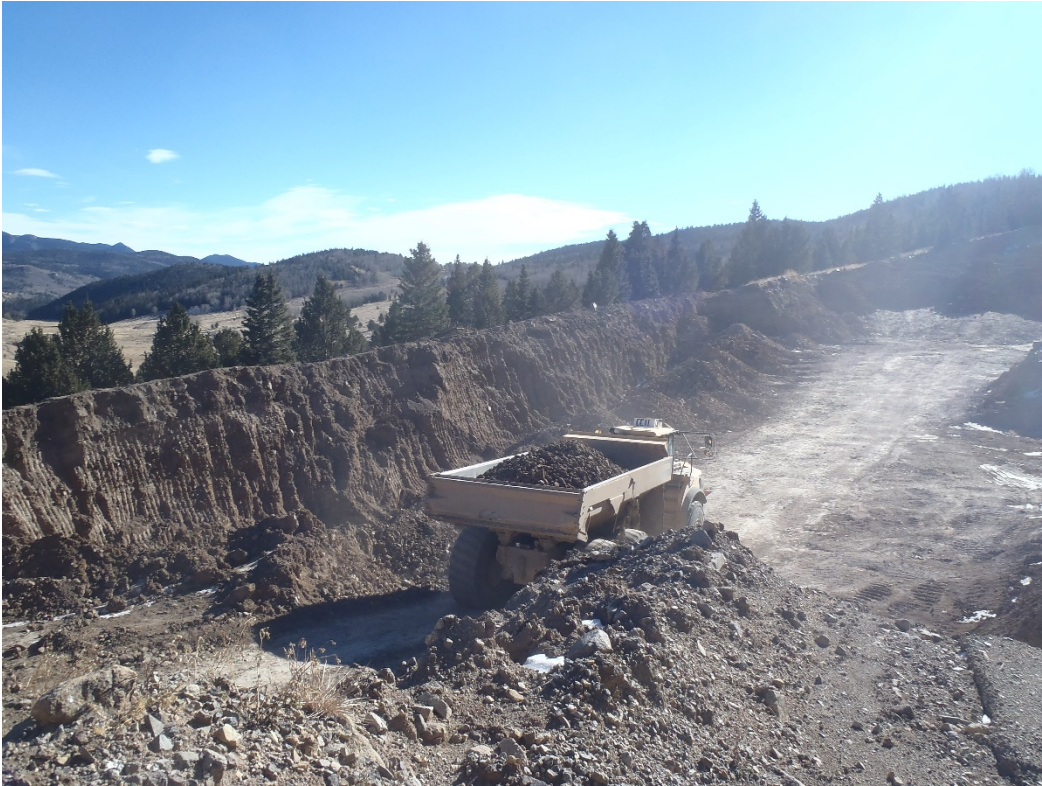
The clay borrow area at the south end of the ECOSA was in the process of being backfilled (see **Photo 7**), as recommended by the DRMS in their September 2021 inspection report. The backfill material appeared to be inert, rather than waste rock. No ponded water (frozen or otherwise) was visible and the bottom of the back fill area (see **Photo 8**).

Photo 7. Backfilling clay borrow area (SE corner of ECOSA, looking south).

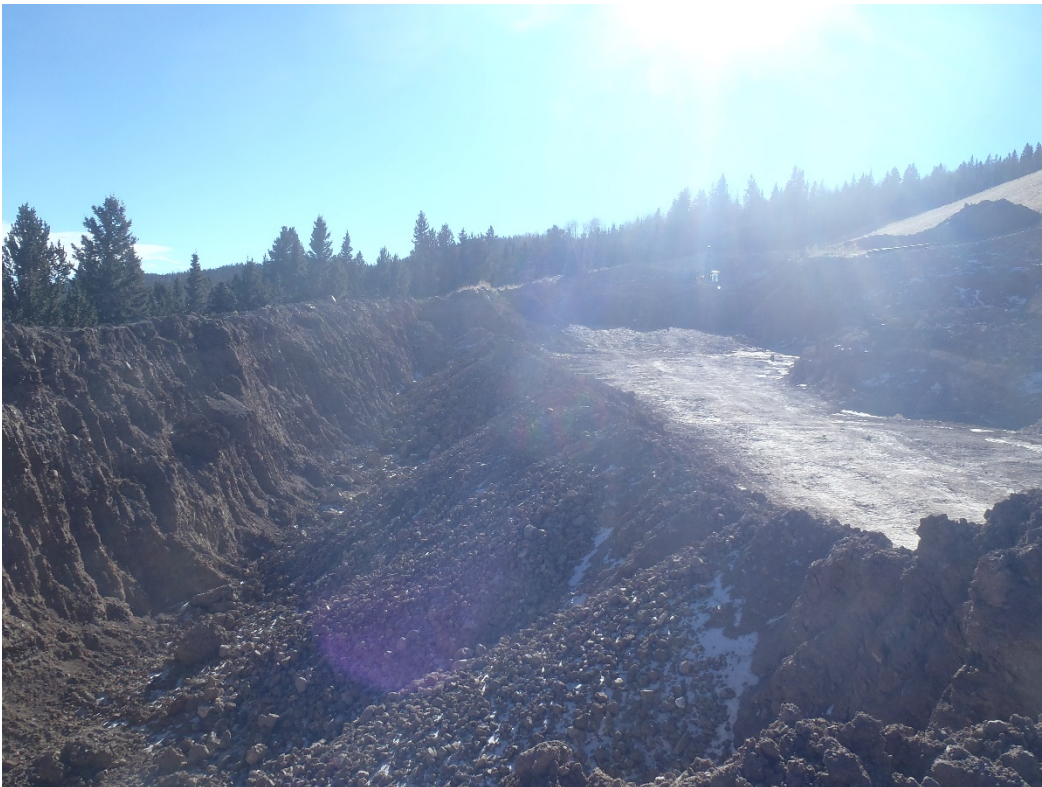
Photo 8. South ECOSA clay borrow pit backfill in progress (looking south, original floor on left).

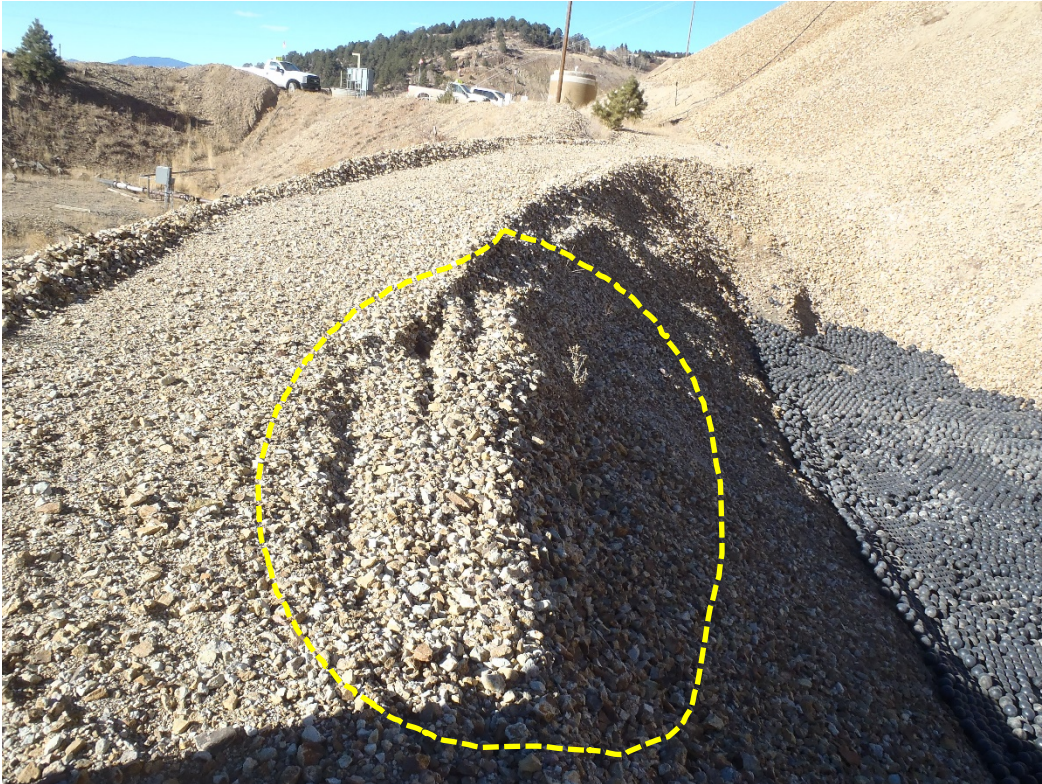
PSES Facility and stormwater pond: Ms. Blake and Mr. Chad Chess accompanied the DRMS to the PSES area. The stormwater pond (a.k.a. bird ball pond) berm was observed to have started sloughing on the inside (see **Photo 9**). [The DRMS recommended monitoring this area and performing repairs as necessary.](#)

Photo 9. Sloughing inside face of bird ball pond NW of the PSES building (looking NW from berm midpoint).

- Bird ball pond berm – concerns over the sloughing berm of the pond west of the PSES were raised and that it should be monitored and repaired as necessary.
- ECOSA Seep – CC&V stated they have hired a consultant to look into acid rock drainage (ARD) management and mitigation to impacts at MW-25 southeast of the ECOSA.

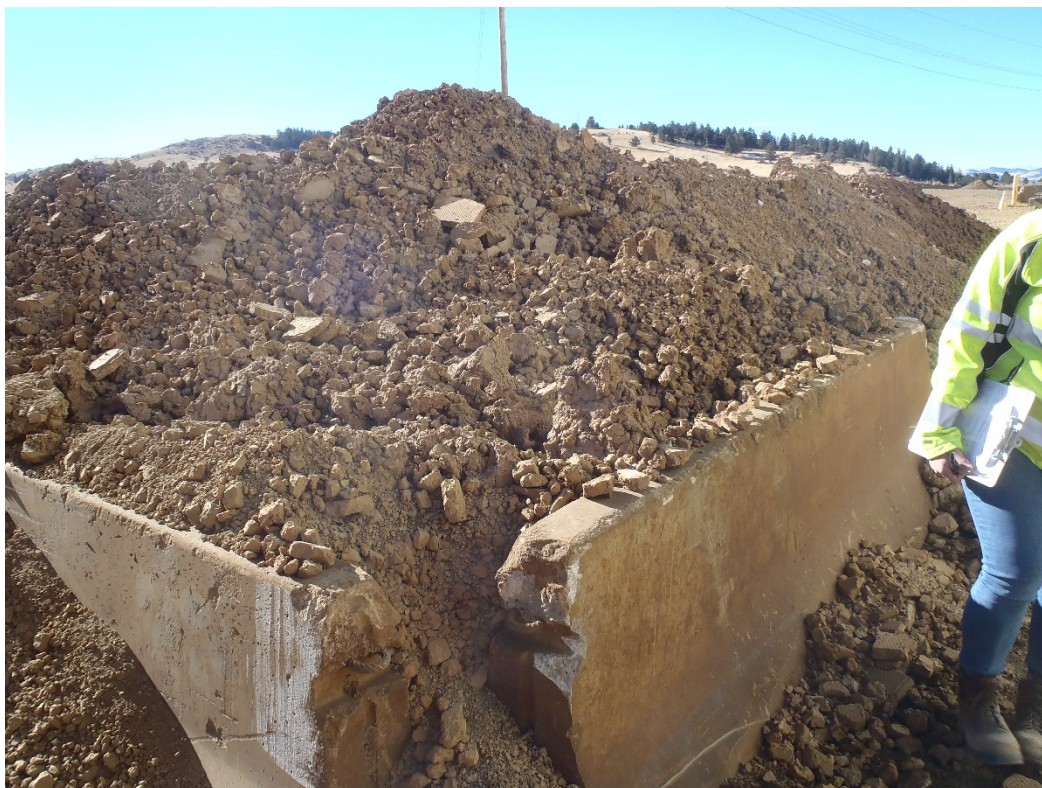
The PSES facility was inspected for general housekeeping, petroleum product spills and hazardous or toxic material containment. A pile of PSES filtrate (milk of lime) was observed with jersey barriers on the edge of the pile (see **Photo 10**) on the south side of the PSES building. The concern here is erosion of the material generating sediment mobilized elsewhere. As the pile was said to be temporary and in a flat area, it was deemed to not be a problem. Site representatives stated the magnetite truck offload area (see **Photo 11**) had been decommissioned. It is a low area near the southwest corner of the PSES building. The perimeter of the building was walked with no observed concerns or problems. The sediment trap on the north side of the PSES facility

Photo 10. PSES filtrate stockpile (looking west from south side of PSES building).

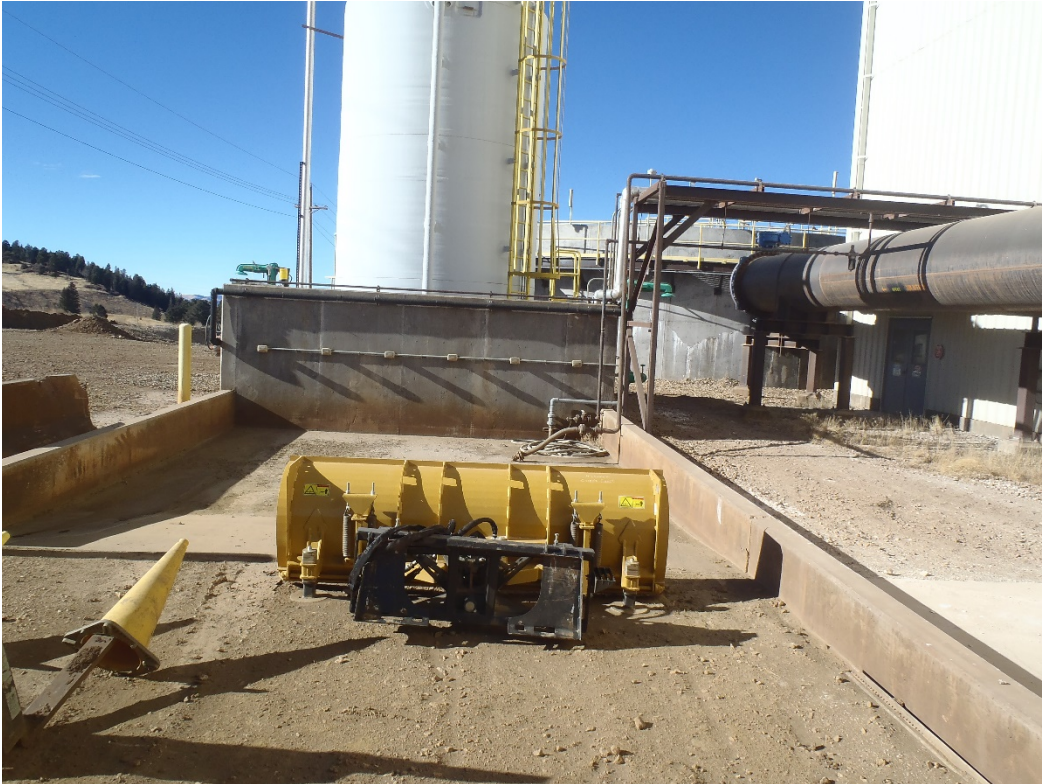
Photo 11. Decommissioned magnetite truck offload (looking NW from south side of PSES building).

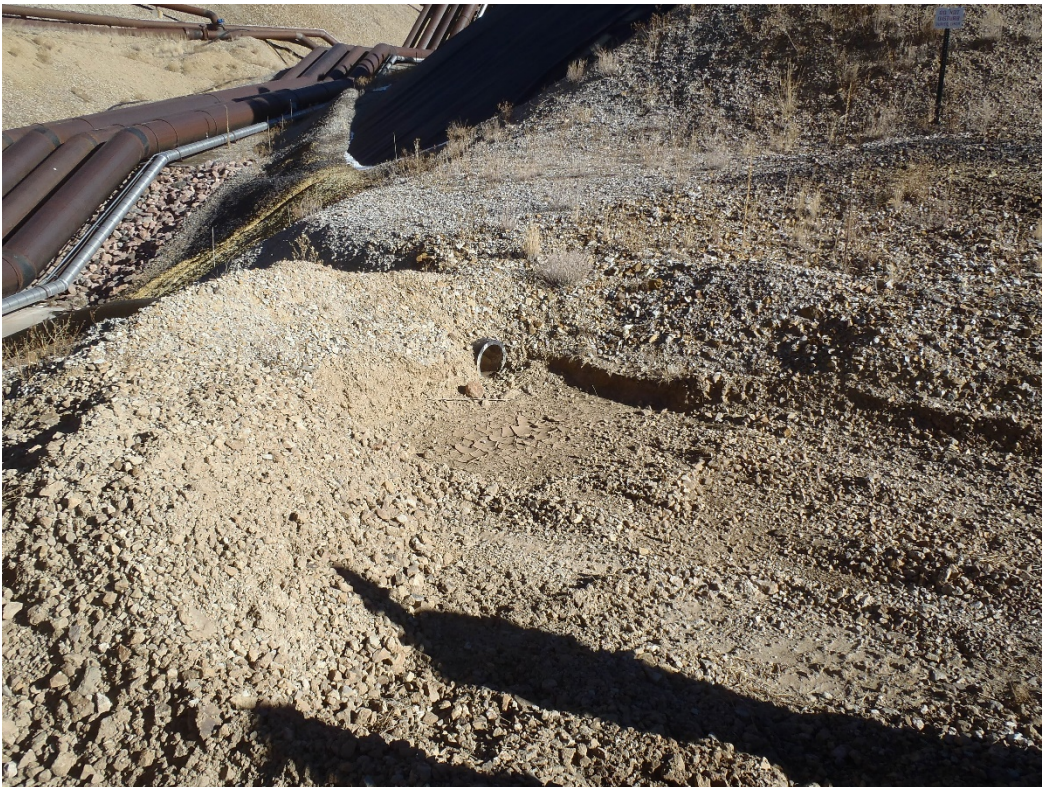
(see **Photo 12**) appeared in good condition and was not in need of sediment removal at the time of the inspection.

Photo 12. PSES building sediment trap (looking NE from north side of PSES building).

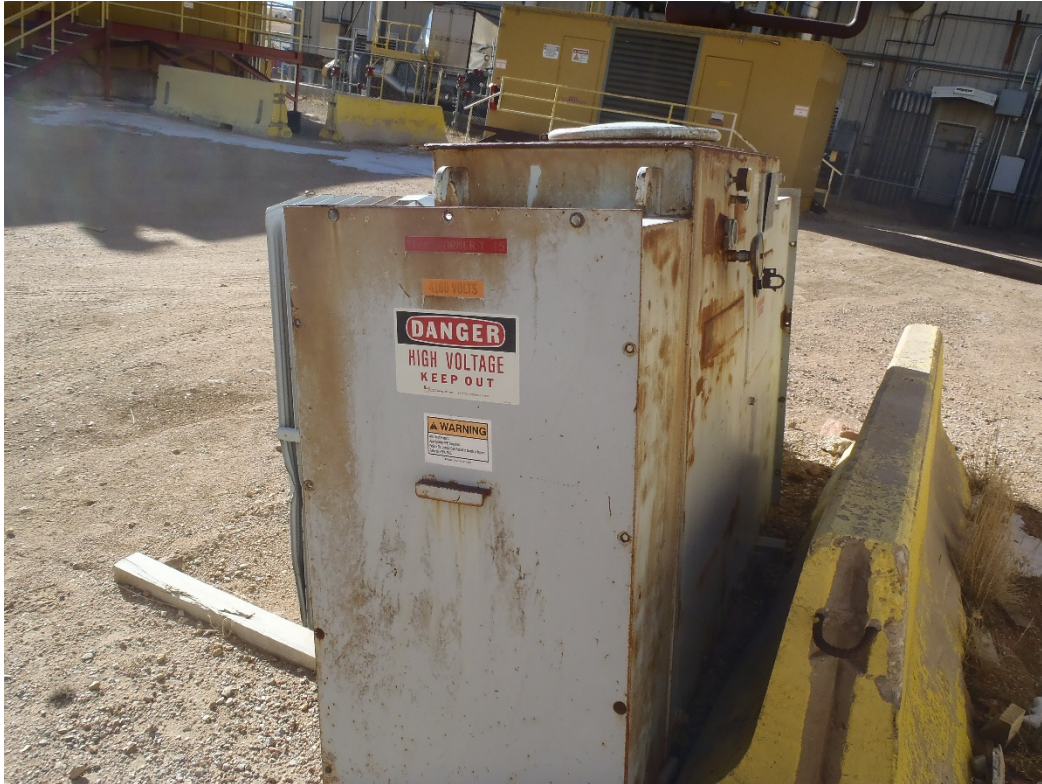
ADR 1 Facility: While in the vicinity of the PSES, this inspector walked the perimeter of the ADR 1 facility with the same purpose as that for the PSES facility. Only two items of potential concern were observed: 1) an old transformer (see **Photo 13**) was observed on the east side of the ADR 1, and 2) a rusty drum (see **Photo 14**) was observed on the north side of the building. The transformer had been replaced recently and had not been drained. Site representatives stated they were working on disposal of the transformer. The rusty drum was determined to be empty and had been placed upside down without a cover. No problems were cited.

Photo 13. Old transformer on east side of ADR 1 (looking west).

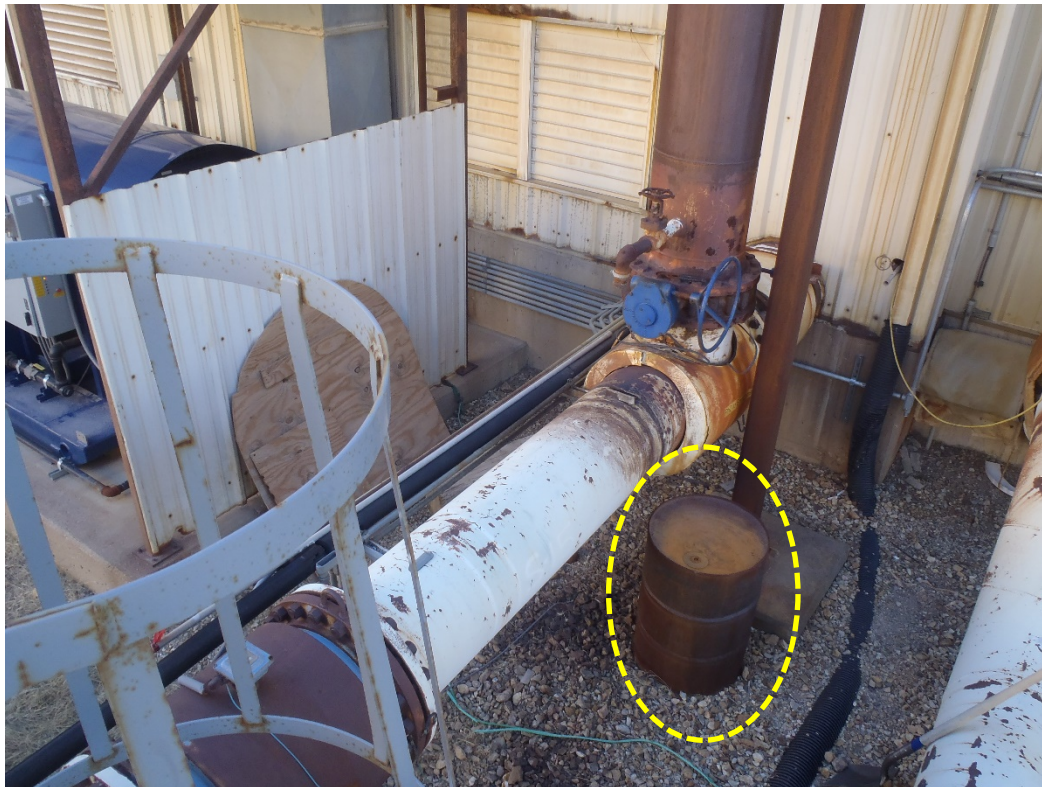
Photo 14. Upside down, empty, rusty drum on north side of ADR 1.
