**COLORADO**  
Division of Reclamation,  
Mining and Safety  
Department of Natural Resources

<b>Permit Number:</b> C-1981-018 <b>Mine Name:</b> Deserado Mine <b>Operator:</b> Blue Mountain Energy, Inc. <b>Operator Address:</b> Mr. Kurtis Blunt 3607 County Road 65 Rangely, CO, 81648	<b>County:</b> Moffat, Rio Blanco <b>Operation Type:</b> Underground <b>Permit Status:</b> Active <b>Ownership:</b> Private
	<b>Operator Representative Present:</b>  NA
<b>Operator Representative Signature:</b> (Field Issuance Only)

<b>Inspection Start Date:</b> January 10, 2022 <b>Inspection Start Time:</b> 11:00 <b>Inspection End Date:</b> January 18, 2022 <b>Inspection End Time:</b> 11:05	<b>Inspection Type:</b> Aerial Inspection <b>Inspection Reason:</b> Normal I&E Program <b>Weather:</b> Clear
<b>Joint Inspection Agency:</b>  None	<b>Joint Inspection Contacts:</b>  None
<b>Post Inspection Agency:</b>  None	<b>Post Inspection Contacts:</b>  None
<b>Inspector(s):</b>  Clayton Wein  Brock Bowles	<b>Inspector's Signature:</b>

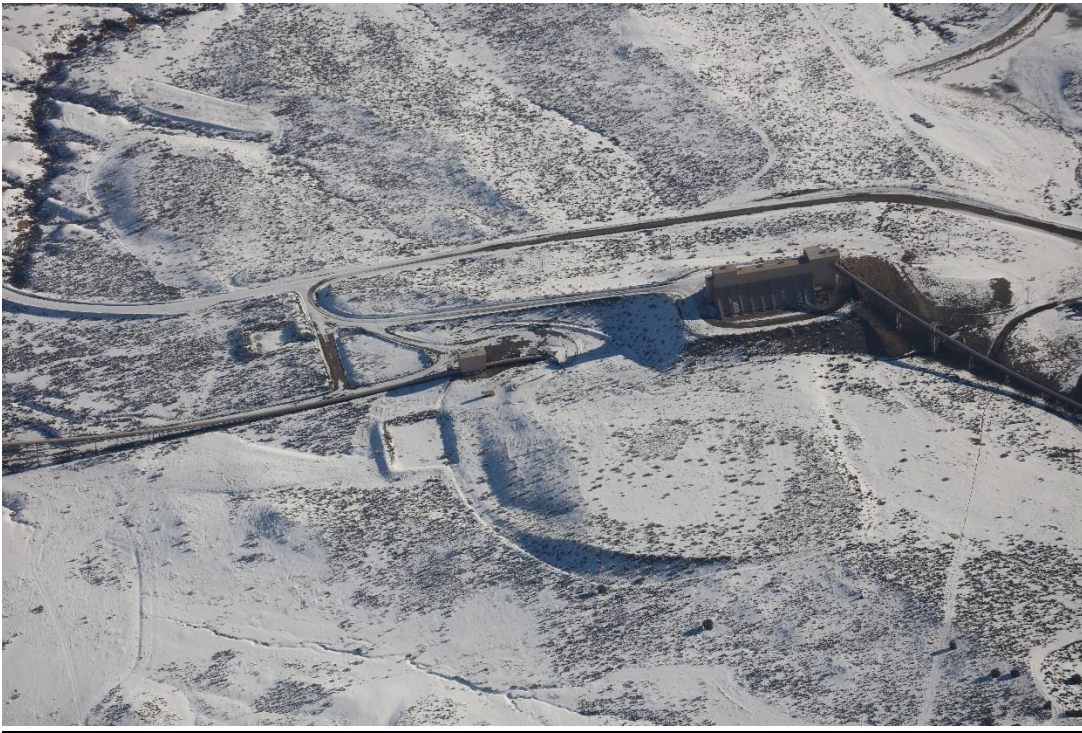
The Slot Storage facility has two ponds associated with it. Both the SS-1 and SS-2 ponds were covered with snow during the inspection. The embankments were stable and there were no erosional features identified. No discharge was observed from the ponds (Photo 1).

**Photo 1:** The Slot Storage facility and the associated ponds, SS-1 and SS-2.

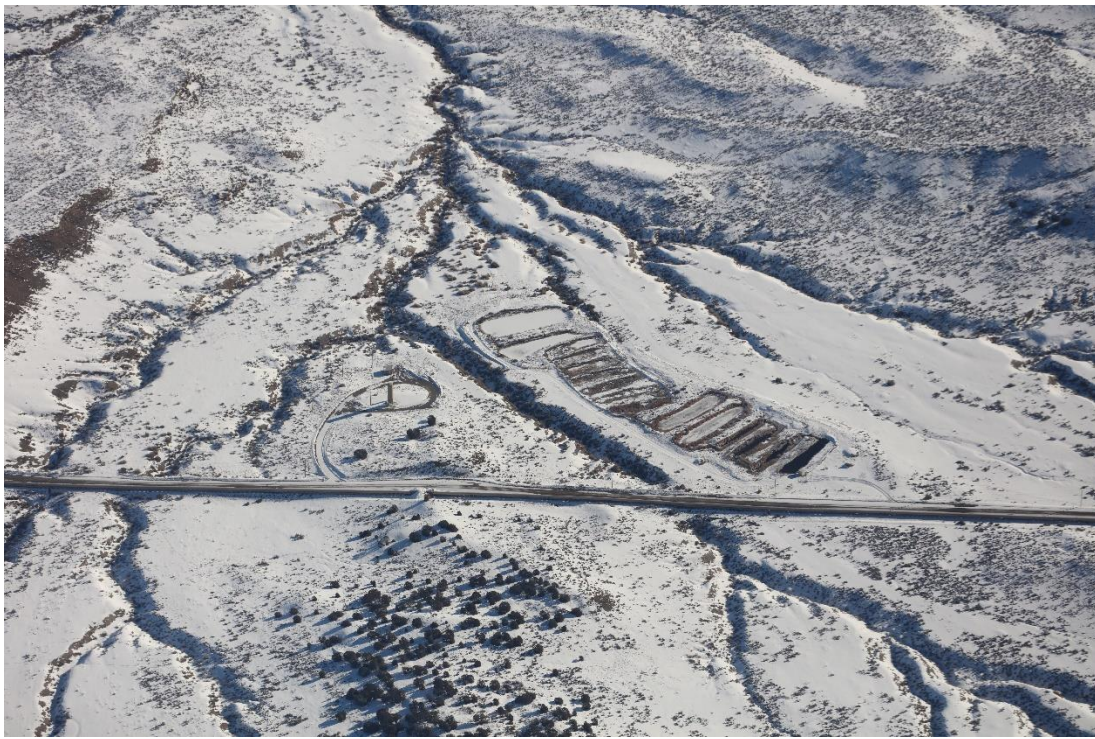
The B Seam No. 1 Dewatering System was impounding water in all of its cells. All but the first four cells were frozen over (Photo 2). The embankments of the cells were covered with snow. There were no indications of embankment failure or erosion.

**Photo 2:** The B Seam Dewatering System No. 1 is in the center of the photo above.

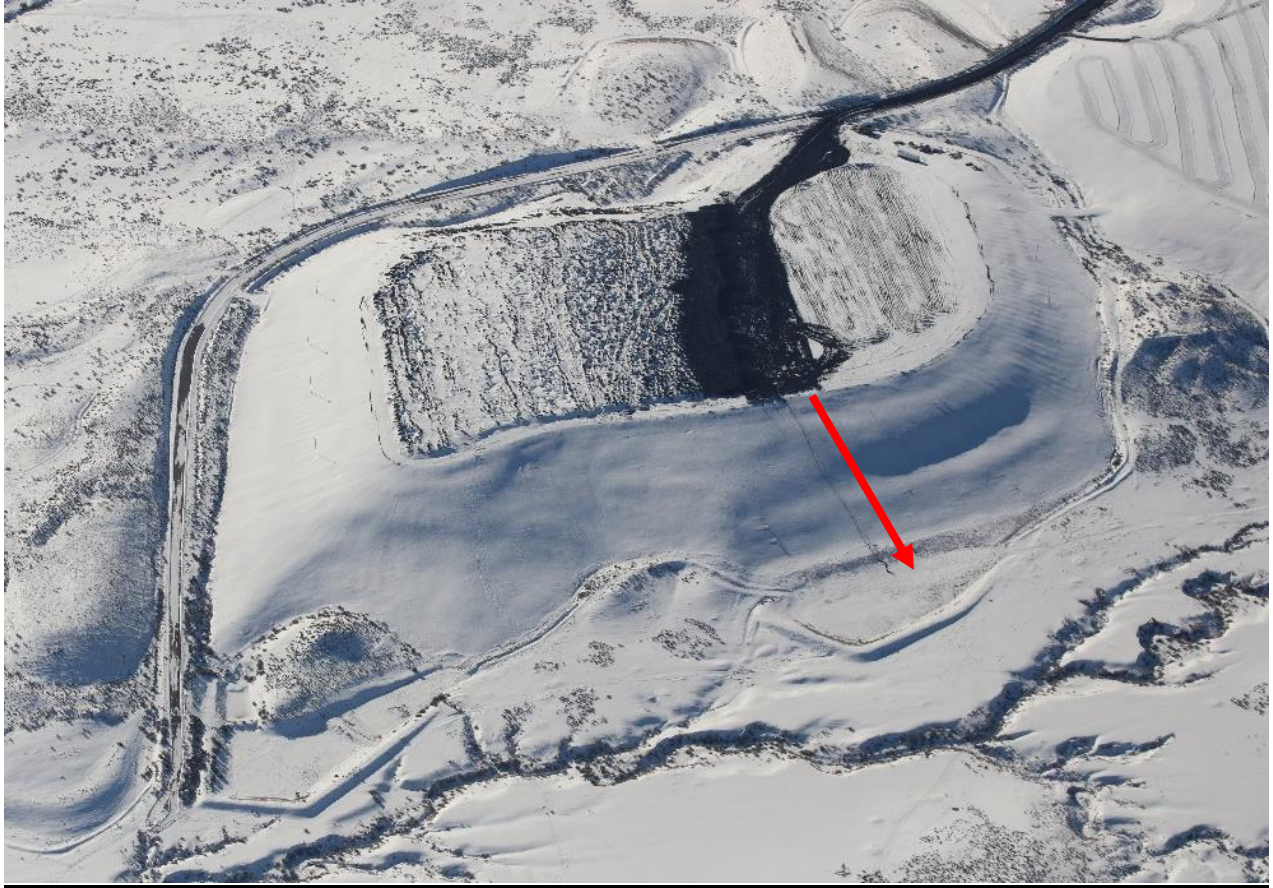
The RP- 2/3/4 refuse pile was the only active pile at the time of the inspection. Refuse material was placed on top of the pile for drying. The slopes of the pile were covered with snow. There were no indications of instability or major erosion. **There was one rill in the snow observed. This rill led directly into the RP-4 Pond. Please keep an eye on this location, if the rill widens and/or deepens it will require maintenance (Photo 3).** The perimeter ditch was also covered with snow. There were no erosional concerns identified. No off site impacts were observed.

**Photo 3:** The RP-2/3/4 refuse pile. The large rill is shown next to the red arrow in the photo above.

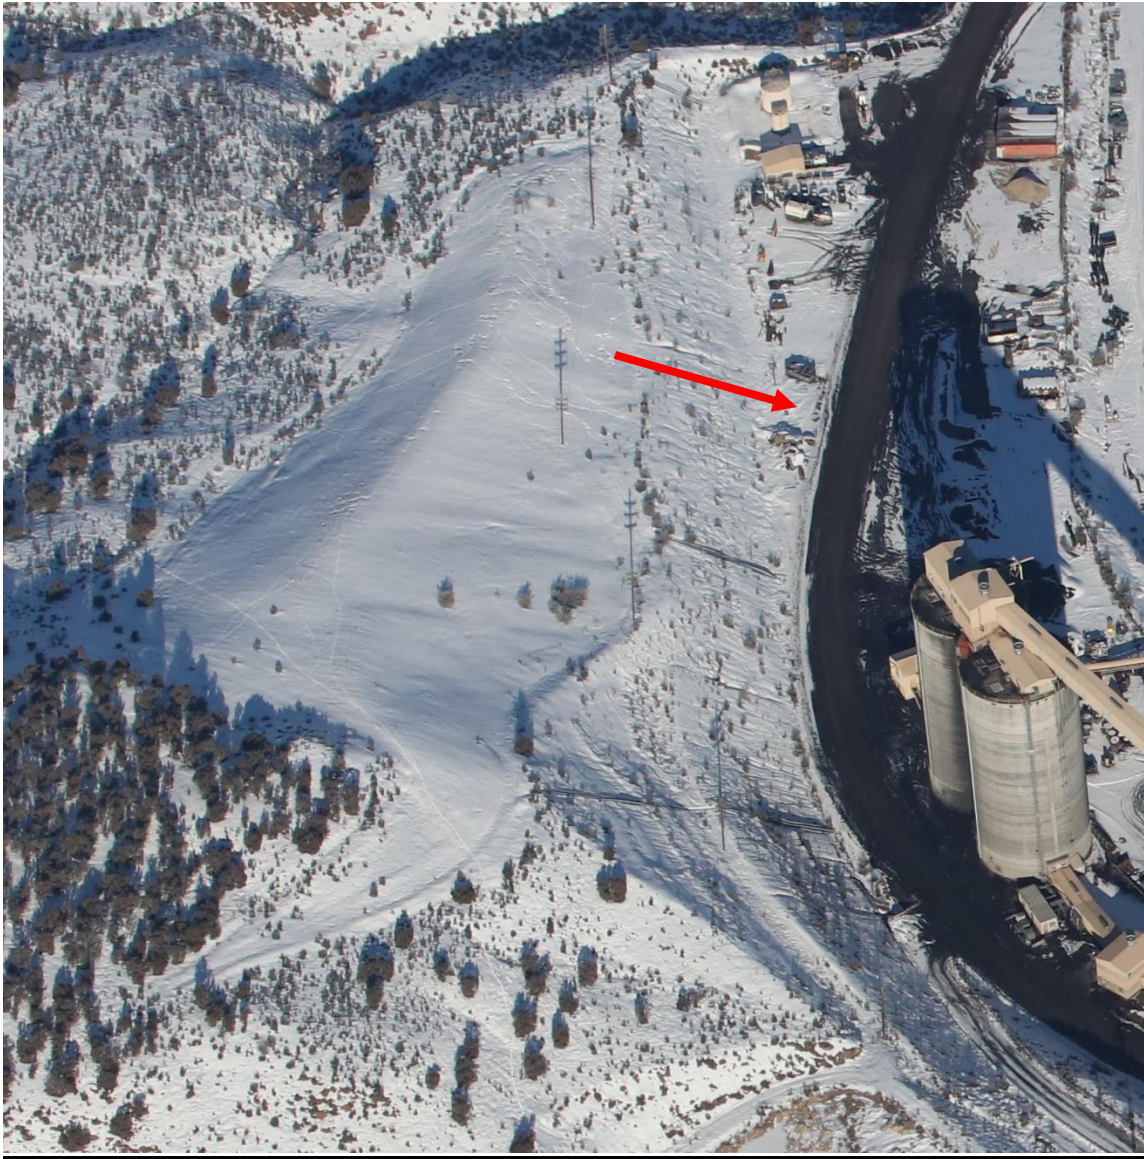
The topsoil pile located above the main facilities/portals area was covered with snow. The pile was stable and there were no indications of erosional features on the pile. **There was a large rill observed on the eastern slope below the topsoil pile. The rill appears to lead up-slope to the perimeter ditch. This rill needs to be included on the spring maintenance list to ensure the perimeter ditch retains its functionality (Photo 4).**

**Photo 4:** The large rill located on the slope below the main facilities/portals area topsoil pile. The rill is just below the perimeter ditch, shown above the red arrow in the photo above.
