MINERALS PROGRAM INSPECTION REPORT
PHONE: (303) 866-3567

MINE NAME: Cottonwood Pit	MINE/PROSPECTING ID#: M-1986-010	MINERAL: Sand and gravel	COUNTY: Fremont
INSPECTION TYPE: Monitoring	INSPECTOR(S): Timothy Cazier, P.E.	INSP. DATE: November 18, 2021	INSP. TIME: 09:45
OPERATOR: Fremont County	OPERATOR REPRESENTATIVE: Sterling Rife	TYPE OF OPERATION: 112c - Construction Regular Operation	
REASON FOR INSPECTION: Normal I&E Program	BOND CALCULATION TYPE: None	BOND AMOUNT: \$0.00	
DATE OF COMPLAINT: NA	POST INSP. CONTACTS: Colo. Land Board	JOINT INSP. AGENCY: None	
WEATHER: Clear	INSPECTOR'S SIGNATURE:

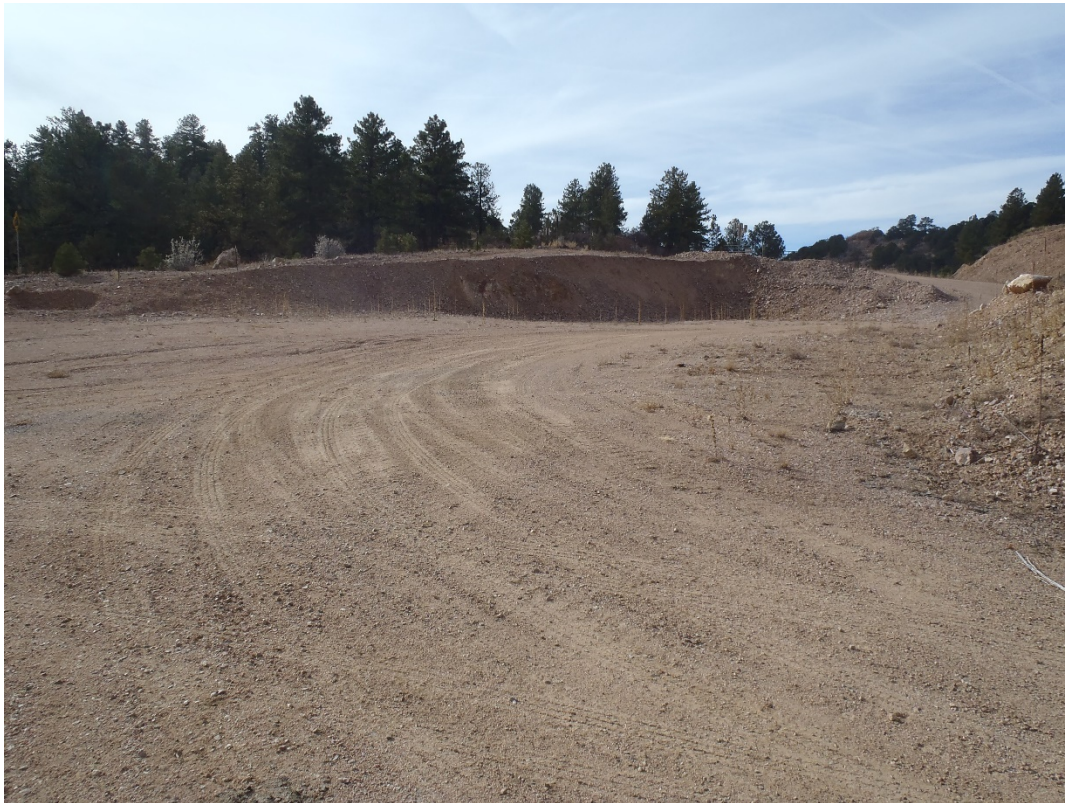
Backfilling and Grading: Sufficient backfill material is available for the south (see **Photo 1**) and north (see **Photo 2**) highwalls to be flattened or backfilled.

Photo 1. South highwall – no taller than ~8 feet (looking SW).

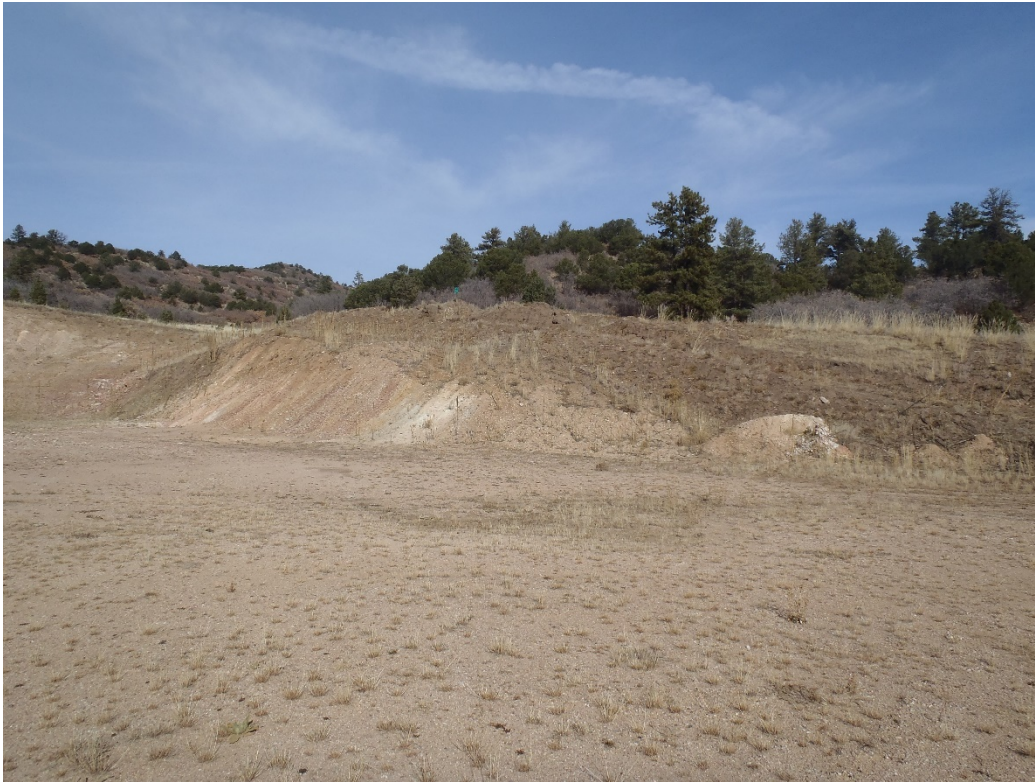
Photo 2. North highwall – no taller than ~12 feet (looking NW).

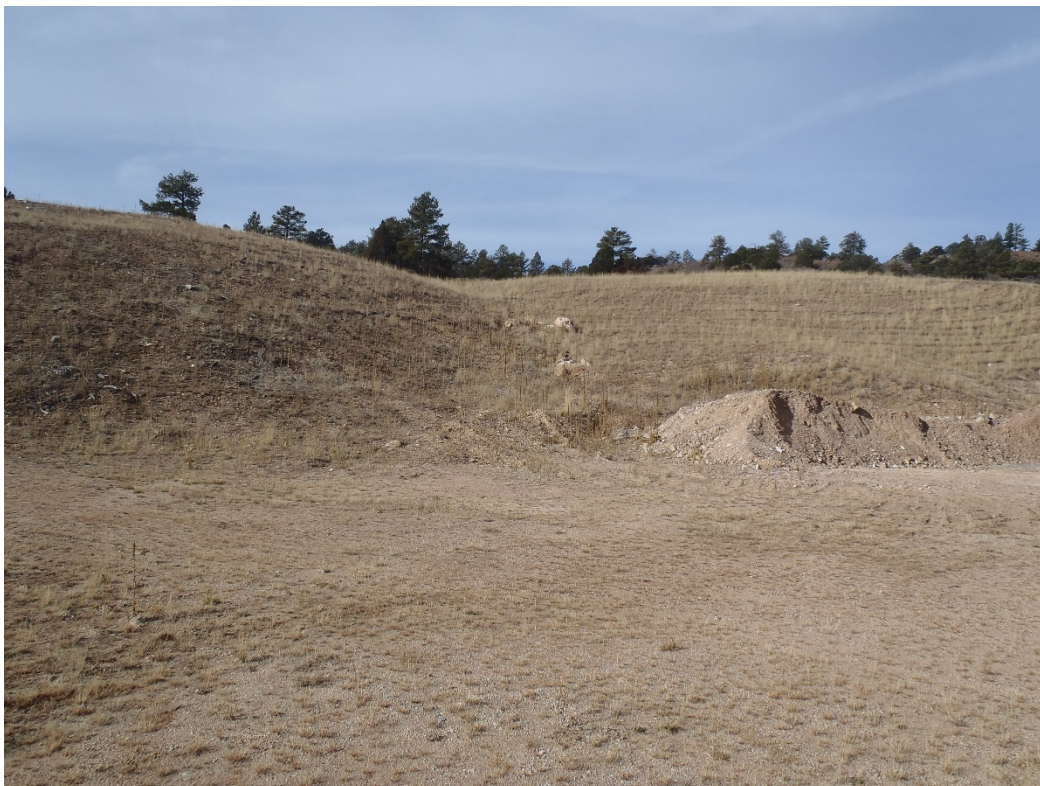
Gen. Compliance with Mine Plan: The operation appeared to be in compliance with the approved mine plan. The maximum allowed disturbed area is 48.4 acres. Google Earth was used to measure the disturbed area, and found to be approximately 8.2 acres, based on 2019 imagery. Highwalls were estimated to be 20 feet in height and appeared stable (see **Photo 3**).

Photo 3. West highwall – nearing final reclamation (looking west).

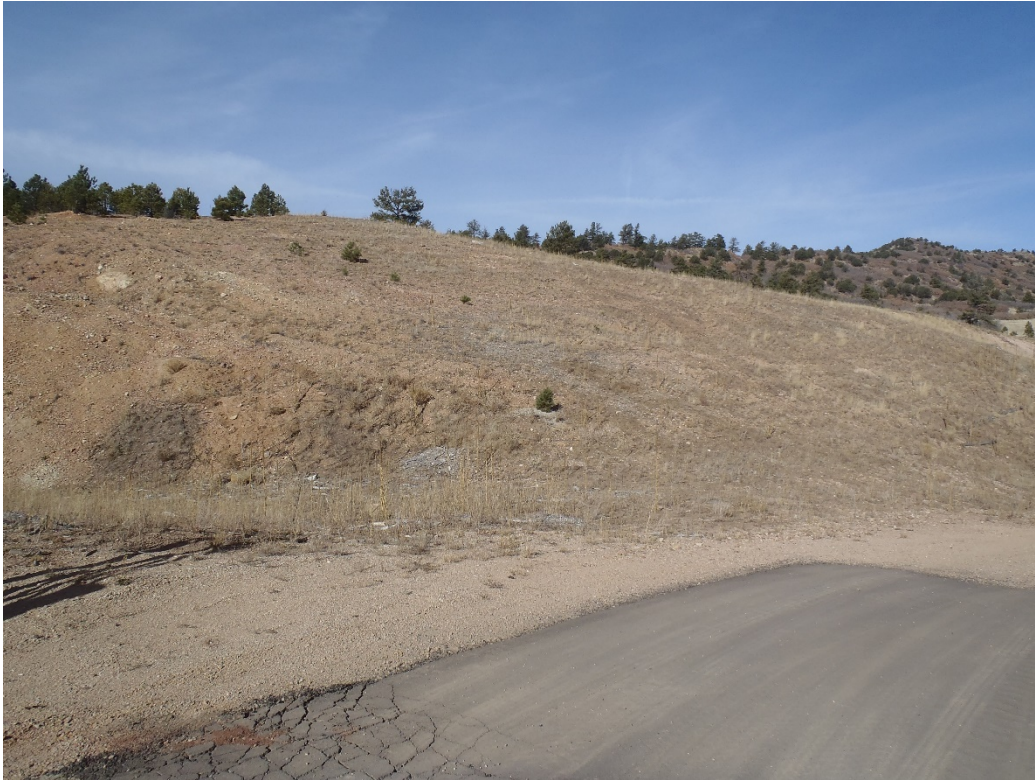
Roads: Haul and access roads did not appear to be a source of sediment that could be tracked offsite. The pit entrance is now paved (see **Photo 4**).

Reclamation Success: The highwalls on the west side of the pit have been graded to 3H:1V, top soiled and seeded (see **Photos 4** and **5**).

Photo 4. Paved pit entrance and south end of west highwall (looking NW).

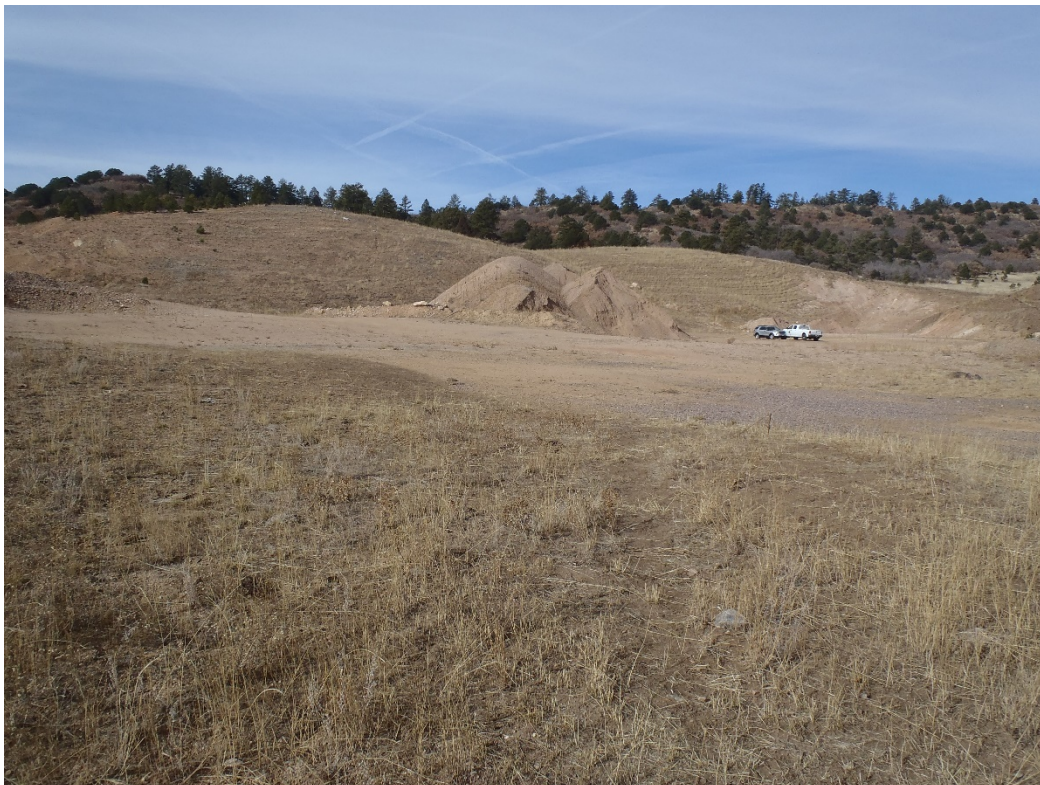
Photo 5. Revegetated west highwall (looking west, product stockpile in center).

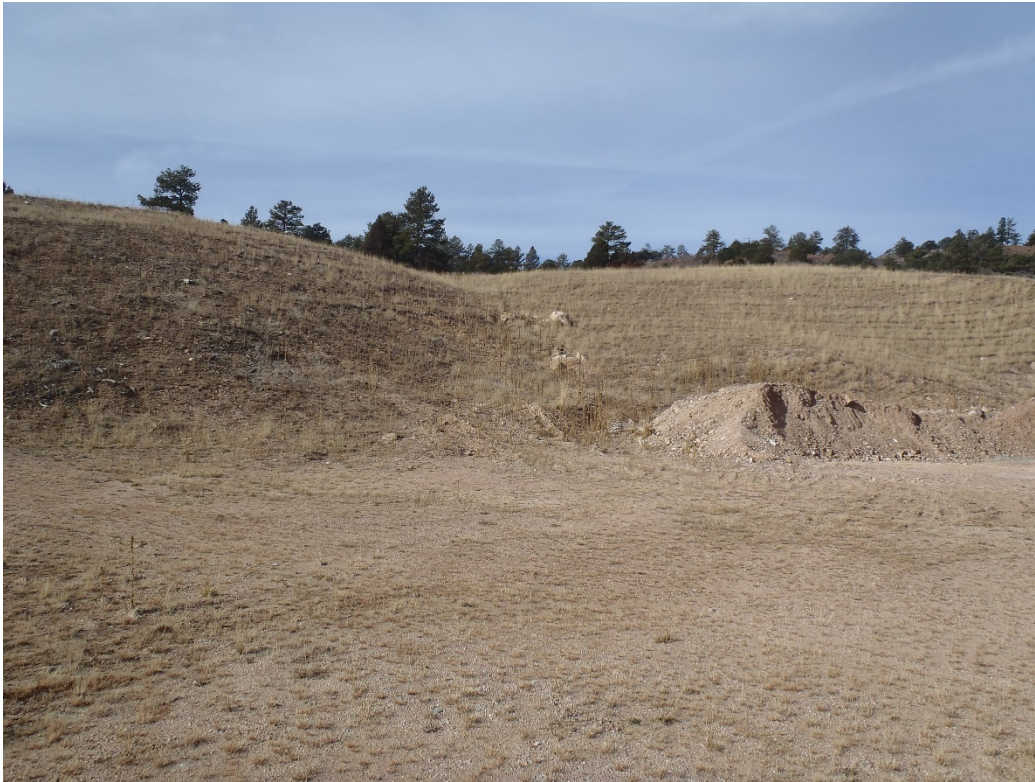
Revegetation: the revegetation on the west pit slope appeared fairly well established (see **Photo 6**). Other than some common Mullein (List C, see **Photo 9**) near the sediment pond outlet, no noxious weeds were observed.

Photo 6. Center of revegetated west highwall (looking NW).

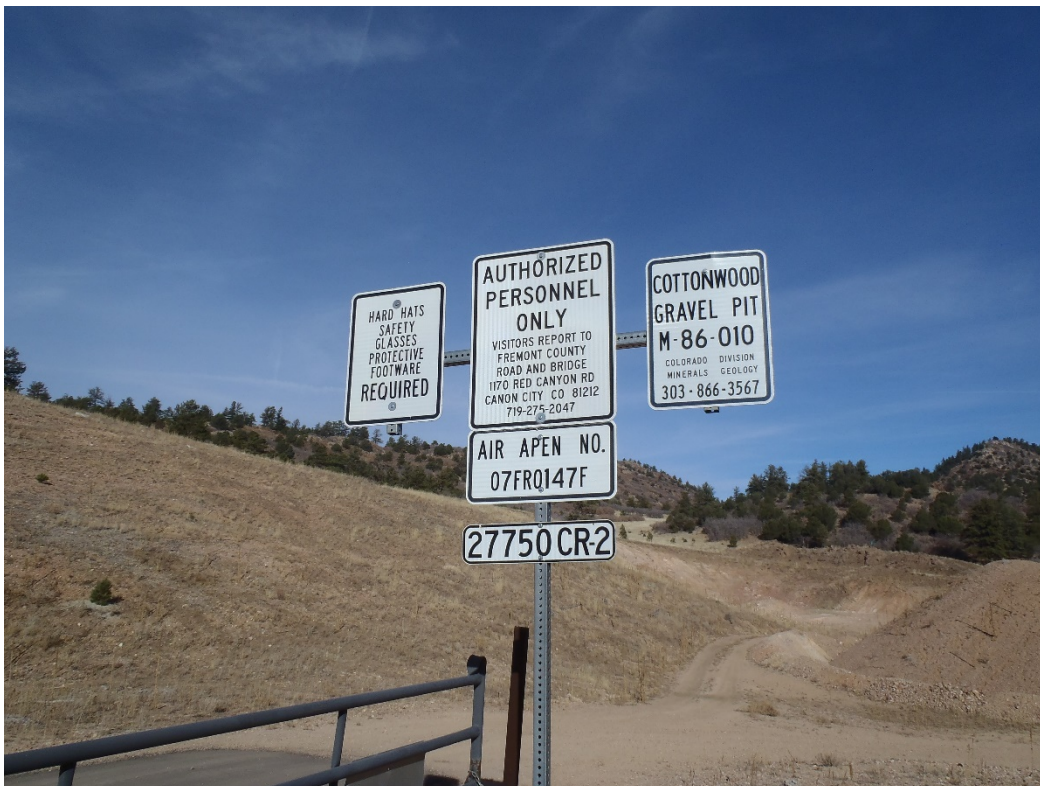
Signs and Markers: The permit sign was properly posted (see **Photo 7**) and fences (along the County road) and boundary markers were observed to delineate the permit boundary (see **Photo 8**).

Photo 7. Permit sign at entrance.

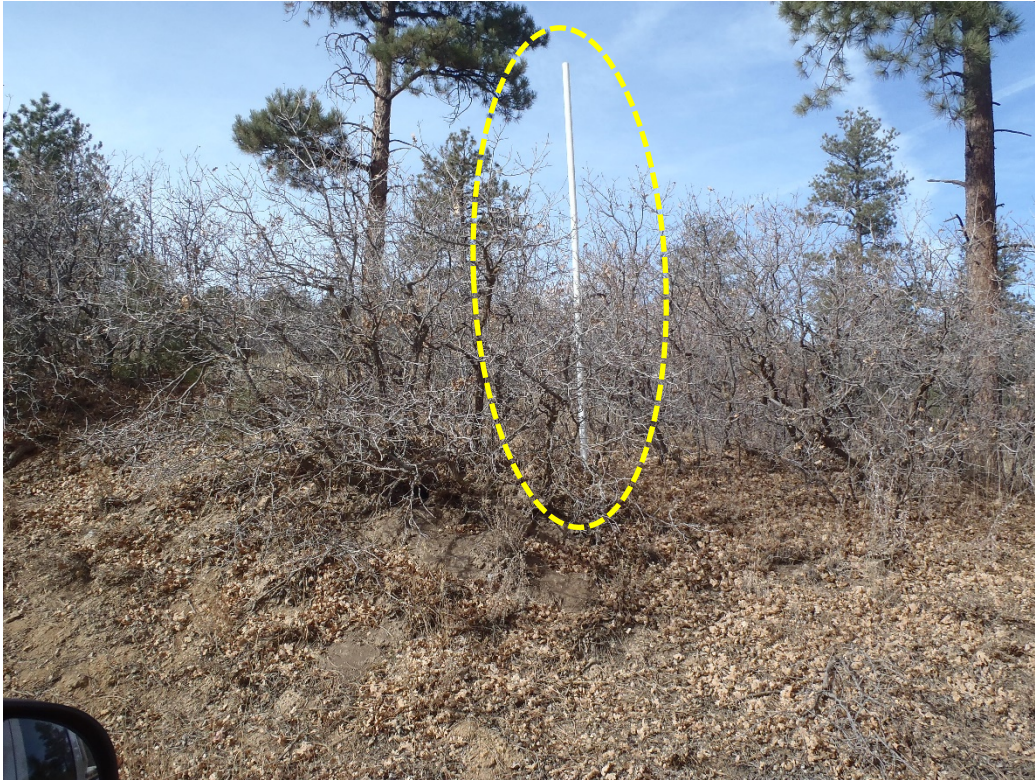
Photo 8. Typical boundary marker (north end).

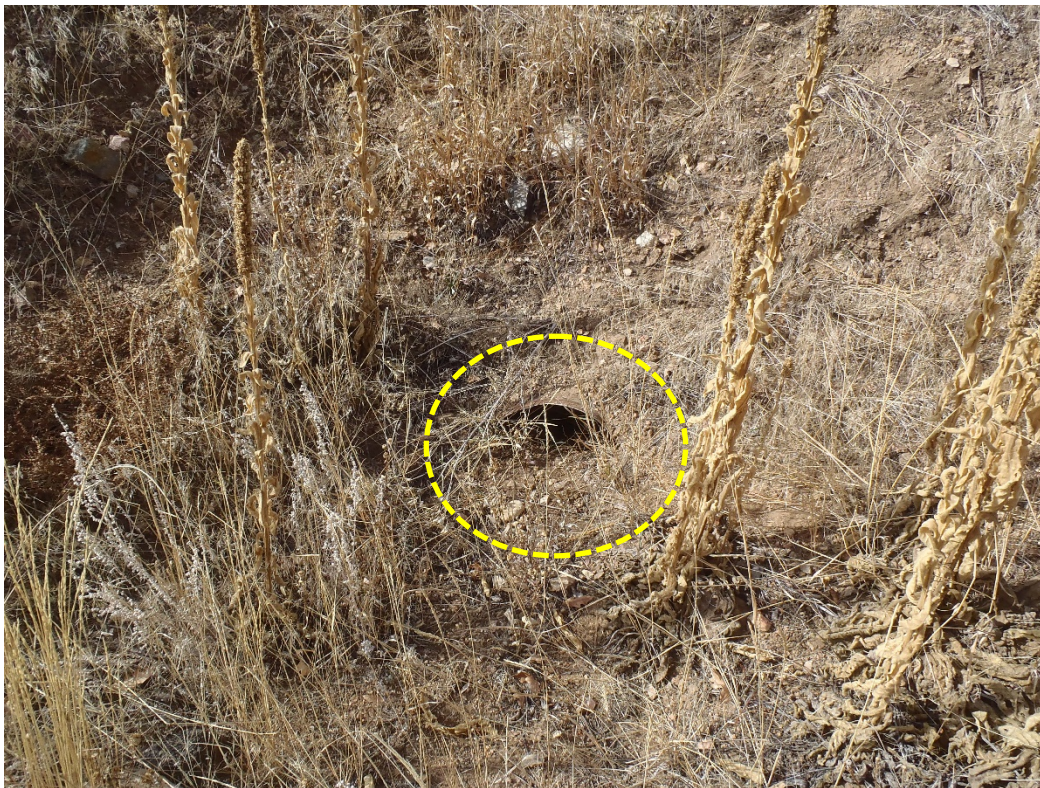
Storm Water MGT Plan: No oil or fuel spills observed. The outlet culvert for the site sediment pond was observed to be partially blocked, only at the outlet of the pipe (see **Photo 9**). Mr. Rife stated he would get it cleared.

Photo 9. Partially blocked outlet pipe (east side, looking west; note common Mullein – List C noxious weed).

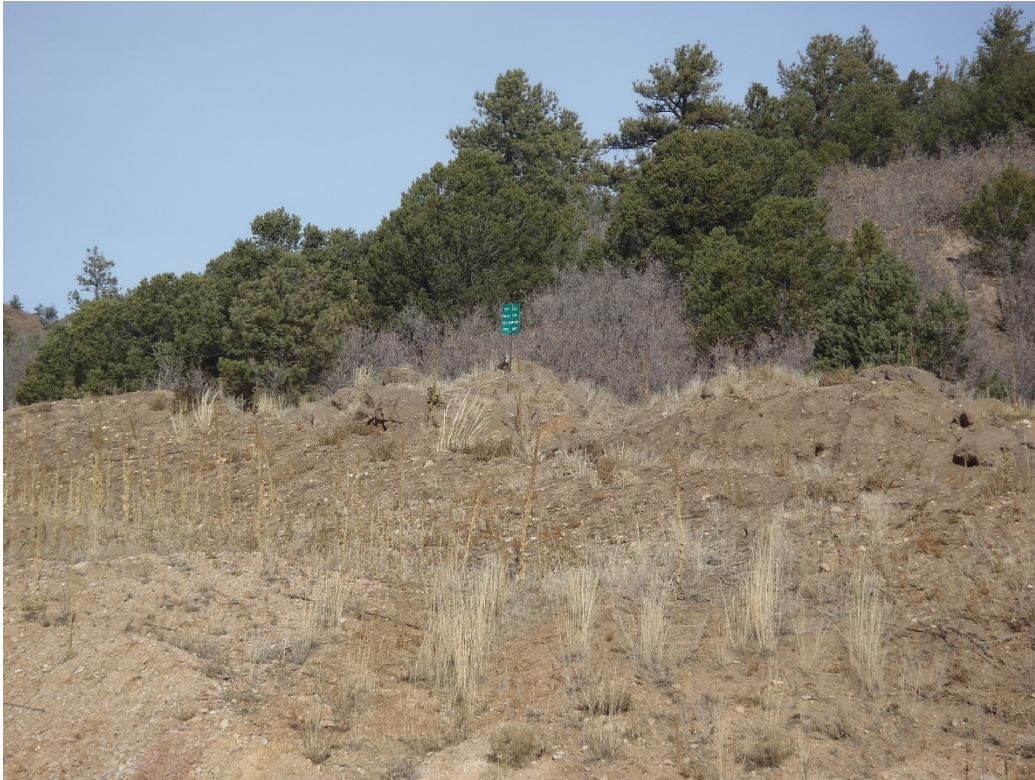
Topsoil: A topsoil stockpile is on the northeast side of the pit and labeled as such (see **Photo 10**).

Photo 10. Topsoil stockpile with sign (looking north).
