**MINERALS PROGRAM INSPECTION REPORT**  
**PHONE: (303) 866-3567**

<b>MINE NAME:</b> Hanna Pit No. 1	<b>MINE/PROSPECTING ID#:</b> M-2004-045	<b>MINERAL:</b> Commod_Table	<b>COUNTY:</b> Rio Grande
<b>INSPECTION TYPE:</b> Monitoring	<b>INSPECTOR(S):</b> Lucas West	<b>INSP. DATE:</b> February 15, 2022	<b>INSP. TIME:</b> 11:45
<b>OPERATOR:</b> Rio Grande Ranch, LLC	<b>OPERATOR REPRESENTATIVE:</b> None	<b>TYPE OF OPERATION:</b> 110c - Construction Limited Impact	
<b>REASON FOR INSPECTION:</b> High Priority	<b>BOND CALCULATION TYPE:</b> None	<b>BOND AMOUNT:</b> \$12,000.00	
<b>DATE OF COMPLAINT:</b> NA	<b>POST INSP. CONTACTS:</b> None	<b>JOINT INSP. AGENCY:</b> None	
<b>WEATHER:</b> Clear	<b>INSPECTOR'S SIGNATURE:</b>

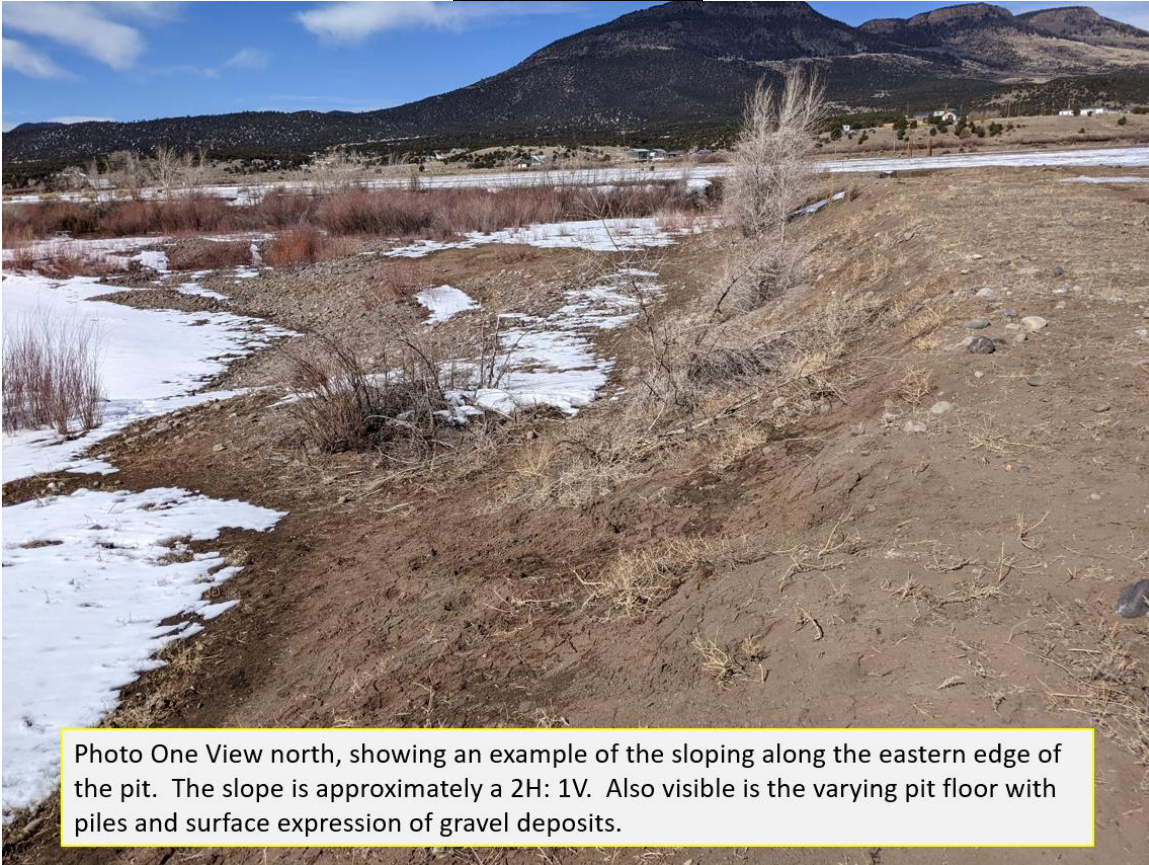
A subdivision road bisects the Permit Area and all mining efforts took place to the north of that road. Mining was conducted in a typical pit fashion resulting in a pond like depression in relation to the surrounding area. The edges of the disturbance range from approximately a 2H:1V slope to small areas of 1H:1V or steeper were observed. Examples of the sloping can be seen in Photos One and Two. The perimeter of the pit forms an undulated shape. Generally the slopes of the pit appeared stable at the time of the inspection and no significant evidence of settling, slumping or erosion was observed. The pit floor ranges in depth, from 8 feet to 15 feet at it's deepest. The deepest portion of the pit can be seen in Photo Three. Conversations with Mr. Hardy indicate that seasonally, a small groundwater expression is present in the deepest portion of the pit. At the time of the inspection, no groundwater was observed. The pit floor is not graded to create a flat bottom pit, ranging in elevation with small piles of gravel material present.

Photo One View north, showing an example of the sloping along the eastern edge of the pit. The slope is approximately a 2H: 1V. Also visible is the varying pit floor with piles and surface expression of gravel deposits.

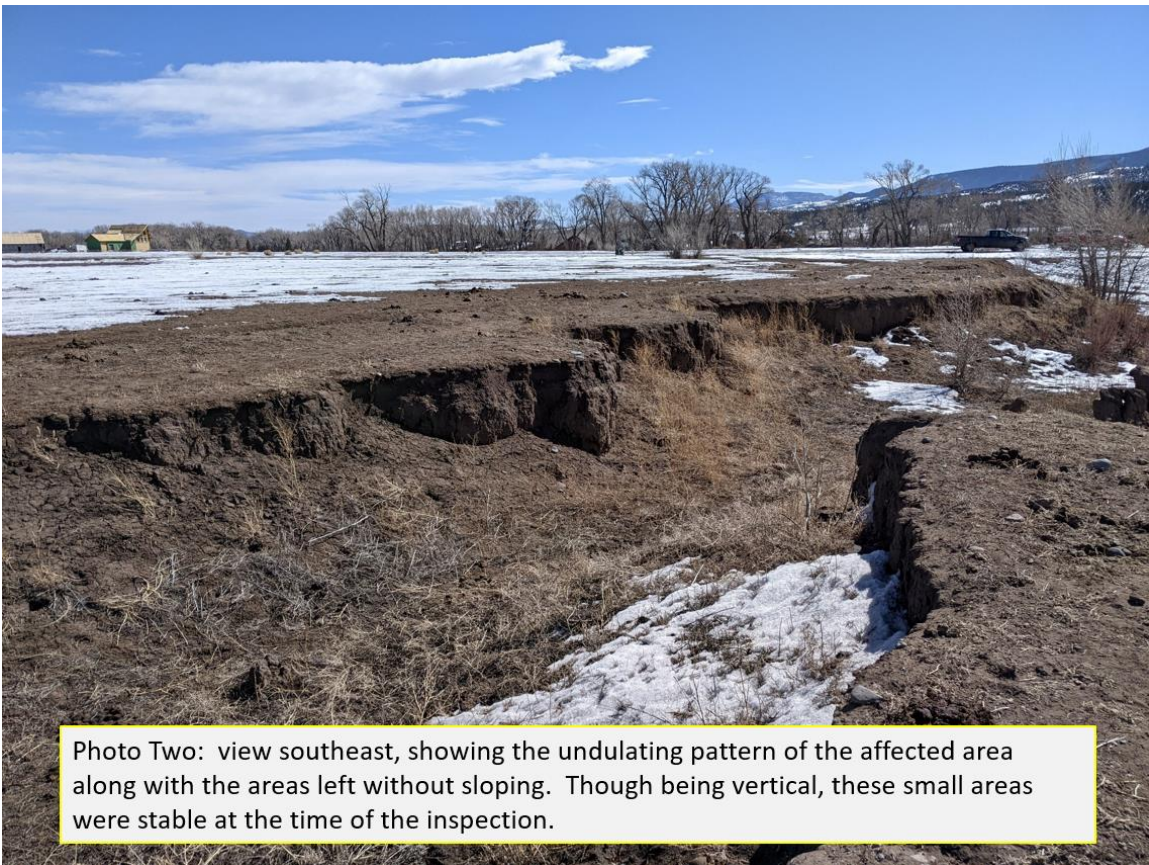
Photo Two: view southeast, showing the undulating pattern of the affected area along with the areas left without sloping. Though being vertical, these small areas were stable at the time of the inspection.

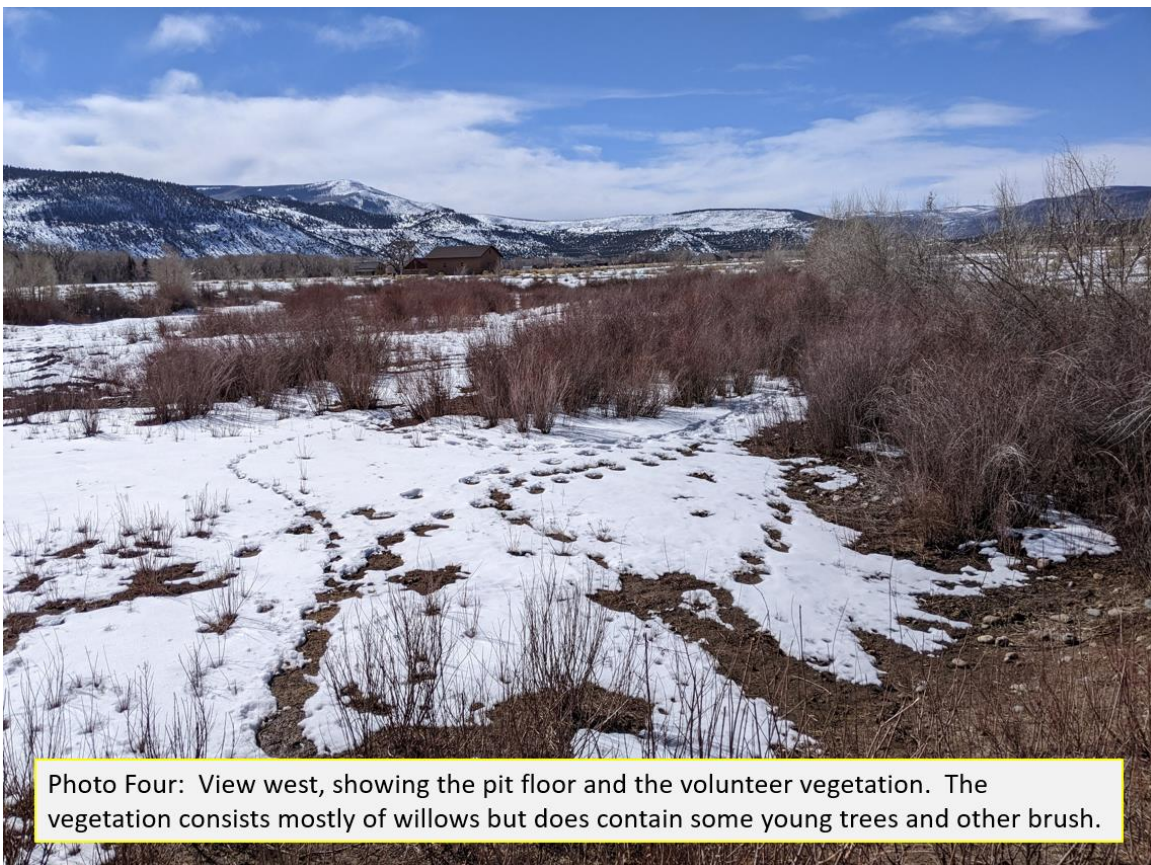
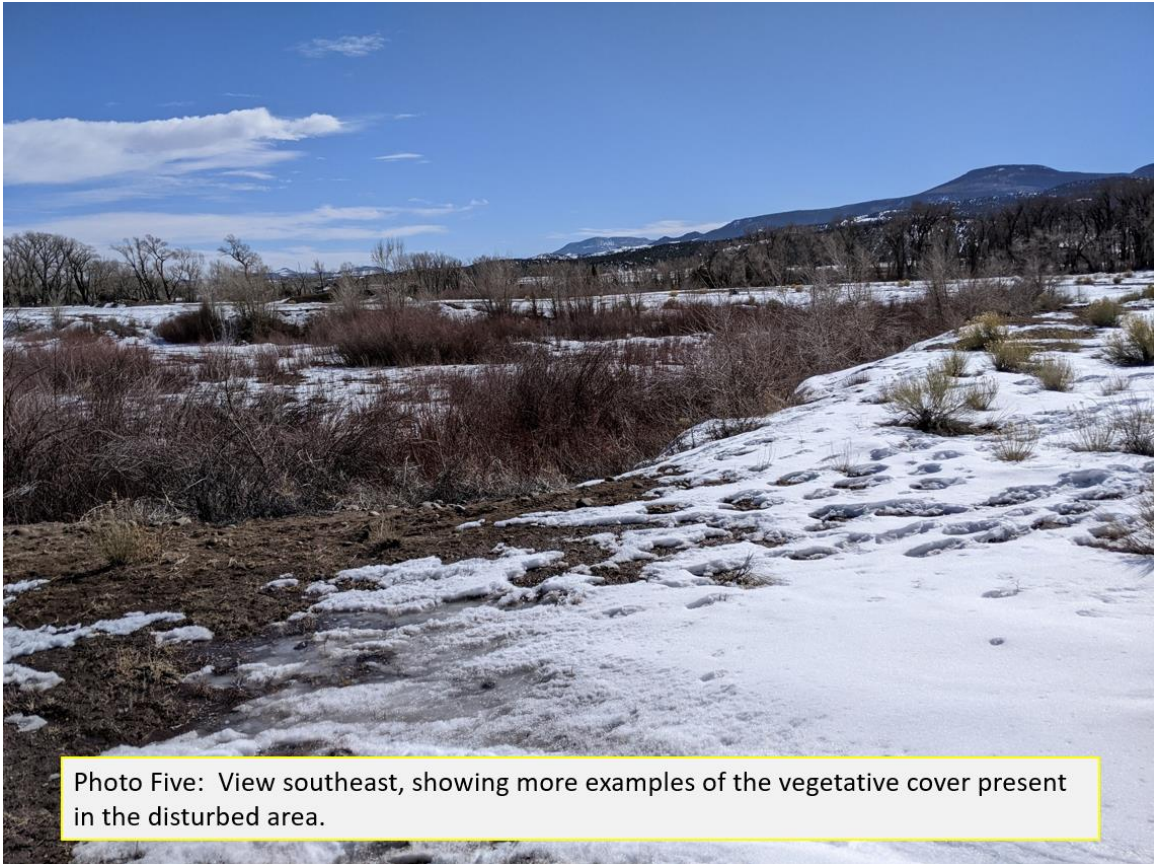
The pit floor as well as the slopes on the north side of the pit are well vegetated with volunteer vegetation including willows, some grasses and other brush. Examples of the vegetation can be seen in Photos Four and Five. The vegetation was not planted in efforts toward reclamation. Located on the south side of the subdivision road area two stockpiles that appear to be topsoil that had been stripped from the mining area and stockpiled for reclamation. The stockpiles range from approximately 6 to 12 feet tall and are partially vegetated. The stockpiles can be seen in Photo Six, and appeared stable at the time of the inspection.
