DRMS Inspection Report

MINERALS PROGRAM INSPECTION REPORT
PHONE: (303) 866-3567

MINE NAME: Buster Quarries	MINE/PROSPECTING ID#: M-1981-107	MINERAL: Sandstone (silica, st quartzite)	COUNTY: Larimer
INSPECTION TYPE: Monitoring	INSPECTOR(S): Robert Zuber, P.E.	INSP. DATE: February 15, 2022	INSP. TIME: 12:45
OPERATOR: ELB Stone, Inc.	OPERATOR REPRESENTATIVE: Bernard Buster	TYPE OF OPERATION: 112c - Construction Regular Operation

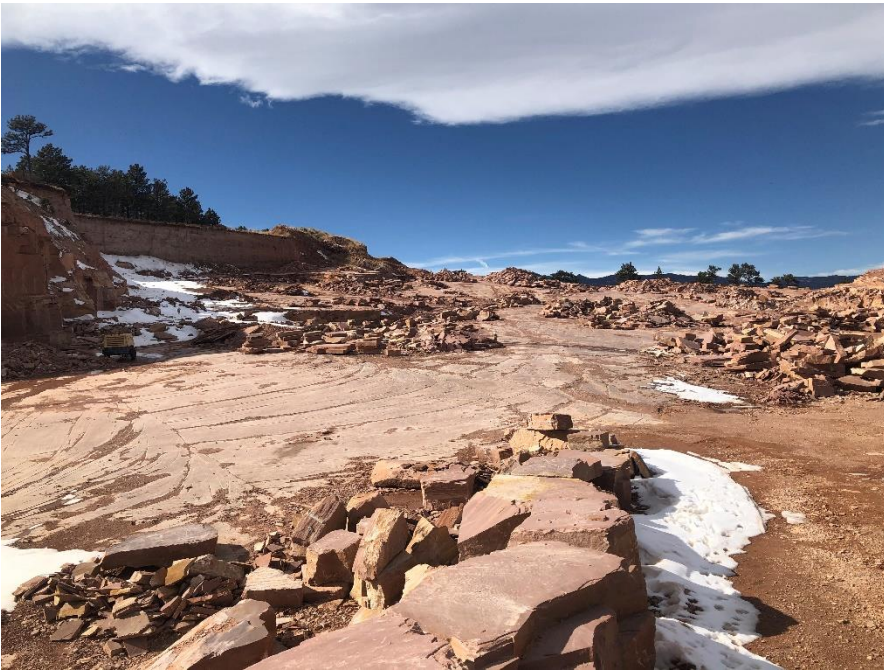
PROBLEM/POSSIBLE VIOLATION: Problem: The current reclamation plan needs to be updated and clarified pursuant to C.R.S. 34-32.5-116 (1). ELB Stone must describe how it intends to reclaim the large area of waste rock south of the #10 Quarry.

There is a storage area south of the #10 Quarry where very large rocks have been placed. If spread out, they could cover an area of more than a half acre. It appears that these are not product that can be sold. Therefore, the operator needs to update the reclamation plan with a Technical Revision to account for this area. (See the problem listed at the beginning of this report.)

CORRECTIVE ACTIONS: The operator shall submit a Technical Revision, with the required \$216 revision fee, to update and clarify the current approved reclamation plan to reflect existing and proposed activities by the corrective action date.

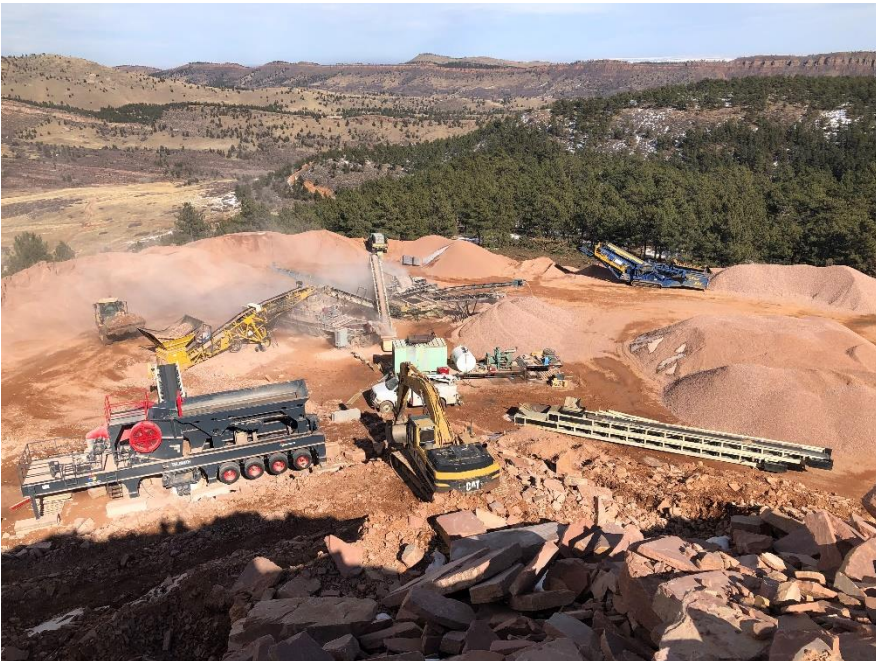
At the time of the inspection, the crushing equipment was operating at the #10 Annex area, and stone was being cut in the indoor facilities.

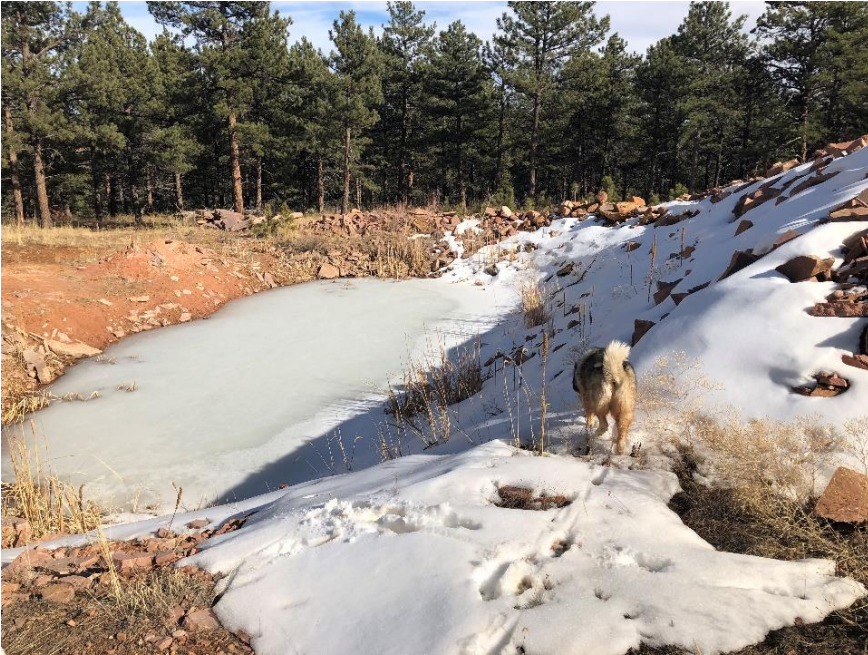
At all of these areas, the material for backfilling is next to the area to be filled. Also, at the Northeast Point area, approximately 1,000 cubic yards needs to be graded. A small hole containing water east of the #10 Annex needs to be filled with approximately 250 cubic yards, which is next to the hole.

Pot hole holding water, east of the #10 Annex

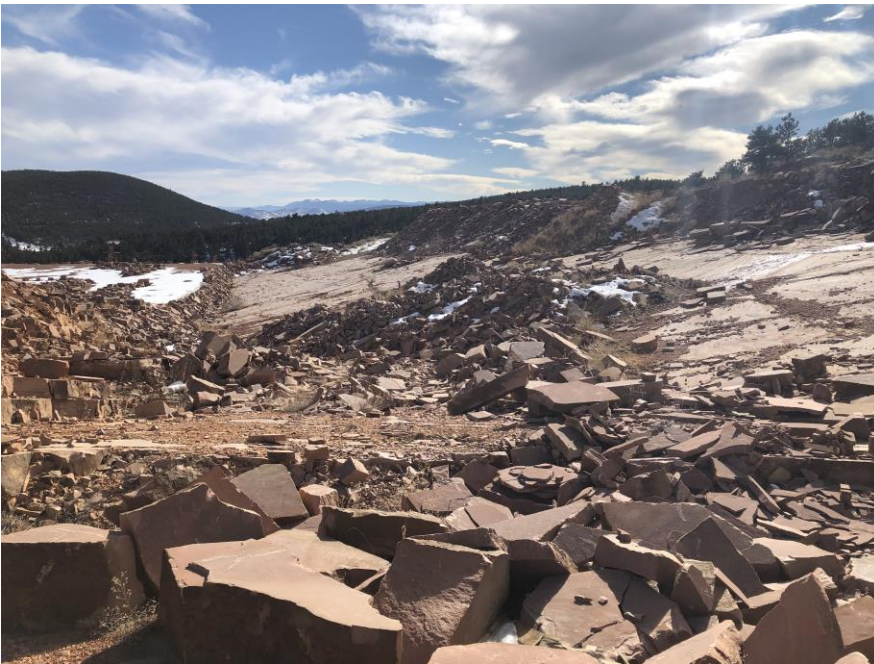
Some backfilling has been conducted at the site, namely at Windy Point and the Felipe area.

Felipe Pit, looking south with B&G operation on the left

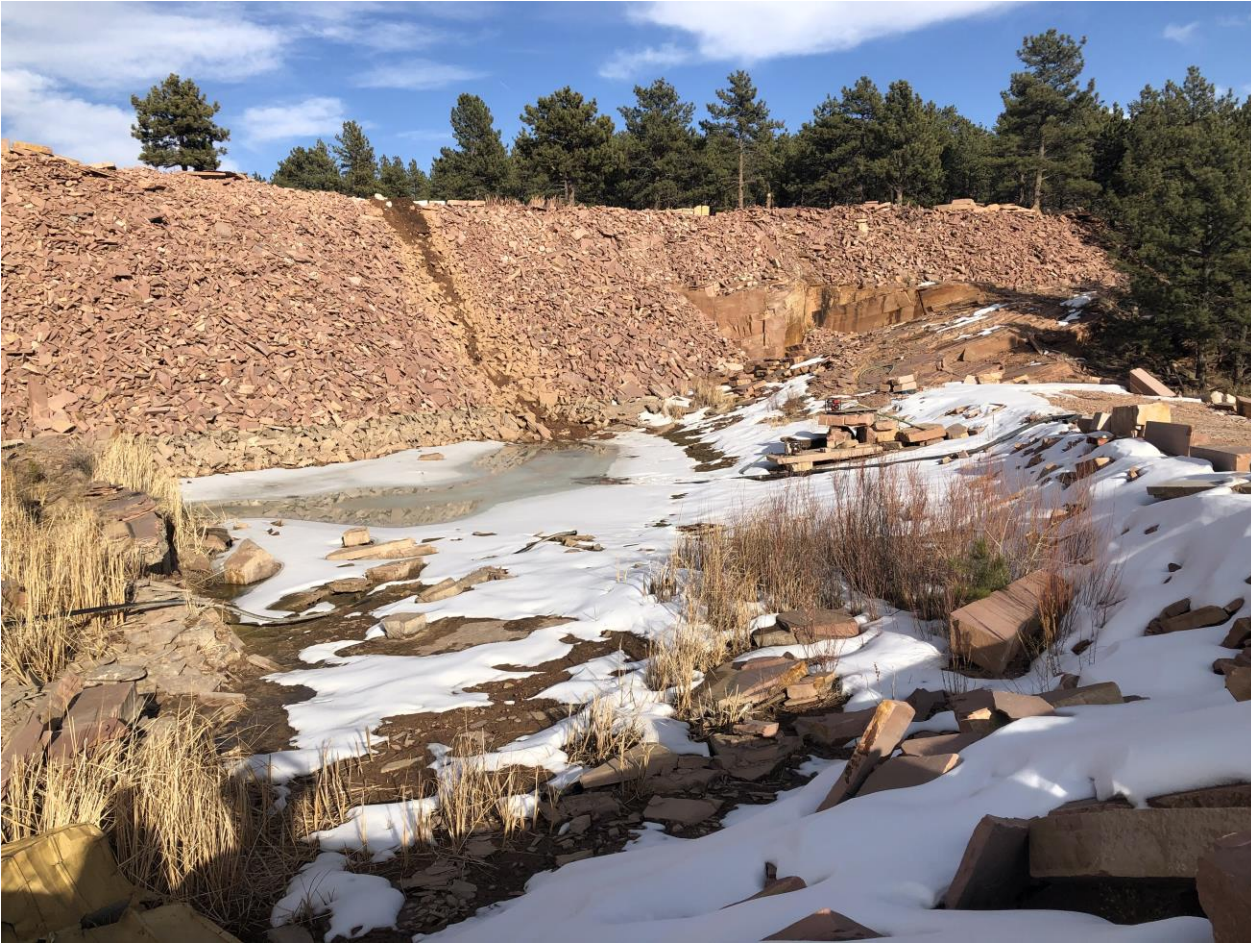
PROBLEM/POSSIBLE VIOLATION: Problem: The site is improperly impounding surface runoff or exposing groundwater without approval from the Division of Water Resources (DWR). This issue has been noted in previous DRMS inspections.

There is impounded surface water or groundwater at the Hotchkiss Pit. Per the regulations of the Division of Water Resources (DWR), this water cannot be impounded for more than 72 hours unless water rights have been approved. Also, if this water is groundwater, a well permit must be obtained. ELB Stone will need to secure approval from DWR to impound this water, backfill the holes, or regrade to provide positive drainage of the area. (See the problem listed at the beginning of this report.)

Hotchkiss Pit, retaining water

CORRECTIVE ACTIONS: Submit documentation from DWR demonstrating that the impoundment of water in this pit is authorized by that office. If it is exposed groundwater, also demonstrate that a well permit has been obtained.

Alternatively, fill in the pit or remove impediments to proper surface drainage.
