MINERALS PROGRAM INSPECTION REPORT

MINE NAME: Stirrup Pit	MINE/PROSPECTING ID#: M-1990-138	MINERAL: Gravel	COUNTY: Fremont
INSPECTION TYPE: Monitoring	INSPECTOR(S): Timothy Cazier, P.E.	INSP. DATE: November 18, 2021	INSP. TIME: 11:10
OPERATOR: Fremont County	OPERATOR REPRESENTATIVE: Sterling Rife	TYPE OF OPERATION: 110c - Construction Limited Impact

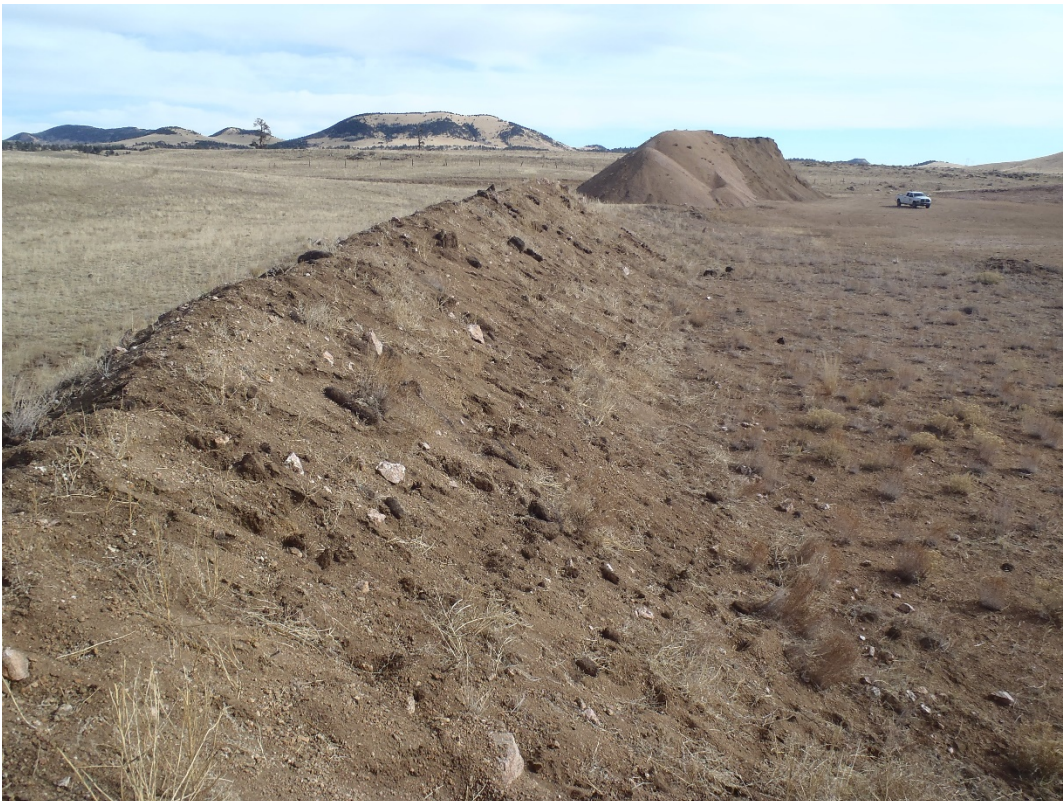
Excess Spoil and Dev. Waste: No overburden piles were observed, all stockpiled cover material is considered topsoil (see **Photos 1 and 2**).

Photo 1. Topsoil stockpile on north side (looking east).

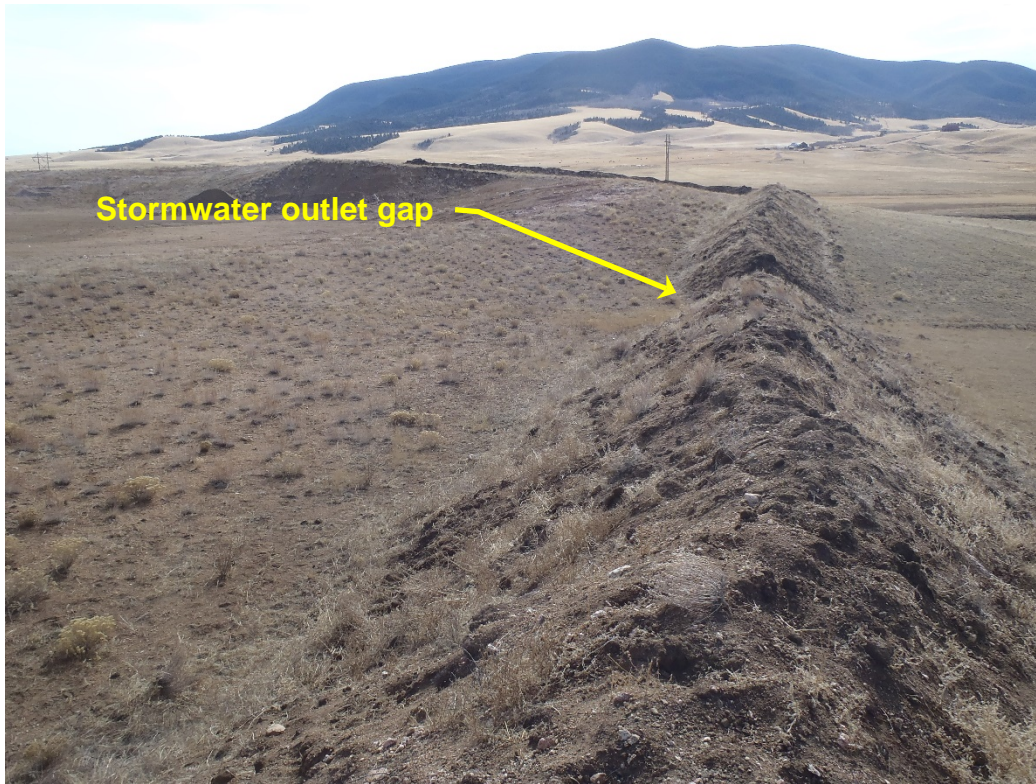
Storm Water MGT Plan: No oil or fuel spills observed. Mr. Rife stated the stormwater management plan is kept the County office in Cañon City. Stormwater either drains to the pit and infiltrates, or discharges thru the gap in the topsoil stockpile on the west side (see **Photos 2 and 6**).

Photo 2. Topsoil stockpile on west side (looking south, note stormwater outlet gap).

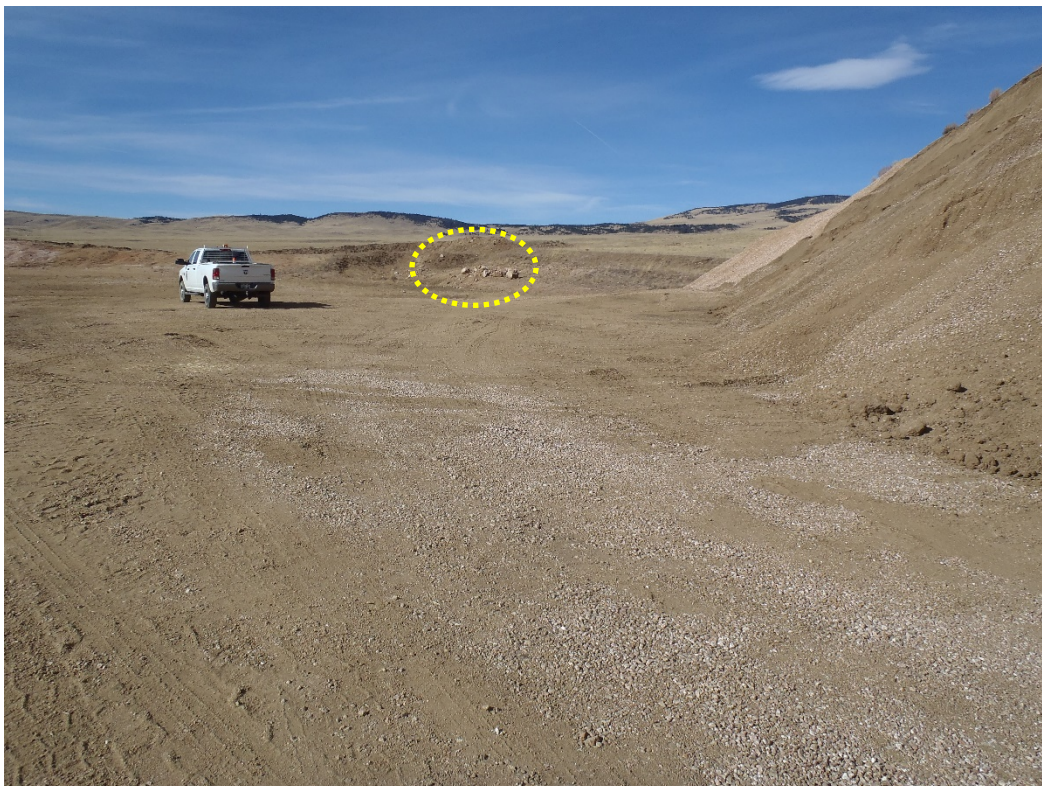
Processing Waste: A few oversized rocks were observed on the north side (see **Photo 3**).

Photo 3. Pit floor (looking WNW, note oversized boulders).

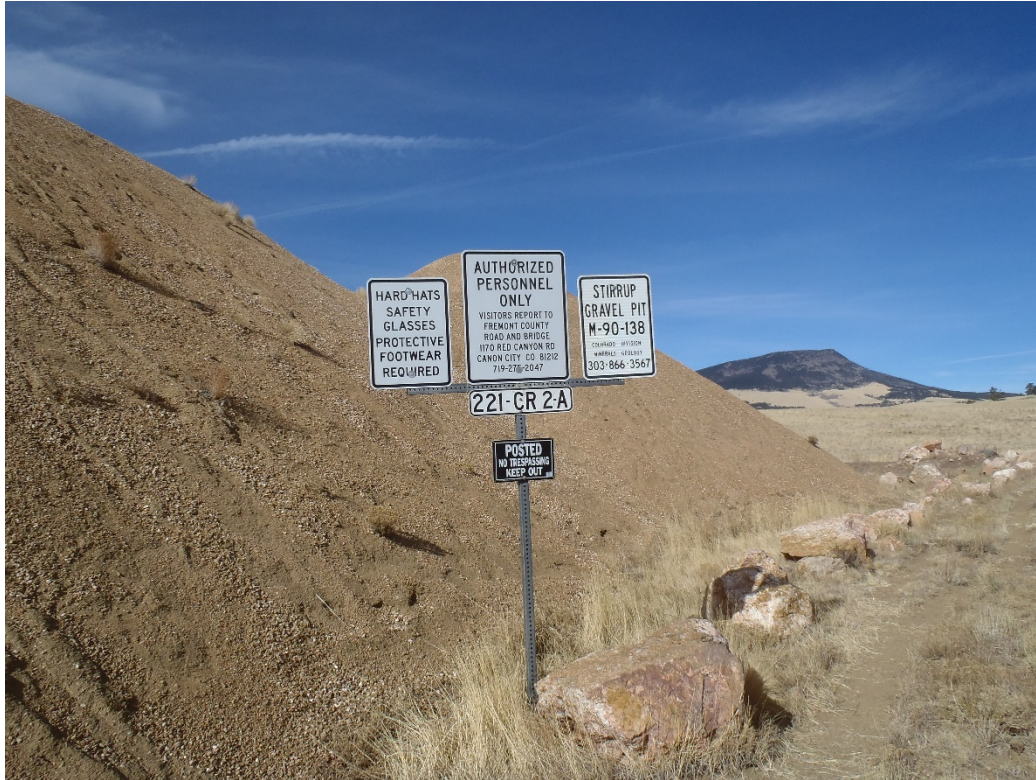
Signs and Markers: The permit sign was properly posted (see **Photo 4**). Four of the expected six boundary markers (see **Photo 5**) were found and locations collected using a handheld Trimble Juno 3B GPS unit (see attached post inspection map). The site disturbance was determined to be within the marked boundary, but the field delineated boundary is shifted to the northeast; of a different shape (perhaps due to not being able to locate the two expected interior corners along the south boundary); and the entrance is on the east side, off CR 2A, rather than as approved on the south side, off CR 2. Based on discussions with Mr. Rife, it appears the current configuration of the boundary has not been altered since it was first mined in the early 1990's. **The discrepancy in the permit boundary between that marked in the field and that in the 1990 application is cited as a Problem on page 1 of this report.**

Photo 4. Permit sign at entrance off CR2A.

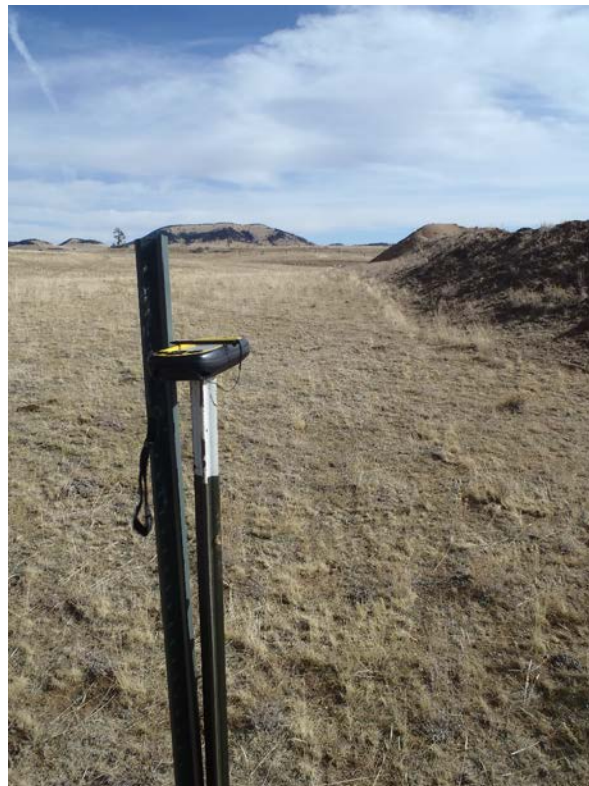
PROBLEM/POSSIBLE VIOLATION: Problem: The in place boundary markers do not coincide with those of the proposed permit boundary in the approved permit.

Photo 5. Typical boundary marker (NW corner, looking east).

CORRECTIVE ACTIONS: Submit a technical revision (along with the required \$216 fee) with a map clarifying the permit boundary not to exceed 9.6 acres.

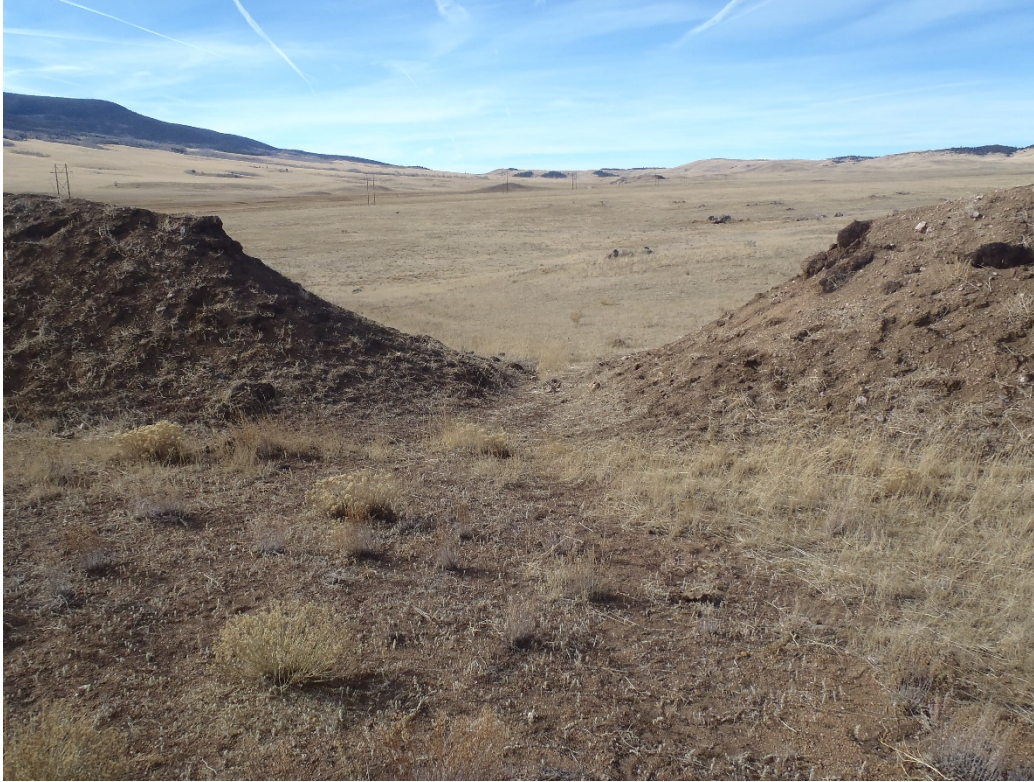
Photo 6. Stormwater outlet gap in west side topsoil stockpile (looking west).

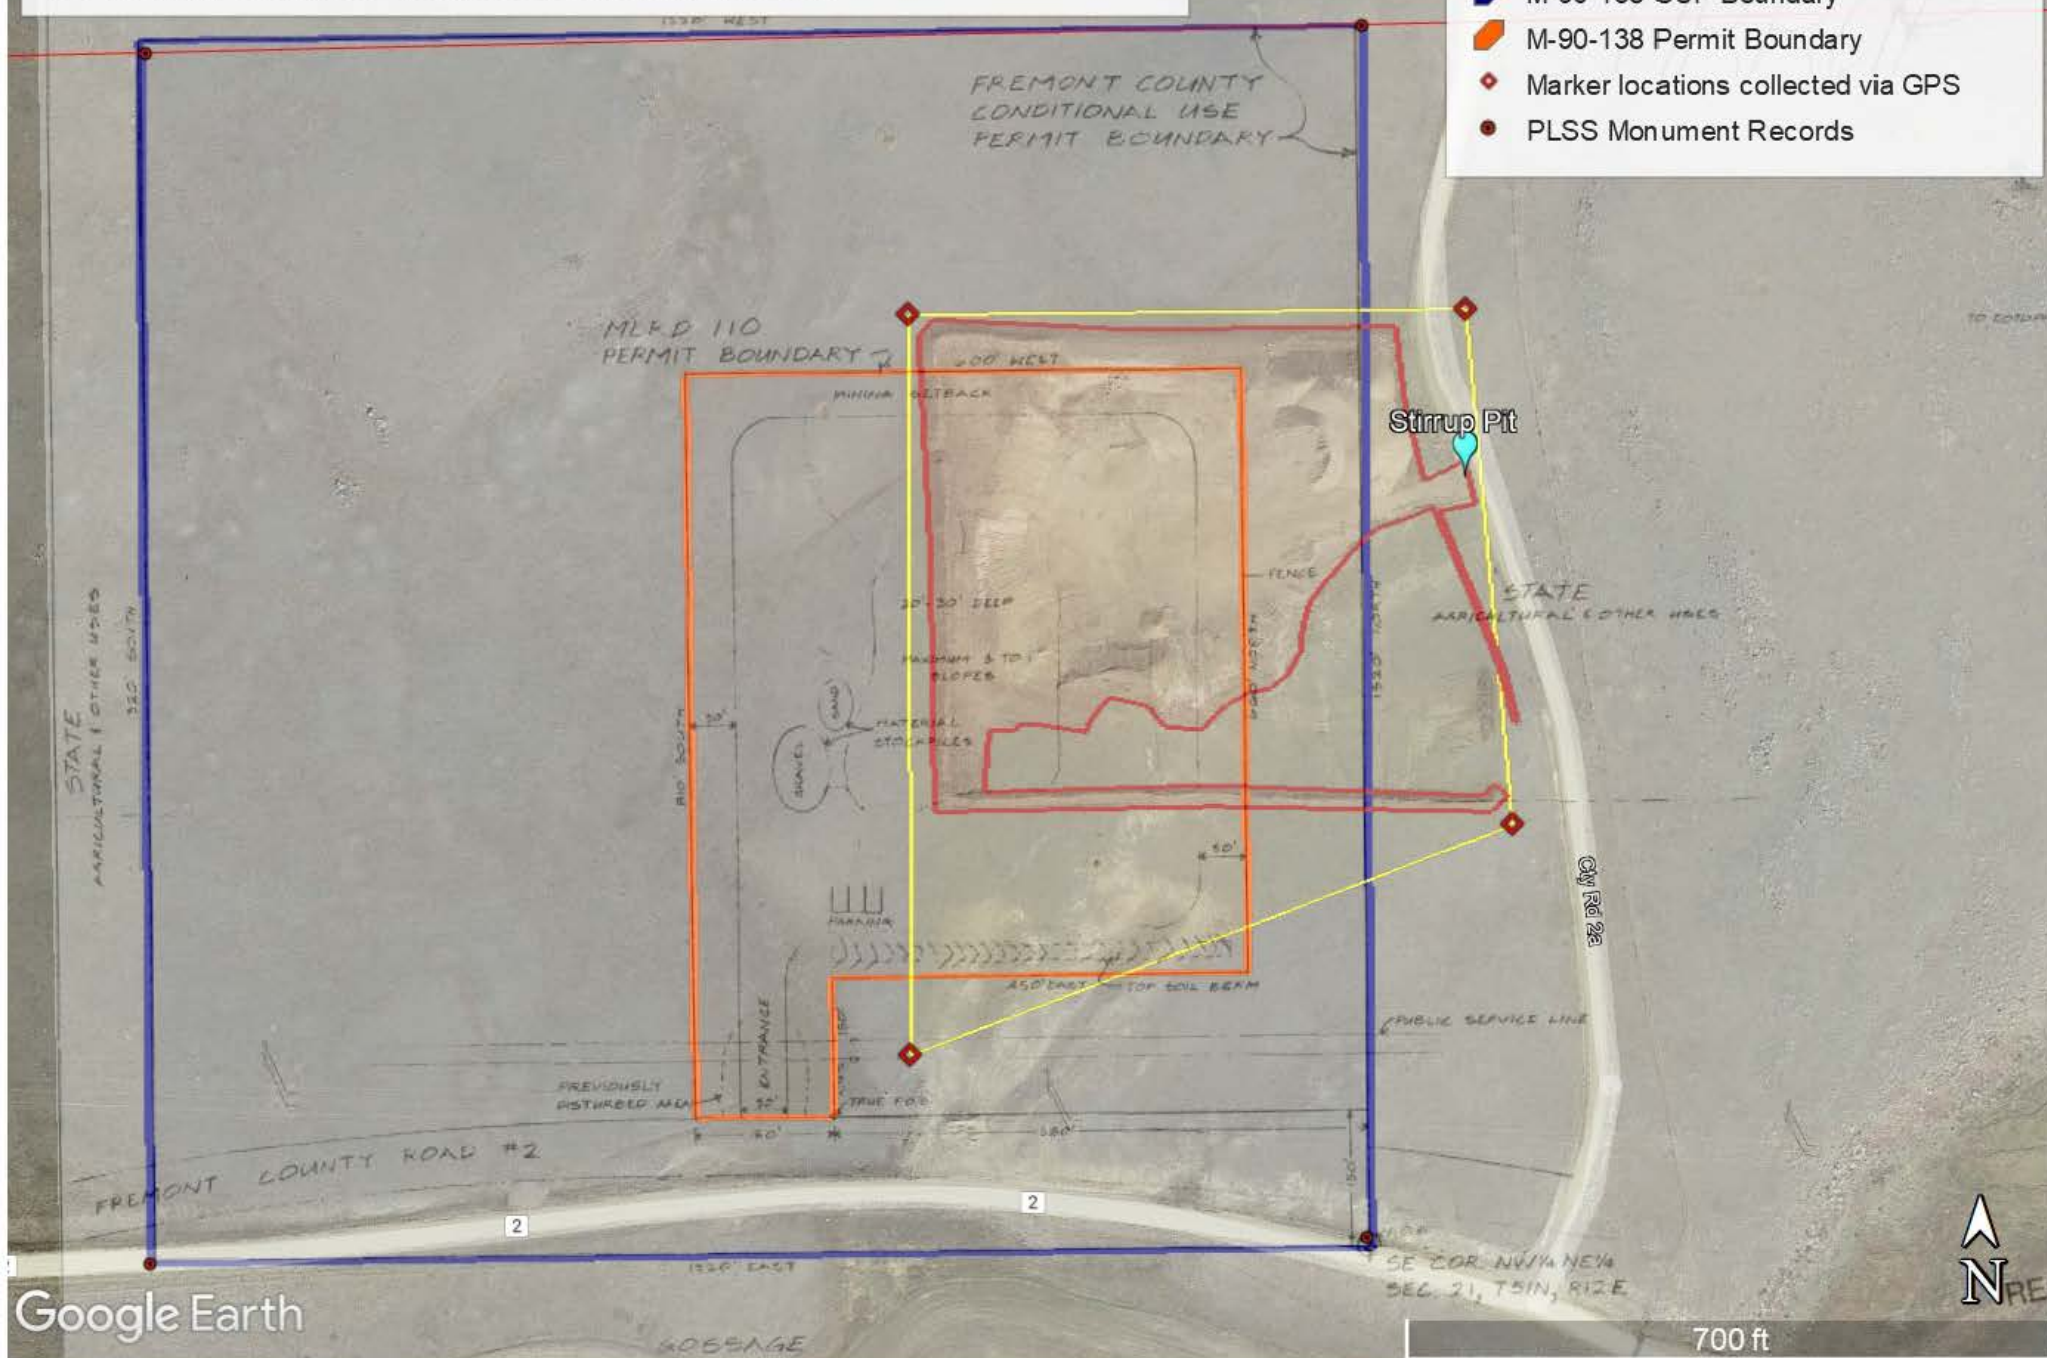
Enclosure: Post Inspection Map

Off-site Damage: The operation appeared to be confined to the permit boundary as delineated by field markers. However, these markers were appear to be inconsistent with the DRMS approved boundary (see Signs and Markers below).
