MINERALS PROGRAM INSPECTION REPORT
PHONE: (303) 866-3567

MINE NAME: Quagmire Creek	MINE/PROSPECTING ID#: M-1990-047	MINERAL: Gravel	COUNTY: Fremont
INSPECTION TYPE: Monitoring	INSPECTOR(S): Timothy Cazier, P.E.	INSP. DATE: November 18, 2021	INSP. TIME: 12:40
OPERATOR: Fremont County	OPERATOR REPRESENTATIVE: Sterling Rife	TYPE OF OPERATION: 110c - Construction Limited Impact	
REASON FOR INSPECTION: Normal I&E Program	BOND CALCULATION TYPE: None	BOND AMOUNT: \$0.00	
DATE OF COMPLAINT: NA	POST INSP. CONTACTS: U.S.BLM	JOINT INSP. AGENCY: None	
WEATHER: Clear	INSPECTOR'S SIGNATURE:

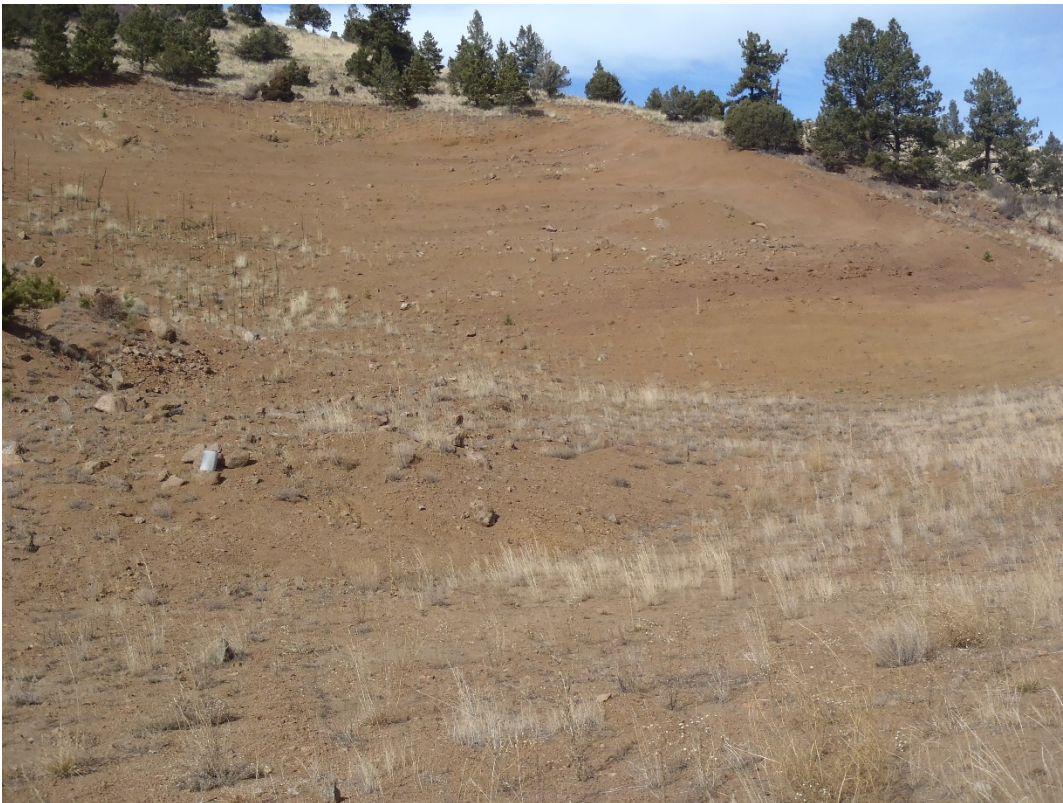
Reclamation Success: Mr. Rife indicated the entire site had been seeded, and the limited available topsoil that was salvaged had been placed on the flatter areas as required by the approved reclamation plan (pit floor and west side of the south end). The approved reclamation plan allows "Where topsoil is not sufficient in quantity to cover disturbed ground 6 inches in depth, subsoils and weathered bedrock will be ripped, stabilized, and planted with the reclamation seed mix." The reclamation on the north end has followed this approach. Furrows along the contours were observed (see **Photo 1**) and are clearly visible in Google Earth images from 2016 and 2019. Furthermore, no erosion rills or gullies were observed on the north, contoured area, indicating the slope is erosionally stable despite the lack of established vegetation.

Photo 1. North end with ripped furrows along the contours (looking north).

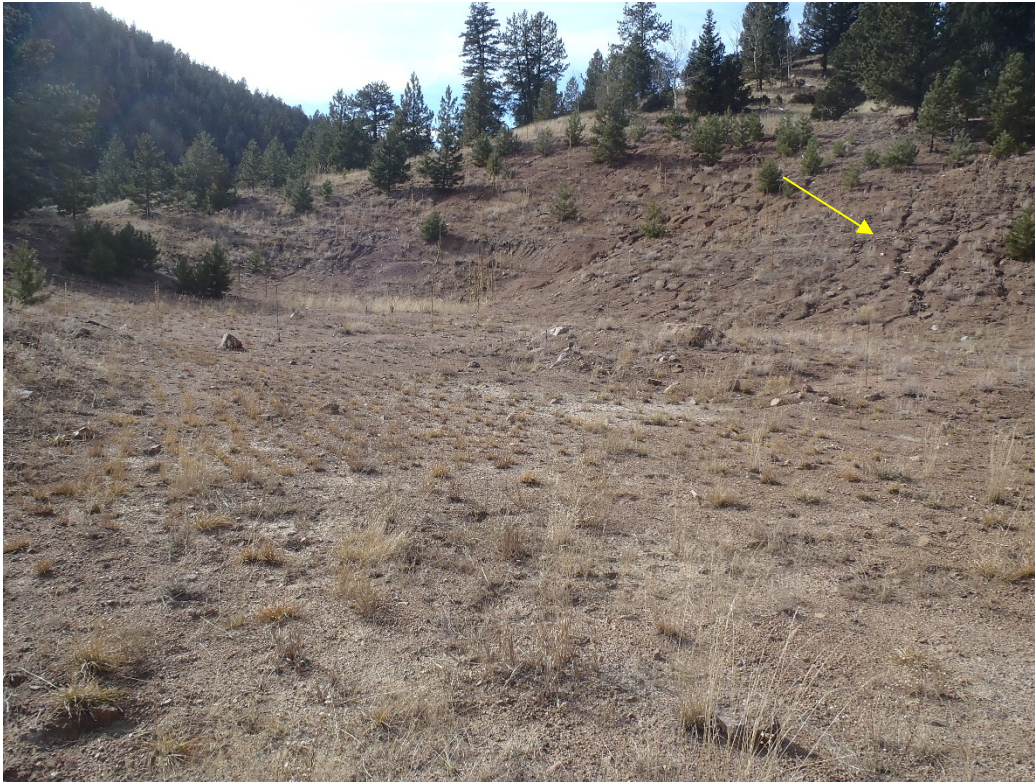
Revegetation: Vegetation in the topsoiled areas appeared to be gradually getting established (see **Photos 2 and 3**). A few plants that appeared to be knapweed were observed (see **Photos 3 and 4**). [This is a noxious weed List B species and should be treated before it becomes pervasive and a problem.](#)

Sediment Control: No significant erosion problems were observed, although some minor rilling was observed in the vegetated area on the west side of the south end (see **Photo 2**). No BMPs were needed at the time of the

Photo 2. Topsoiled south end with establishing vegetation and minor rilling (looking SW).

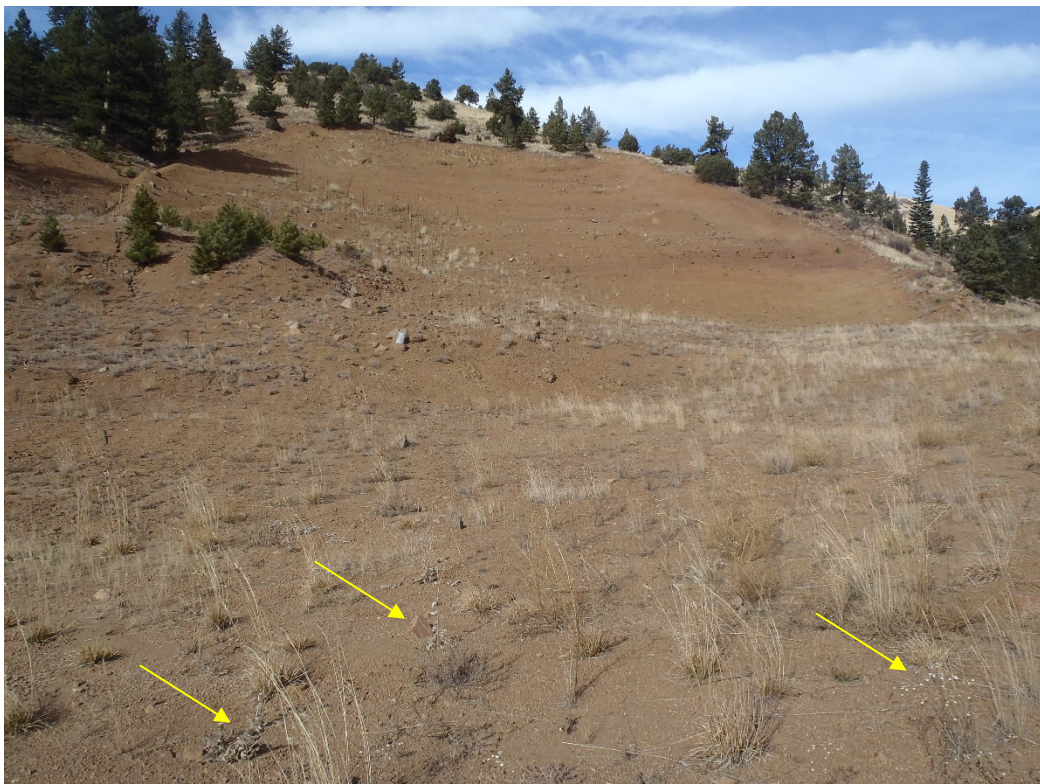
Photo 3. Topsoiled pit floor with establishing vegetation (looking north, possible knapweed in foreground).

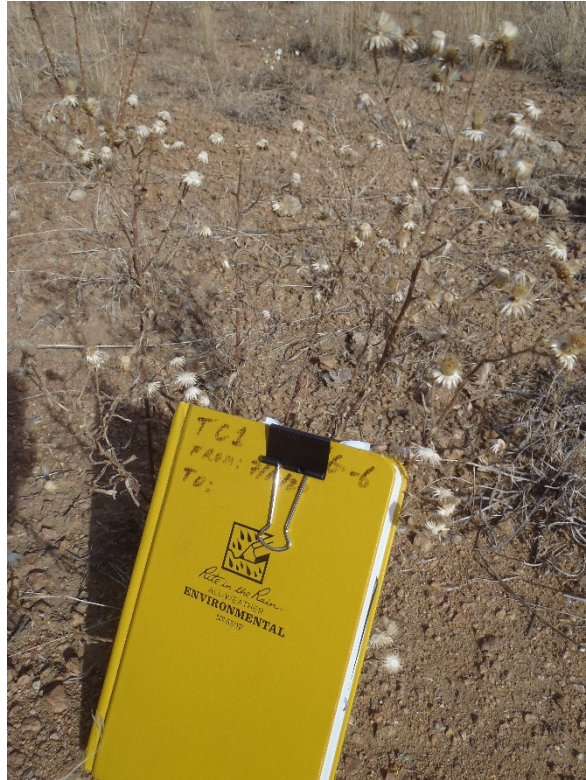
Photo 4. Possible knapweed observed on pit floor.

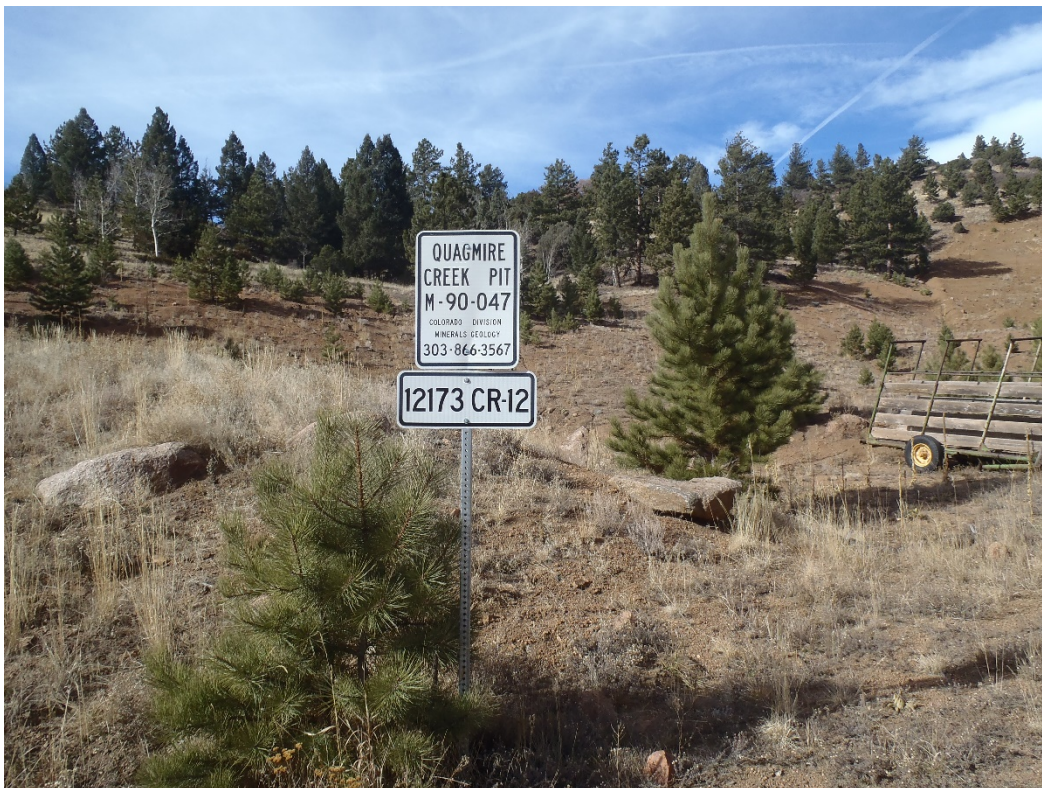
Signs and Markers: The permit sign was properly posted (see **Photo 5**). As the site is in final reclamation and the disturbed area has not increased since the boundary markers were checked during the 2013 inspection, the remote boundary markers were checked.

Photo 5. Permit sign at entrance.
