MINERALS PROGRAM INSPECTION REPORT
PHONE: (303) 866-3567

MINE NAME: Buss Barrow Pit	MINE/PROSPECTING ID#: M-2019-021	MINERAL: Borrow material for	COUNTY: Fremont
INSPECTION TYPE: Monitoring	INSPECTOR(S): Timothy Cazier, P.E.	INSP. DATE: December 2, 2021	INSP. TIME: 12:25
OPERATOR: Fremont Paving & Redi-Mix, Inc.	OPERATOR REPRESENTATIVE: John Paul Ary & Jodi Schreiber	TYPE OF OPERATION: 111 - Construction by Government Agency	
REASON FOR INSPECTION: Normal I&E Program	BOND CALCULATION TYPE: None	BOND AMOUNT: \$8,376.00	
DATE OF COMPLAINT: NA	POST INSP. CONTACTS: None	JOINT INSP. AGENCY: None	
WEATHER: Clear	INSPECTOR'S SIGNATURE:

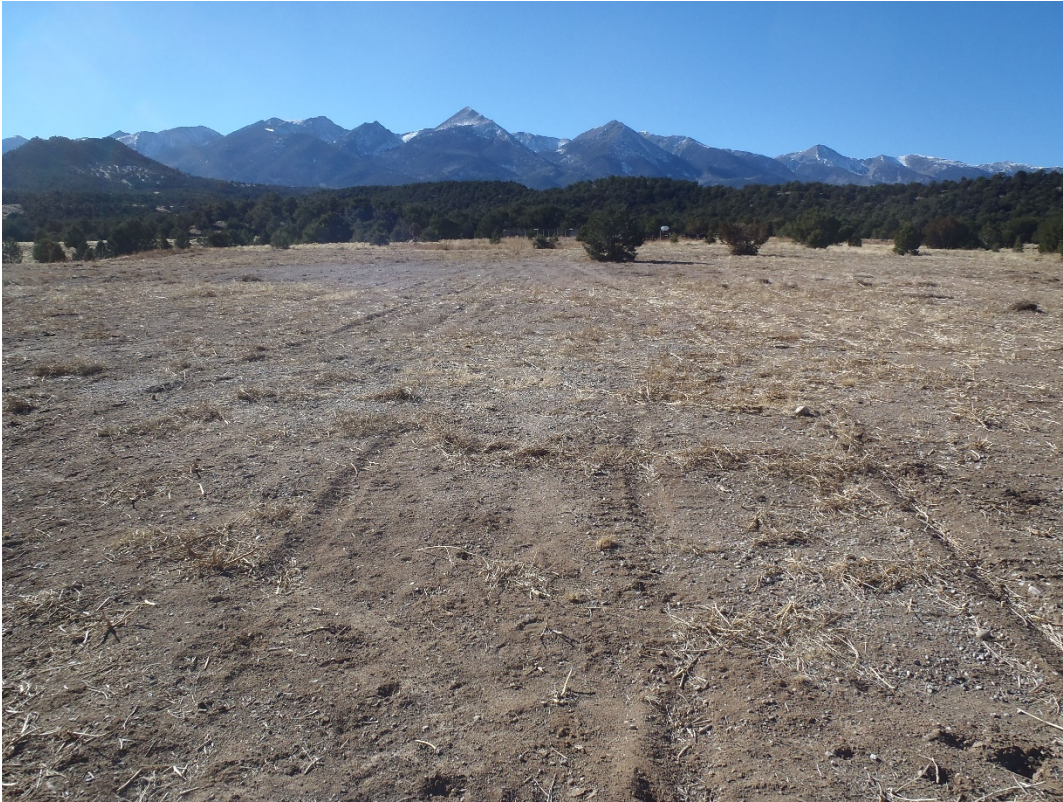
Reclamation Success: Reclamation has been completed (see **Photos 1 and 2**) with the exception of re-establishing vegetation. DRMS records indicate the site was seeded the day before the previous inspection (i.e., May 11, 2020). Site representatives indicated there was very little precipitation in the area in 2020.

Photo 1. Reclaimed area (looking SW from the middle of the disturbance).

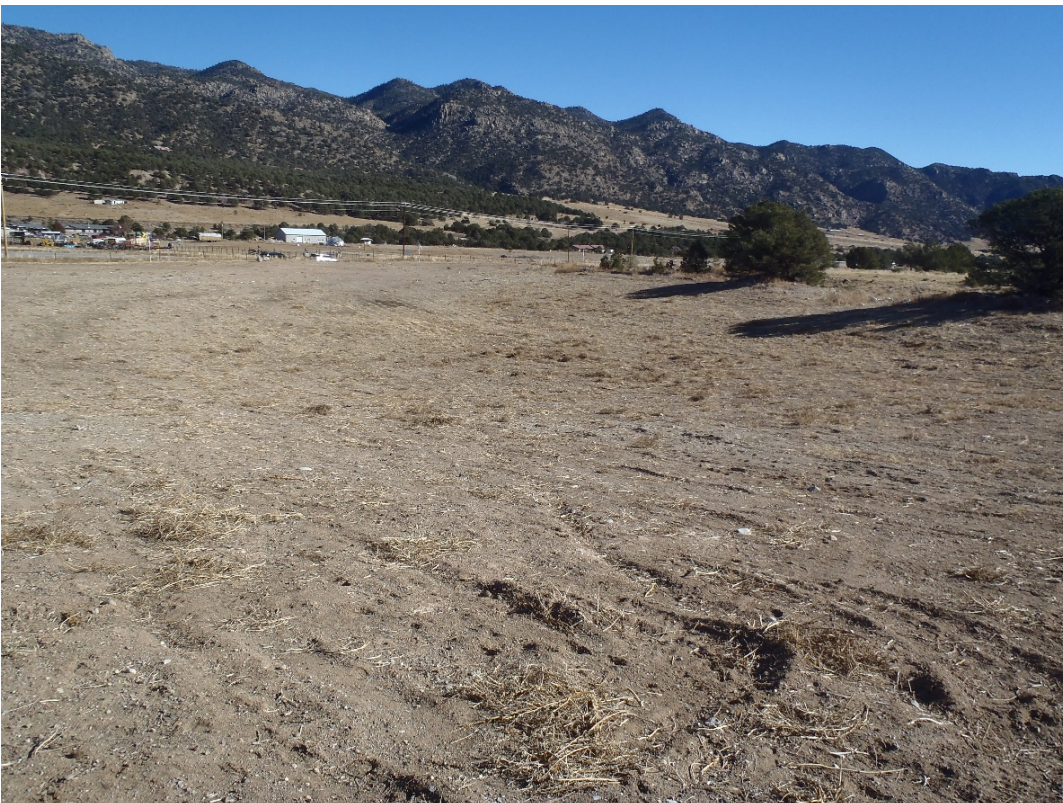
Photo 2. Reclaimed area (looking NE from the middle of the disturbance).
