To: Jerald Schnabel From: Paul Kos
Continental Materials Corp. Denver, CO 80222
File: January 2022 Monitoring Summary Date: February 28, 2022

Reference: January 2022 Geotechnical Monitoring Summary Pikeview Quarry

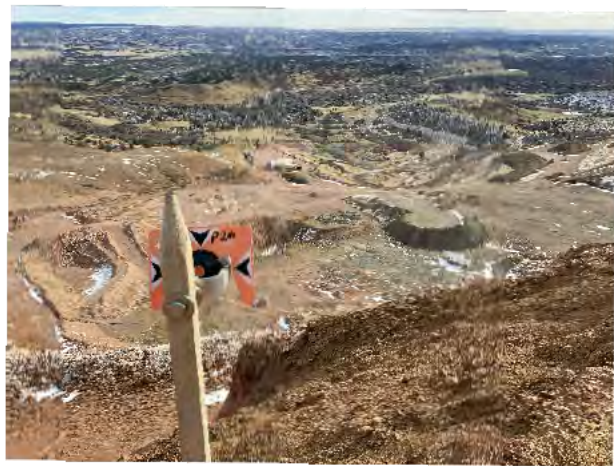
- Several prisms were passed along the walking route and appeared to be in their original position and operating normally. Control points and most of the monitoring points are permanently cemented into the ground while some of the monitoring points are cemented into 5-gal buckets to be portable as needed. (Photo 6)

6. Prism along road overlooking production floor.

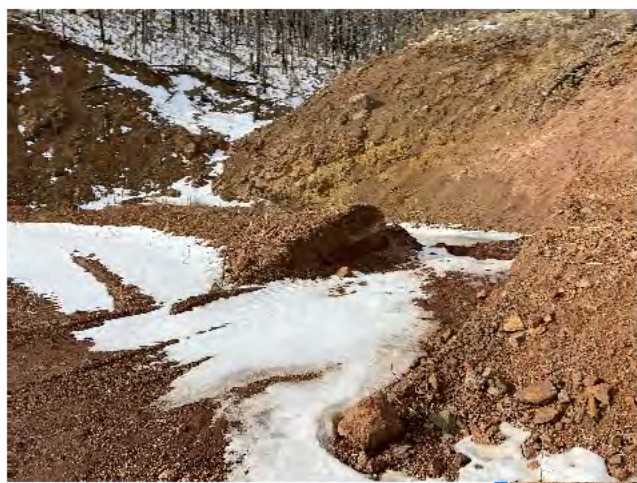
- The berm of the pond below the Middle Peak has been notched as previously recommended. This will serve to keep the water level from exceeding a specific level. (Photo 5)

5. Level-control notch cut into pond.

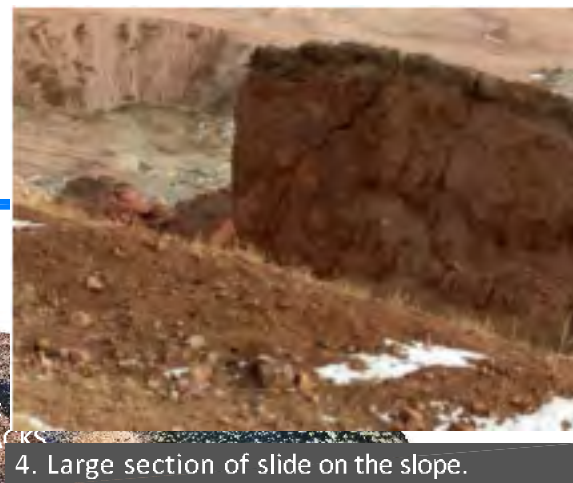
- Larger pieces of the slide continue break down and break away into smaller pieces. (Photo 4)
- Previously Observed Cracks: Previously observed tension cracks remain on the production floor and at the crest of fill slopes. These cracks appeared the same as in previous inspections.

4. Large section of slide on the slope.

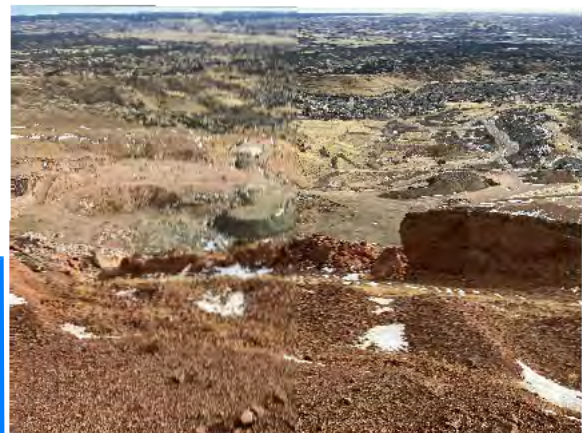
- Riprap continues to be produced on the production floor.
- Fill material continues to be delivered to the central location on the production floor where it is temporarily placed. (Photos 3 and 7)

3. Topsoil stockpiles on the right and fill on the left.

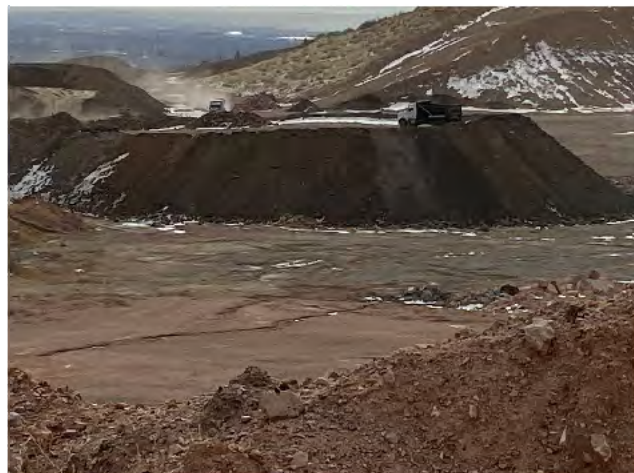
7. Fill material is dumped here then pushed by dozer.

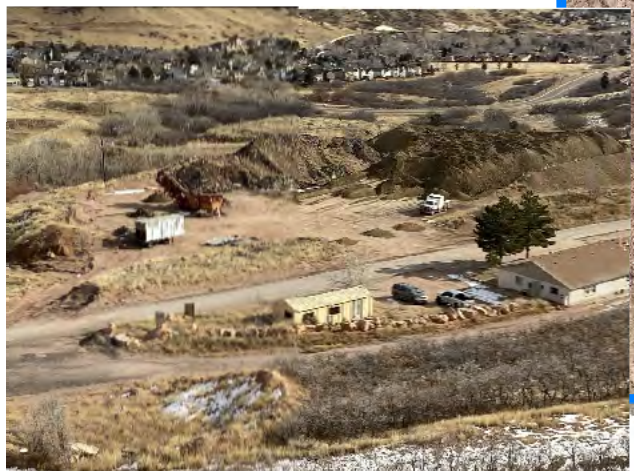
- Topsoil is being delivered to site and placed in four locations on site for future use. (Photos 1 and 8)
- The main topsoil stockpile located at the top of the access road ramp is receiving most of the material. After it is dumped here it is pushed by a loader. (Photo 2)

8. Topsoil stockpiled across from the scale house.

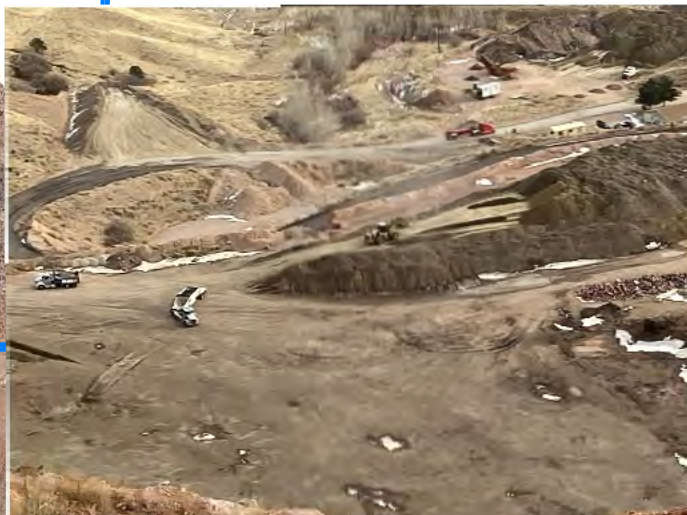
2. Topsoil stockpile at top of ramp being pushed by loader.

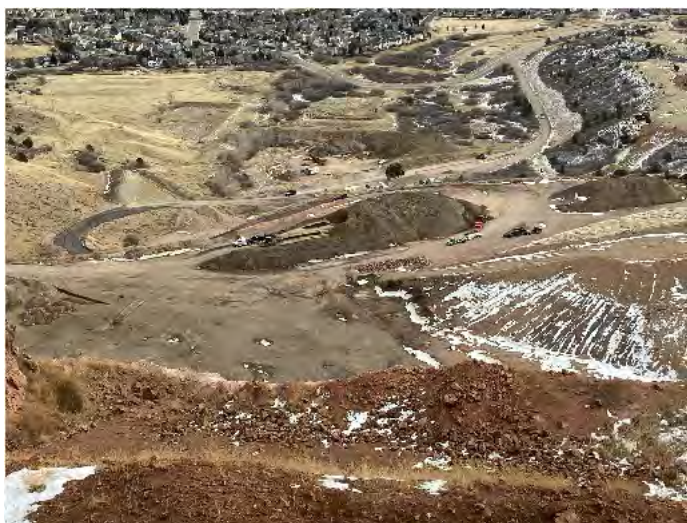
1. Topsoil is delivered to four locations on site.

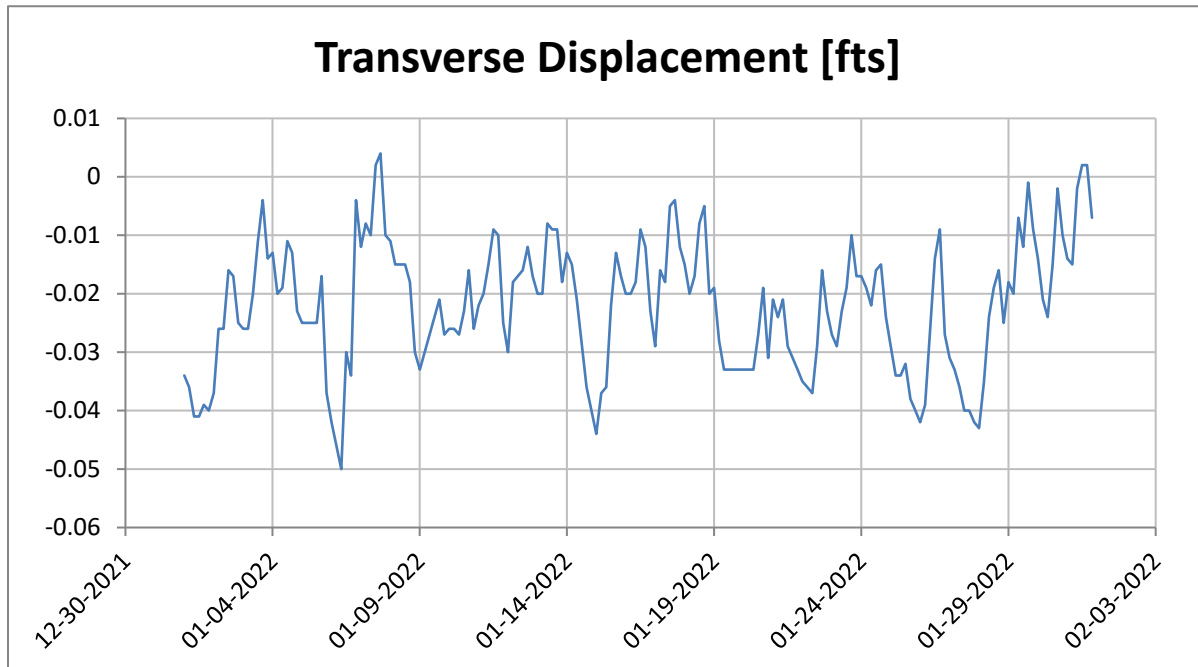
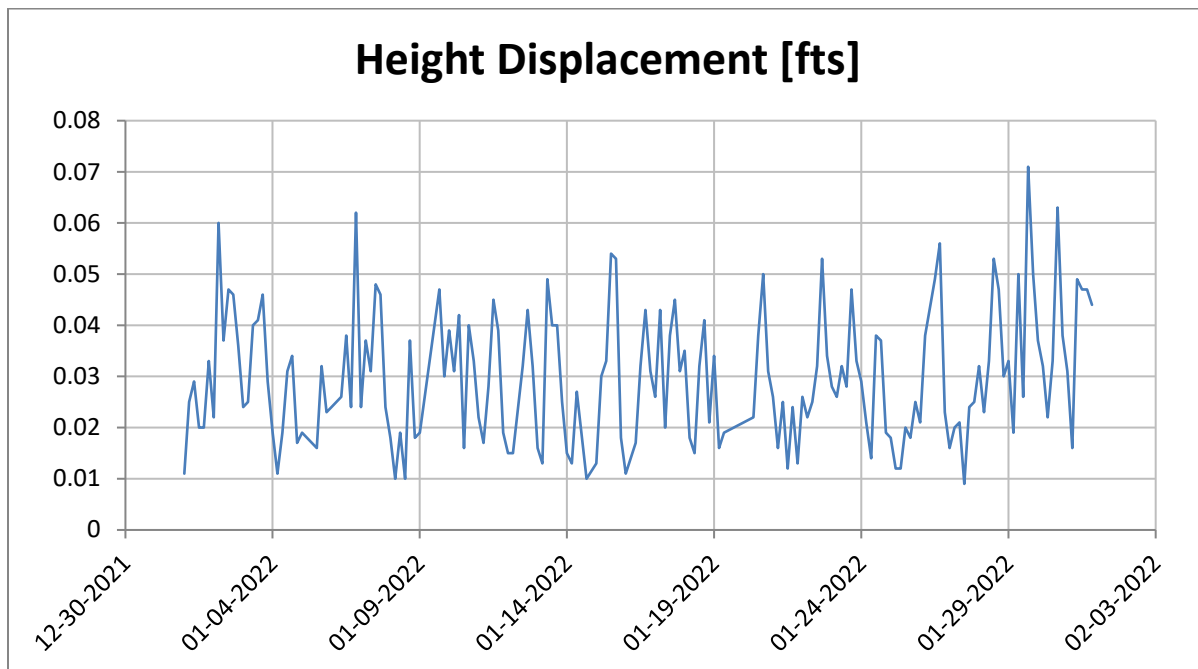
The data show stable conditions with no movement for 15 of 20 prisms with recorded displacements limited to data scatter and not actual movements. As discussed above, Prism P25 was displaced by wildlife on January 11, 2022. There were no signs of movement in the areas of these prisms, and there were signs of wildlife in the area. Prisms P63 and TOE3 are located at the toe of the landslide, and these locations showed slope creep movements at slow velocities. Prisms NP2 and NP66 are located above the landslide, and these prism also recorded slope creep movements at slow velocity. This settlement is likely related to the landslide material consolidating under its own weight. Plots of the transverse and height displacements for each prism are included in Appendix B.

1. Survey accuracy is ± 0.016 feet.
2. Alarm threshold is ± 0.35 feet.
3. Transverse displacement is in the horizontal direction. Positive direction means closer to the robotic station.
4. Height displacement is in the vertical direction. Positive direction means higher in elevation.
5. Alarm recorded on January 11, 2022. Attributed to wildlife in the area.

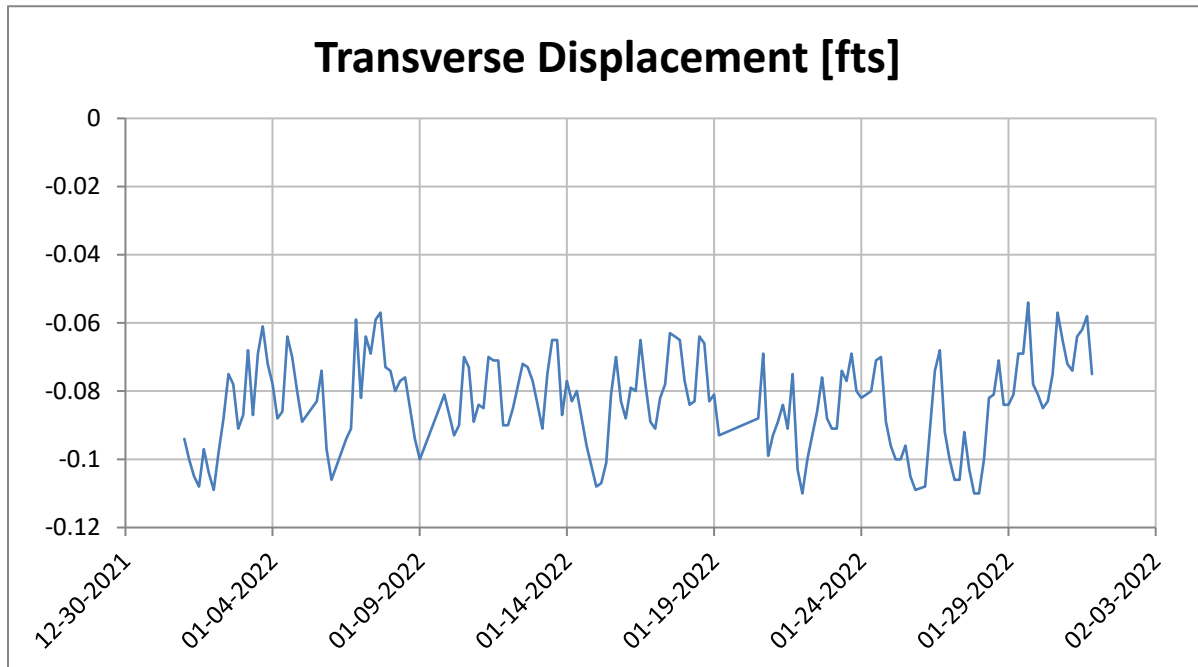
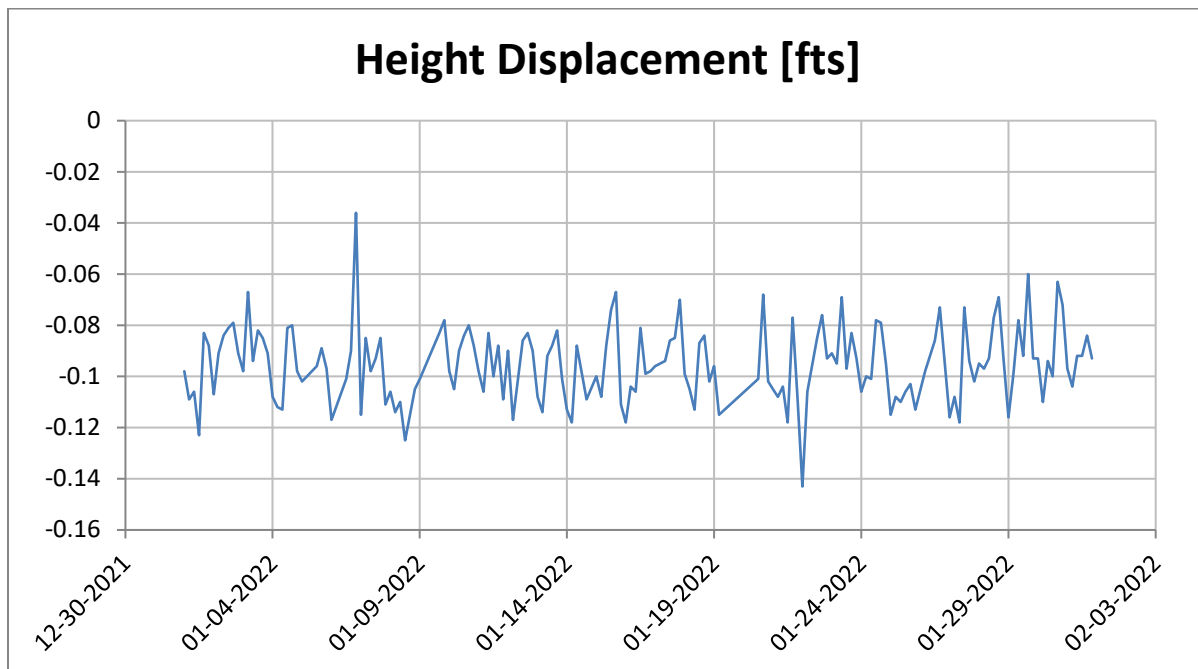
Prism P32

1. Survey accuracy is +/-0.016 feet.
2. Alarm threshold is +/-0.35 feet.
3. Transverse displacement is in the horizontal direction. Positive direction means closer to the robotic station.
4. Height displacement is in the vertical direction. Positive direction means higher in elevation.
5. Alarm recorded on January 6, 2022. Assumed to be data error from inclement weather.

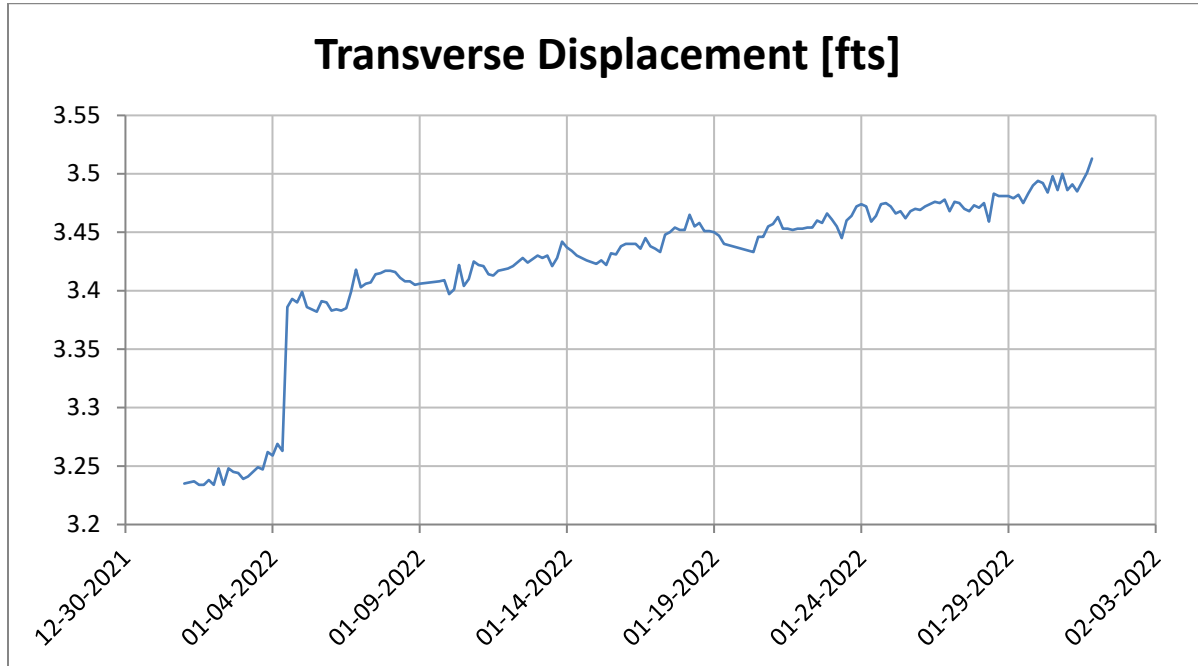
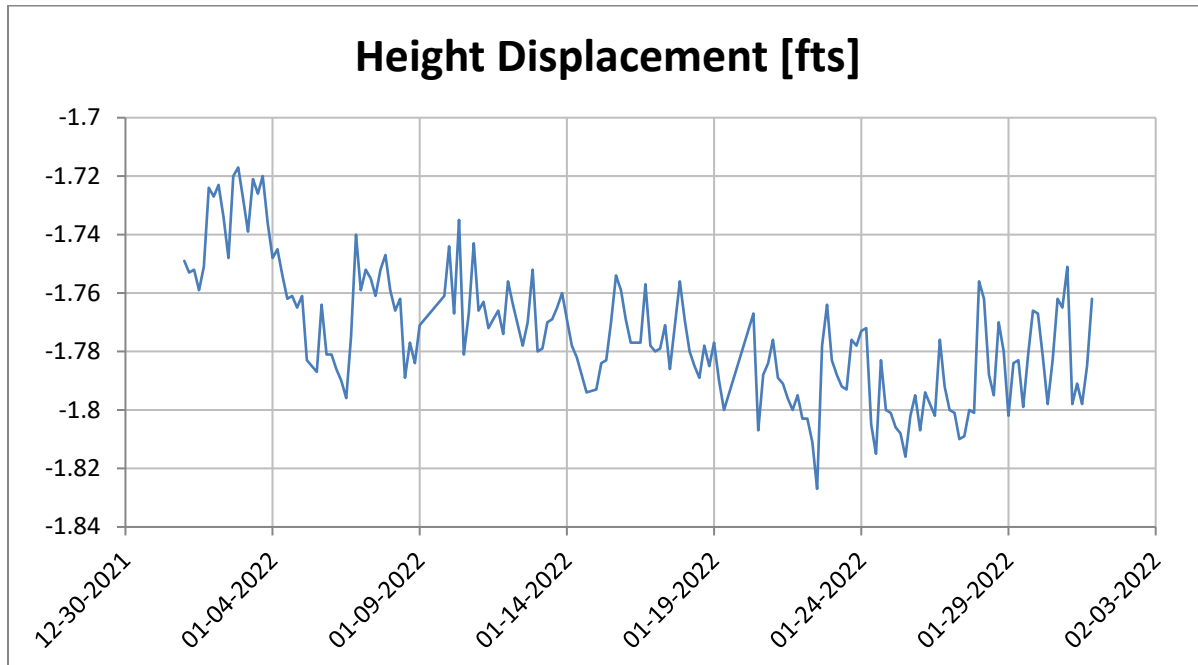
Prism TOE3

1. Survey accuracy is ± 0.016 feet.
2. Alarm threshold is ± 0.35 feet.
3. Transverse displacement is in the horizontal direction. Positive direction means closer to the robotic station.
4. Height displacement is in the vertical direction. Positive direction means higher in elevation.
5. Prism located at toe of slide where ongoing slope creep movements at slow velocity are expected.

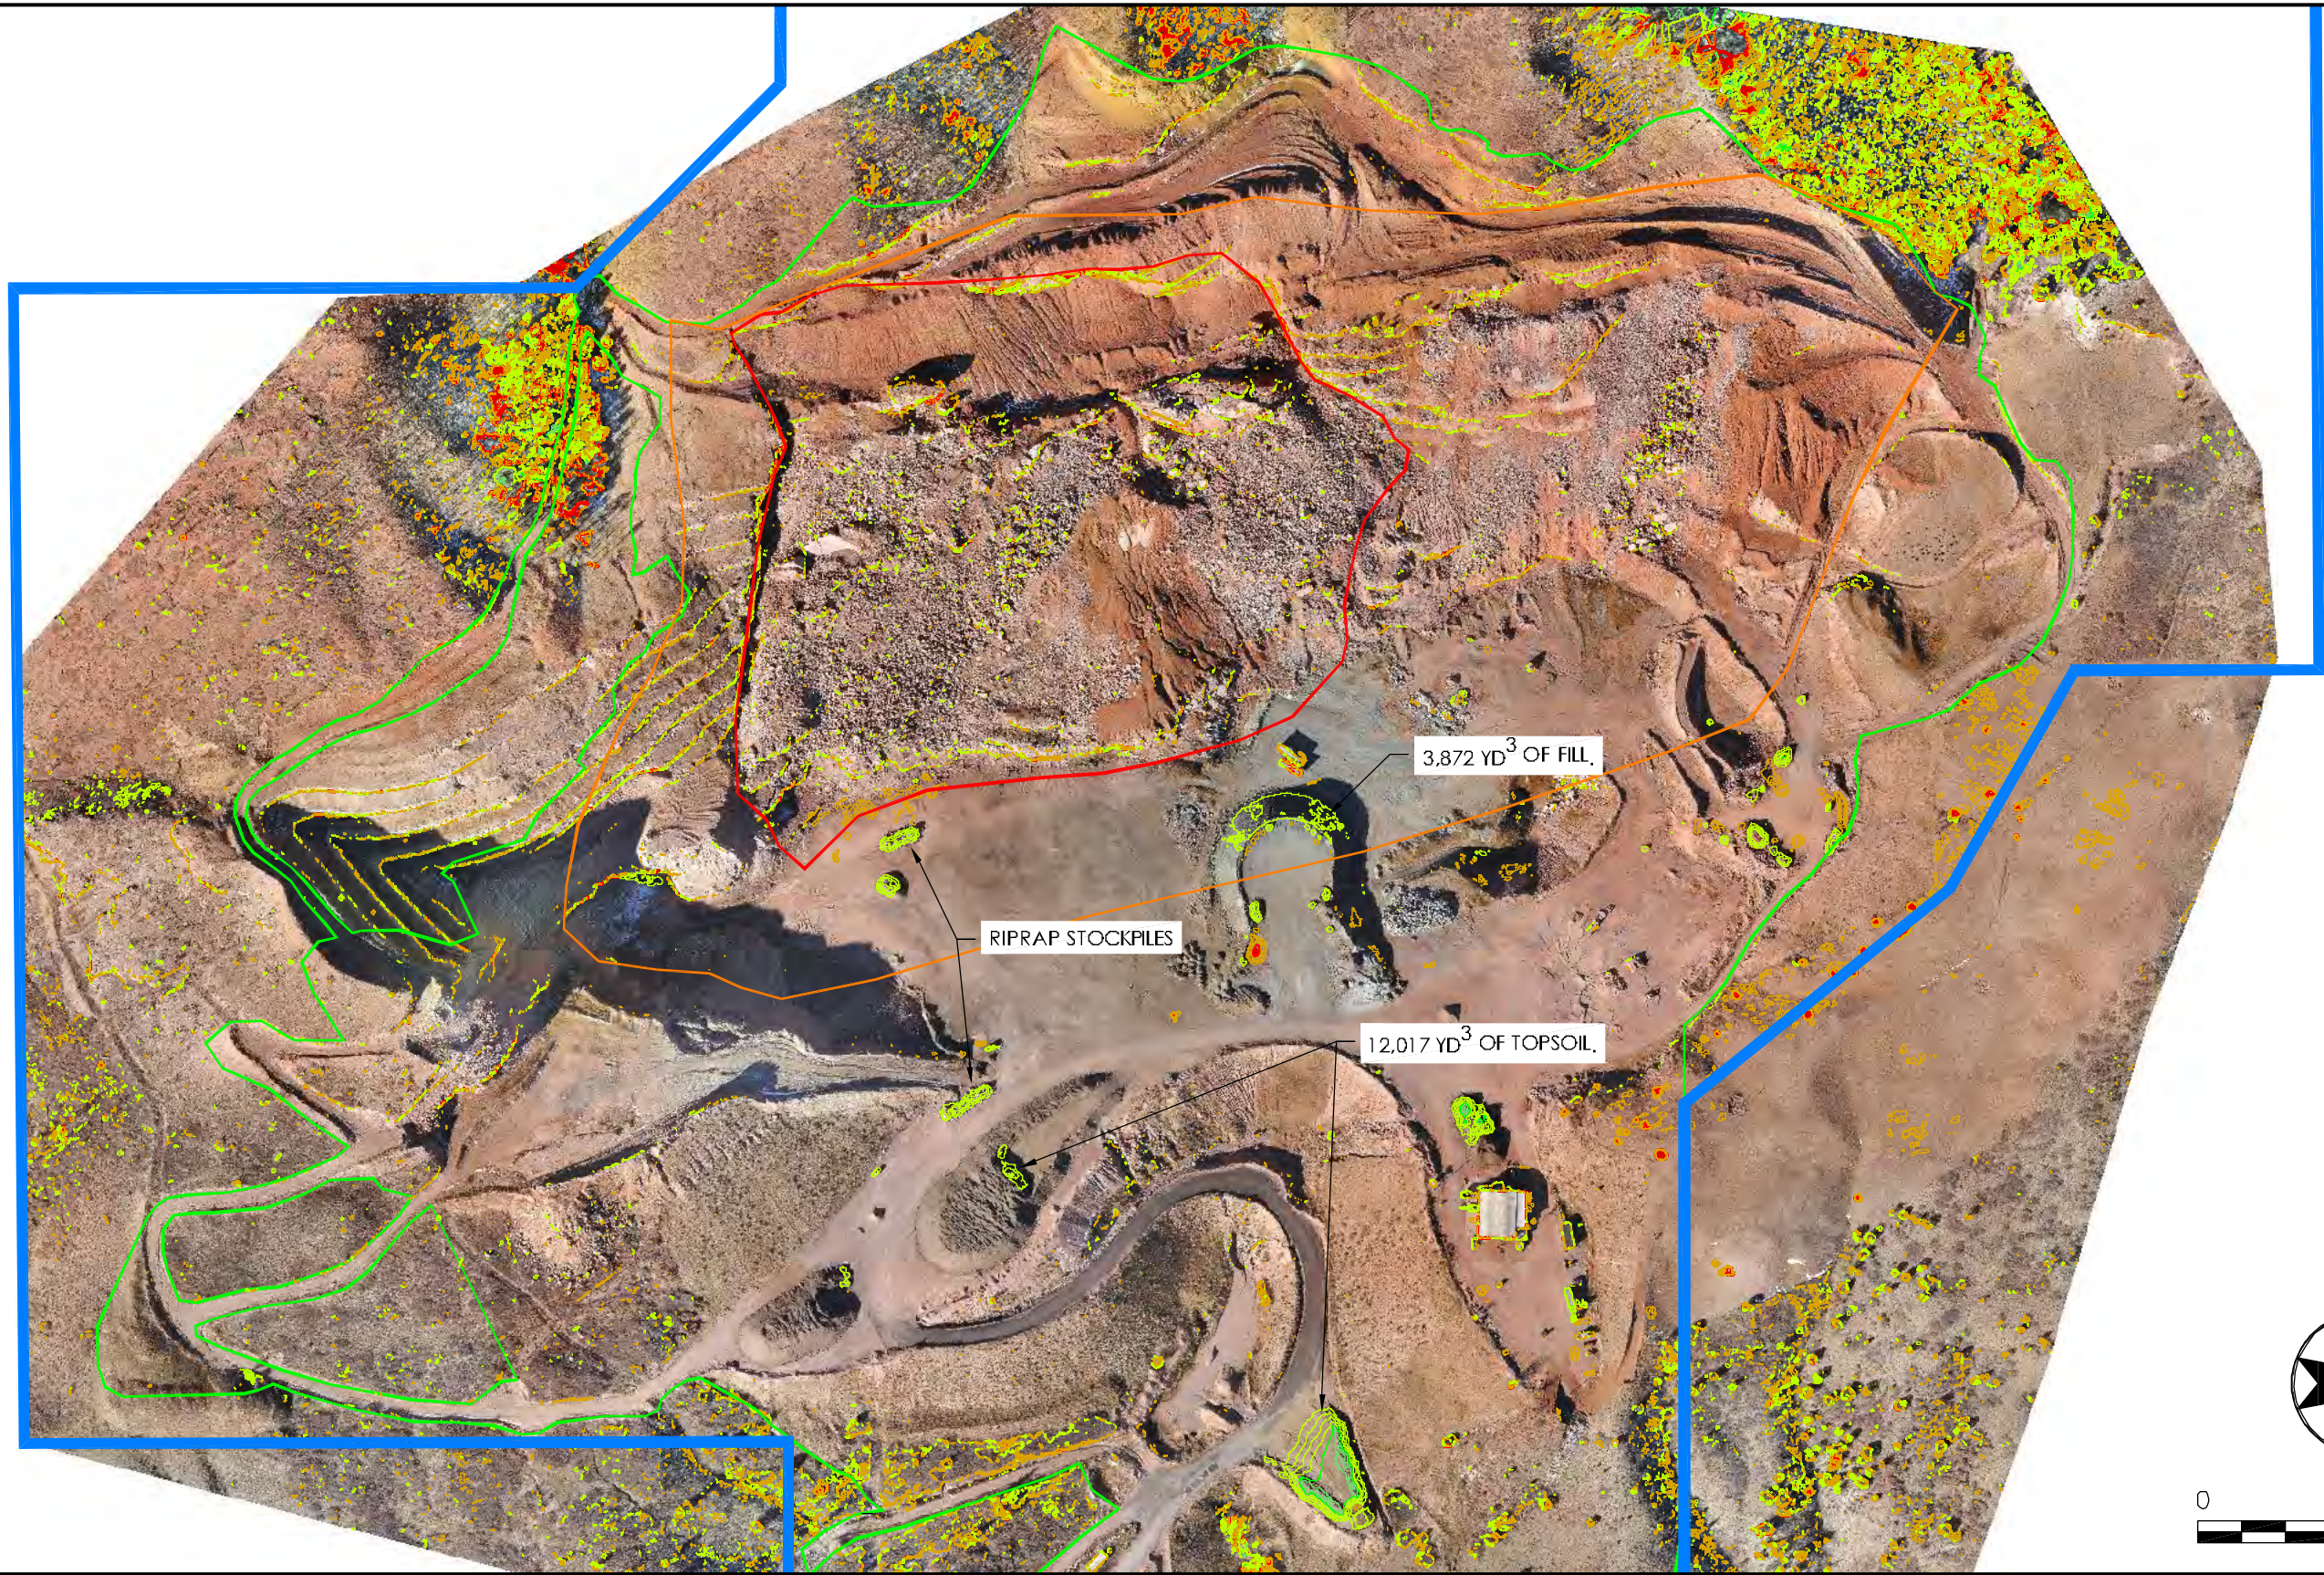
The December topography was also compared to the January topography to identify changes in the site topography. Comparison of the two surveys showed that approximately 3,872 yd³ of fill had been imported and temporarily placed on the stockpile near the top of the ramp. Additionally, 12,000 yd³ of topsoil were imported for a total of approximately 60,000 yd³ of topsoil stockpiled onsite. No slope movements or other changes in topography were identified. The current imagery and topography are included in Figures 1 and 3, and the comparison surface is included as Figure 5 in Appendix C.

As previously reported in the September 2020 monitoring report, there are limitations with the method of comparing drone surveys from different months. The drone data indicate changes in the slopes along each of

the reclamation benches, buildings, and areas with trees or shrubs. These areas are stable, and the changes are the result of survey limitations on or near vertical slopes.
