**MINERALS PROGRAM INSPECTION REPORT**  
**PHONE: (303) 866-3567**

<b>MINE NAME:</b> Cresson Project	<b>MINE/PROSPECTING ID#:</b> M-1980-244	<b>MINERAL:</b> Gold	<b>COUNTY:</b> Teller
<b>INSPECTION TYPE:</b> Monitoring	<b>INSPECTOR(S):</b> Elliott Russell	<b>INSP. DATE:</b> January 27, 2022	<b>INSP. TIME:</b> 10:00
<b>OPERATOR:</b> Cripple Creek & Victor Gold Mining Company	<b>OPERATOR REPRESENTATIVE:</b> Katie Blake	<b>TYPE OF OPERATION:</b> 112d-3 - Designated Mining Operation	
<b>REASON FOR INSPECTION:</b> Normal I&E Program	<b>BOND CALCULATION TYPE:</b> None	<b>BOND AMOUNT:</b> \$209,491,188.00	
<b>DATE OF COMPLAINT:</b> NA	<b>POST INSP. CONTACTS:</b> None	<b>JOINT INSP. AGENCY:</b> None	
<b>WEATHER:</b> Snowing	<b>INSPECTOR'S SIGNATURE:</b>

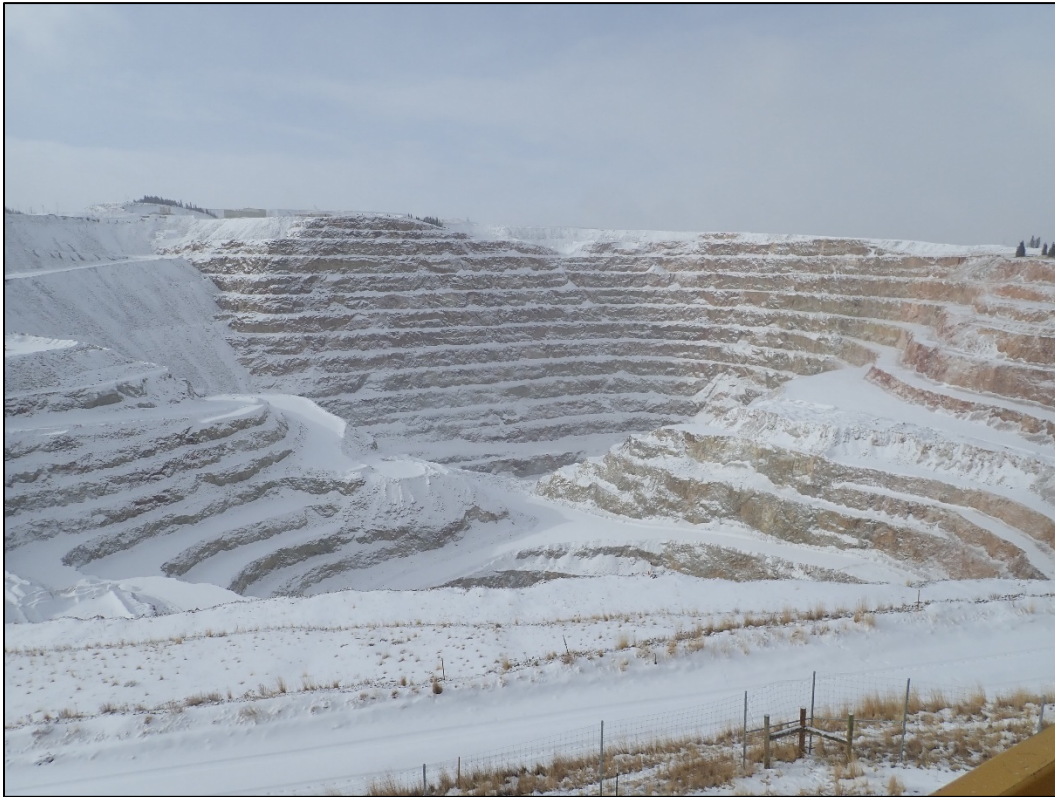
The Division arrived to the site ahead of schedule and observed the WHEX Pit and western portion of the East Cresson Overburden Storage Area (ECOSA) from the Grassy Valley Overlook along CR82 (see **Photo 1** and **Photo 2**).

**Photo 1.** WHEX Pit as viewed from the Grassy Valley Overlook along CR82; looking southwest.

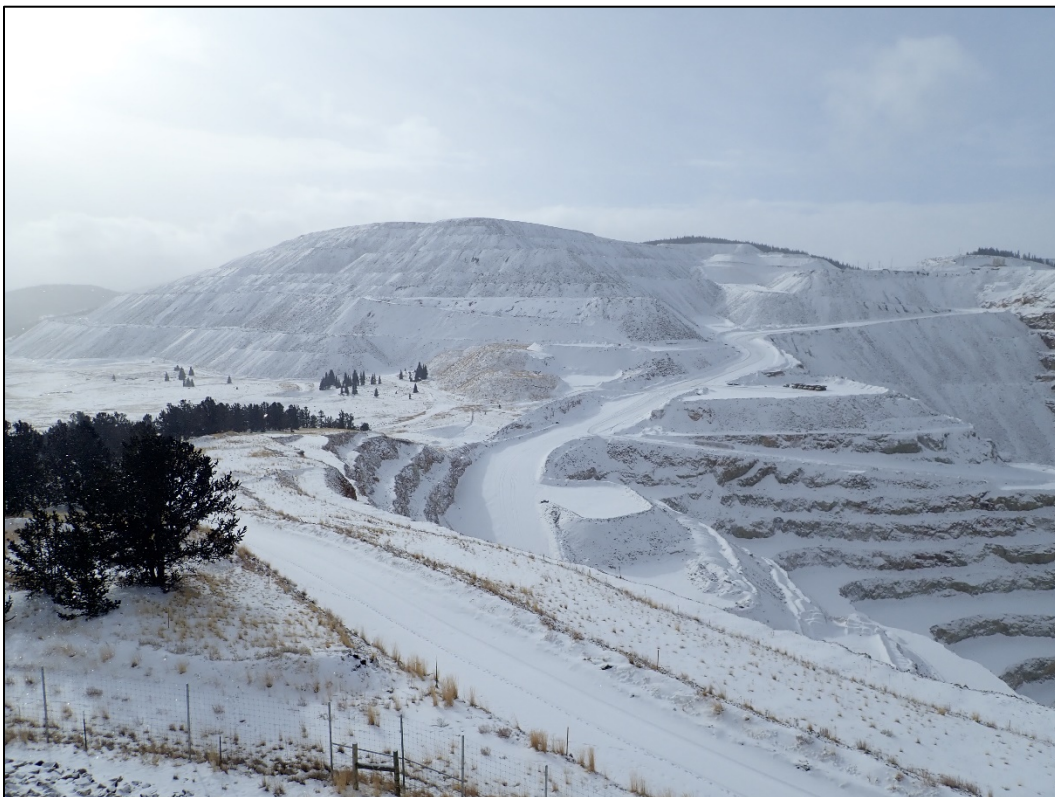
**Photo 2.** Western portion of the ECOSA as viewed from the Grassy Valley Overlook along CR82; looking southeast.

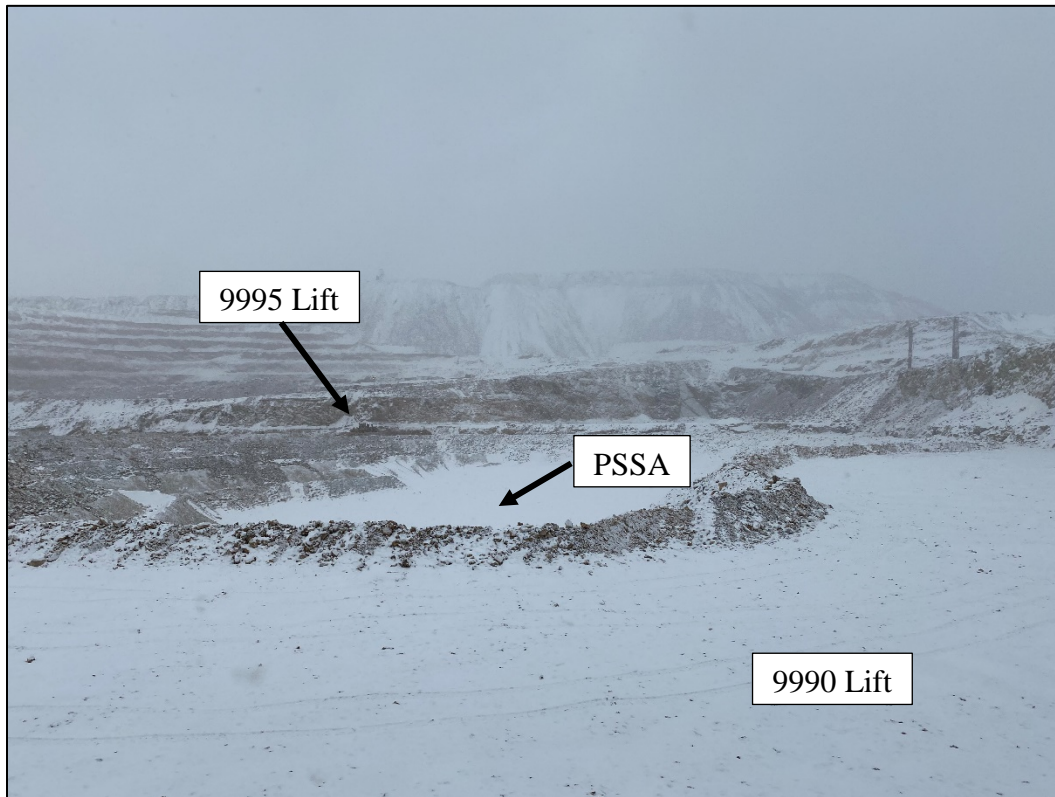
The Operator accompanied the Division to an area above the west highwall of the Schist Island Pit to observe the progress of backfill operation (see **Photo 3**). As approved in Amendment 13, the Schist Island Pit will be backfilled to allow the construction of the Phase 3 of VLF 2, including an additional Pregnant Solution Storage Area (PSSA). The Division met with Tyler Wendlandt with Newfields, the third-party Engineer of Record (EoR) who was observing and certifying placement of material and the lifts of the backfill. The Operator was currently placing material on the 9995 lift level as a part of the high compaction backfill zone. All placed material observed from the overlook appeared to be less than the maximum allowed 24-inch specification. The PSSA was starting to take shape as the 5-foot lifts have been placed around the PSSA footprint. The bottom of the PSSA is at the 9940 lift level. The EoR explained that the lifts are currently being overbuilt slightly into the PSSA area whereas upon completion of backfilling activities, approximately 100,000 tons of material will need to be removed to complete the final grading of the PSSA. This ensures the all of the material adjacent to the future geomembrane has been adequately compacted to the approved specification as compared to a cut/fill approach to achieve the final grading where material on the final slopes would need to be compacted again.

**Photo 3.** Schist Island Pit overview, bulldozer working on the 9995 backfill lift; looking east.

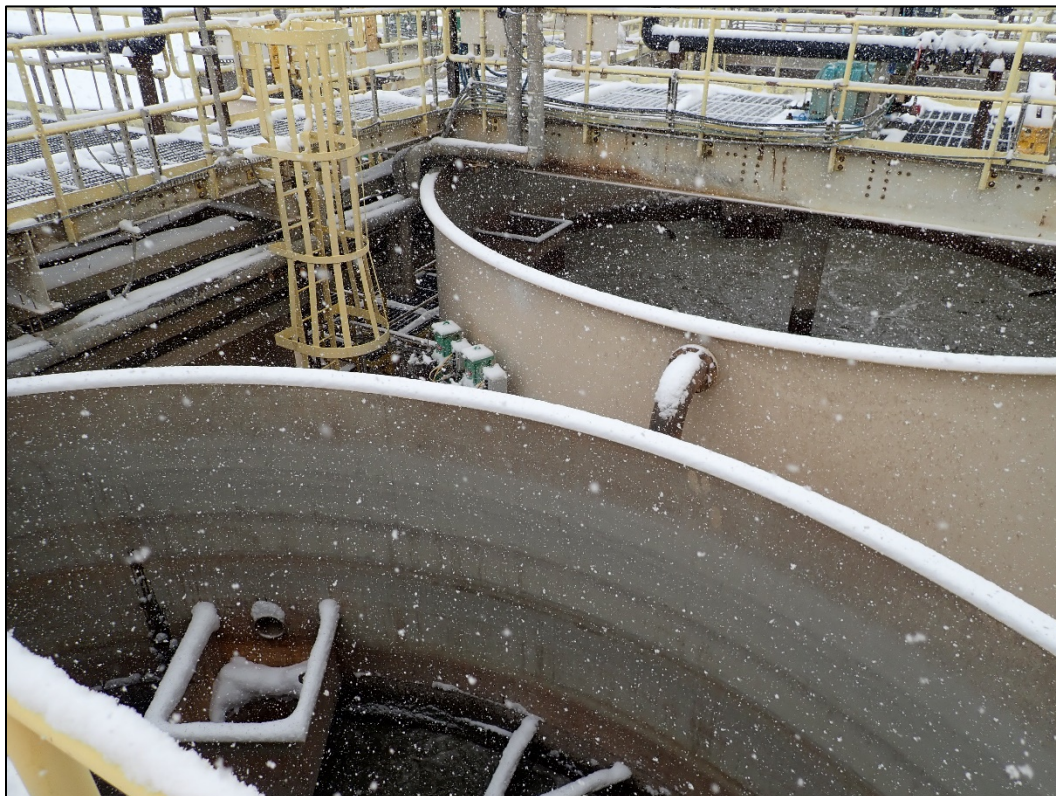
**Photo 4.** Natural pH Process Water within the vat leach tanks on the west side of the mill; looking north.

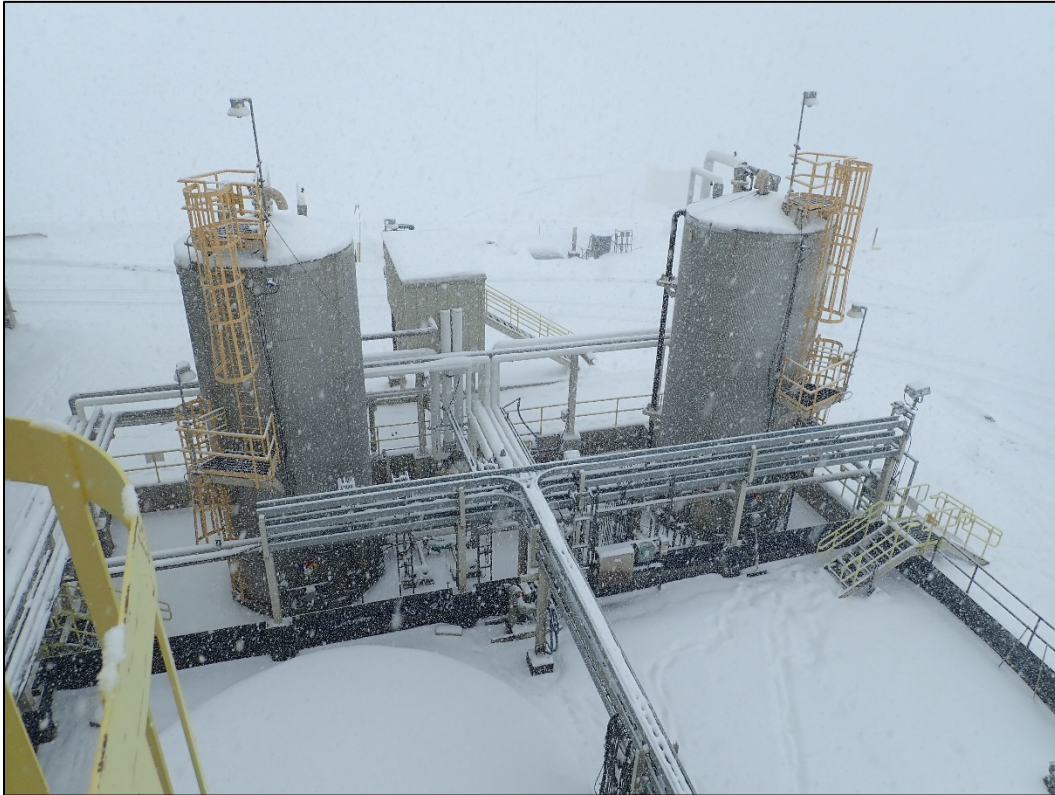
**Photo 5.** Empty Cyanide storage tanks on the west side of the mill; looking south.

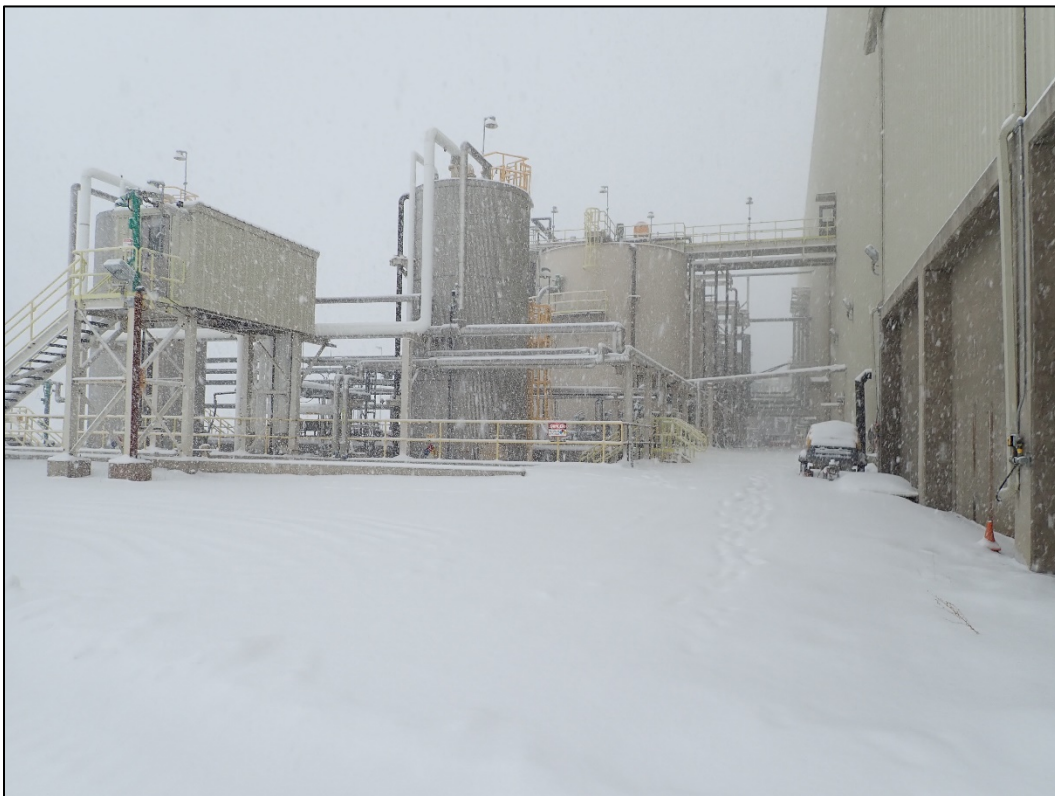
**Photo 6.** West side of HGM; looking north.

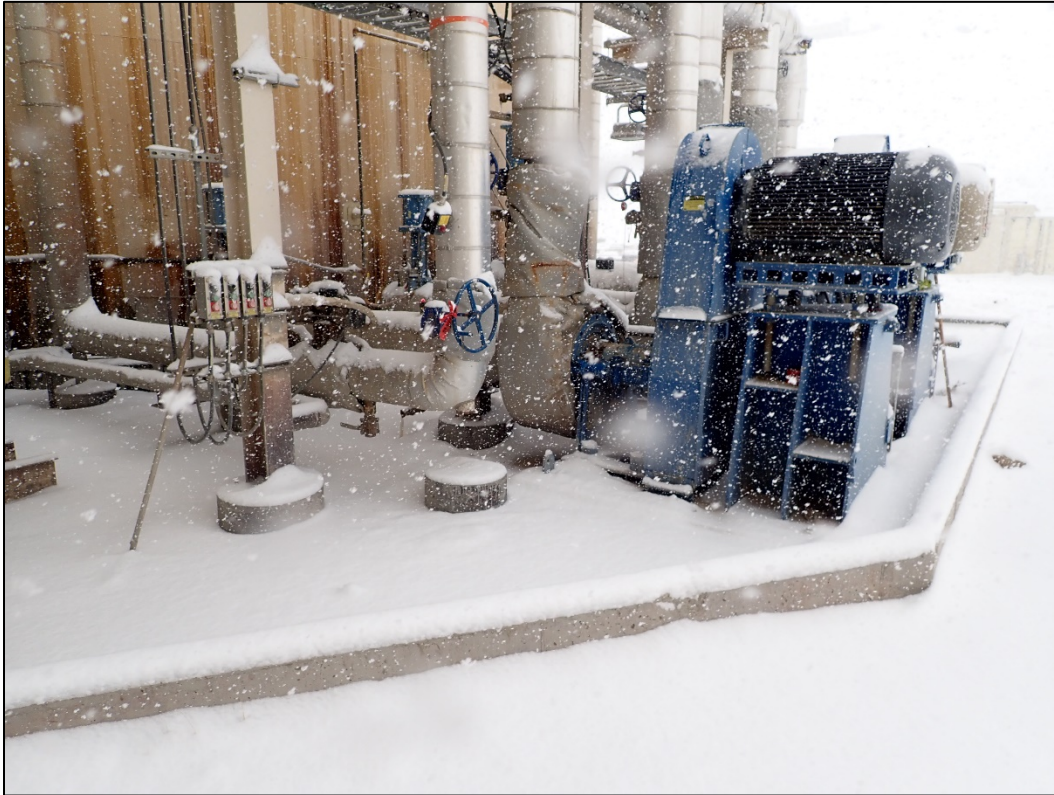
**Photo 7.** Neutral pH Process Water Tank curbing on the east side of the HGM; looking east.

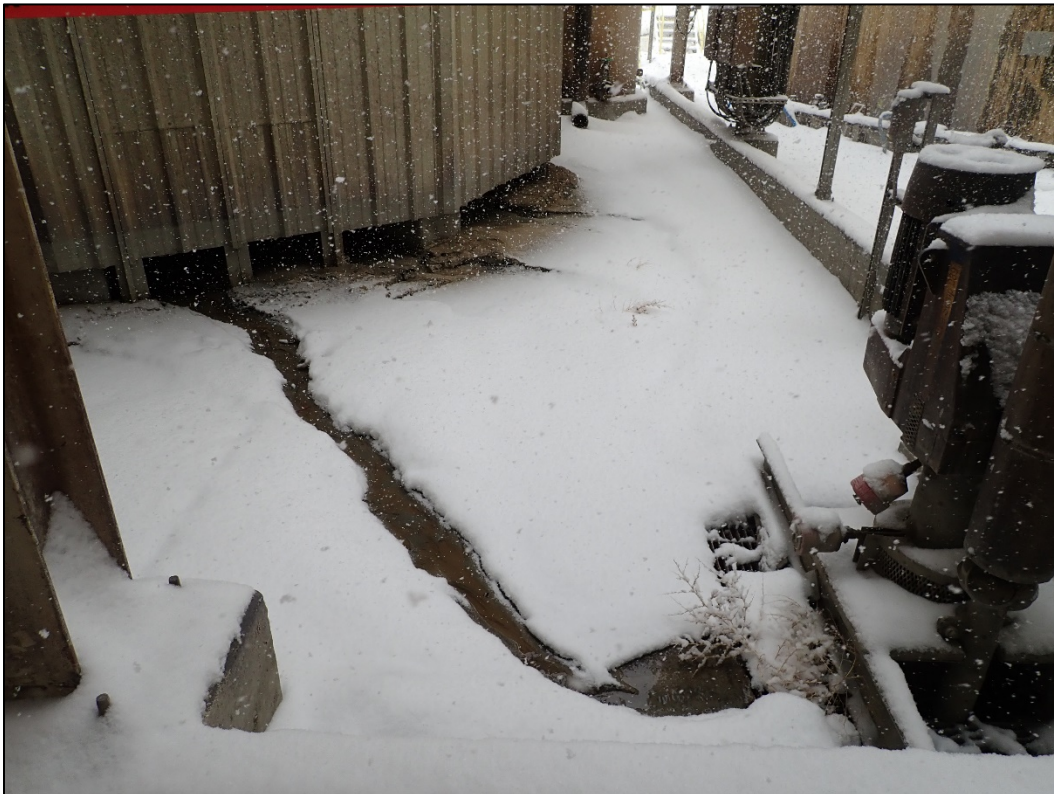
**Photo 8.** High pH Thickener curbing on the east side of the HGM; looking east.

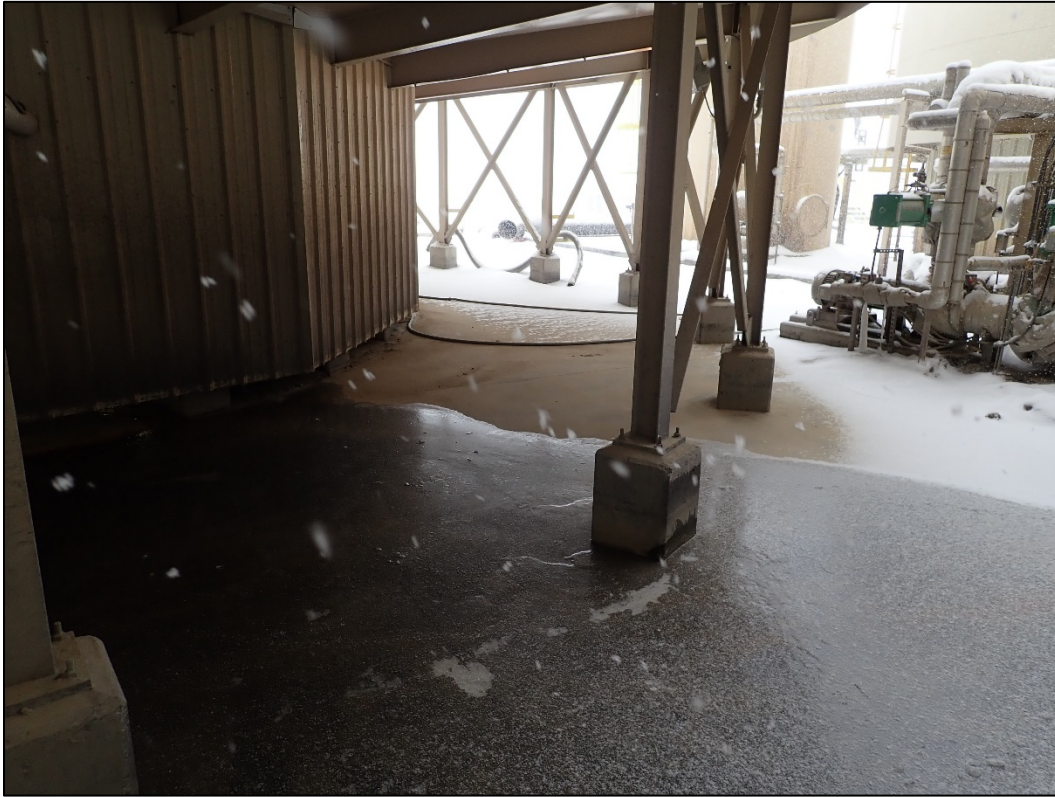
**Photo 9.** Processed Ore Thickener curbing on the east side of the HGM; looking southeast.
