COLORADO
Division of Reclamation,
Mining and Safety
Department of Natural Resources

Permit Number: C-1981-041 Mine Name: Roadside Portals Operator: Snowcap Coal Company, Inc. Operator Address: MS Tonya Hammond P.O. Box 1430 Palisade, CO 81526	County: Mesa Operation Type: Underground Permit Status: Active Ownership: Private
	Operator Representative Present: Tonya Hammond
Operator Representative Signature: (Field Issuance Only)

Inspection Start Date: February 25, 2022 Inspection Start Time: 09:35 Inspection End Date: February 25, 2022 Inspection End Time: 10:00		Inspection Type: Coal Partial Inspection Inspection Reason: Normal I&E Program Weather: Clear	
Joint Inspection Agency: None		Joint Inspection Contacts: None	
Post Inspection Agency: None		Post Inspection Contacts: None	
Inspector(s): Clayton Wein	Inspector's Signature: <i>Clayton Wein</i>		Signature Date: 2/28/2022

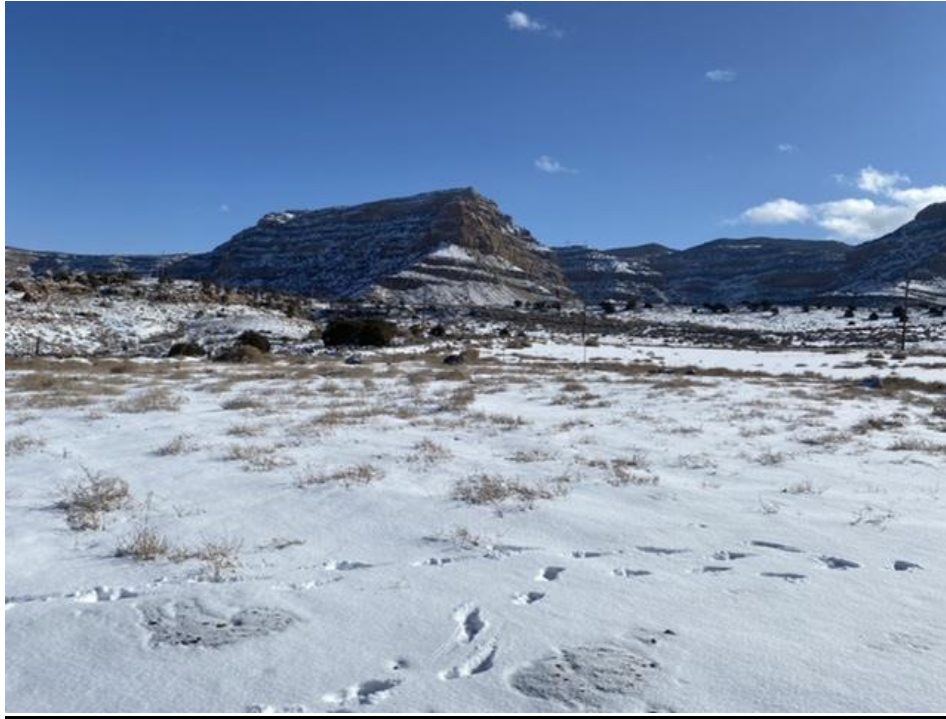
The remaining disturbed area at the Roadside Mine is approximately 0.4 acres located in the southwestern portion of the permit area, on Tract 71. This area is associated with the work conducted under Technical Revision No. 69 (TR-69). The site was completely covered with snow at the time of the inspection (Photos 1 and 2). There were no indications of instability or erosion. The Disturbed boundary markers were identified at the site. There is a mine ID sign located on a t-post at the entrance to the site from the access road. The sign had fallen off of the post but was located next to the post. The sign will be mounted to the post again. The sediment logs on the lower contours of the site were intact and covered with snow. There were no indications of off-site impacts.

Photo 1: The eastern portion of the 0.4 acres of disturbed area.

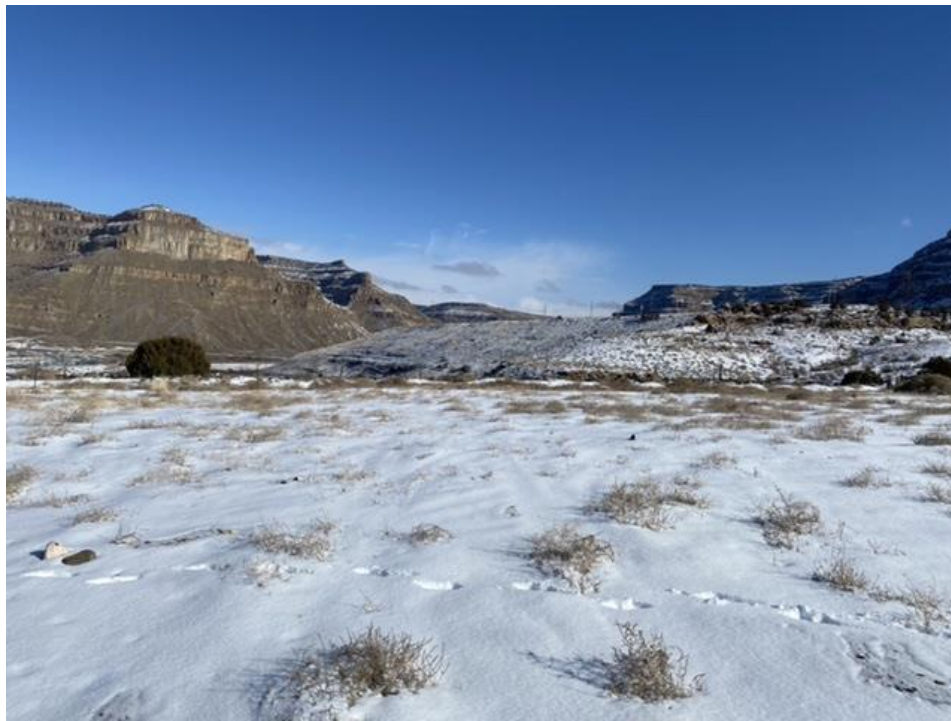
Photo 2: The central portion of the TR-69 Repair Area.
