COLORADO
Division of Reclamation,
Mining and Safety
Department of Natural Resources

Permit Number: C-1982-056 Mine Name: Foidel Creek Mine Operator: Twentymile Coal, LLC Operator Address: Ms Miranda Kawcak 29515 Routt County Road No. 27 Oak Creek, CO 80467	County: Routt Operation Type: Underground Permit Status: Active Ownership: Private
	Operator Representative Present: Miranda Kawcak
Operator Representative Signature: (Field Issuance Only)

Inspection Start Date: February 23, 2022 Inspection Start Time: 09:00 Inspection End Date: February 23, 2022 Inspection End Time: 13:00		Inspection Type: Coal Partial Inspection Inspection Reason: Normal I&E Program Weather: Snowing	
Joint Inspection Agency: None		Joint Inspection Contacts: 	
Post Inspection Agency: None		Post Inspection Contacts: 	
Inspector(s): Tabetha Lynch	Inspector's Signature:  		Signature Date: 2/28/22

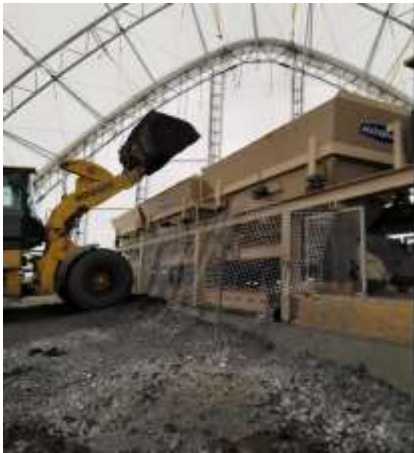
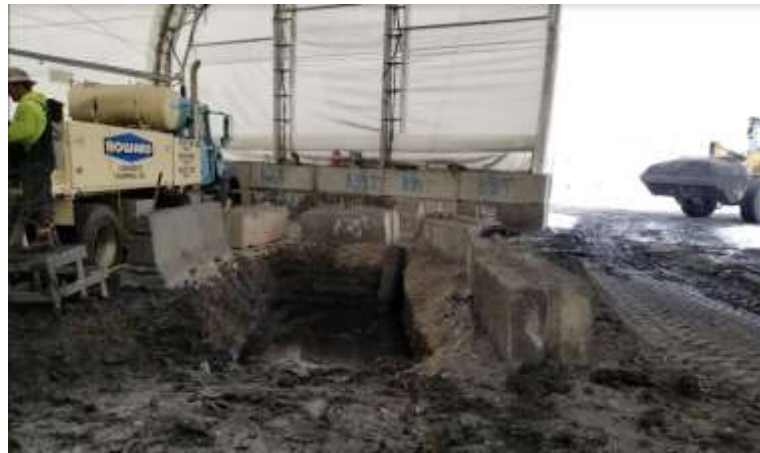
At the time of inspection a grout was being mixed at the 7E cement drop pad. Fly ash trucks were hauling ash to the pad for the mixture. The grout/cement mixture will ultimately be mined out as the longwall passes through. Photos below of the work at the 7E pad.

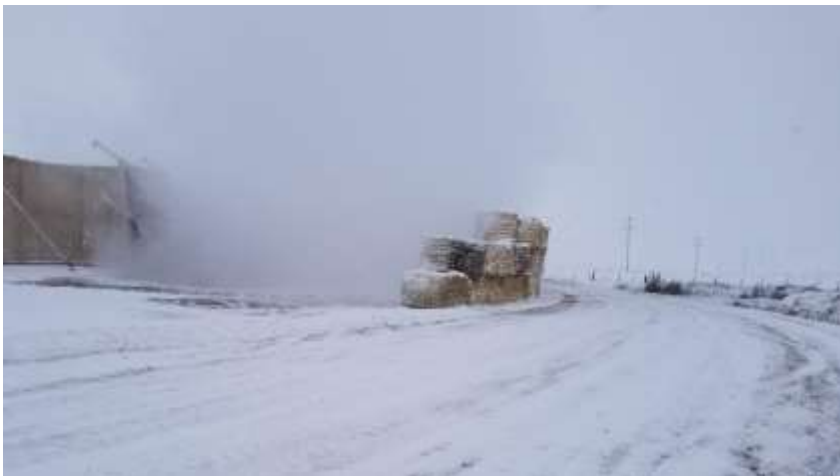
Active roads were well plowed. Stream buffer signs and barrier were in place at the facilities area. Ponds were mostly snow and ice covered. Straw bales have been placed between the vent fan output and the access road to the ventilation pad. The water air was creating a visibility issue for traffic on the access road. Per the operator the bales are weed free straw. Shown below.
