MINERALS PROGRAM INSPECTION REPORT
PHONE: (303) 866-3567

MINE NAME: Climax Mine	MINE/PROSPECTING ID#: M-1977-493	MINERAL: Molybdenum	COUNTY: Lake, Summit
INSPECTION TYPE: Monitoring	INSPECTOR(S): Lucas West	INSP. DATE: February 28, 2022	INSP. TIME: 10:32
OPERATOR: Climax Molybdenum Company	OPERATOR REPRESENTATIVE: Diana Kelts	TYPE OF OPERATION: 112d-3 - Designated Mining Operation	
REASON FOR INSPECTION: Normal I&E Program	BOND CALCULATION TYPE: None	BOND AMOUNT: \$91,011,850.00	
DATE OF COMPLAINT: NA	POST INSP. CONTACTS: None	JOINT INSP. AGENCY: None	
WEATHER: Clear	INSPECTOR'S SIGNATURE:

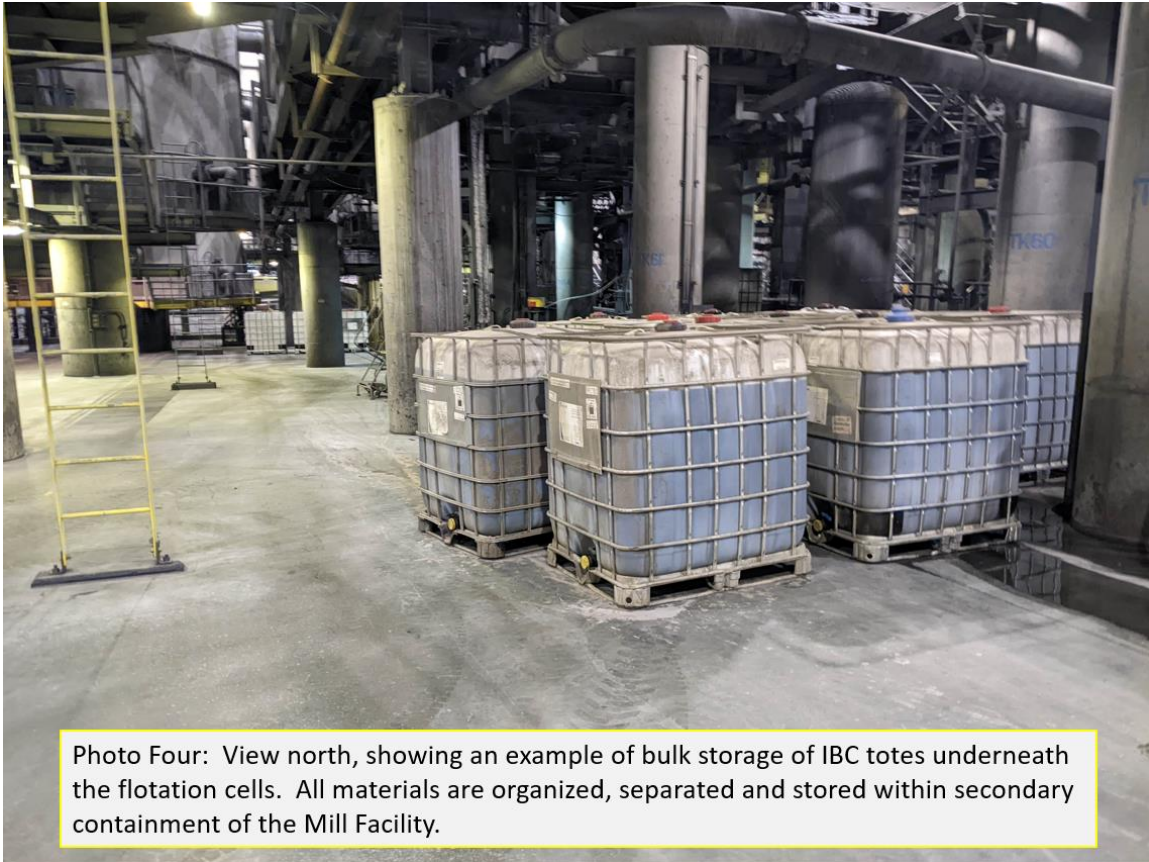
Located below the flotation cells within the Mill Facility, various chemicals are stored in IBC totes. The materials stored in this area range from chemical deicer to flocculants and various other items. An example of the bulk storage can be seen in Photo Four. All items stored in this area are neat and well kept, separated and clearly labeled. Secondary containment for these chemicals is achieved by the greater secondary containment of the Mill Facility and appears to be more than adequate.

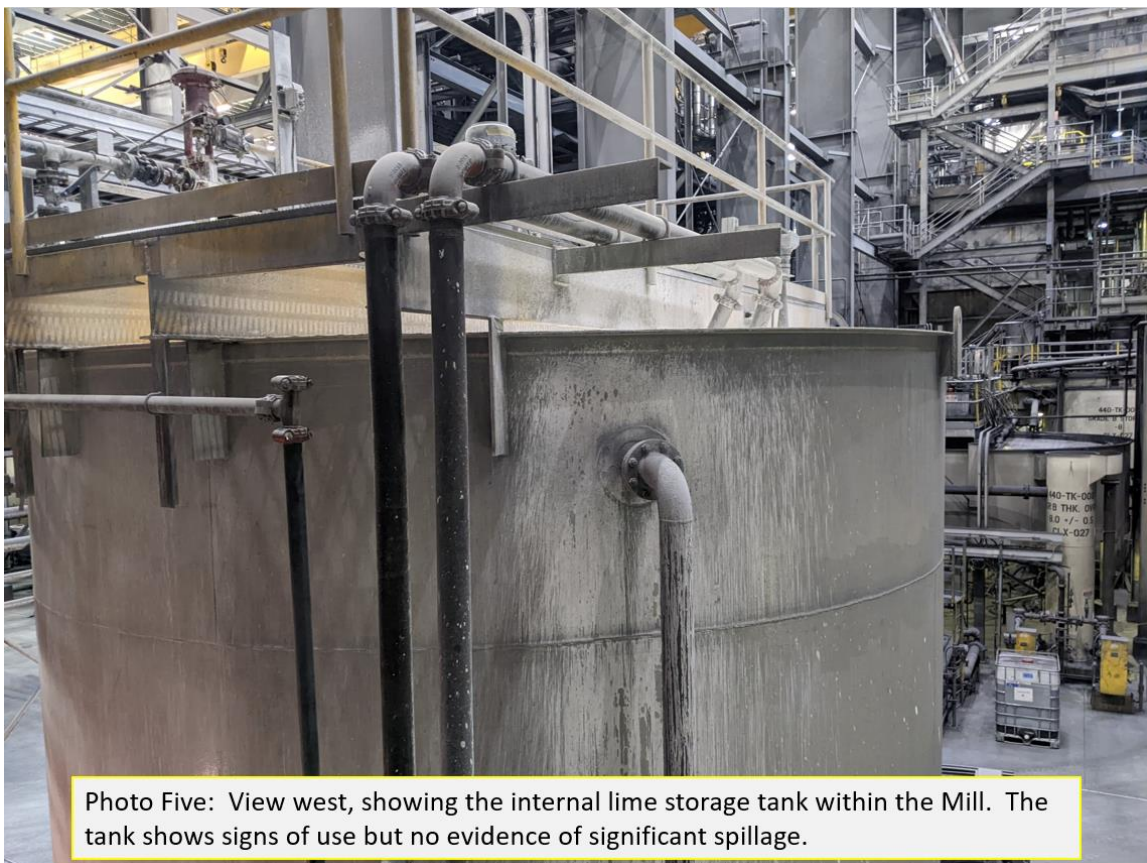
Concentrated lime storage is achieved in two locations of the Mill Facility. The internal lime storage tank which is connected to the mill feed lines, and the bulk lime storage silo located just outside the Mill Building. The internal lime storage tank can be seen in Photo Five. Evidence of use and lime scaling was observed around the tank, which is consistent with normal operations. No evidence of significant spillage was observed, and because the tank is located within the Mill Facility, secondary containment is achieved through the greater secondary containment of the Mill Facility. The external lime storage silo was also observed to be in excellent condition and can be seen in Photo Six. No evidence of spillage or lime scaling was observed on or around the silo. Secondary containment for the silo is achieved by the pads surrounding the Mill Facility that would contain any possible spillage.

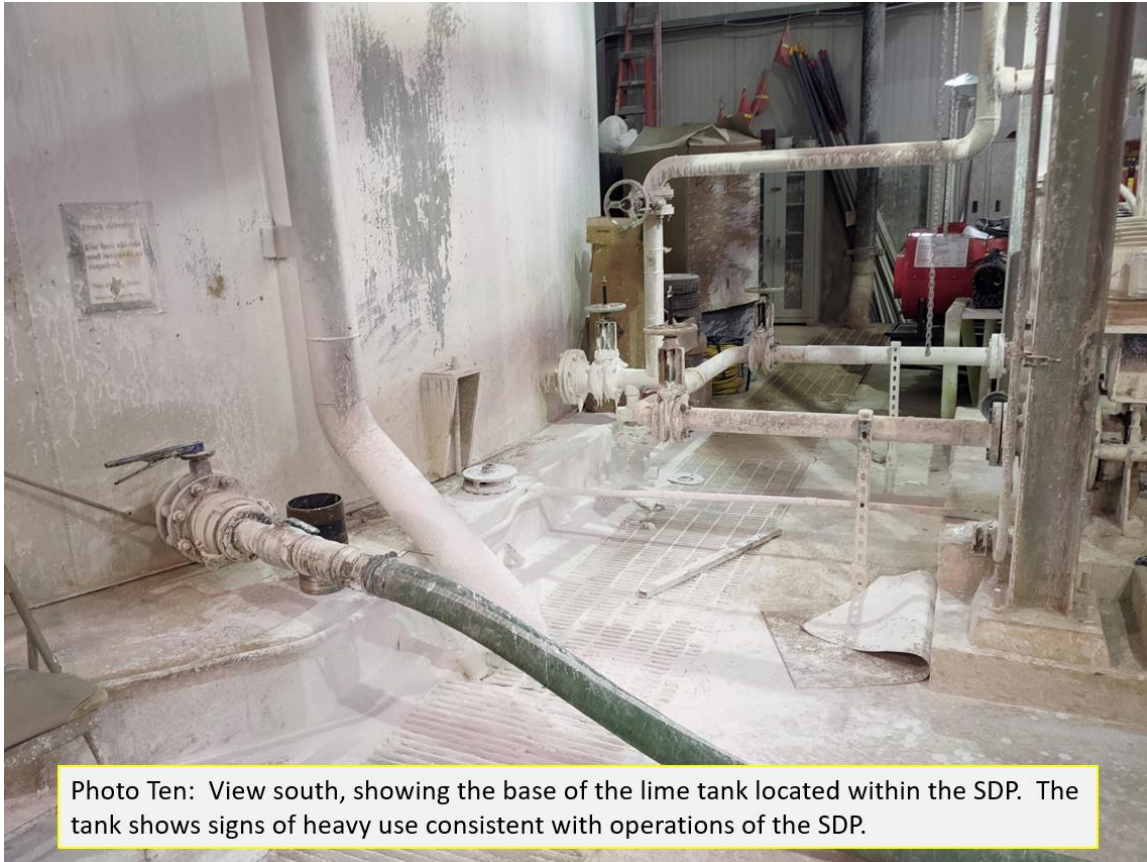
The lime slurry is directed to the SDP, where it is mixed with seepage water in a series of neutralization tanks. The neutralization tanks are large steel tanks set on concrete foundations with agitators and pumps to lower the pH. The tanks were not operating at the time of inspection, and all tanks appeared to be in excellent condition. An example of the tanks can be seen in Photo Ten. Once the target pH is achieved a polymer flocculent is added to assist in metals precipitation and the slurry pumped to the clarifier. The polymer flocculent is stored and mixed for use in the plant. The storage and mixing tanks can be seen in Photo Eleven. A small steel containment berm is located on the floor surrounding the tanks to contain minor spillage. No evidence of spillage was observed in that area.

Photo Ten: View south, showing the base of the lime tank located within the SDP. The tank shows signs of heavy use consistent with operations of the SDP.

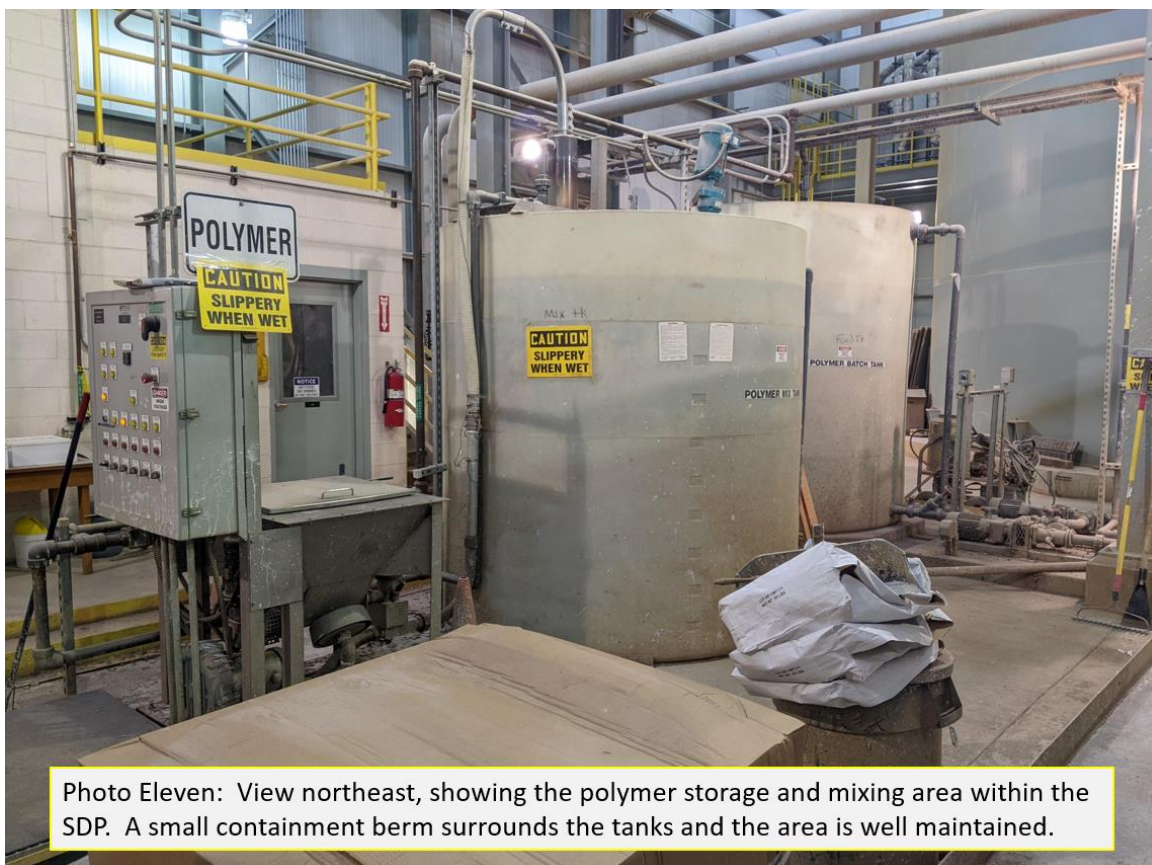
Photo Eleven: View northeast, showing the polymer storage and mixing area within the SDP. A small containment berm surrounds the tanks and the area is well maintained.

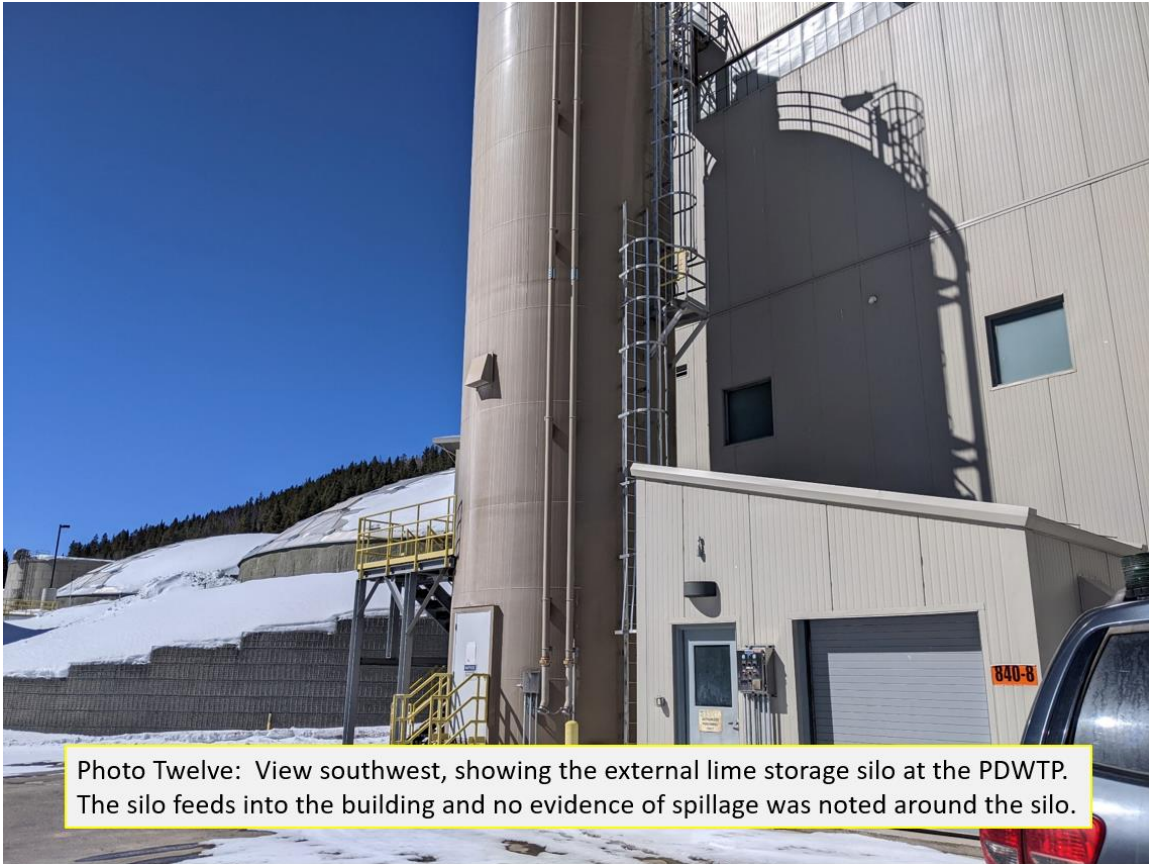
The Property Discharge Water Treatment Plant is located near the most down gradient area of the permit area and houses the final water treatment facility prior to discharge. Similar to the SDP, the facility contains a lime storage area used for pH adjustment during water treatment operations. The lime silo can be seen in Photo Twelve and is in excellent condition. The interior of the PDWTP contains several tanks where lime is mixed creating a slurry, mixed with process water, has polymer added for precipitation, and sent to the clarifiers for polishing prior to discharge. All tanks, reactors and mixing facilities are in excellent condition, the main facility is very well kept, clean neat and organized. The main facility has a series of troughs leading to main sump for secondary containment. A view of the troughs and tanks can be seen in Photo Thirteen. After water runs through the reactors and undergoes pH adjustment it is sent to the primary and secondary clarifiers.

Photo Twelve: View southwest, showing the external lime storage silo at the PDWTP. The silo feeds into the building and no evidence of spillage was noted around the silo.

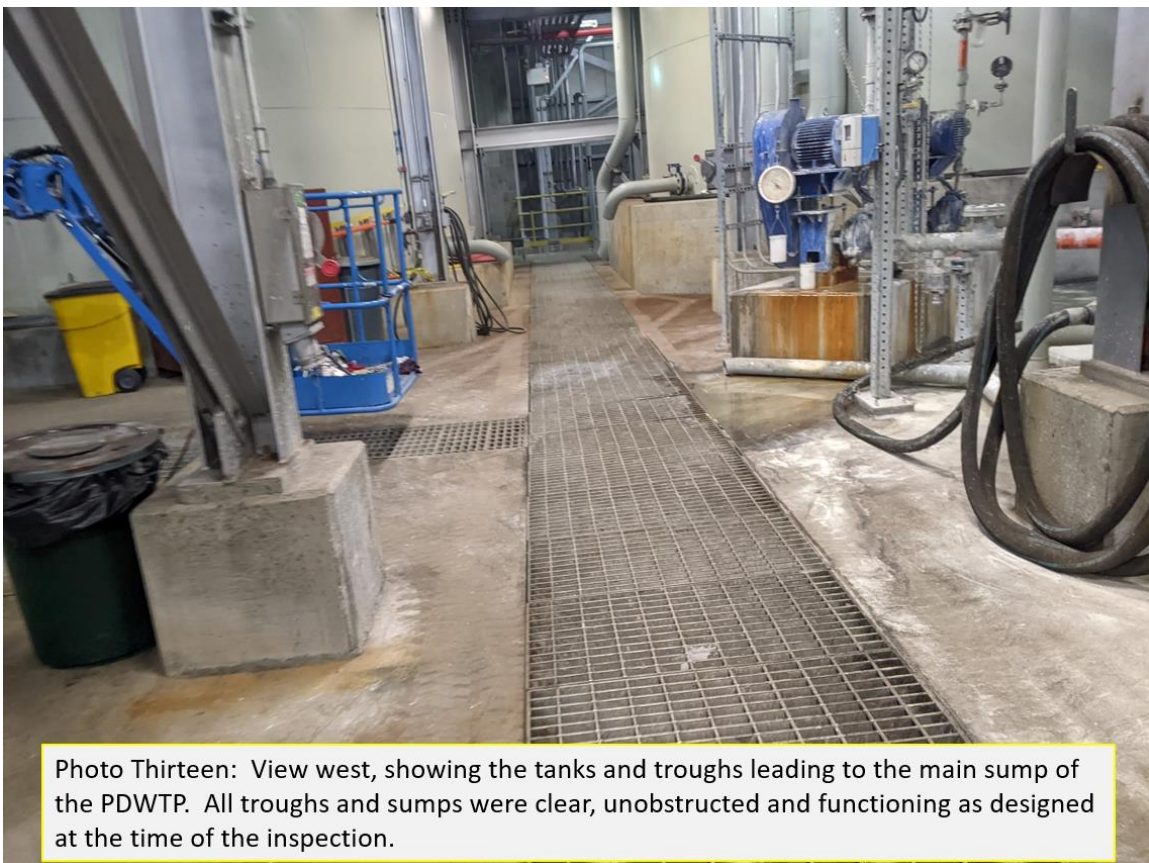
Photo Thirteen: View west, showing the tanks and troughs leading to the main sump of the PDWTP. All troughs and sumps were clear, unobstructed and functioning as designed at the time of the inspection.

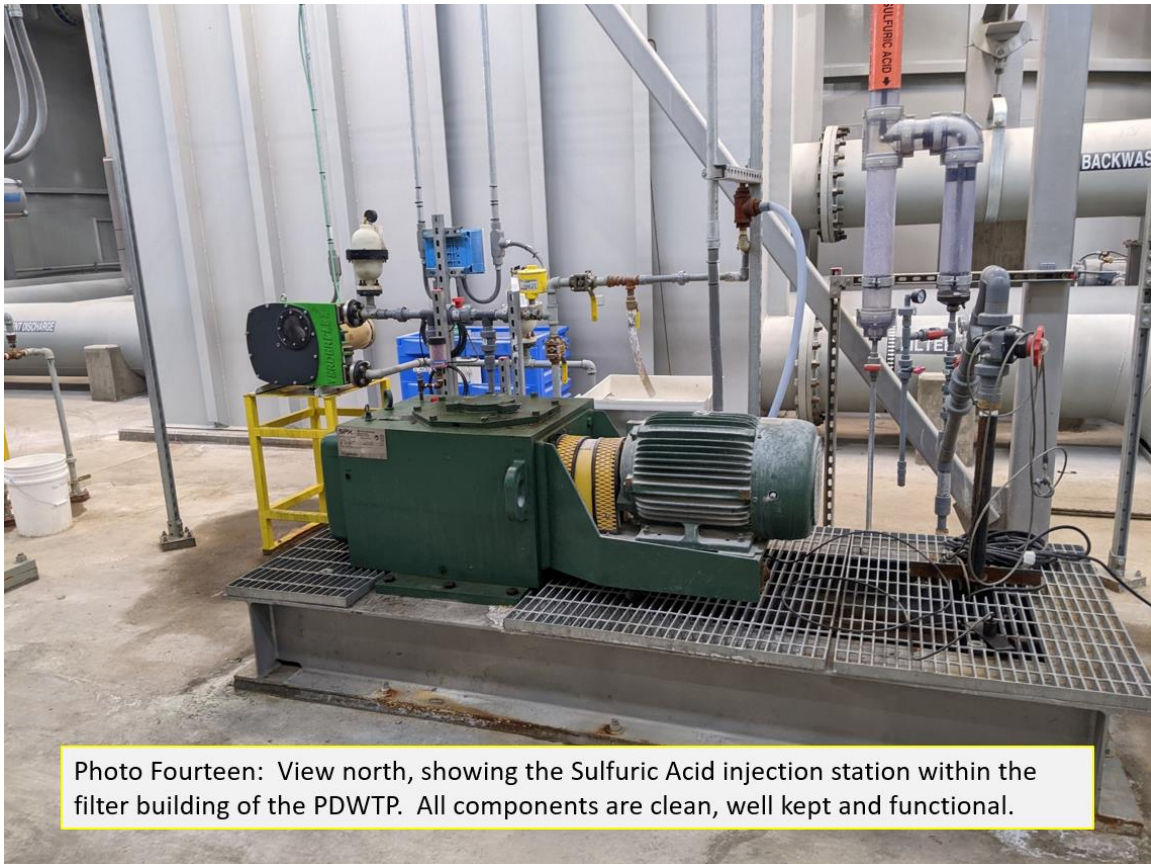
Connected by an underground man-way, the filter building is located adjacent to the clarifier tanks. The filter building is in good condition and contains various chemicals used during the water treatment process. Most notable is sulfuric acid, used for pH adjustment. The sulfuric acid injection station can be seen in Photo Fourteen. Photo Fifteen shows the sulfuric acid storage area which is its own separate room equipped with

Photo Fourteen: View north, showing the Sulfuric Acid injection station within the filter building of the PDWTP. All components are clean, well kept and functional.

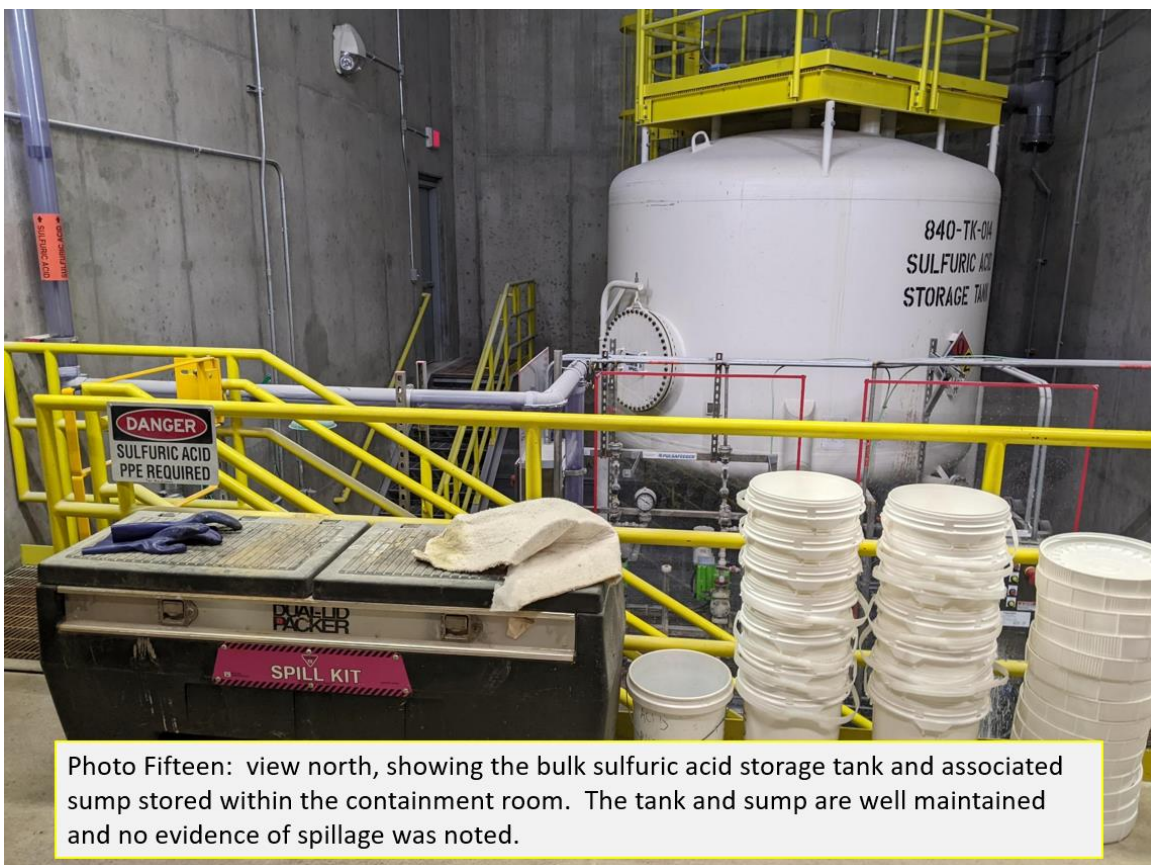
sump, spill kits and readily accessible PPE. The tank and sump are in excellent condition. Located just outside the filter building is the sulfuric acid loading station. The loading station is equipped with secondary containment for possible spills that may happen during the unloading process. The station has been cleared of snow and is good operating condition. It can be seen in Photo Sixteen.

Photo Fifteen: view north, showing the bulk sulfuric acid storage tank and associated sump stored within the containment room. The tank and sump are well maintained and no evidence of spillage was noted.

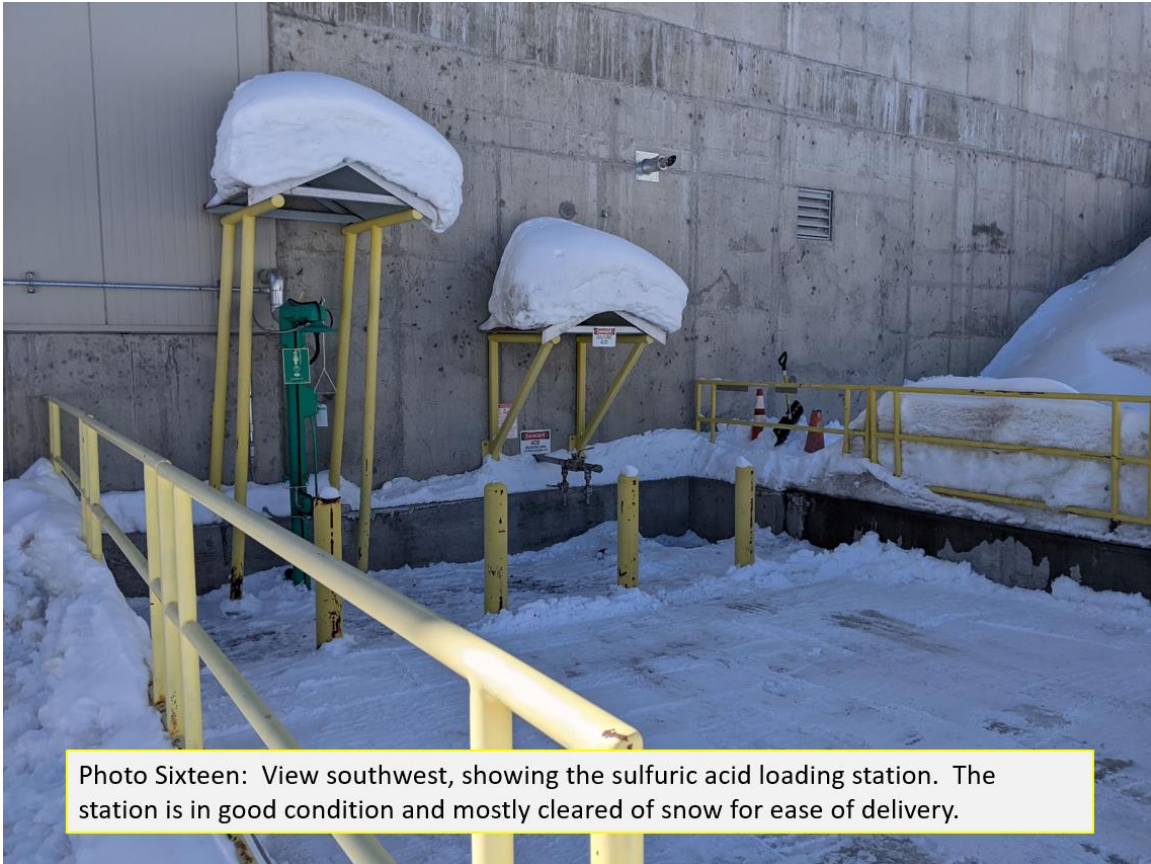
Photo Sixteen: View southwest, showing the sulfuric acid loading station. The station is in good condition and mostly cleared of snow for ease of delivery.
