**RE: Permit No. M-1980-244; Cripple Creek & Victor Gold Mining Company; Cresson Project;  
Schist Island Backfill Weekly Report**

Newmont Mining Corporation  
 Cripple Creek & Victor Gold Mine  
 2022 Quality Assurance Oversight  
 NewFields Job No. 475.0106.056  
 Week Ending Friday, February 11, 2022

**PROJECT:** VALLEY LEACH FACILITY (VLF2) PHASE 3 CQA HIGH COMPACTION BACKFILL  
**SITE:** CRIPPLE CREEK & VICTOR GOLD MINE (COLORADO)  
**CONTRACTOR:** NEWMONT CC&V MINING OPERATIONS  
**WEEK ENDING:** FRIDAY, FEBRUARY 11, 2022

**REPORTING PERIOD: 02.05.2022 THROUGH 02.11.2022**

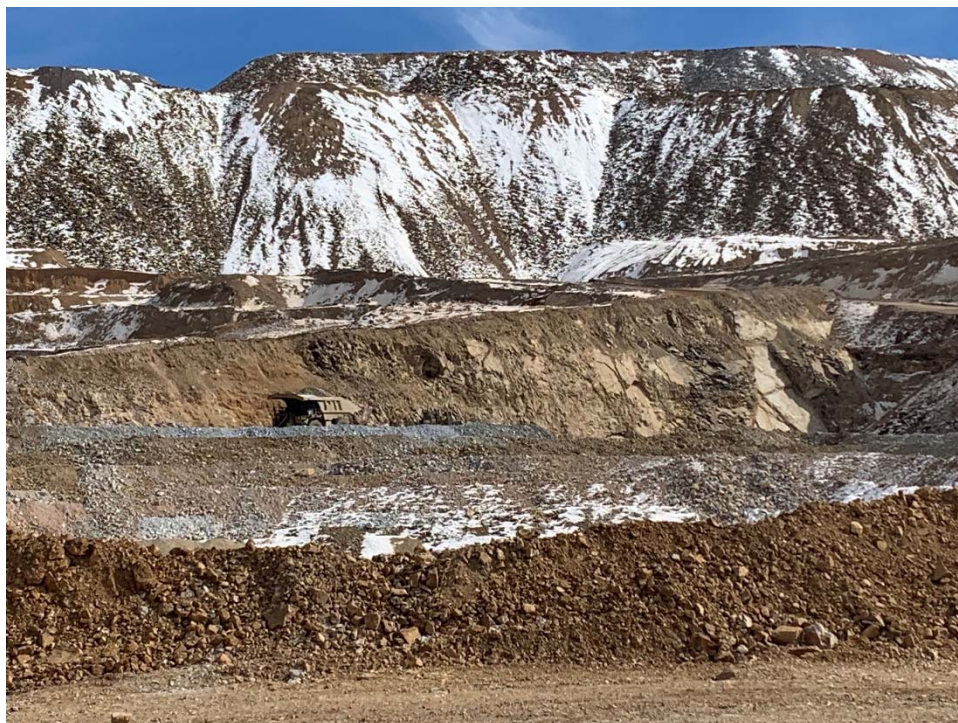
**February 10, 2022 – High Compaction Backfill placement (TW)**

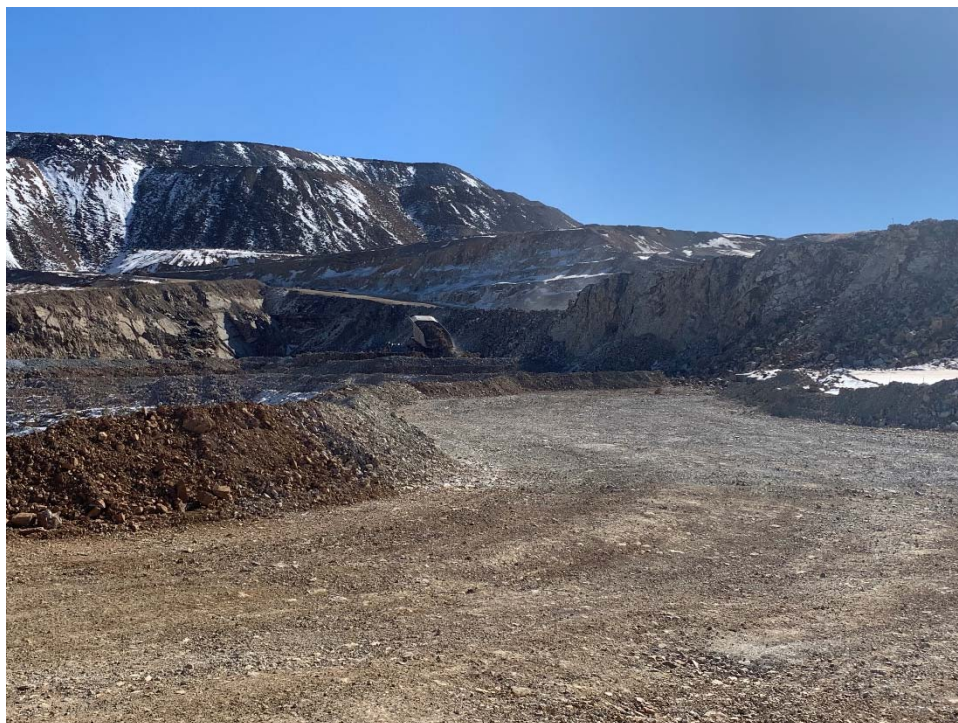
**February 11, 2022 – High Compaction Backfill wheel rolling (TW)**

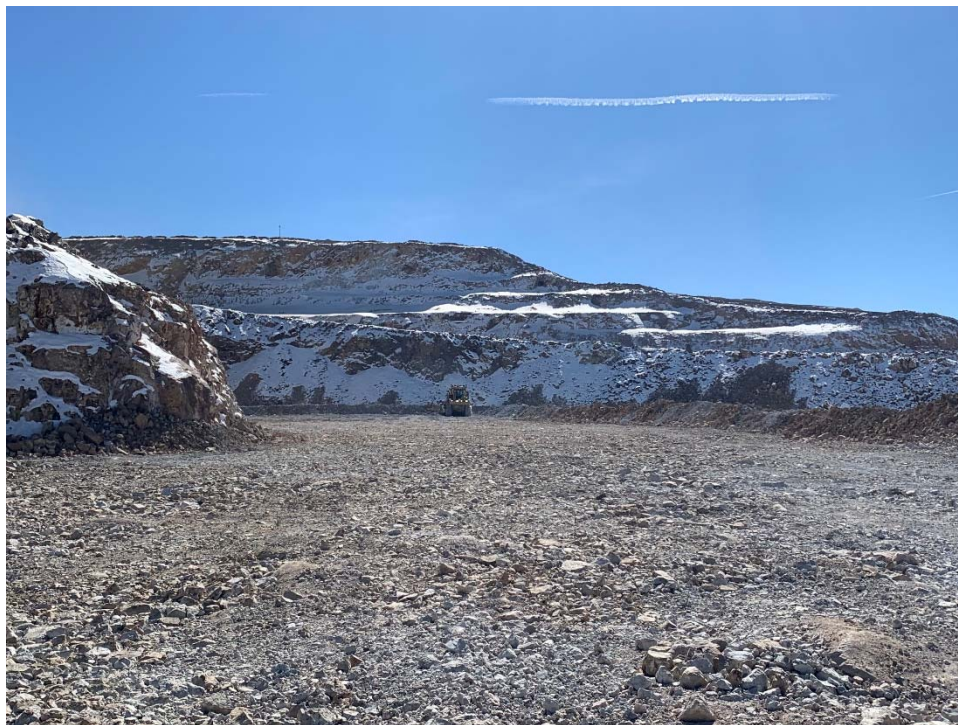
**February 11, 2022 – High Compaction Backfill placement (TW)**

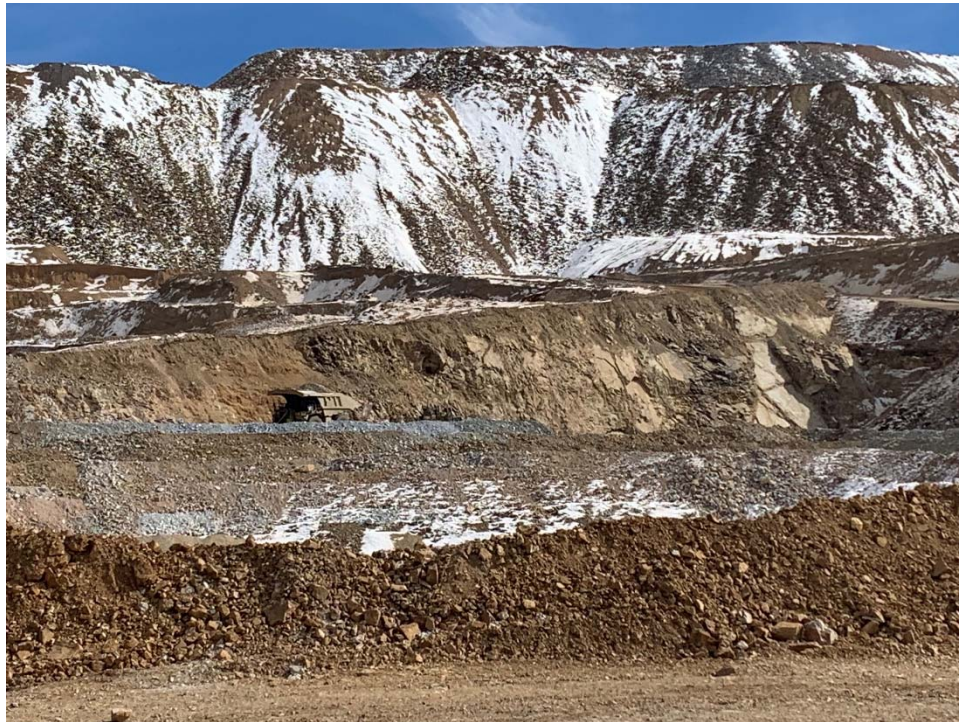
**February 10, 2022 – High Compaction Backfill placement (TW)**

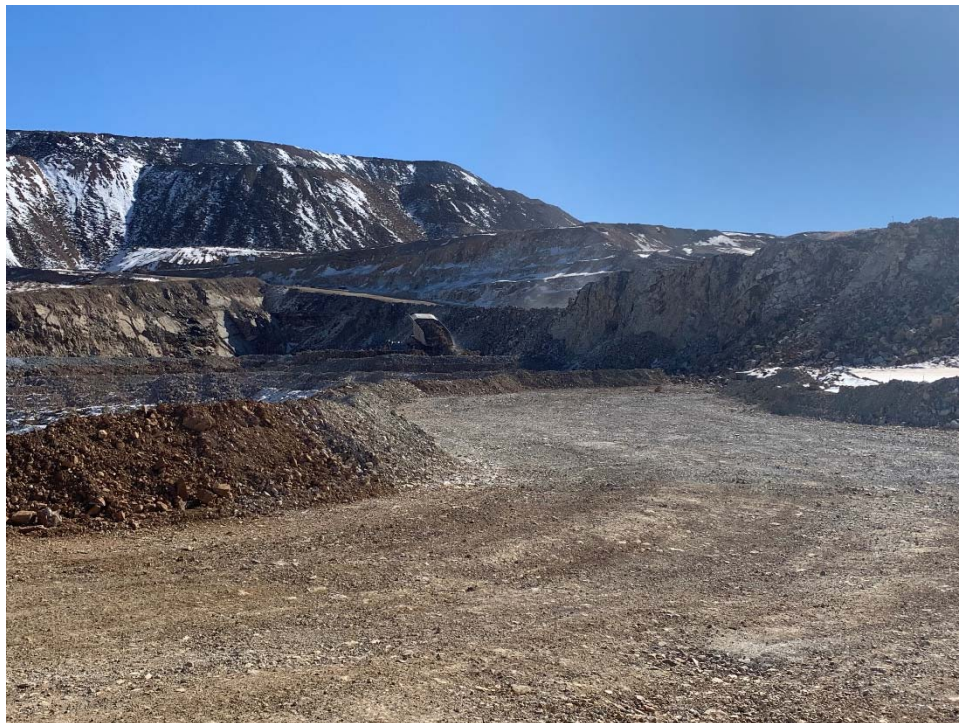
**February 11, 2022 – High Compaction Backfill wheel rolling (TW)**

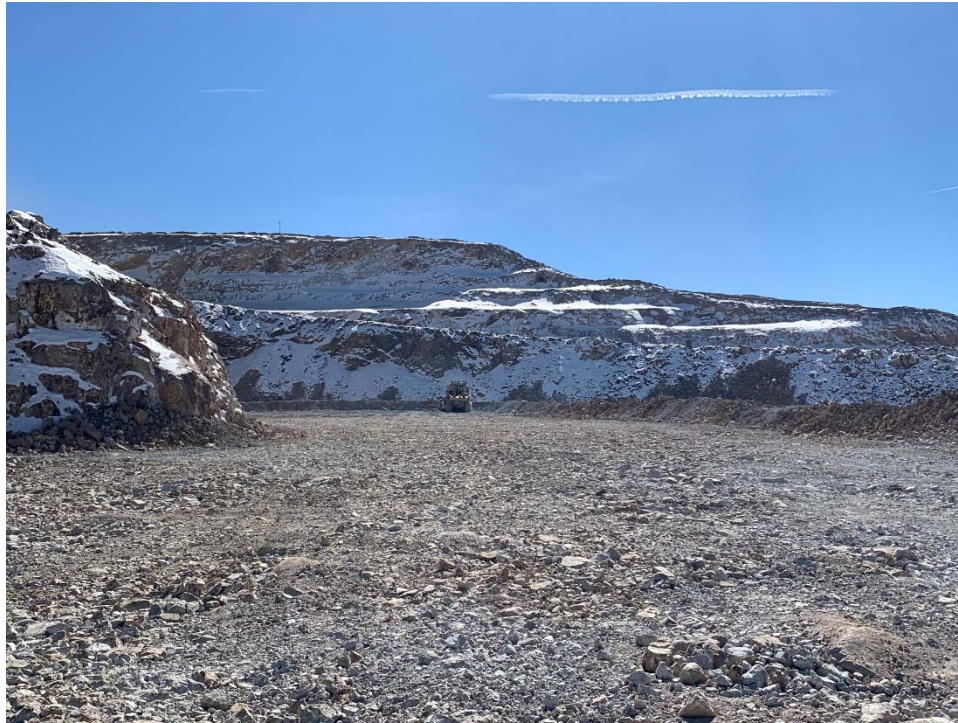
**February 11, 2022 – High Compaction Backfill placement (TW)**
