**MINERALS PROGRAM INSPECTION REPORT**  
**PHONE: (303) 866-3567**

<b>MINE NAME:</b> Pikeview Quarry	<b>MINE/PROSPECTING ID#:</b> M-1977-211	<b>MINERAL:</b> Limestone (general), granite, granite gneiss and dolomite	<b>COUNTY:</b> El Paso
<b>INSPECTION TYPE:</b> Monitoring	<b>INSPECTOR(S):</b> Timothy Cazier, P.E.	<b>INSP. DATE:</b> February 4, 2022	<b>INSP. TIME:</b> 09:30
<b>OPERATOR:</b> Continental Materials Corporation	<b>OPERATOR REPRESENTATIVE:</b> Jerry Schnabel	<b>TYPE OF OPERATION:</b> 112c - Construction Regular Operation	
<b>REASON FOR INSPECTION:</b> Normal I&E Program	<b>BOND CALCULATION TYPE:</b> None	<b>BOND AMOUNT:</b> \$13,389,784.00	
<b>DATE OF COMPLAINT:</b> NA	<b>POST INSP. CONTACTS:</b> None	<b>JOINT INSP. AGENCY:</b> None	
<b>WEATHER:</b> Clear	<b>INSPECTOR'S SIGNATURE:</b>

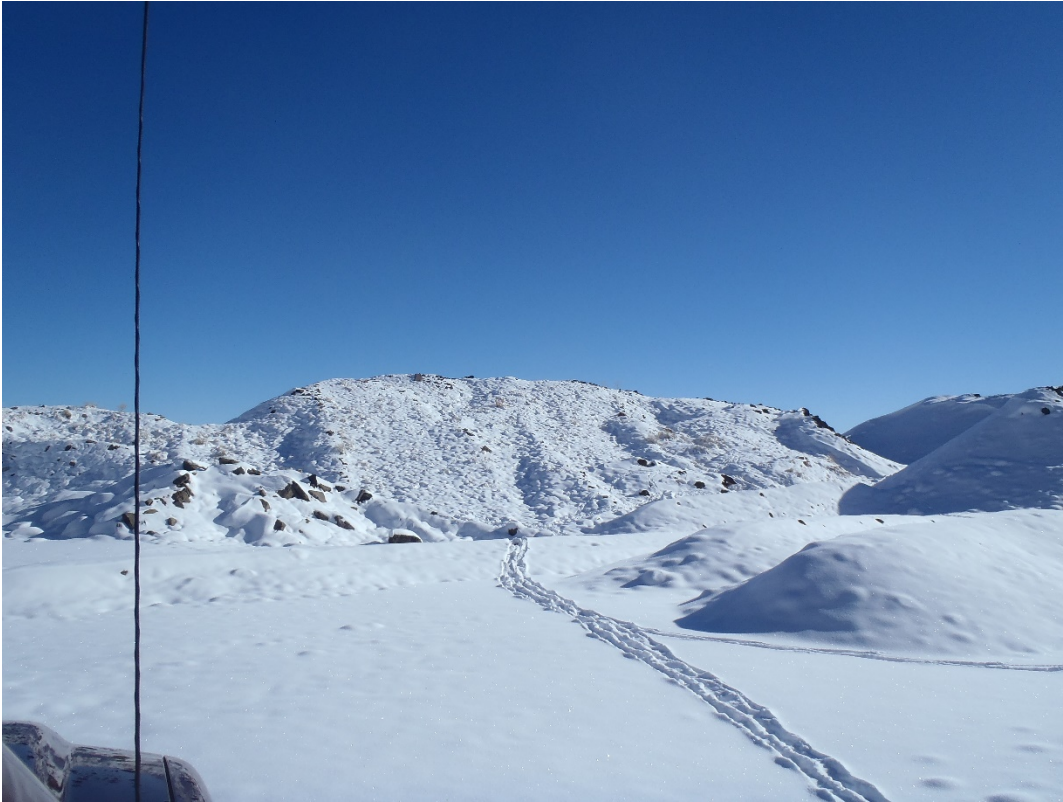
Backfilling and Grading: Site representatives indicated a stockpile (see **Photo 1**) of recycled asphalt (RAP) near the scale house might be used for backfill. The revised signed material affidavit received by the DRMS on 11/20/2017 allows fragmented asphalt to be used as backfill pursuant to Rule 1.2(22). As such, the RAP is allowed to be used as backfill. Mr. Schnabel pointed out stockpiles of processed (see **Photo 2**) and unprocessed riprap (see **Photo 3**) intended for construction of the drainage channels.

Photo 1. Recycled asphalt material stockpile near scale building (looking NE).

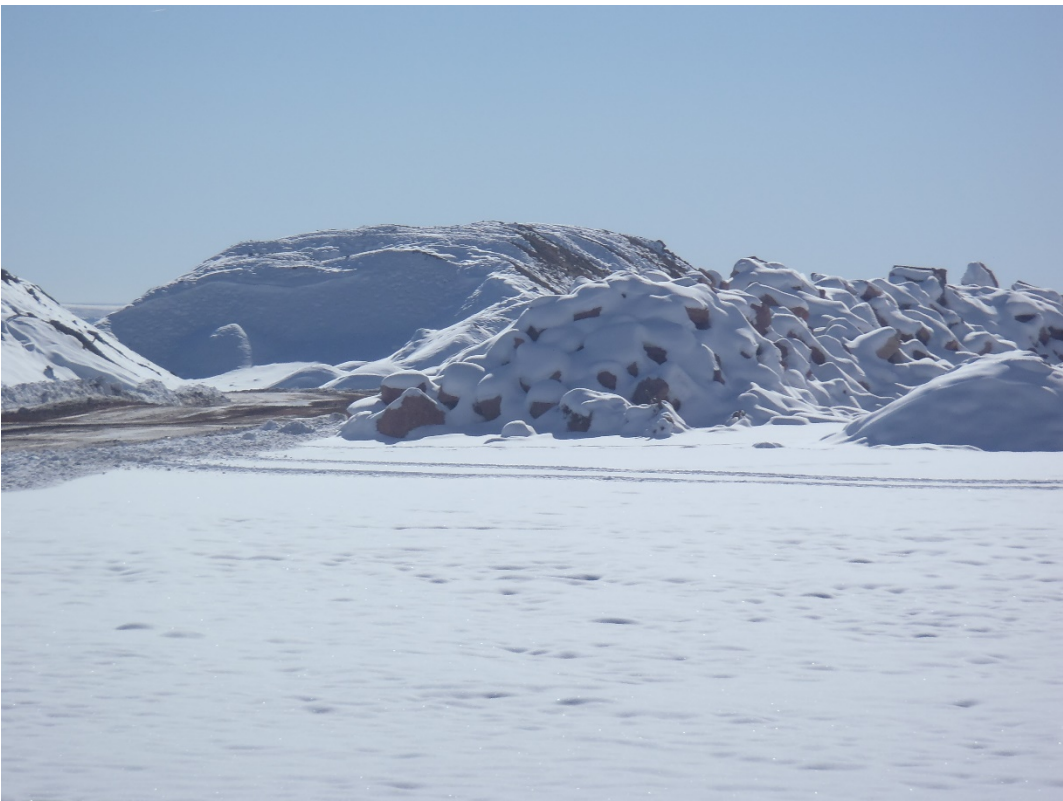
Photo 2. Processed riprap stockpile (south end of pit floor, looking SE).

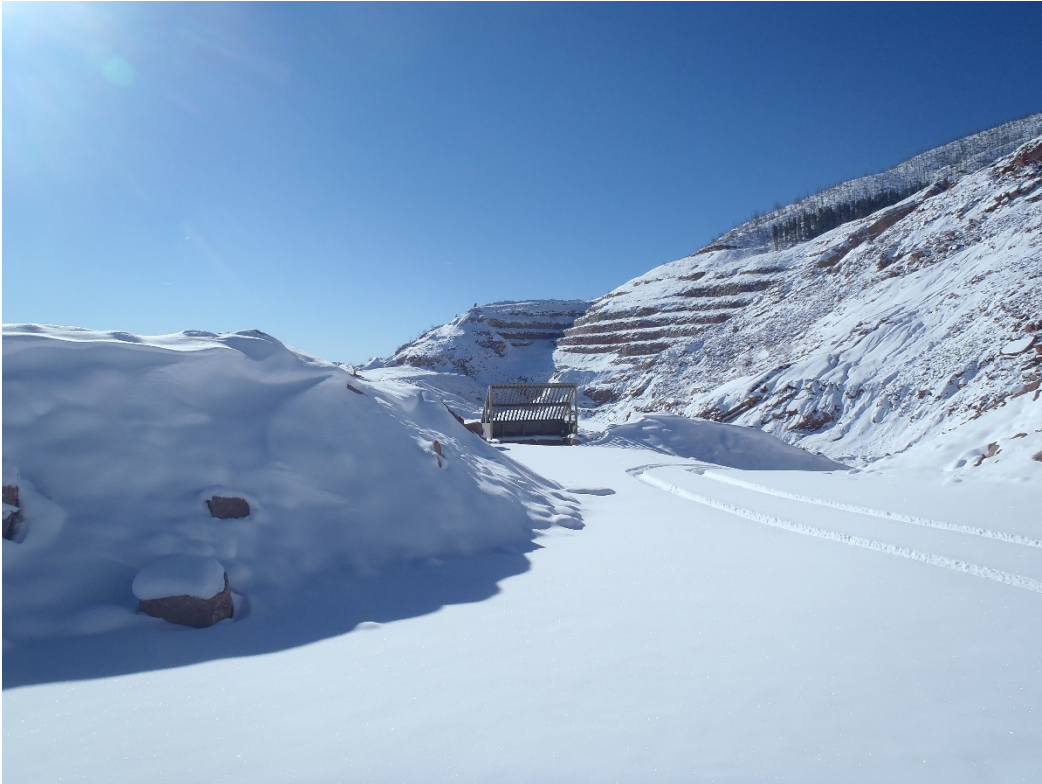
Photo 3. Unprocessed riprap stockpile & grizzly screen (north end of pit, looking south).

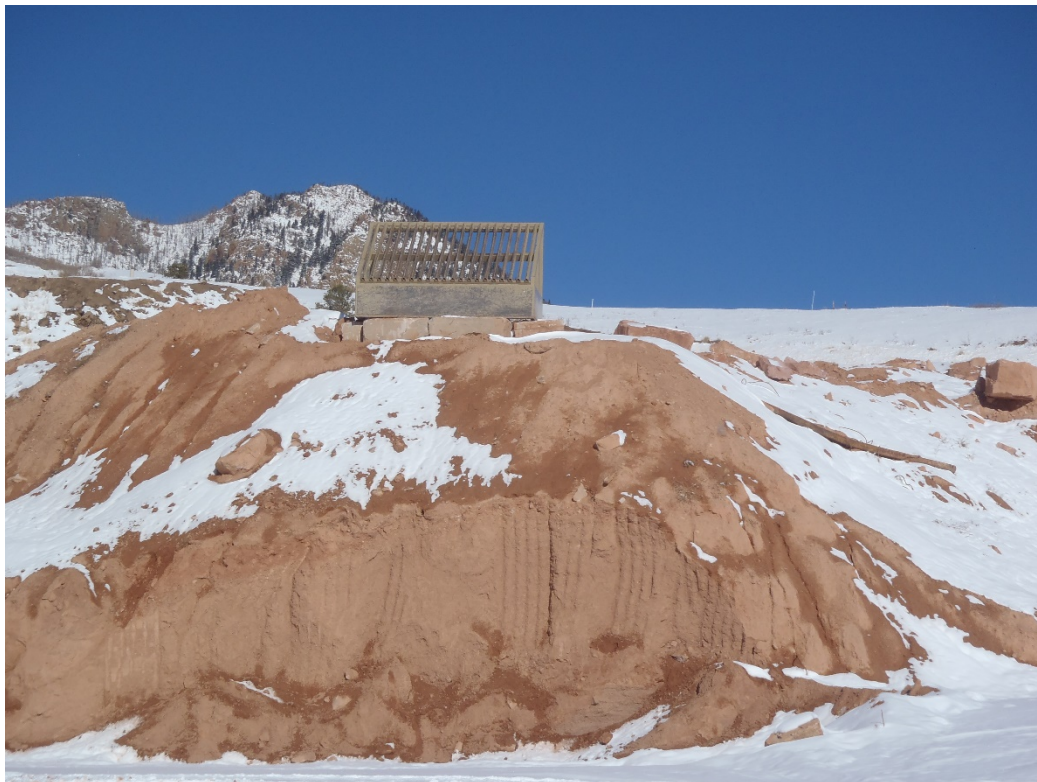
Support Facilities On-site: A grizzly screen was observed for processing riprap need for the drainage channels (see **Photo 4**).

Photo 4. Grizzly screen (north end of pit, looking north).

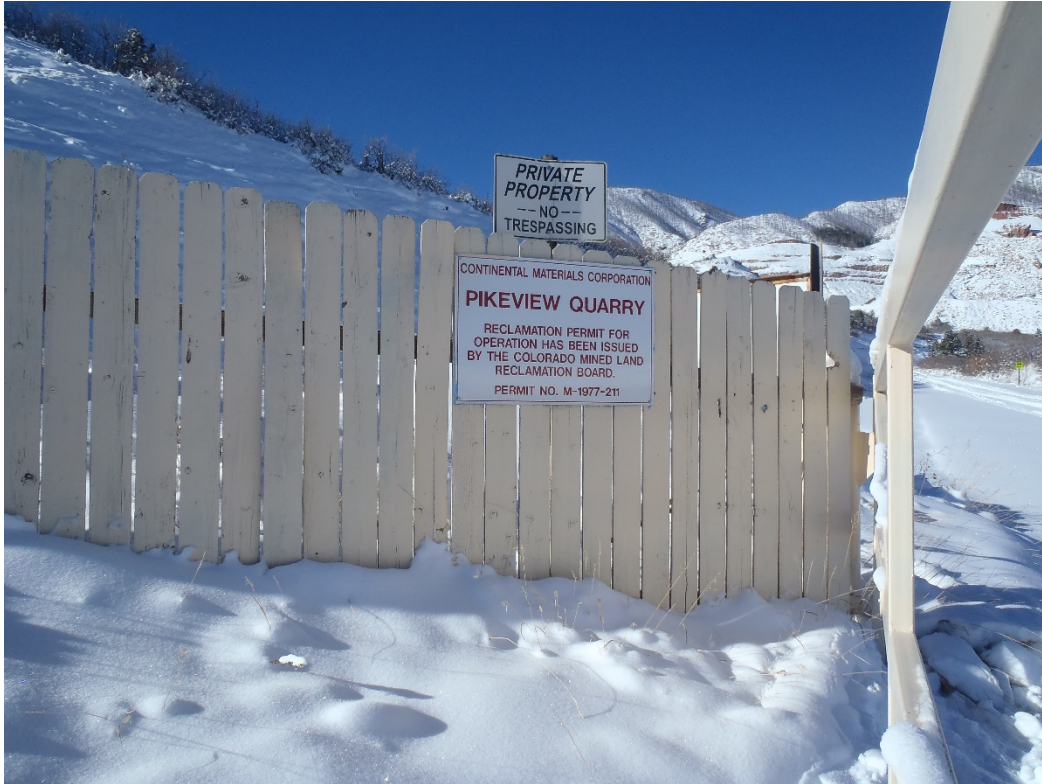
Signs and Markers: The permit sign was properly posted (see **Photo 5**).

Photo 5. Permit sign (at gate off Allegheny Dr).

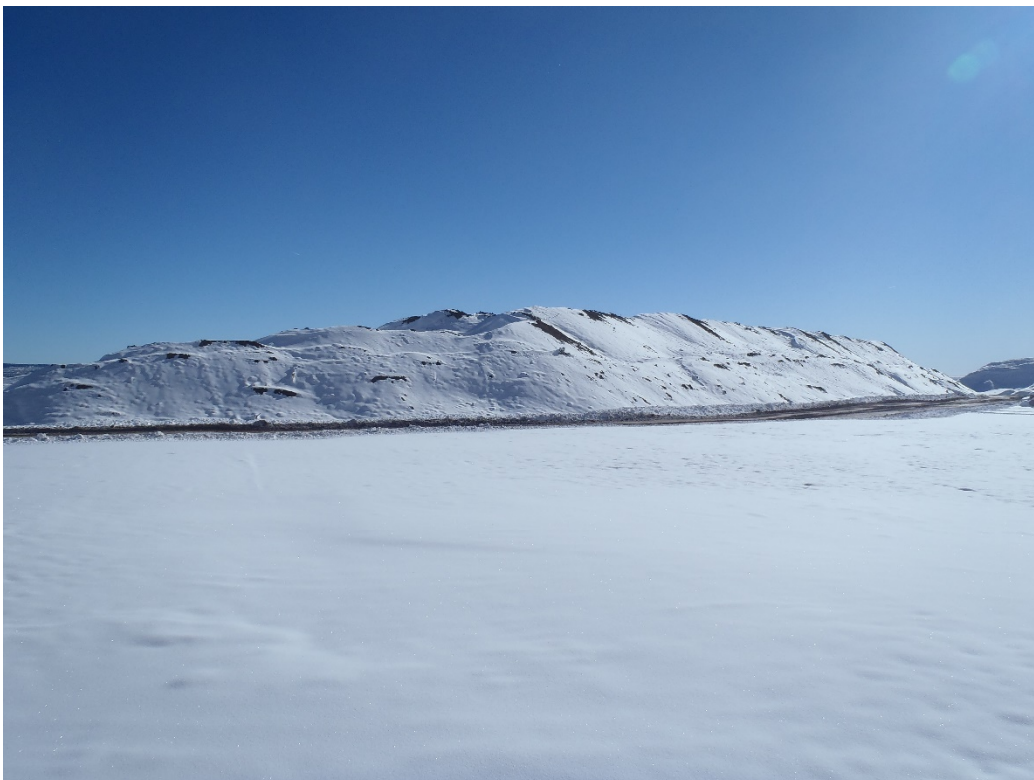
Topsoil: Site representatives stated they have stockpiled an estimated 60,000 CY of growth media (see **Photo 6**). The reclamation plan calls for 57,000 CY.

Photo 6. Largest of several growth media stockpiles (SE corner of pit floor, looking SE).
