**MINERALS PROGRAM INSPECTION REPORT**  
**PHONE: (303) 866-3567**

<b>MINE NAME:</b> Cresson Project	<b>MINE/PROSPECTING ID#:</b> M-1980-244	<b>MINERAL:</b> Gold	<b>COUNTY:</b> Teller
<b>INSPECTION TYPE:</b> Aerial Inspection	<b>INSPECTOR(S):</b> Elliott Russell	<b>INSP. DATE:</b> March 31, 2021	<b>INSP. TIME:</b> 08:53
<b>OPERATOR:</b> Cripple Creek & Victor Gold Mining Company	<b>OPERATOR REPRESENTATIVE:</b> None	<b>TYPE OF OPERATION:</b> 112d-3 - Designated Mining Operation	
<b>REASON FOR INSPECTION:</b> Normal I&E Program	<b>BOND CALCULATION TYPE:</b> None	<b>BOND AMOUNT:</b> \$159,491,188.00	
<b>DATE OF COMPLAINT:</b> NA	<b>POST INSP. CONTACTS:</b> None	<b>JOINT INSP. AGENCY:</b> DRMS	
<b>WEATHER:</b> Clear	<b>INSPECTOR'S SIGNATURE:</b>

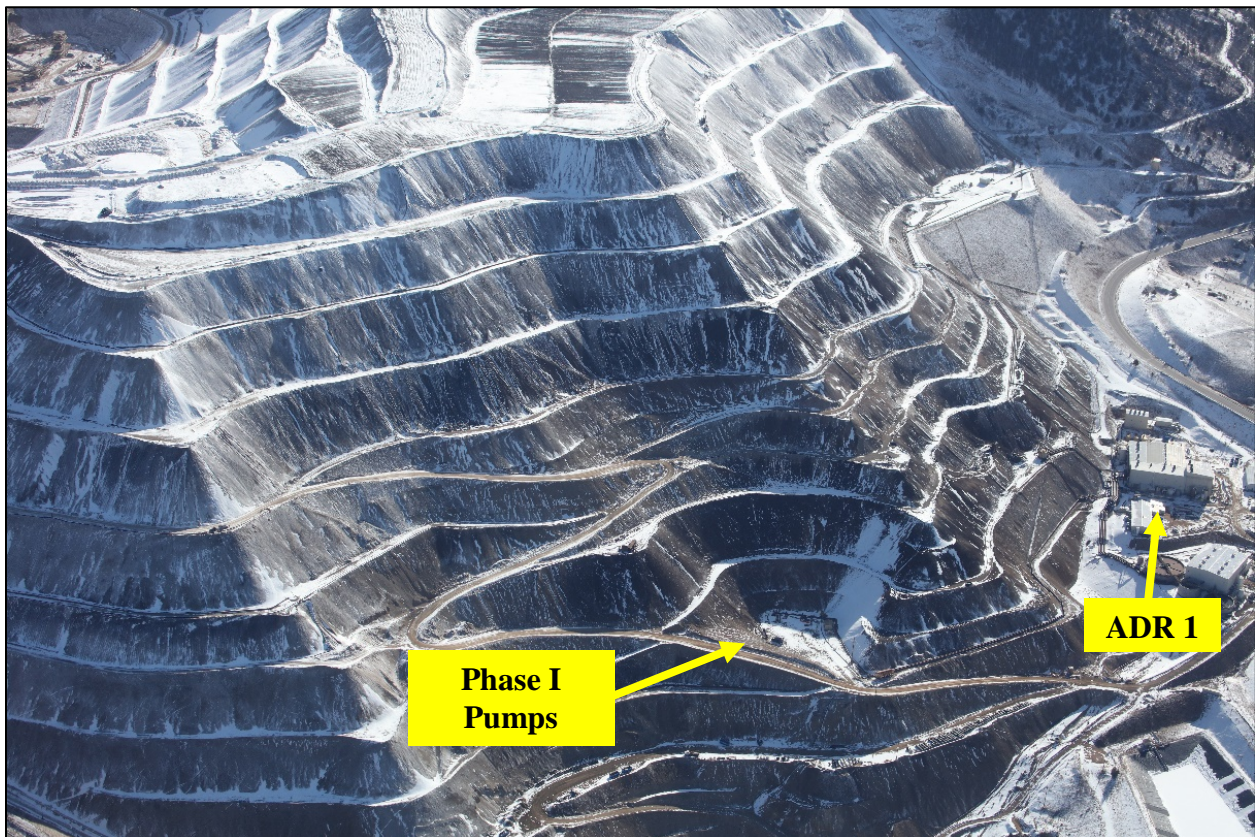
No ponded process solution was observed in the active leach areas of VLF 1 (see **Photo 1** and **Photo 2**). No observable issues are noted for VLF 1.

**Photo 1.** VLF 1; looking east.

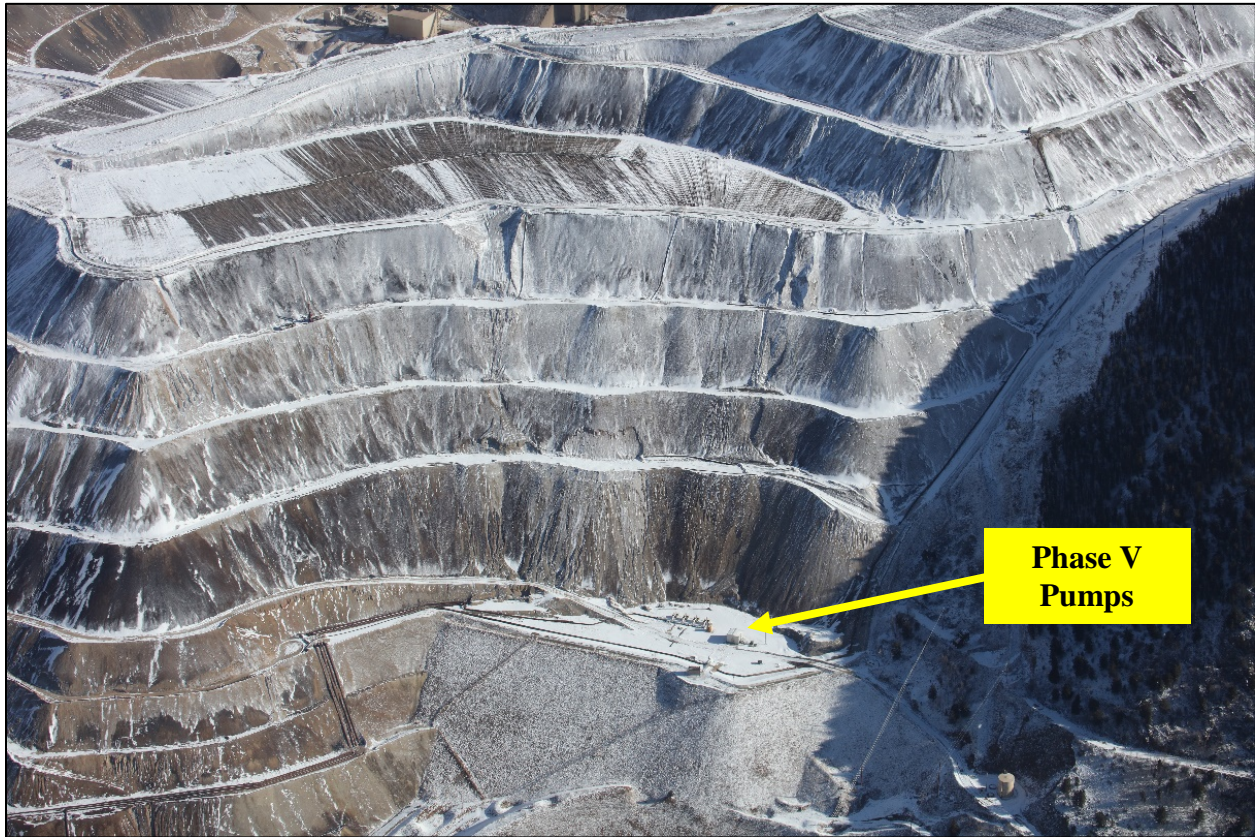
**Photo 2.** VLF 1; looking northeast.

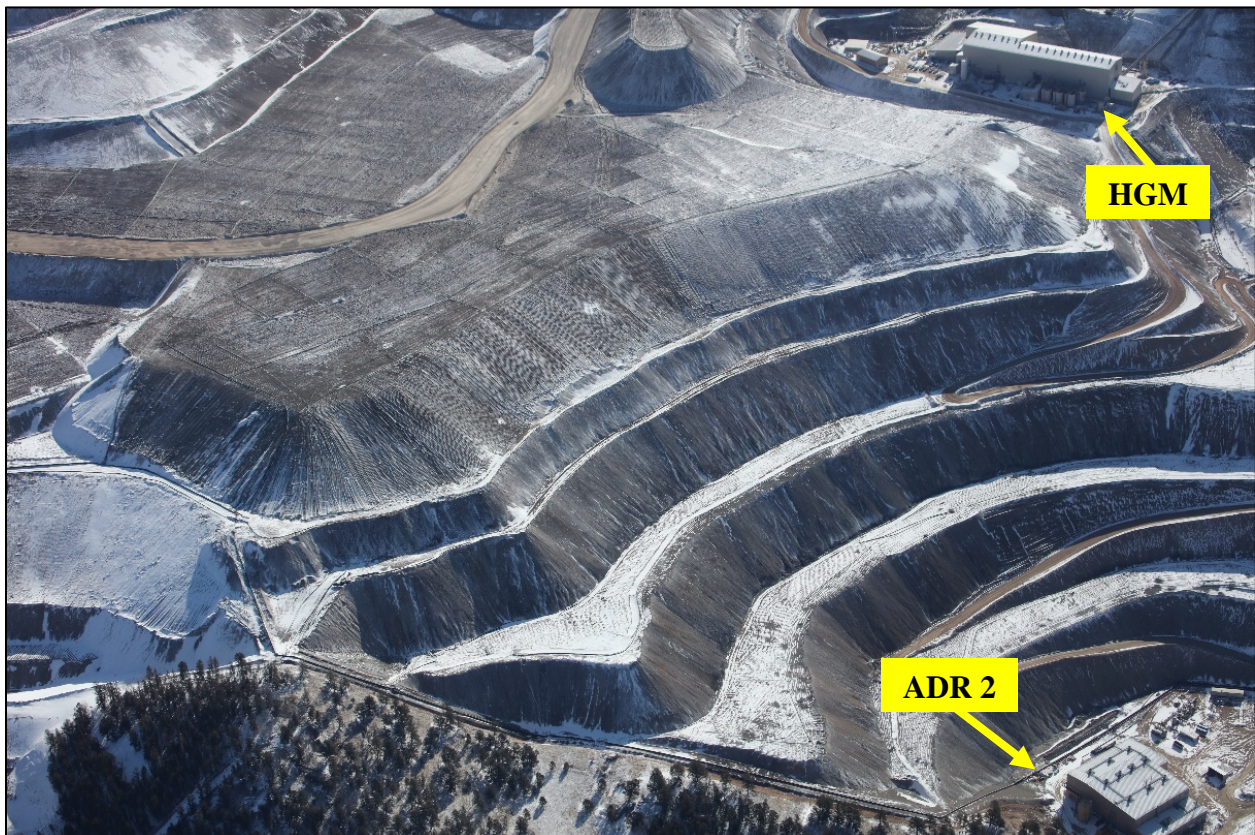
No ponded process solution was observed in the active leach areas of VLF 2 (see **Photo 3**). Active ore stacking was occurring in the northeast portion of VLF 2 (see **Photo 4**). No observable issues are noted for VLF 2.

**Photo 3.** VLF 2; looking east.

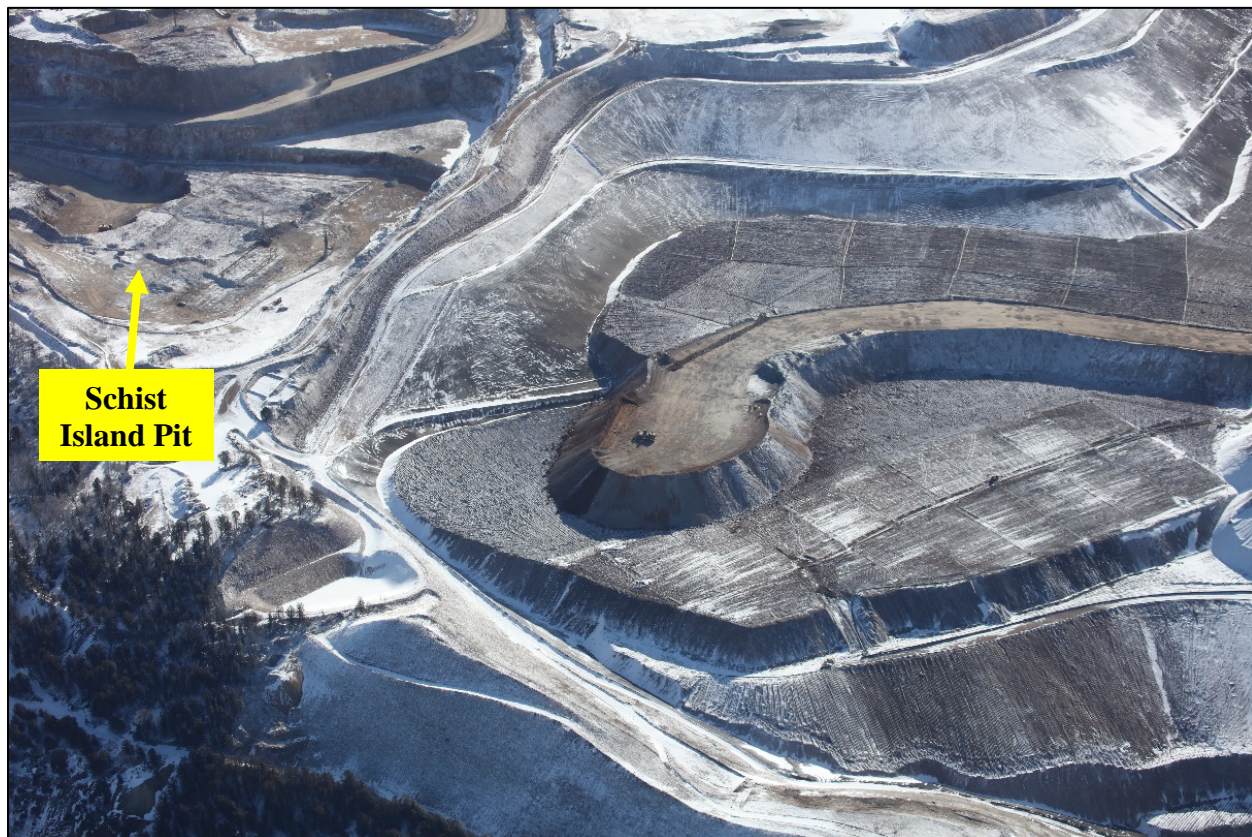
**Photo 4.** VLF 2 active loading; looking east.

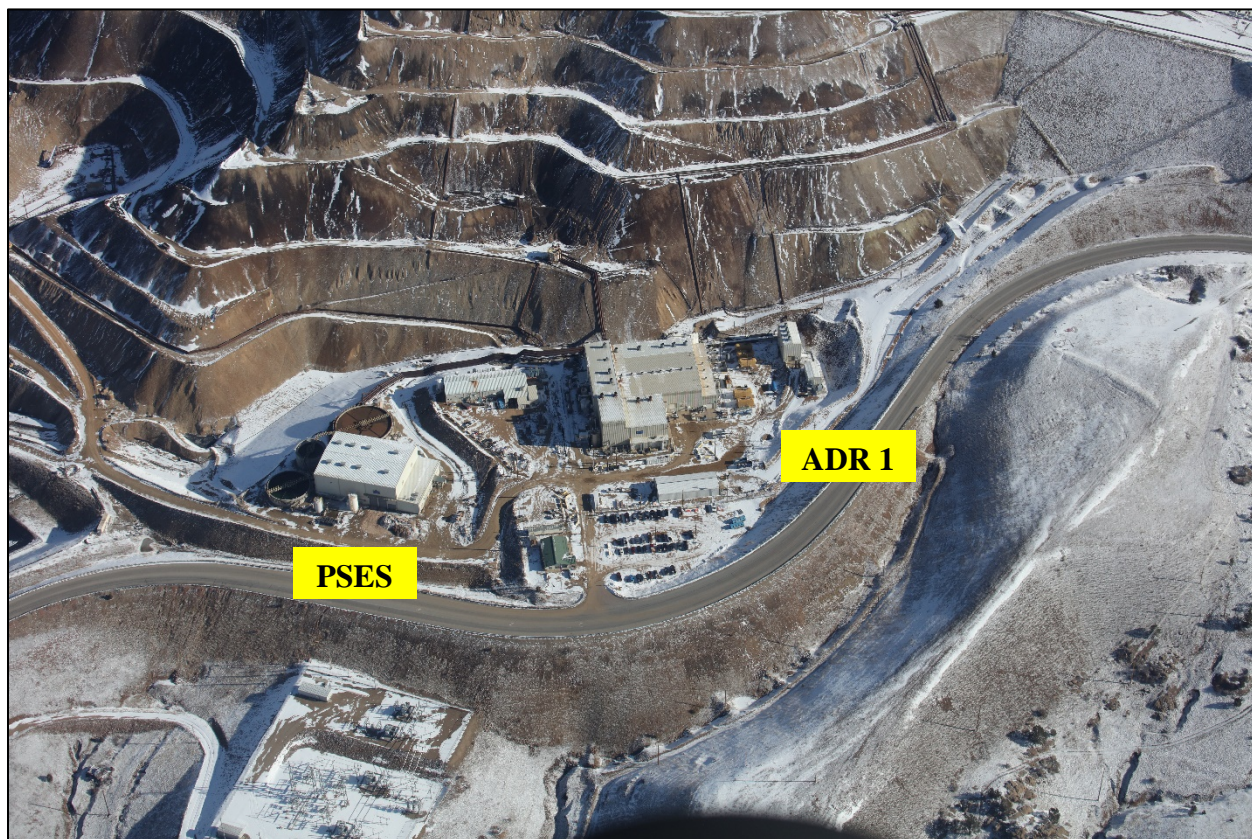
Aerial images of the two Adsorption, Desorption, and Recovery Facilities (ADR 1 and ADR 2) and the Process Solution Enhancement System Facility (PSES) are used to perform a broad visual inspection for leaks, spills, secondary containment problems, and other potential issues that cannot easily be obtained from the ground. The ADR 1 and the PSES (see **Photo 5**) are both located on the south side of VLF 1 while ADR 2 (see **Photo 6**) is located on the west side of VLF 2. No observable issues are noted for either ADR facility or the PSES.

**Photo 5.** ADR 1 and PSES; looking north.

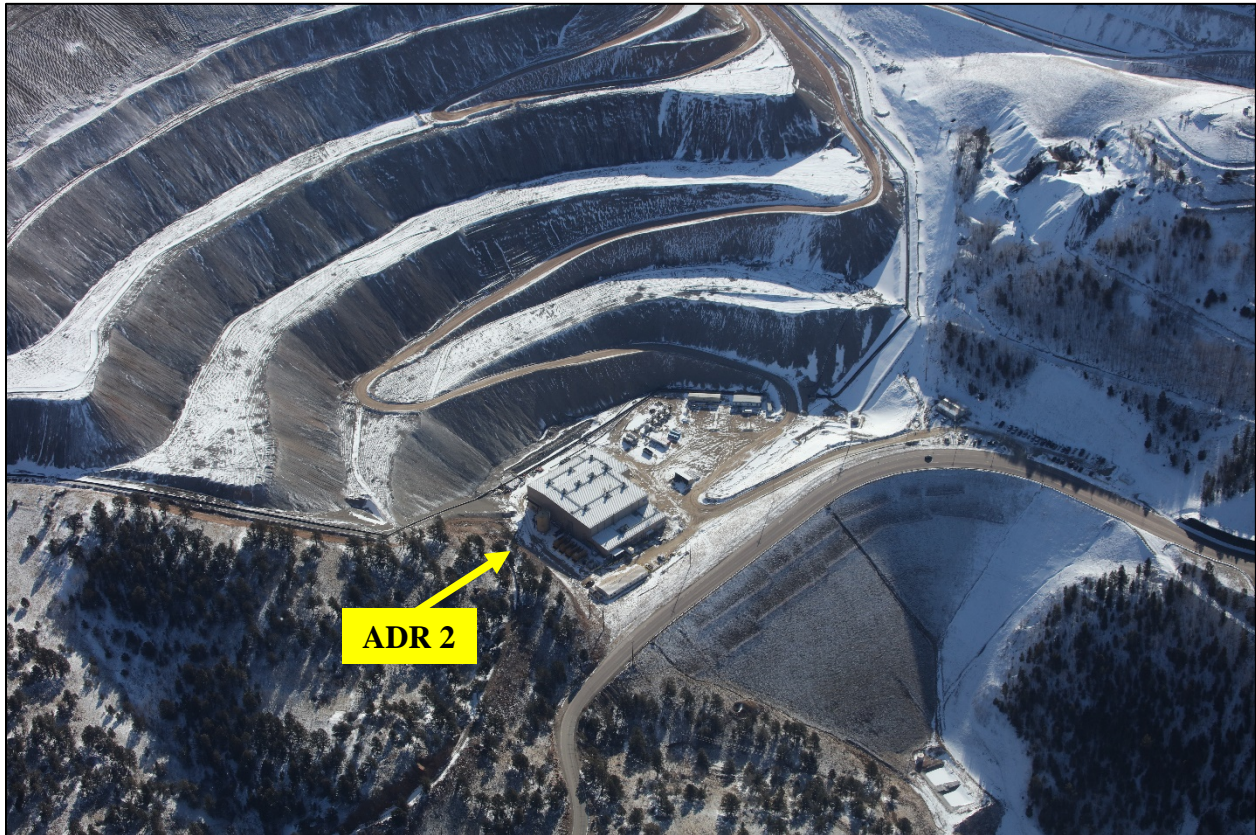
**Photo 6.** ADR 2; looking east.

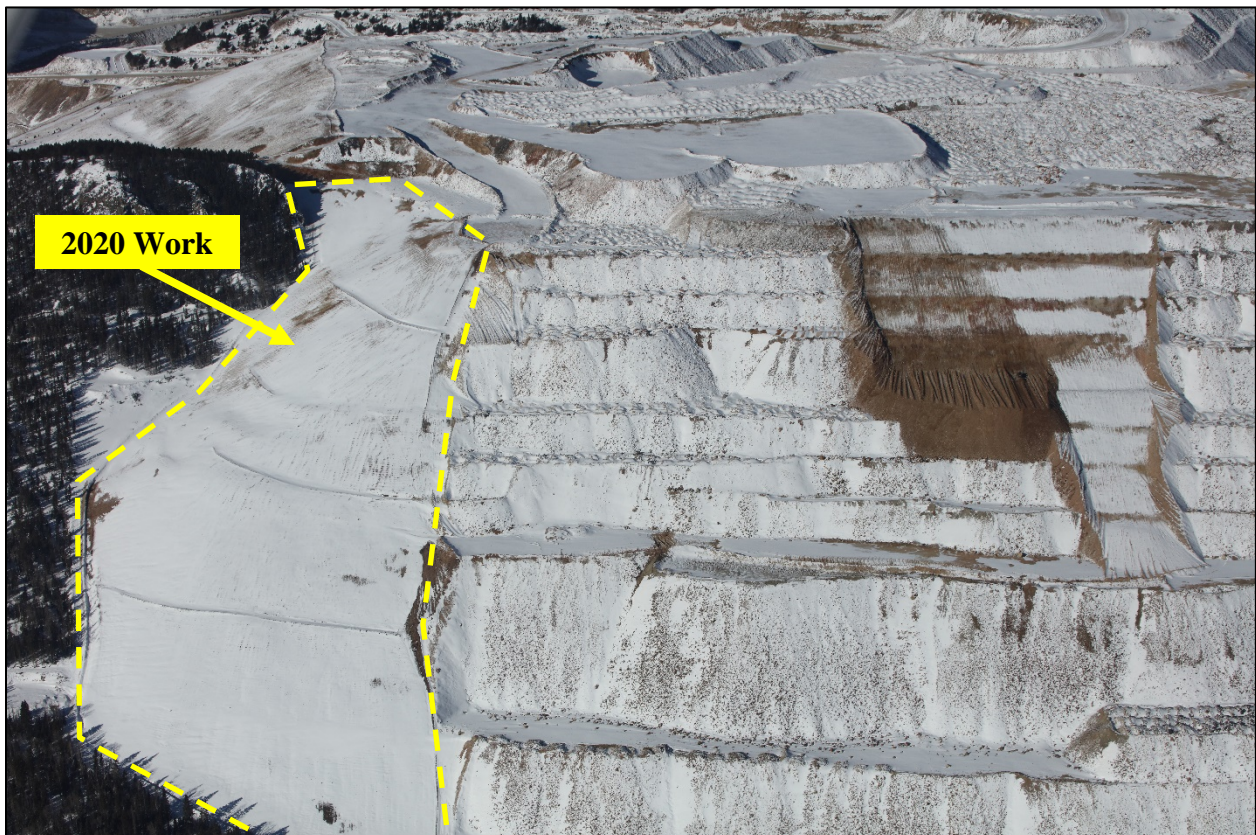
Slope grading was occurring at the time of the inspection on the portion of the ECOSA which is a continuation of the concurrent reclamation project on the far eastern portion of the facility (see **Photo 7**).

**Photo 7.** ECOSA concurrent reclamation area; looking southwest.

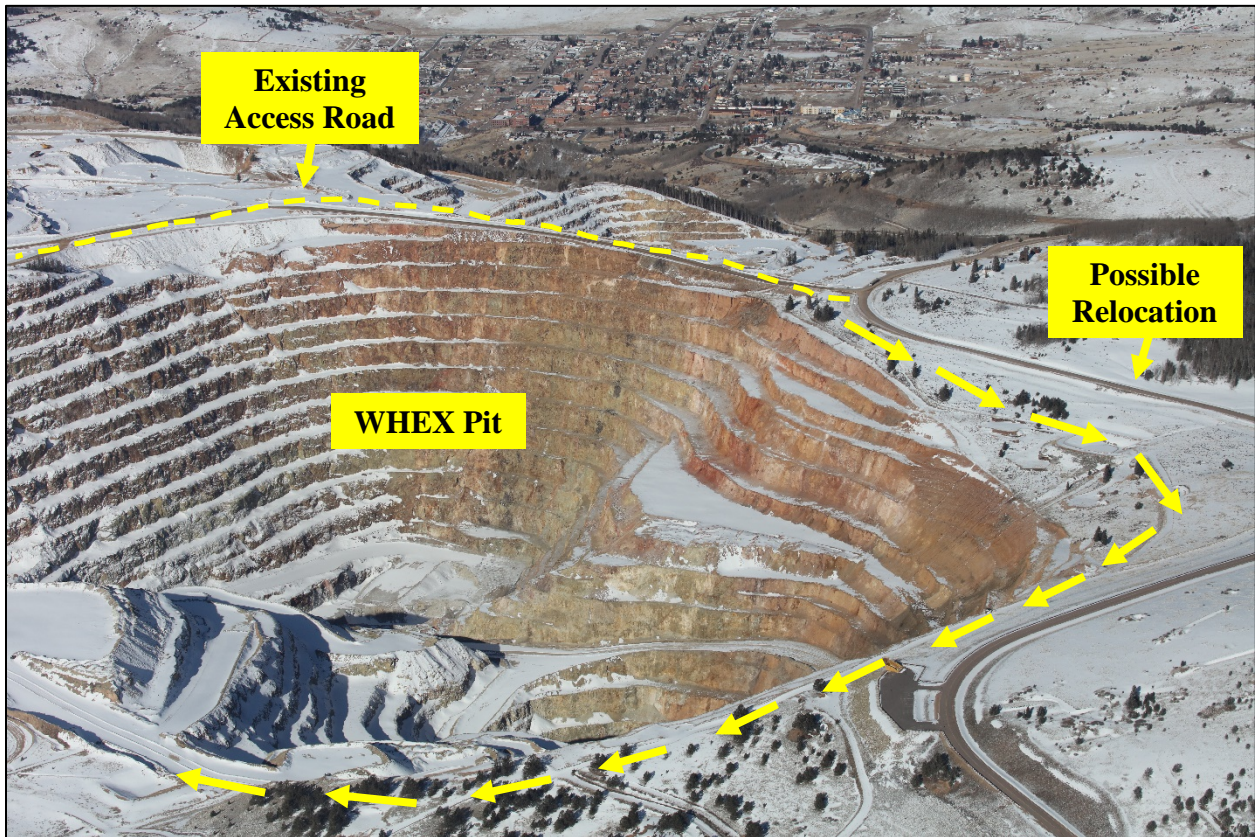
The Operator recently disused a forthcoming technical revision regarding the relocation of the Ironclad Access Road from its current location between the WHEX and Globe Hill Pits to around the WHEX Pit and across Grassy Valley (see **Photo 8** and **Photo 9**). Likely to be assigned TR128, this relocation will allow the Operator to mine the ridge left between the WHEX and Globe Hill Pits.

**Photo 8.** Area of planned relocation of the Ironclad Access Road; looking west.

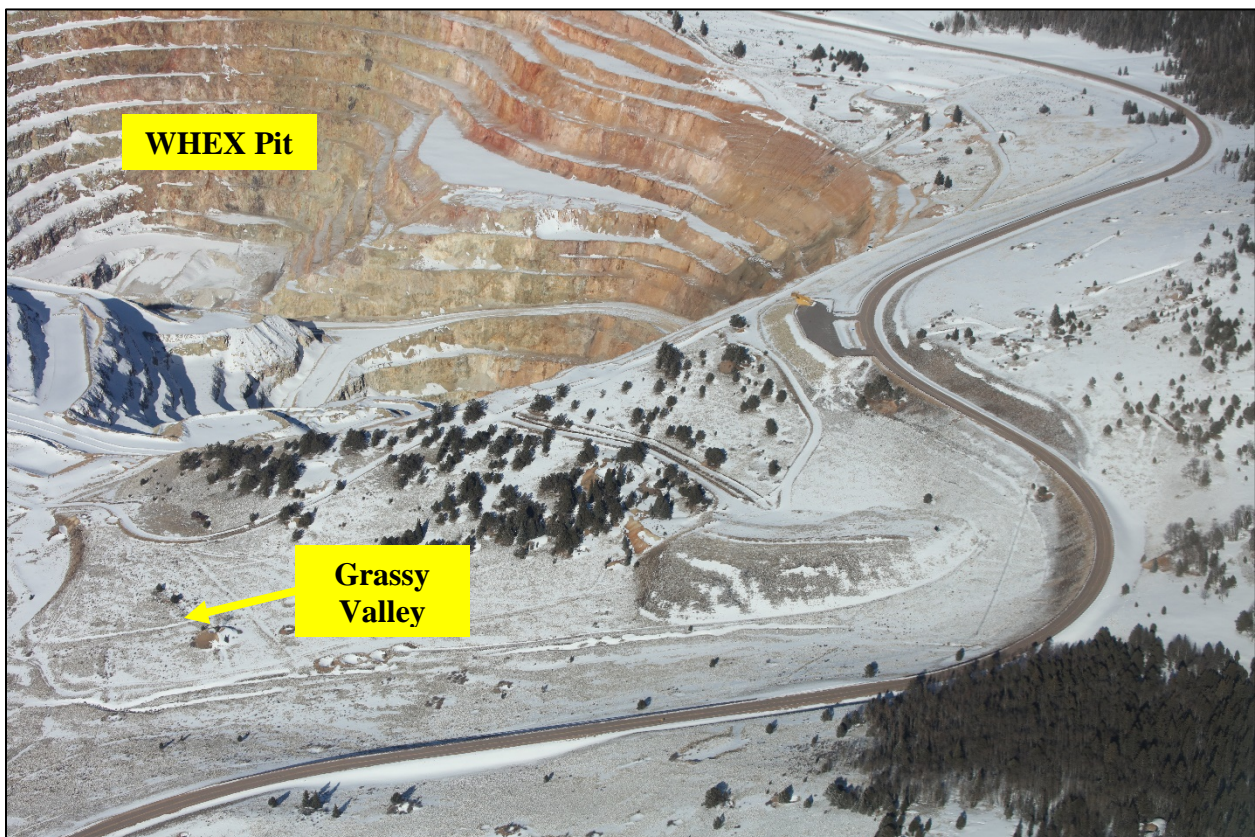
**Photo 9.** Area of planned relocation of the Ironclad Access Road; looking west.

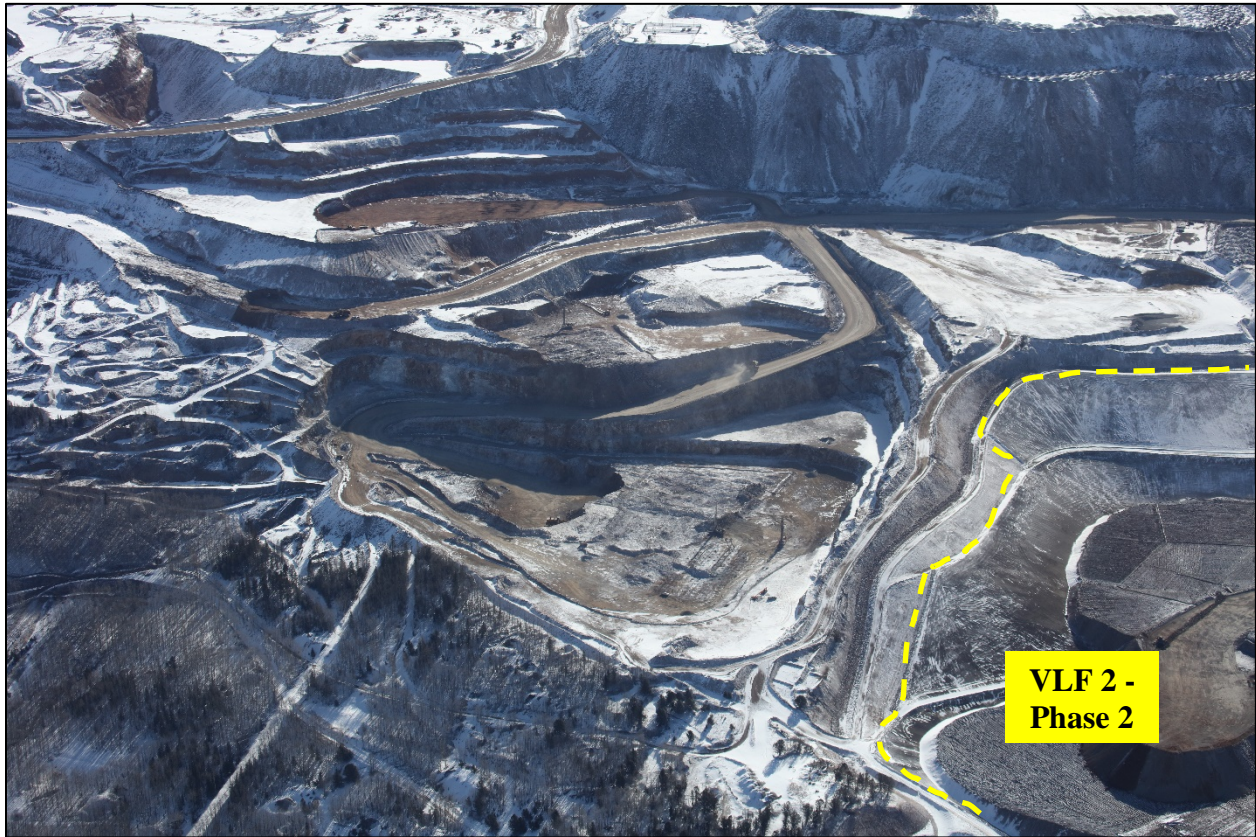
Aerial images of the Schist Island (see **Photo 10** and **Photo 11**), Globe Hill (see **Photo 12**), WHEX (see **Photo 13**), Main Cresson (see **Photo 14** and **Photo 15**), and South Cresson Pits (see **Photo 16**) are presented for

**Photo 10.** Schist Island Pit; looking east.

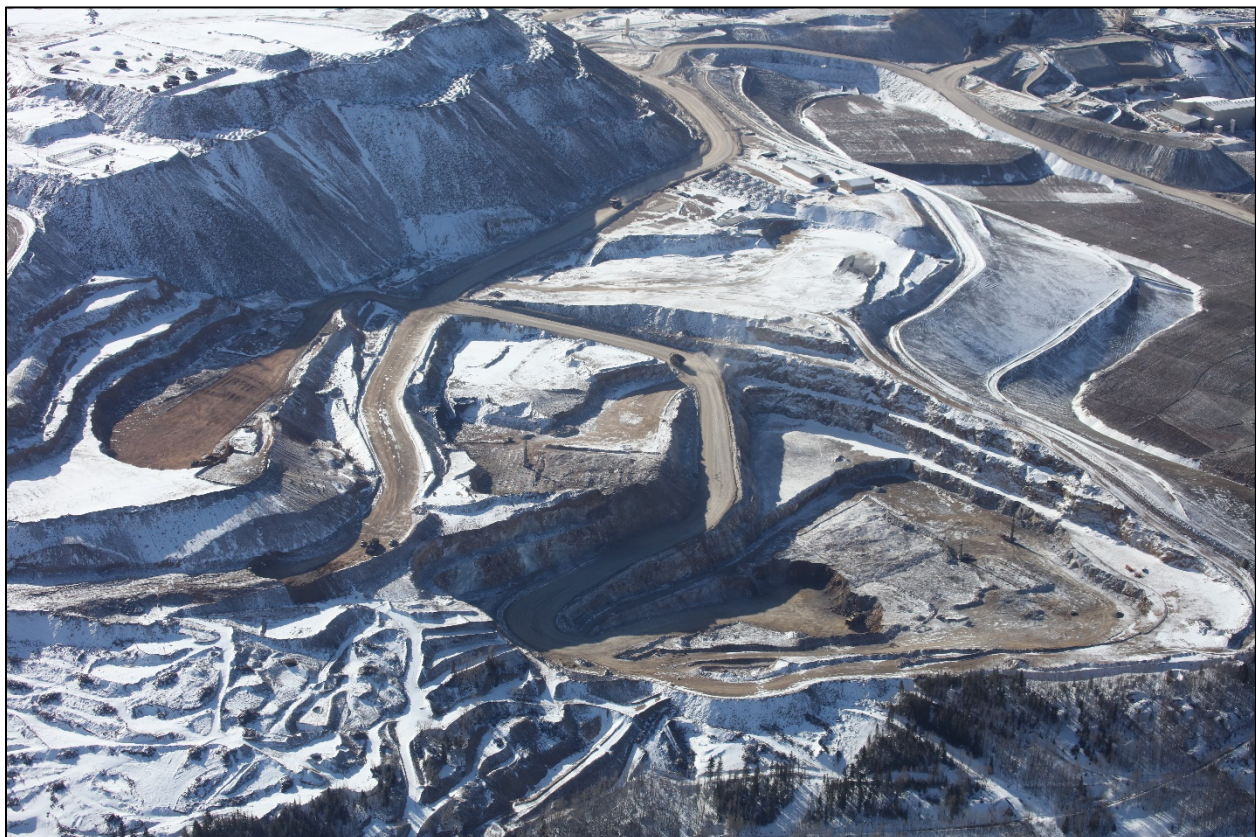
**Photo 11.** Schist Island Pit; looking south.

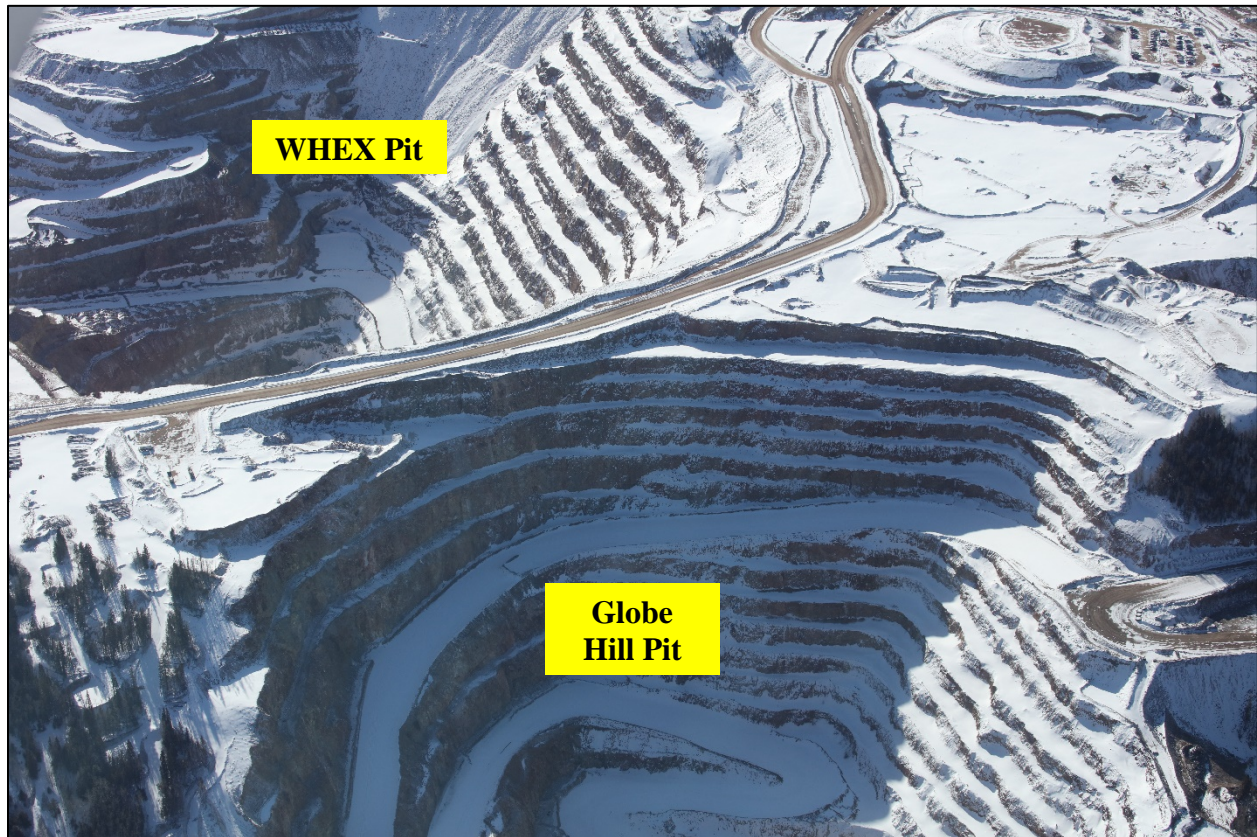
**Photo 12.** Globe Hill Pit, east highwall; looking southeast.

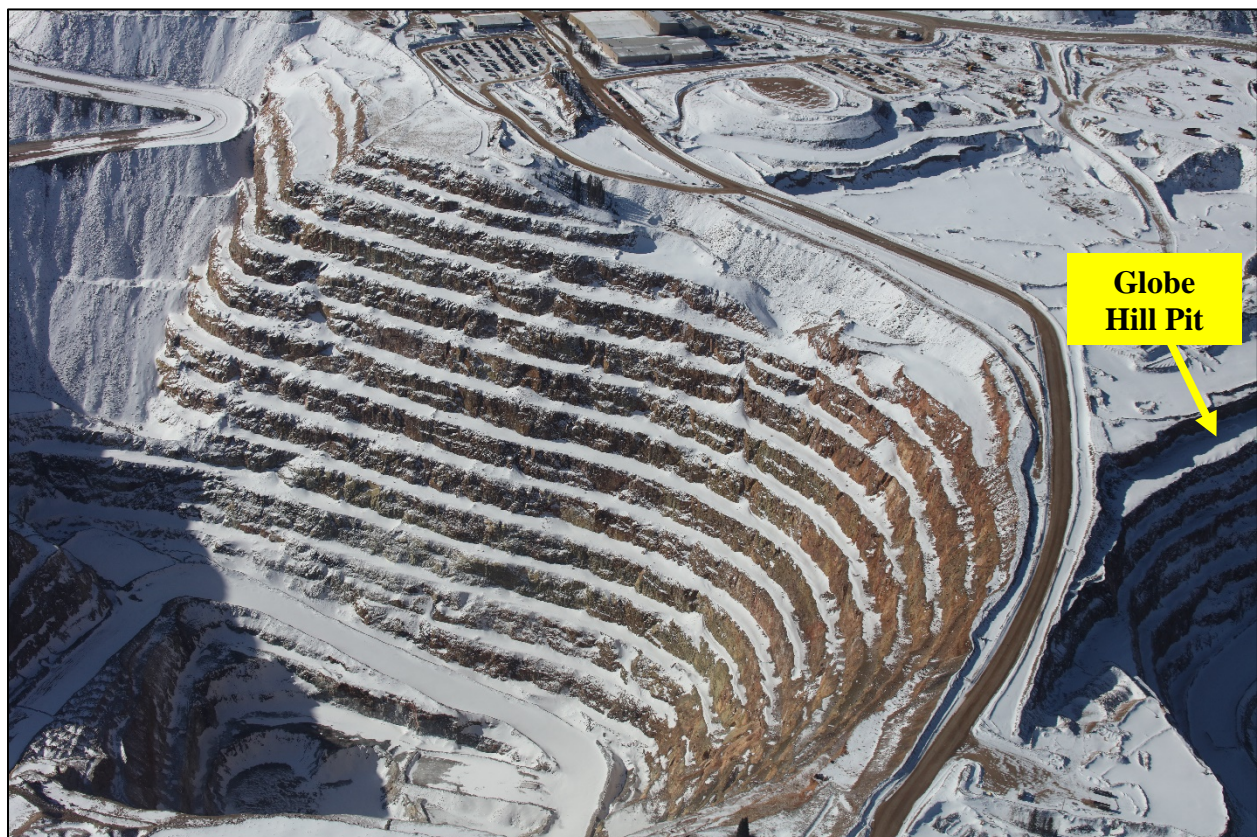
**Photo 13.** WHEX Pit, south highwall; looking south.

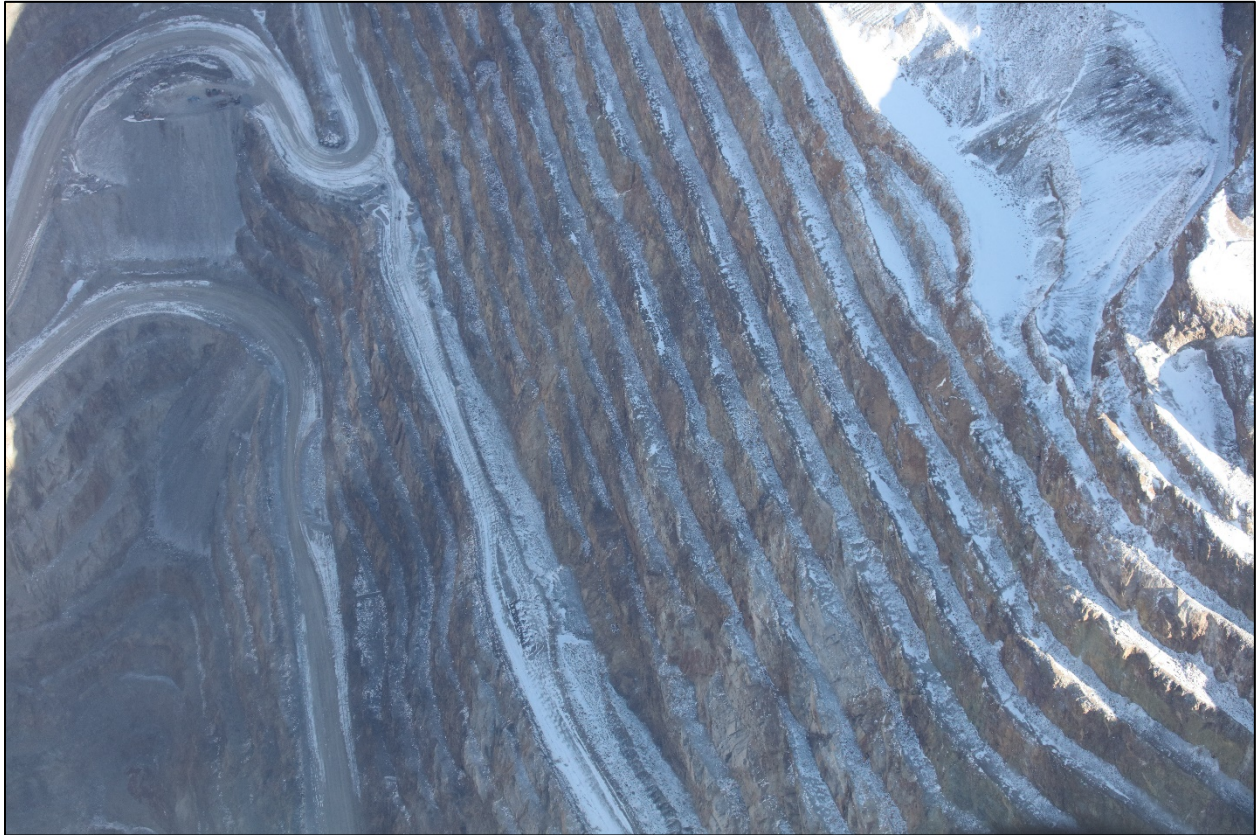
**Photo 14.** Main Cresson Pit, east highwall; looking north.

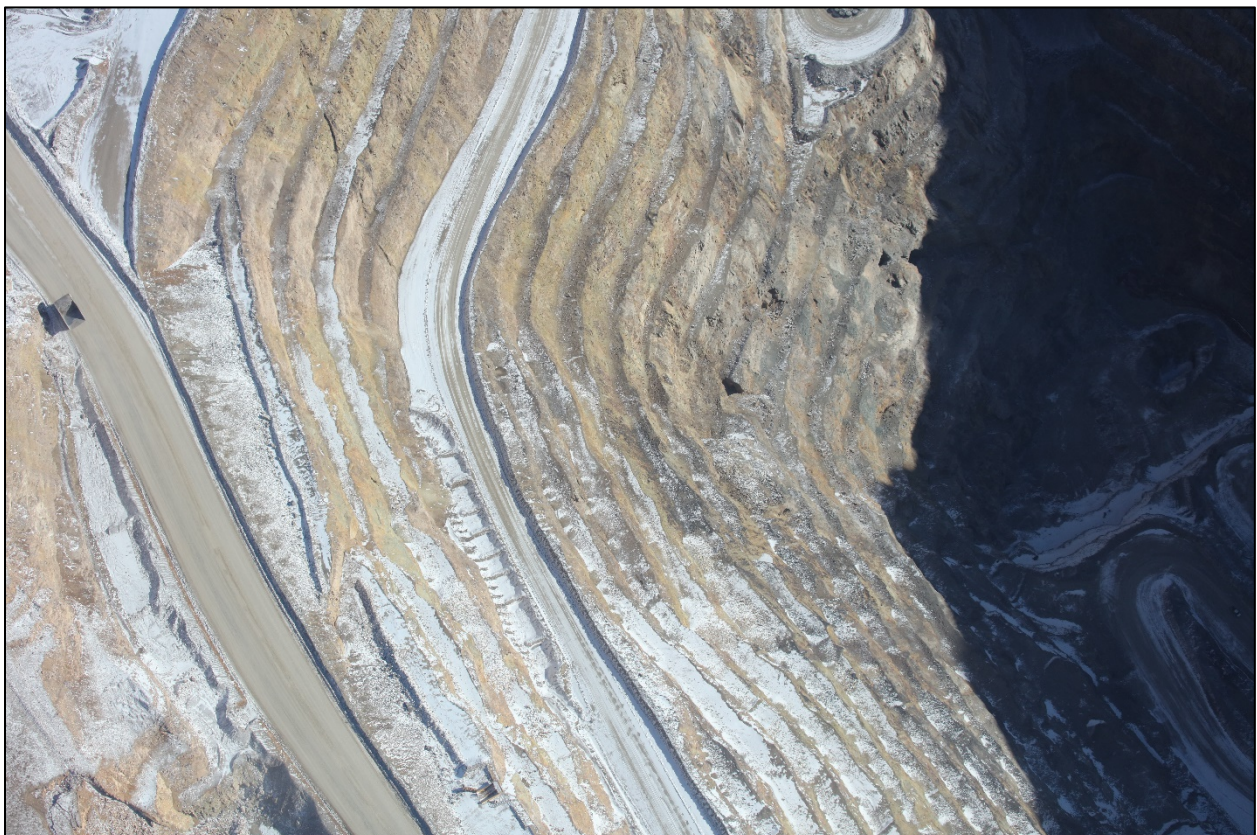
**Photo 15.** Main Cresson Pit, west highwall; looking north.

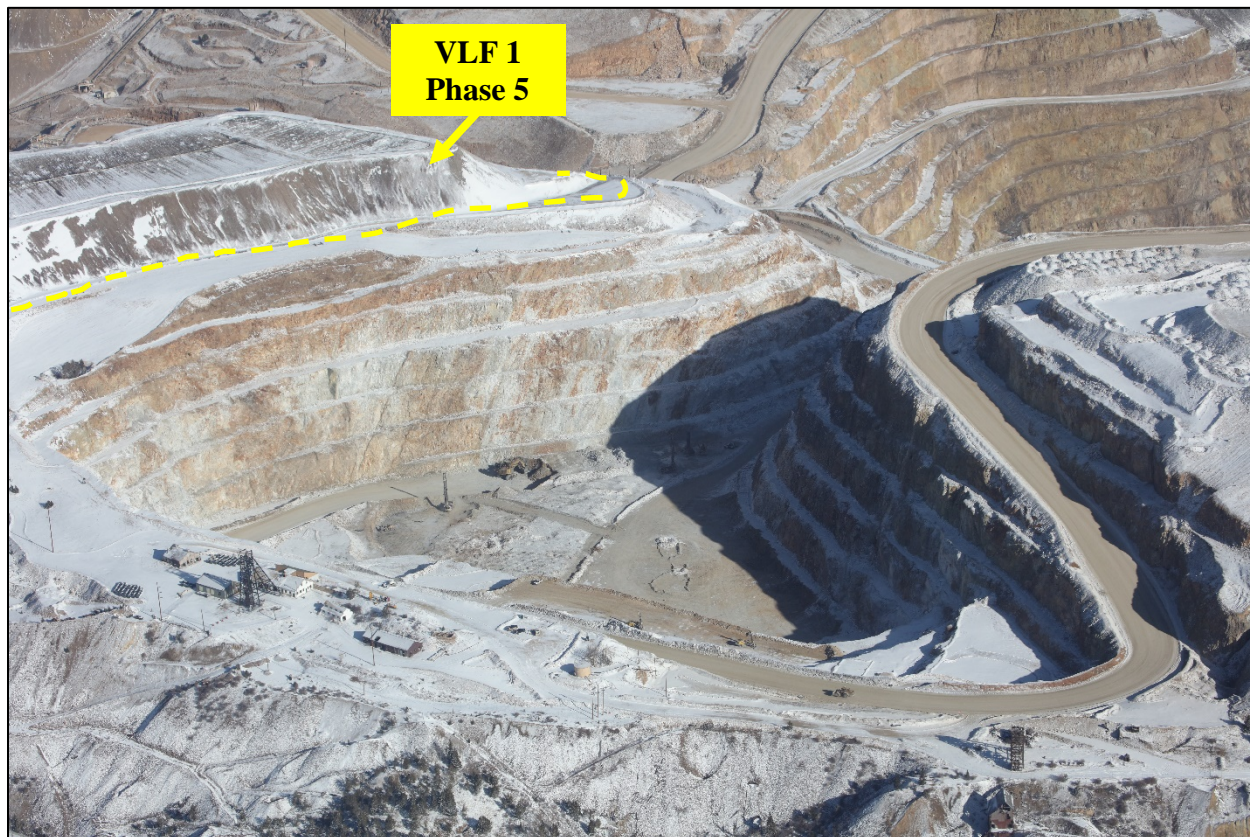
**Photo 16.** South Cresson Pit; looking northwest.
