MINERALS PROGRAM INSPECTION REPORT
PHONE: (303) 866-3567

MINE NAME: Cresson Project	MINE/PROSPECTING ID#: M-1980-244	MINERAL: Gold	COUNTY: Teller
INSPECTION TYPE: Aerial Inspection	INSPECTOR(S): Elliott Russell	INSP. DATE: July 30, 2021	INSP. TIME: 12:30
OPERATOR: Cripple Creek & Victor Gold Mining Company	OPERATOR REPRESENTATIVE: None	TYPE OF OPERATION: 112d-3 - Designated Mining Operation	
REASON FOR INSPECTION: Normal I&E Program	BOND CALCULATION TYPE: None	BOND AMOUNT: \$159,491,188.00	
DATE OF COMPLAINT: NA	POST INSP. CONTACTS: None	JOINT INSP. AGENCY: DRMS	
WEATHER: Cloudy	INSPECTOR'S SIGNATURE:

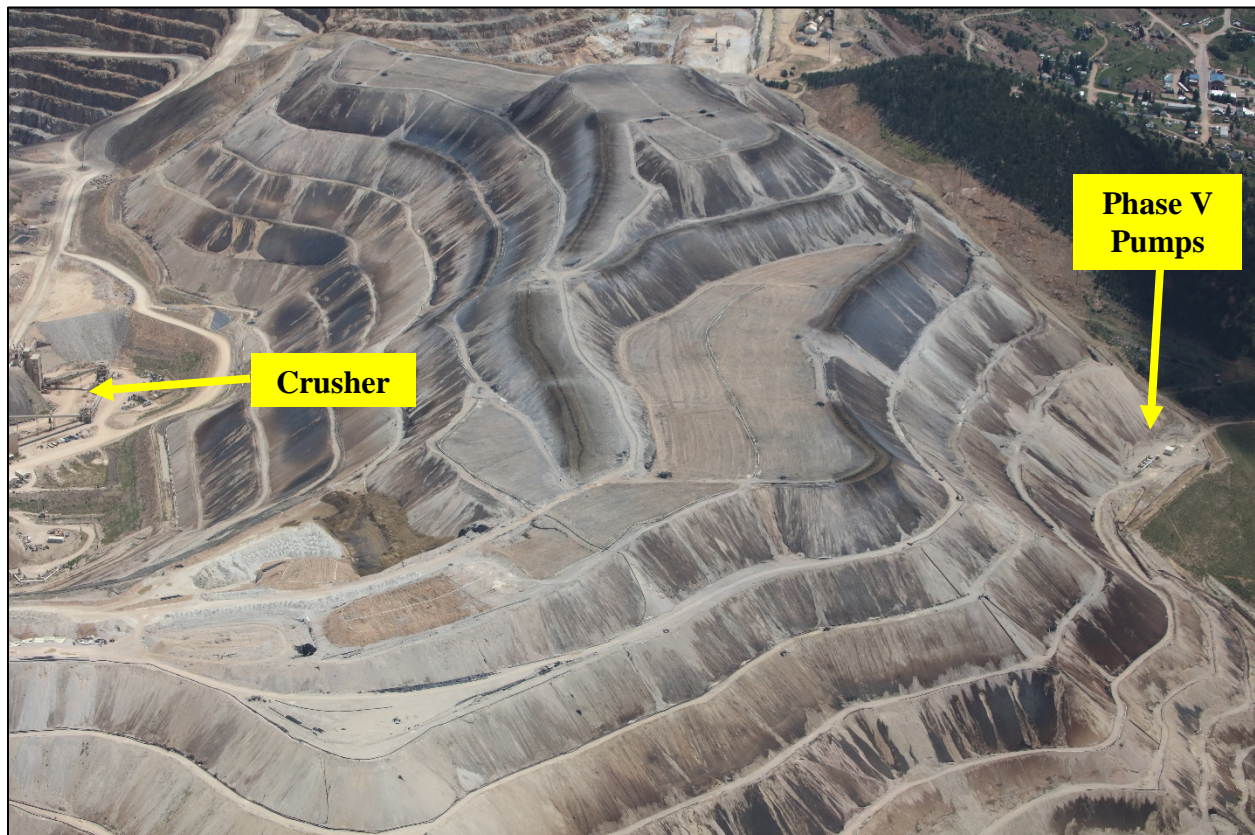
Aerial images of the two Valley Leach Facilities (VLF 1 and VLF 2) are used to perform a broad visual inspection for ponded solution, slope stability concerns, ore stacking compliance, and other potential issues that cannot easily be obtained from the ground. No ponded process solution was observed in the active leach areas of VLF 1 (see **Photo 1** and **Photo 2**). No observable issues are noted for VLF 1. No ponded process solution was observed in the active leach areas of VLF 2 and active ore stacking was occurring in the northwest portion of VLF 2 (see **Photo 3**). No observable issues are noted for VLF 2.

Photo 1. VLF 1; looking east.

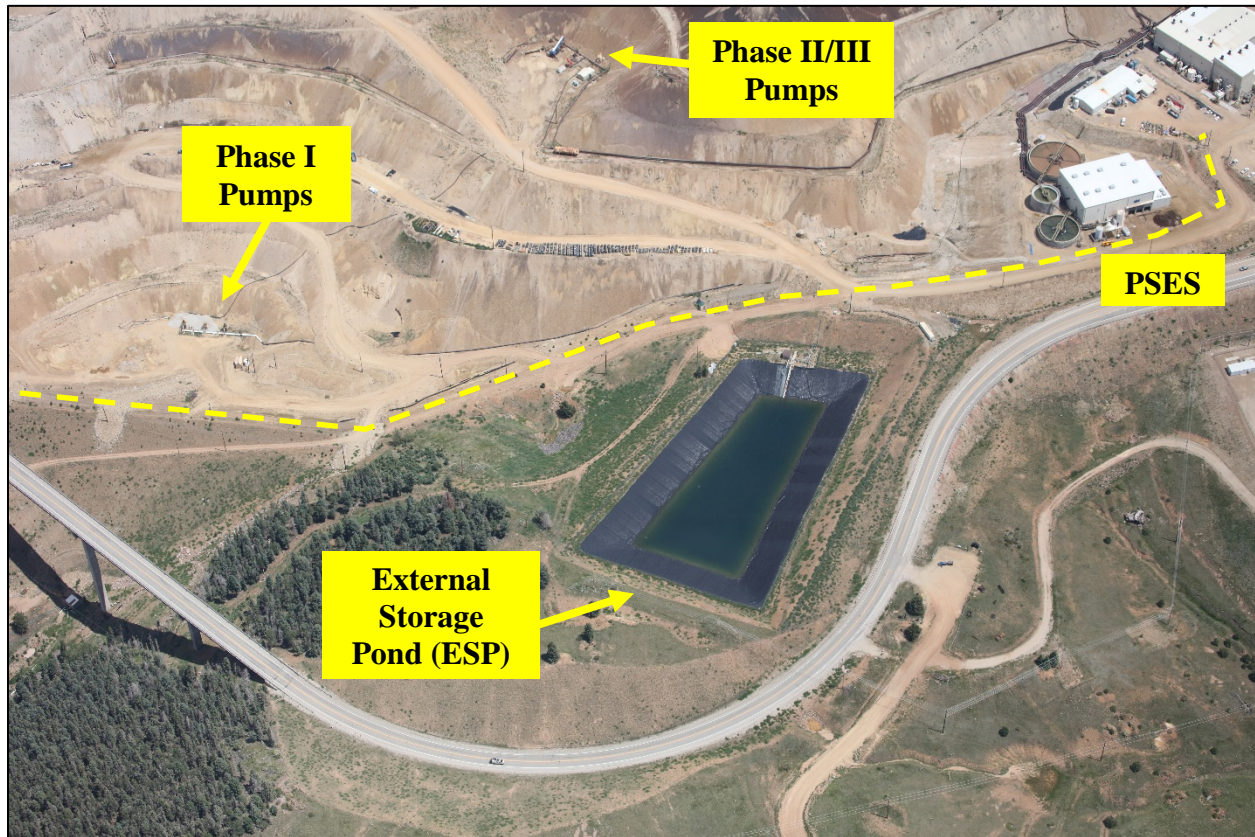
Photo 2. VLF 1, approximate Edge of Liner highlighted; looking east.

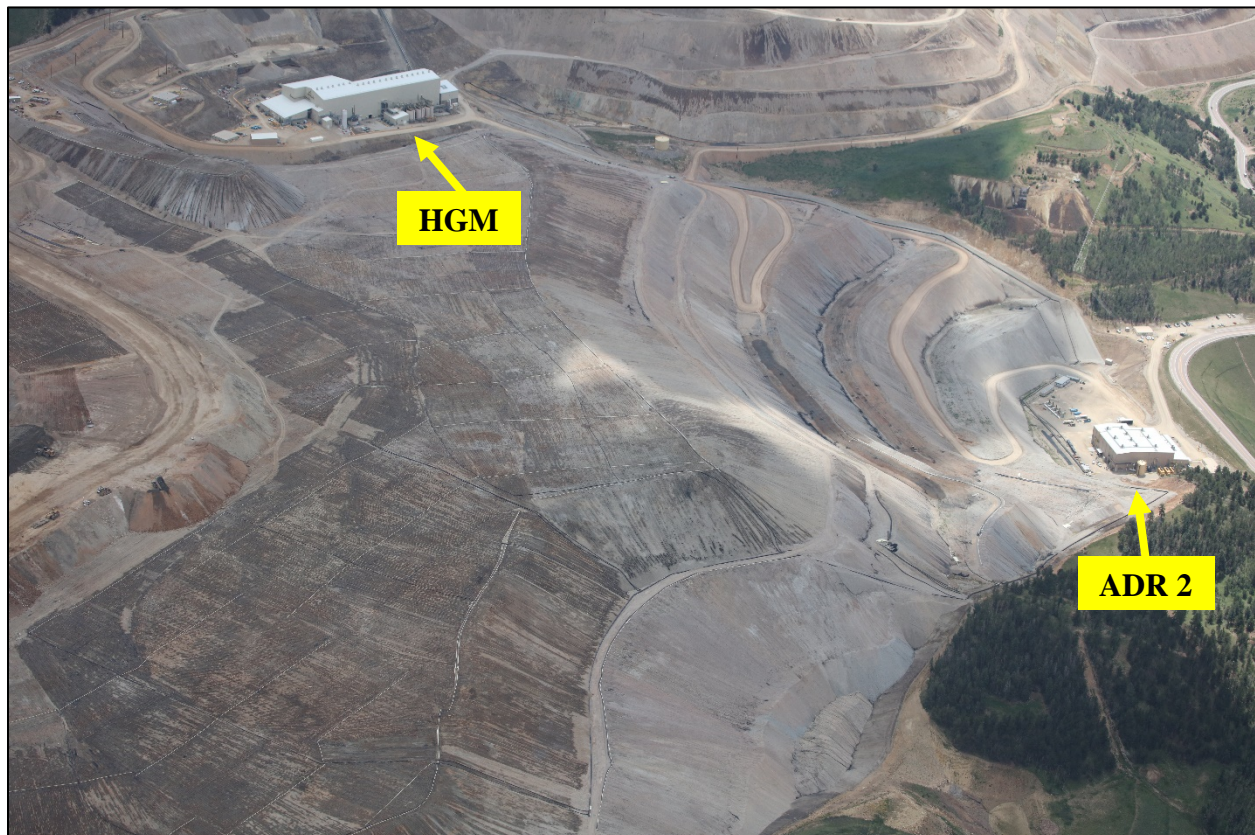
Photo 3. VLF 2; looking southeast.

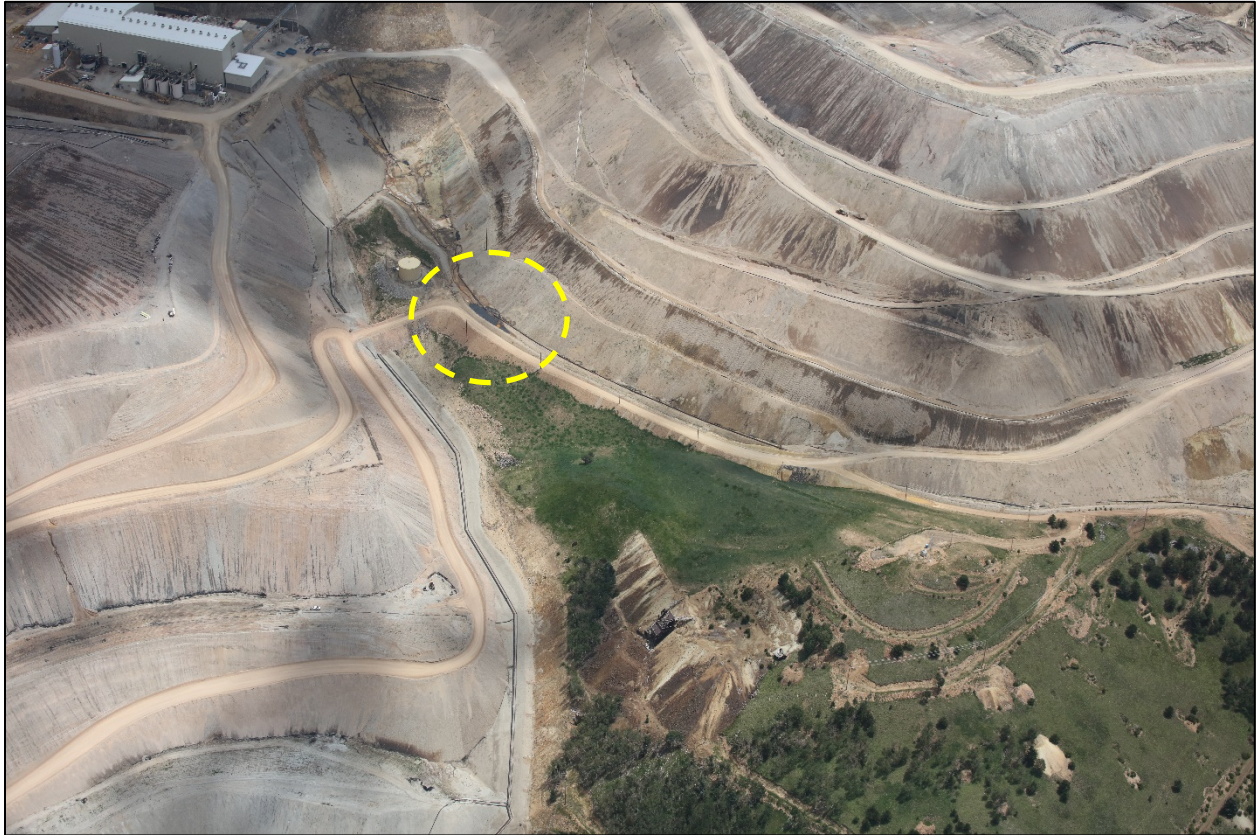
After the aerial inspection, but prior to the date of this report, the Operator notified the Division on August 4th, that the site received significant rainfall the previous evening which exceeded stormwater controls on VLF 1 near the High Grade Mill (HGM) water tank (see **Photo 4**). The Division inspected this area during the August 10, 2021 site inspection.

Photo 4. 8/3/21 Storm Event area discharge area circled; looking east.

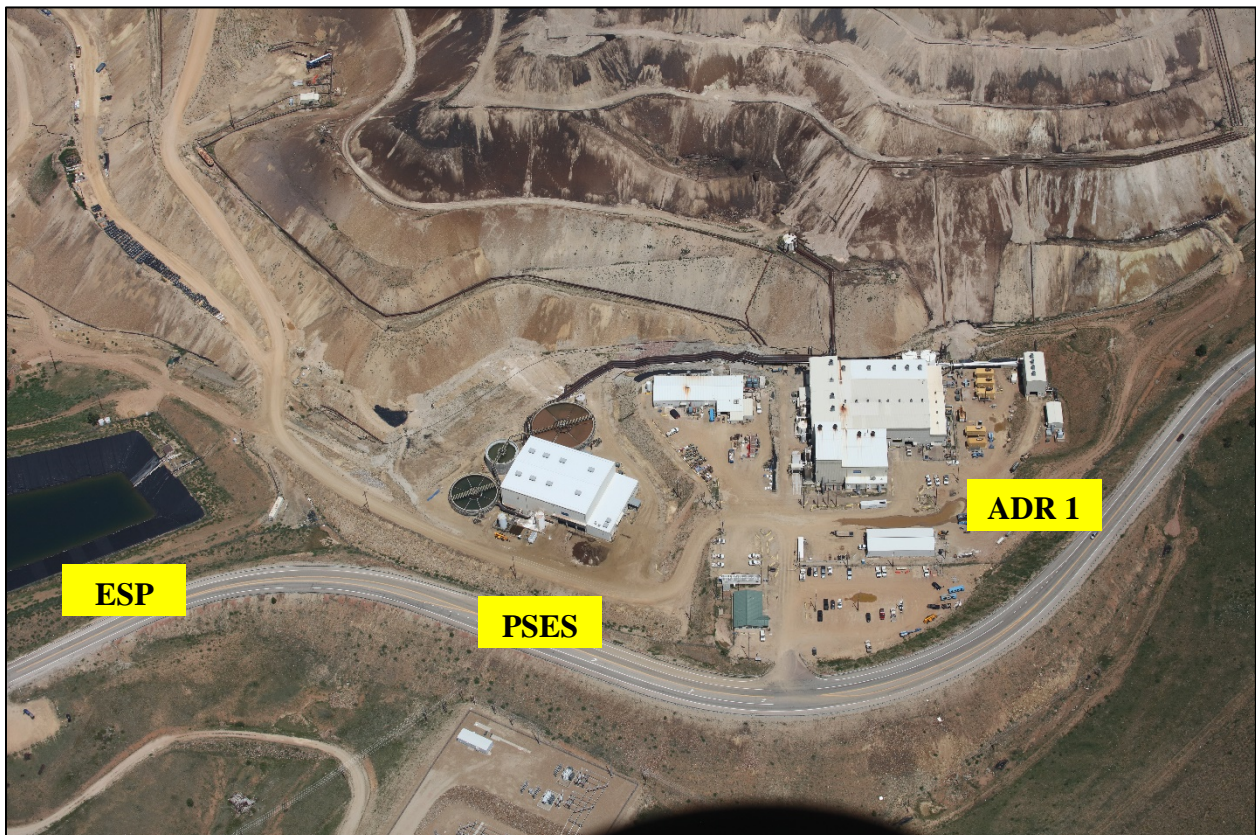
Aerial images of the Adsorption, Desorption, and Recovery Facilities (ADR 1) the Process Solution Enhancement System Facility (PSES), and the HGM are used to perform a broad visual inspection for leaks, spills, secondary containment problems, and other potential issues that cannot easily be obtained from the ground. Please note, detailed photos of ADR 2 were not taken during the inspection. The ADR 1 and the PSES are both located on the south side of VLF 1 (see **Photo 5**). The HGM is located between VLF 1 and VLF 2 (see **Photo 6**). No observable issues are noted for ADR 1, PSES, or the HGM facilities.

Photo 5. ADR 1 and PSES; looking north.

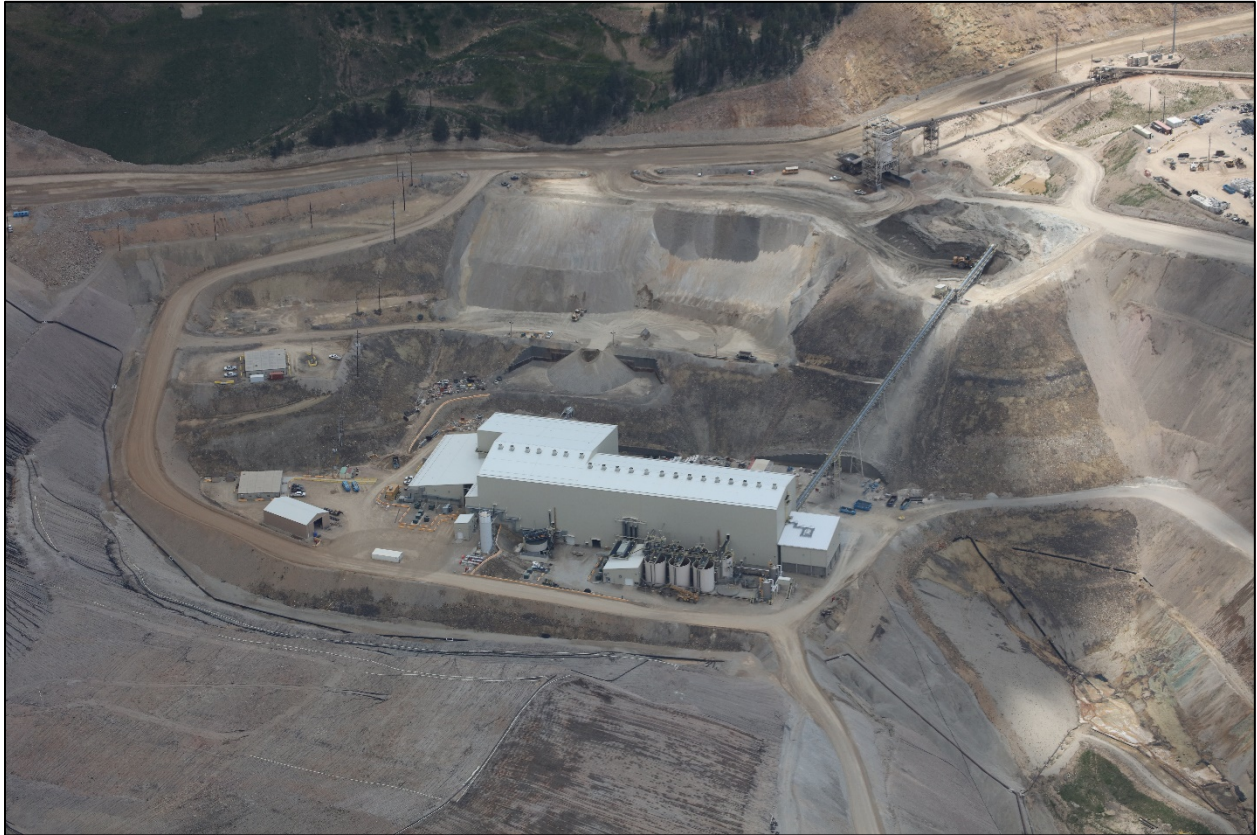
Photo 6. HGM; looking east.

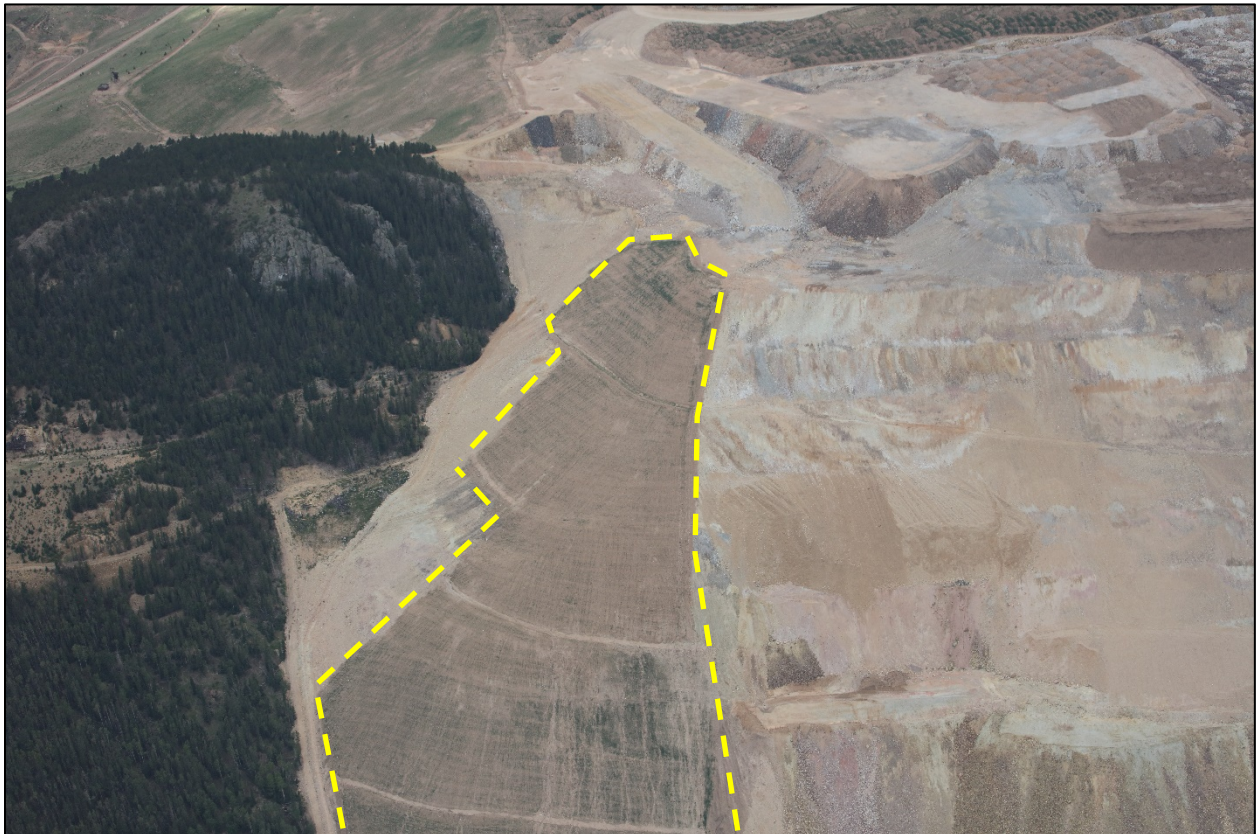
In 2020, the Operator completed partial reclamation of an area on the far eastern portion of the ECOSA (see **Photo 7**). Erosion rills and gullies observed during the July 28, 2021 site inspection can be seen from the aerial photos of the reclamation area. Slope grading has recently occurred on the area to the west of the 2020 reclamation as a continuation of the concurrent reclamation project and topsoil has been staged at the crest of the slope (see **Photo 8**).

Photo 7. 2020 concurrent reclamation area on the ECOSA; looking southwest.

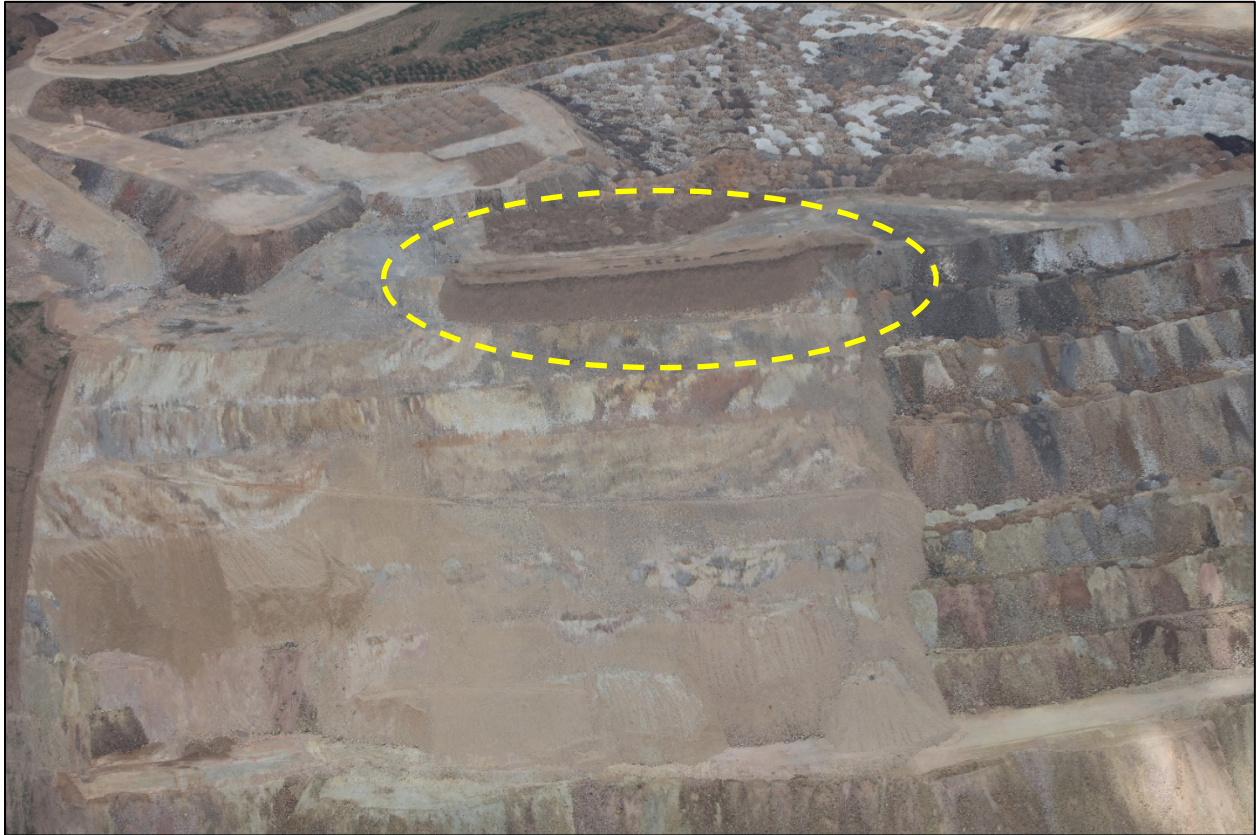
Photo 8. 2021 concurrent reclamation area on the ECOSA, staged topsoil circled; looking southwest.

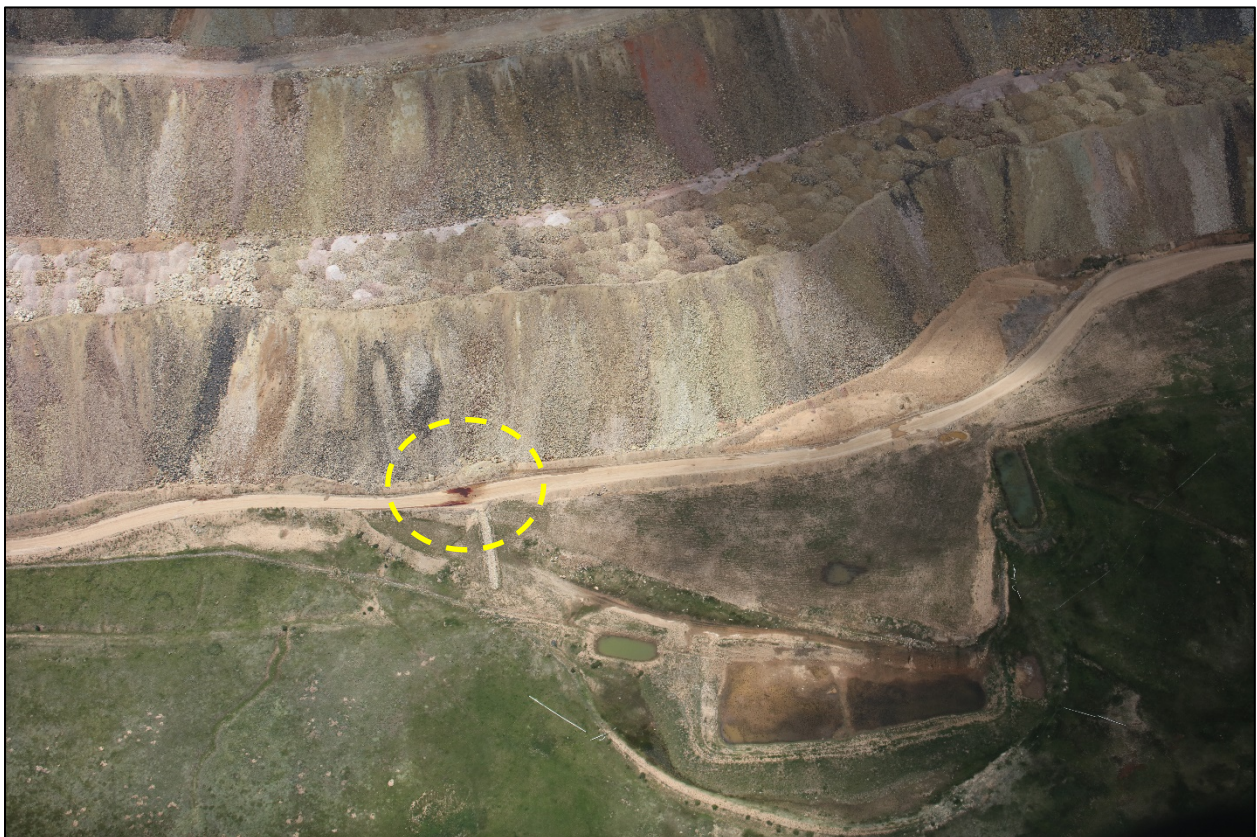
18th, that an additional seep has expressed at the toe of the ECOSA; the Division has included an aerial photo in this report with the possible area of the new seep and will inspect this area during the next normal monitoring inspection (see **Photo 9**).

Photo 9. Possible new seep location at toe of ECOSA circled; looking southwest.

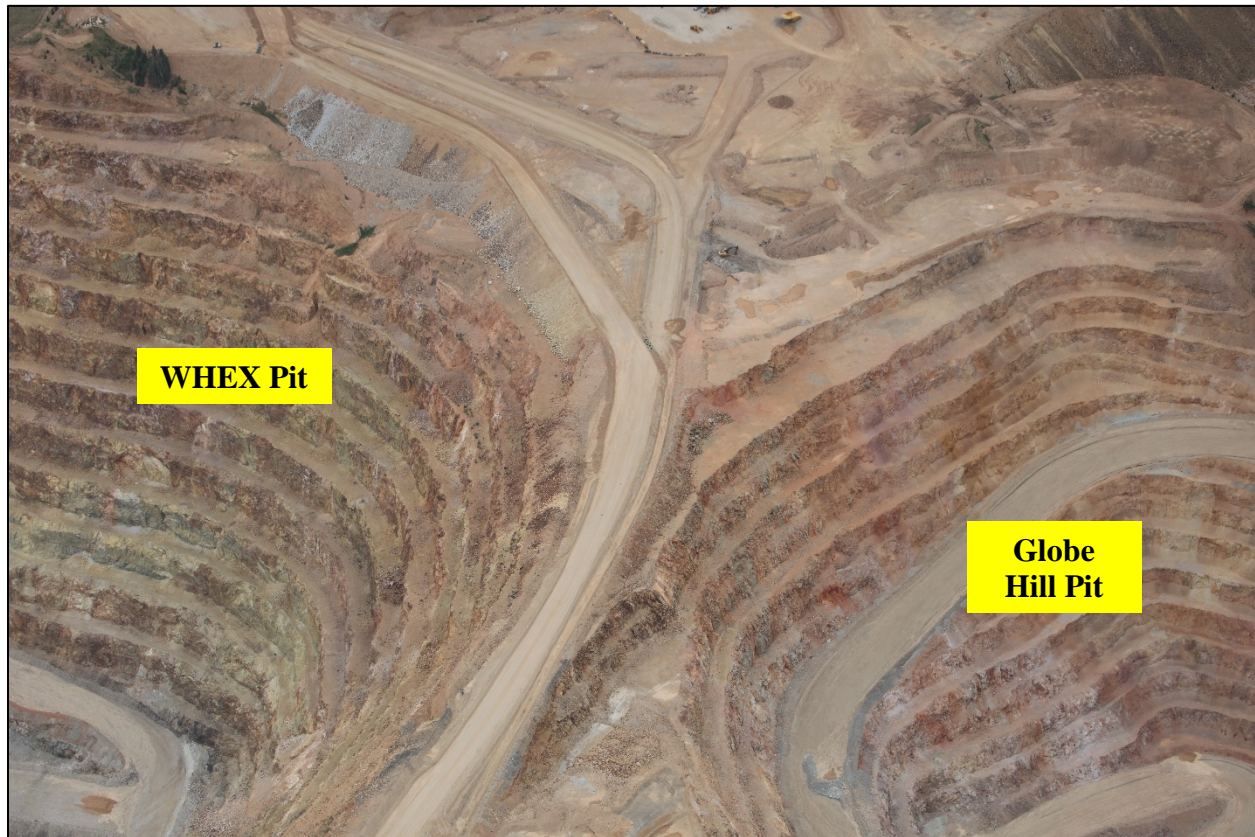
On July 8, 2021, the Operator submitted Technical Revision TR128 proposing the relocation of the Ironclad Access Road from its current alignment located between the WHEX and Globe Hill Pits (see **Photo 10**) to the area around the north and east sides of the WHEX Pit and then across Grassy Valley (see **Photo 11** and **Photo 12**). The Ironclad Access Road relocation will allow the Operator to mine the ridge that has been left between the WHEX and Globe Hill Pits. The current decision date for TR128 has been extended to September 17, 2021.

Photo 10. Existing Ironclad Access Road; looking south.

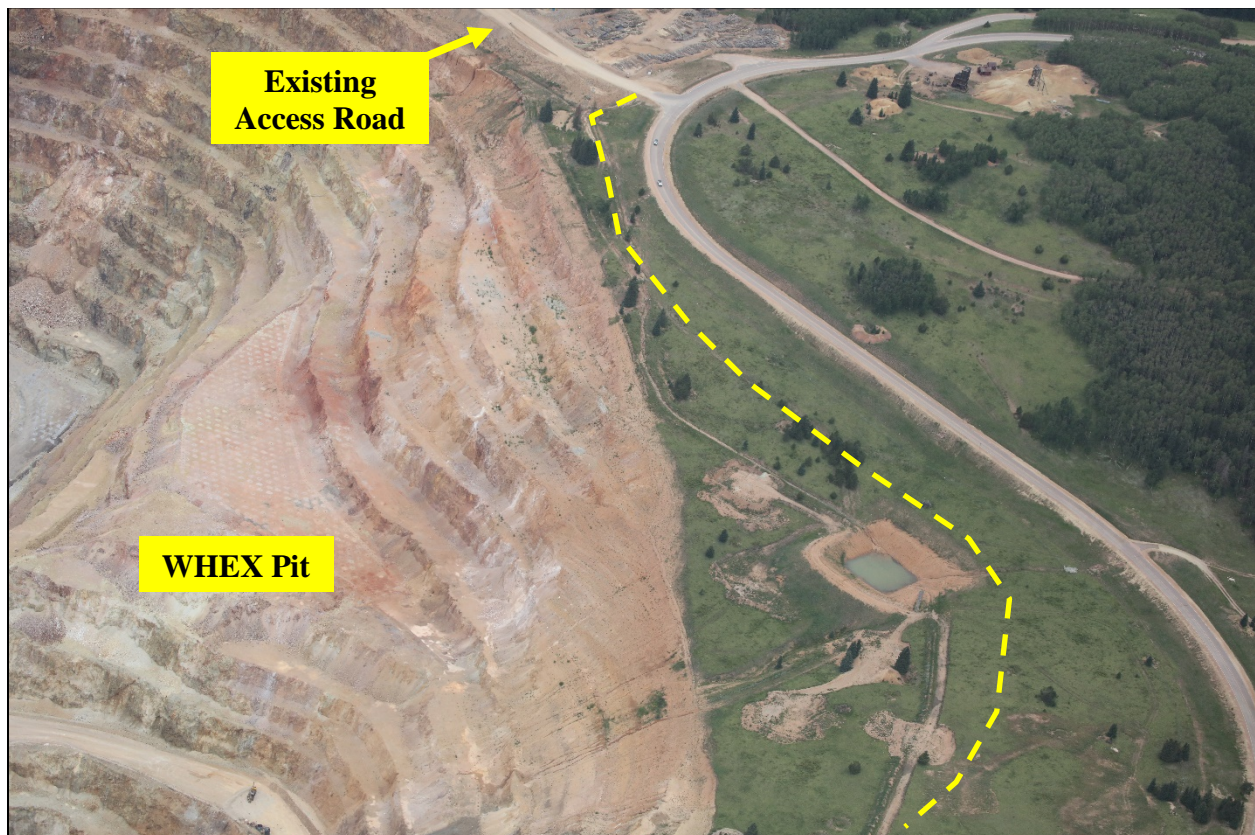
Photo 11. Area of proposed Ironclad Access Road relocation; looking west.

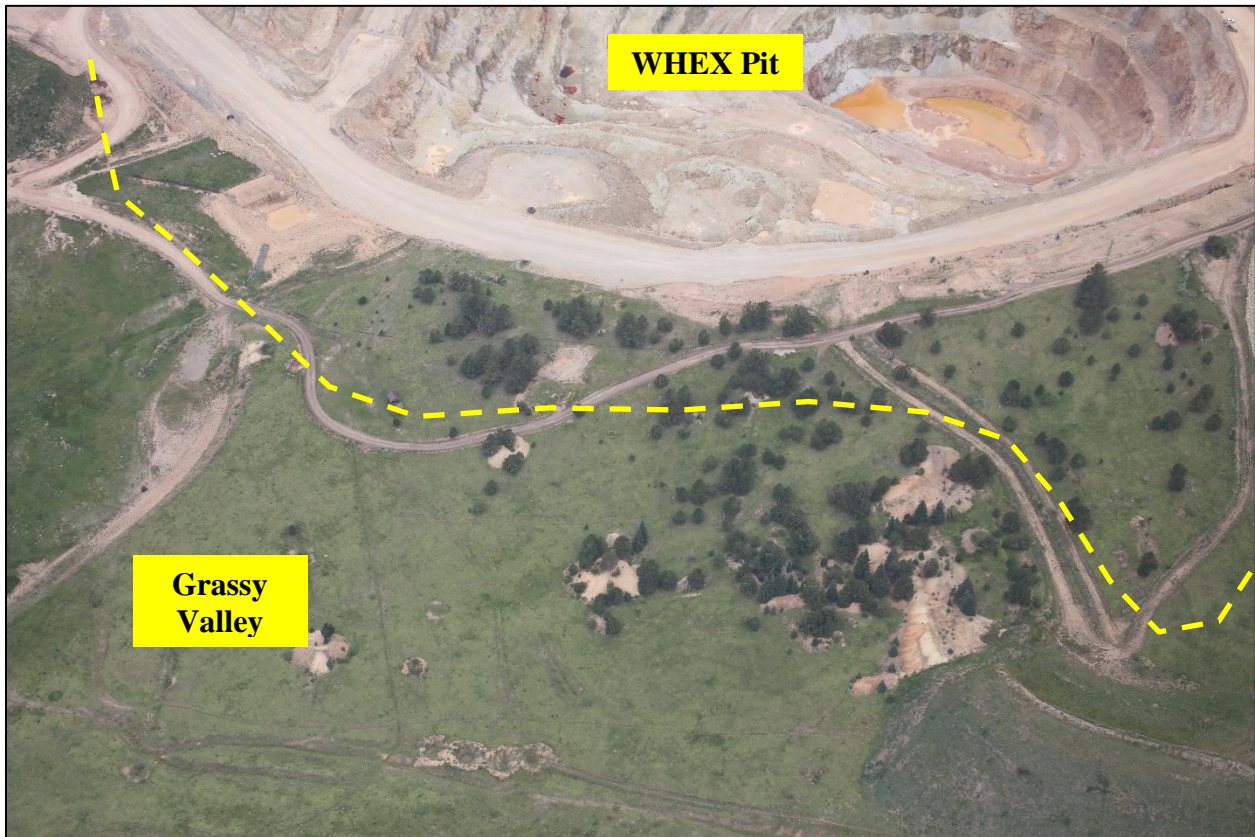
Photo 12. Area of proposed Ironclad Access Road relocation; looking southwest.

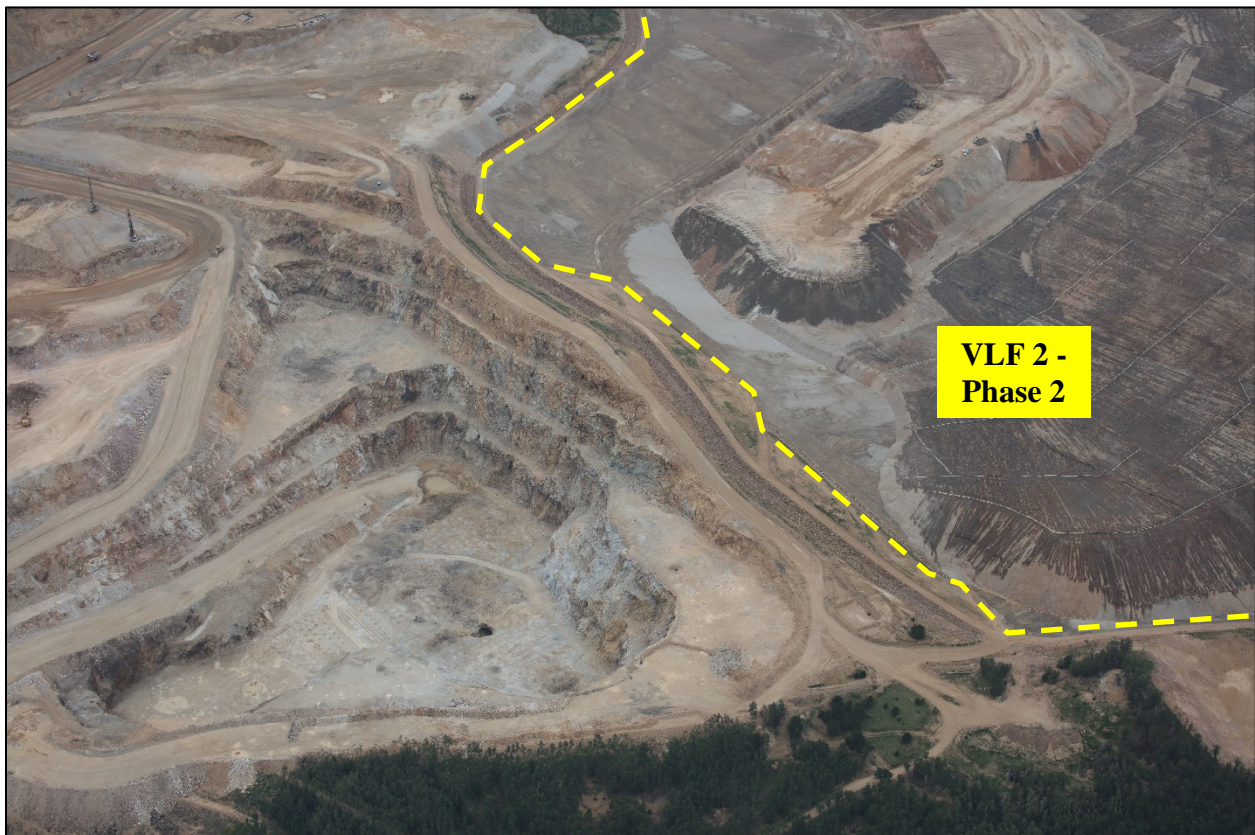
Aerial images of the Schist Island (see **Photo 13**), Globe Hill (see **Photo 14**), Main Cresson (see **Photo 15**), and South Cresson Pits (see **Photo 16**) are presented for comparison with previous aerial inspection reports. Based on aerial photos taken at the time of the inspection, active mining was occurring in the Schist Island, Globe Hill, and South Cresson Pits.

Photo 13. Schist Island Pit; looking southeast.

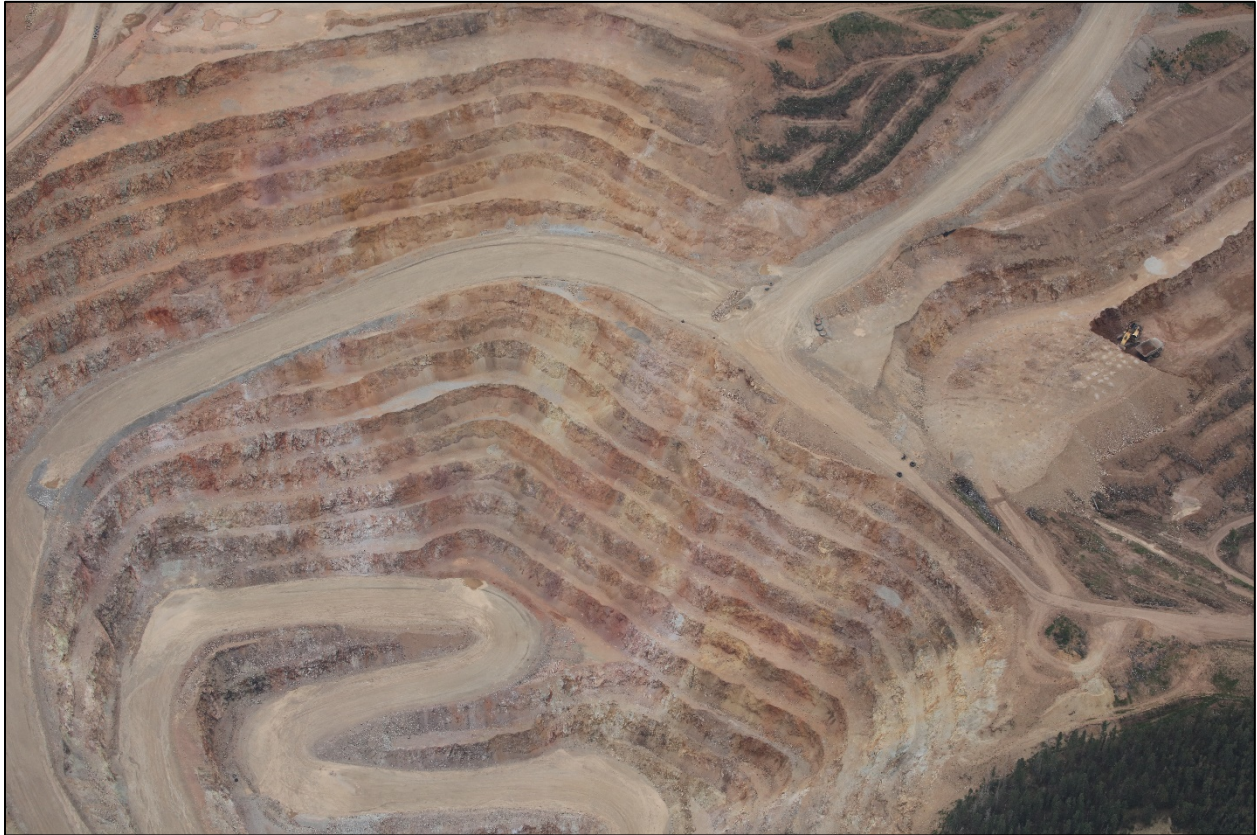
Photo 14. Globe Hill Pit; looking east.

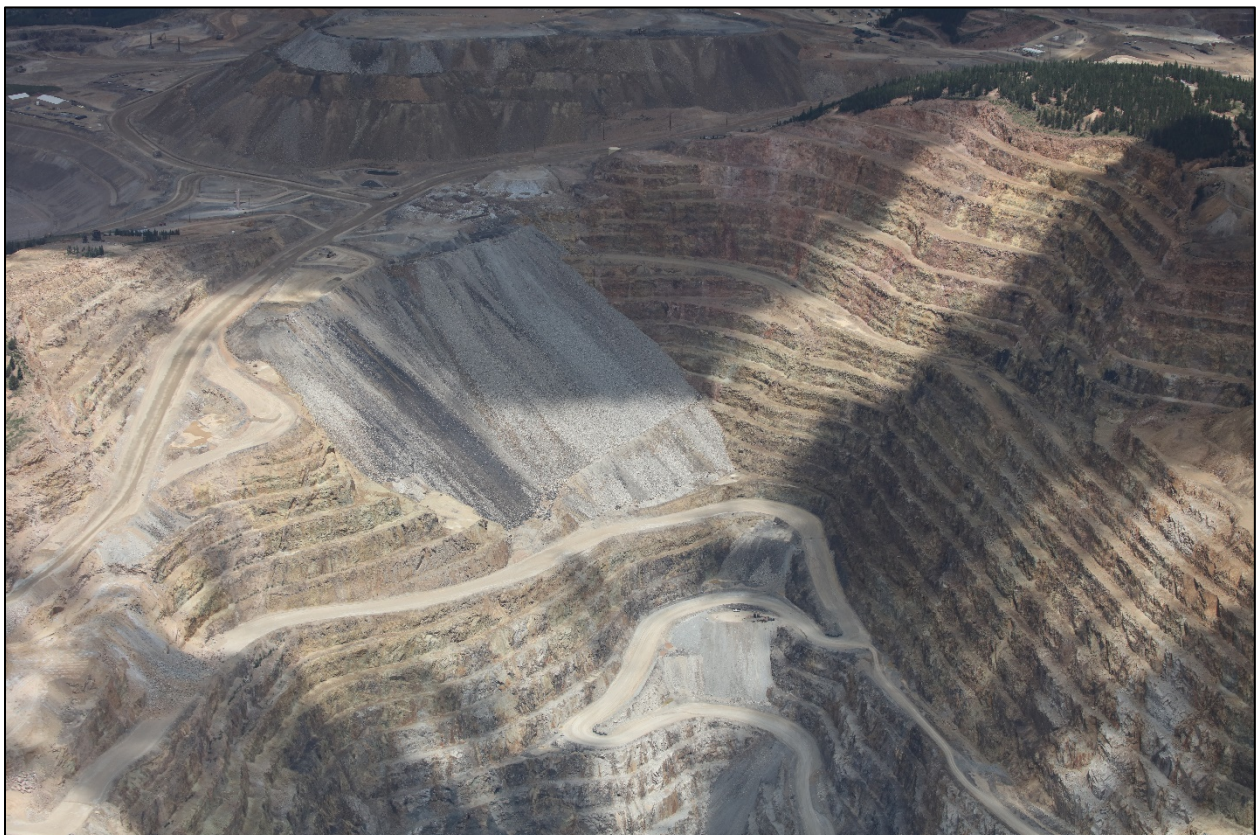
Photo 15. Main Cresson Pit; looking north.

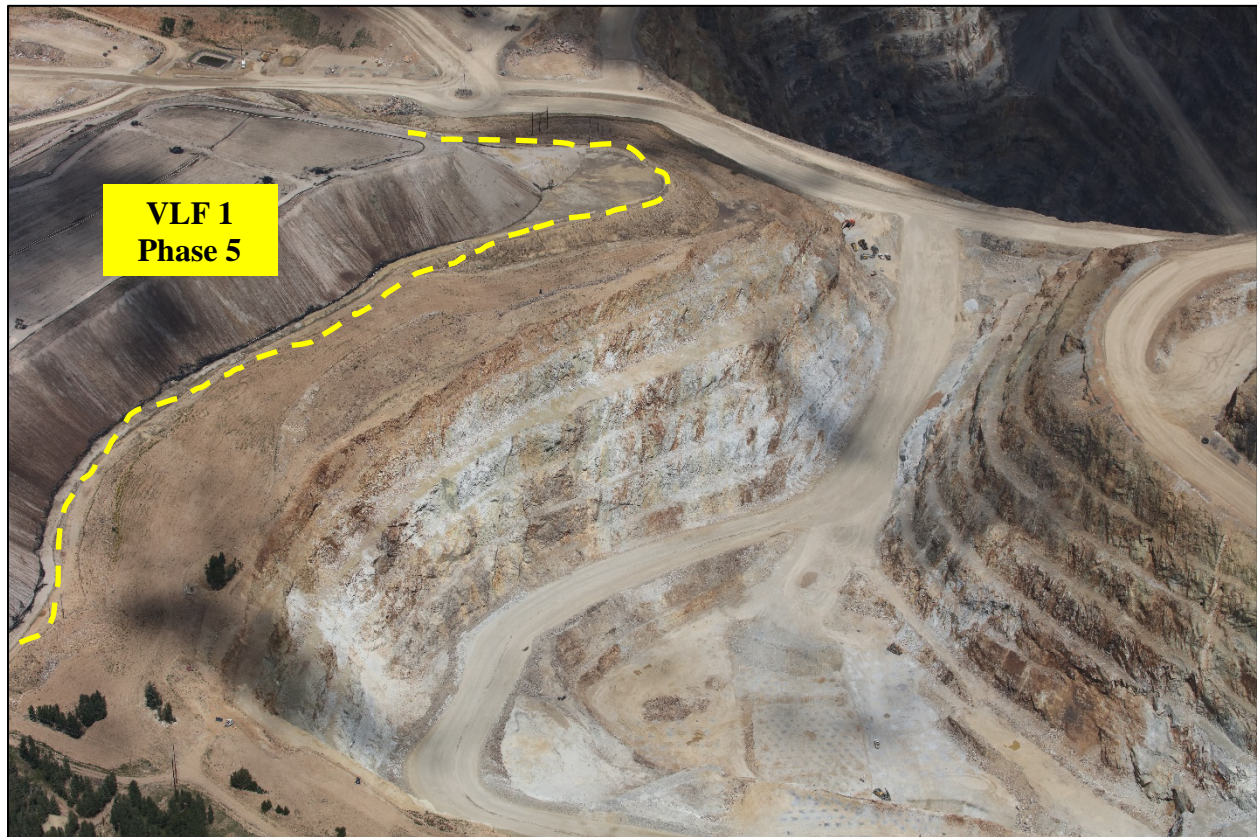
Photo 16. South Cresson Pit; looking northwest.
