STATE OF
COLORADO

Bowie No. 1 inspection report

Permit Number: C-1981-038 Mine Name: Bowie No. 1 Mine Operator: Bowie Resources, LLC Operator Address: Mr. Basil R Bear P.O. Box 1488 Paonia, CO 81428	County: Delta Operation Type: Underground Permit Status: Active Ownership: Private
	Operator Representative Present: Basil Bear
Operator Representative Signature: (Field Issuance Only)

Inspection Start Date: March 3, 2022 Inspection Start Time: 14:00 Inspection End Date: March 3, 2022 Inspection End Time: 16:15		Inspection Type: Coal Complete Inspection Inspection Reason: Normal I&E Program Weather: Cloudy	
Joint Inspection Agency: None		Joint Inspection Contacts: 	
Post Inspection Agency: None		Post Inspection Contacts: 	
Inspector(s): Robert Zuber, P.E.	Inspector's Signature: <i>Robert D. Zuber</i>		Signature Date: 3/6/2022

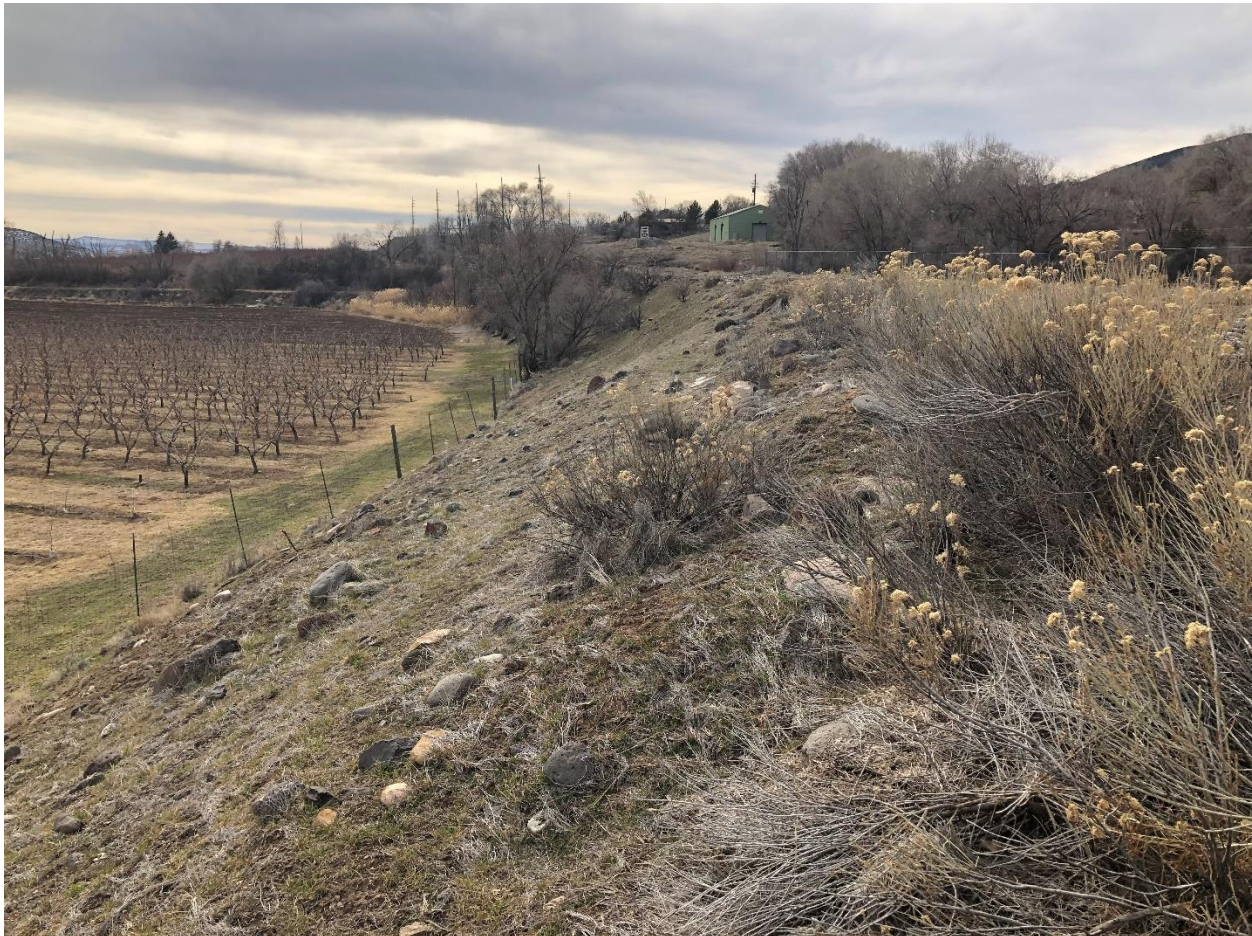
The slope below the Loadout is stable. No erosion or other problems were seen there. Some trash, equipment, and branches were seen at the Loadout, and BRL should remove the trash and branches in the near future.

Slope below Loadout

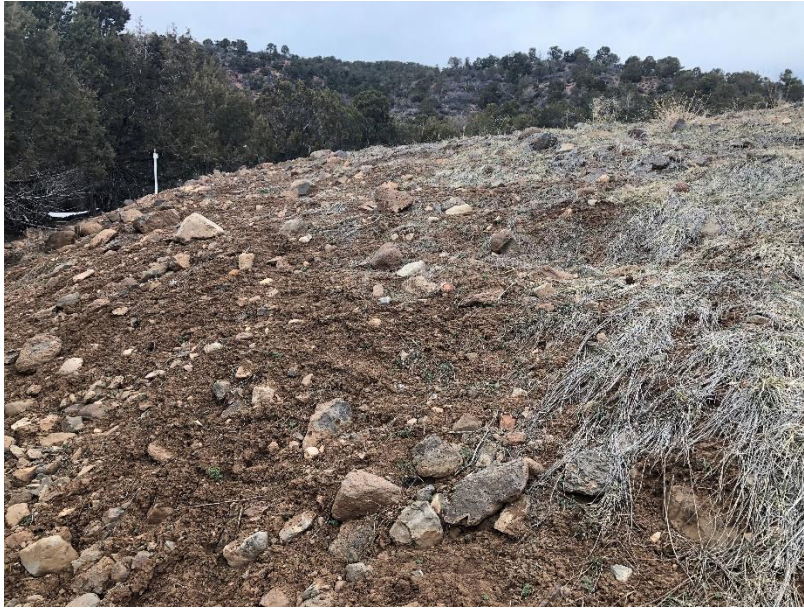
At the first bend in the haul road west of the RDA (across the valley from the ROM), the slope below the road was inspected. It was generally stable, but a bare spot was seen near the bottom (edge of disturbed area). BRL should use silt fence, erosion logs, or other practices to prevent erosion at this location.

Bare area below haul road (southwest corner of East Mine)

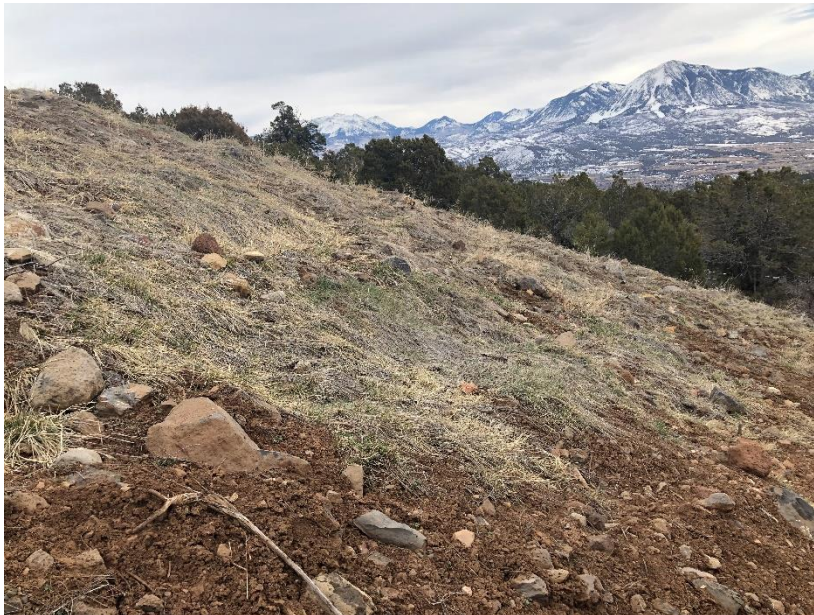
Stable slope below haul road (southwest corner of East Mine) with roughened surface to prevent erosion

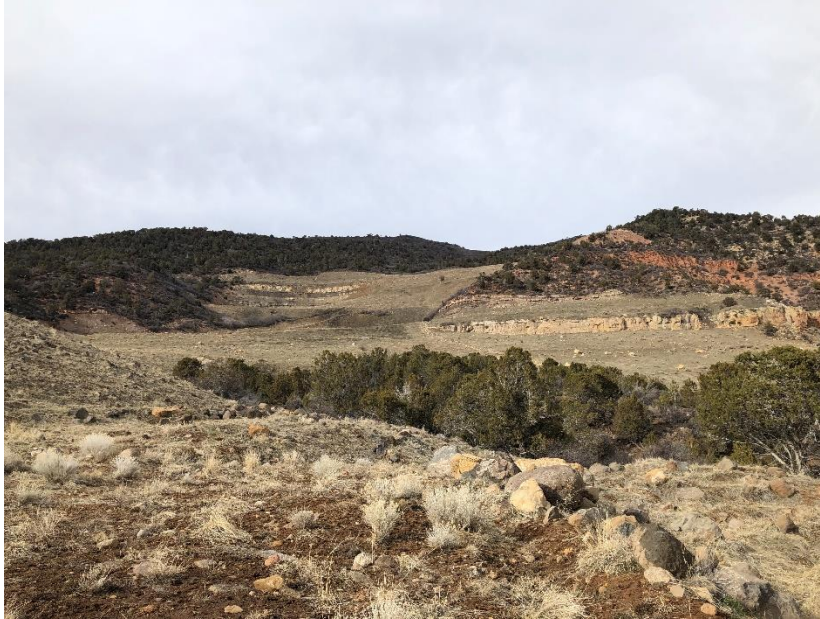
East Mine viewed from bottom

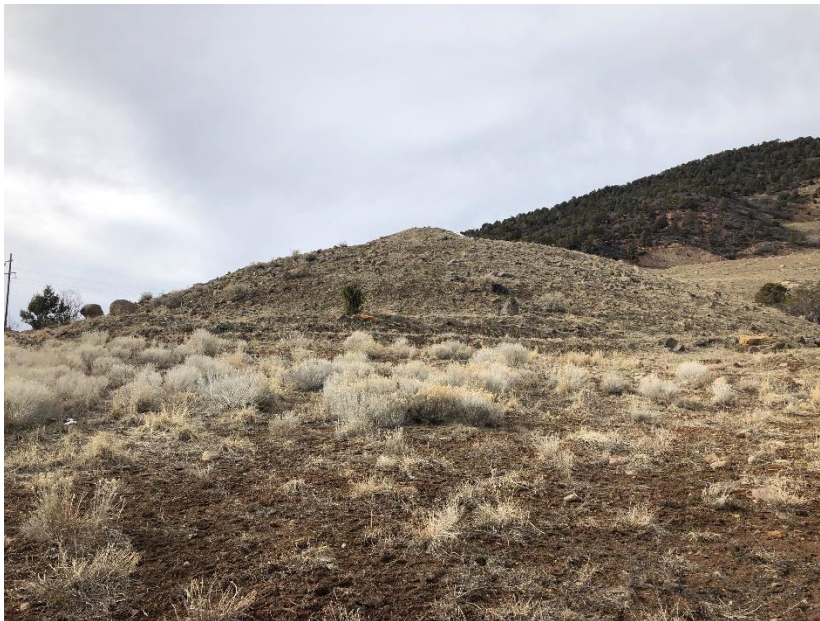
Refuse Disposal Area at East Mine

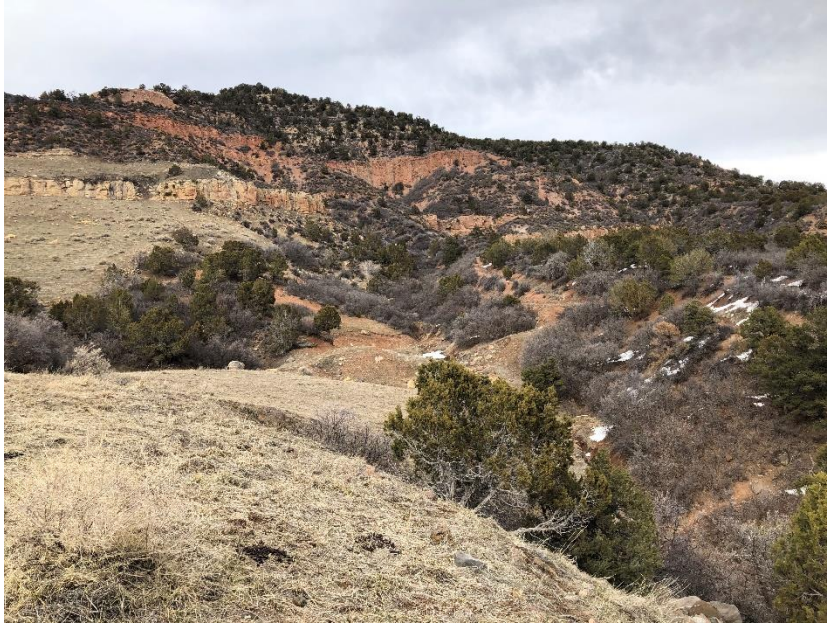
Looking up drainage where Pond 1 and Pond 2 were located (now reclaimed)

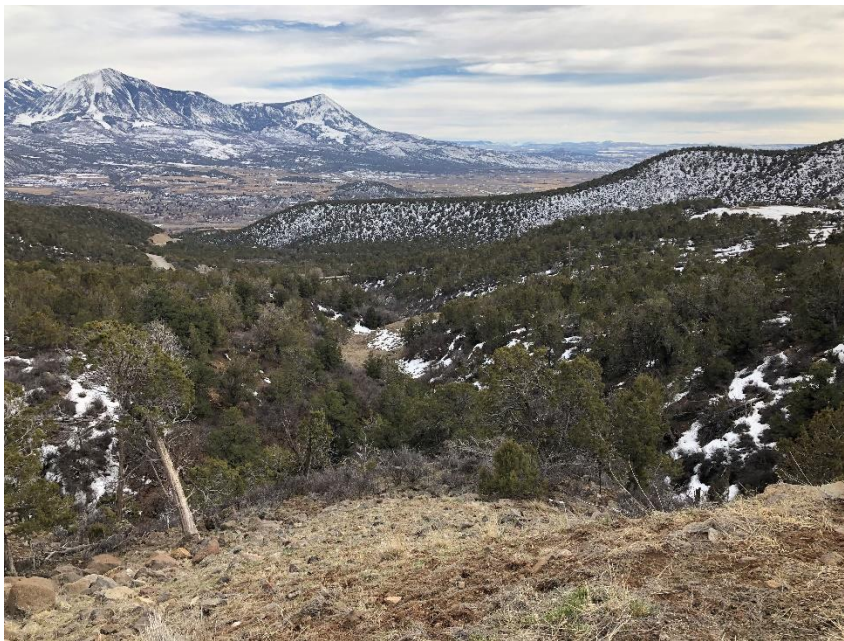
Looking down drainage where Pond 3 and Pond 4 were located (now reclaimed)

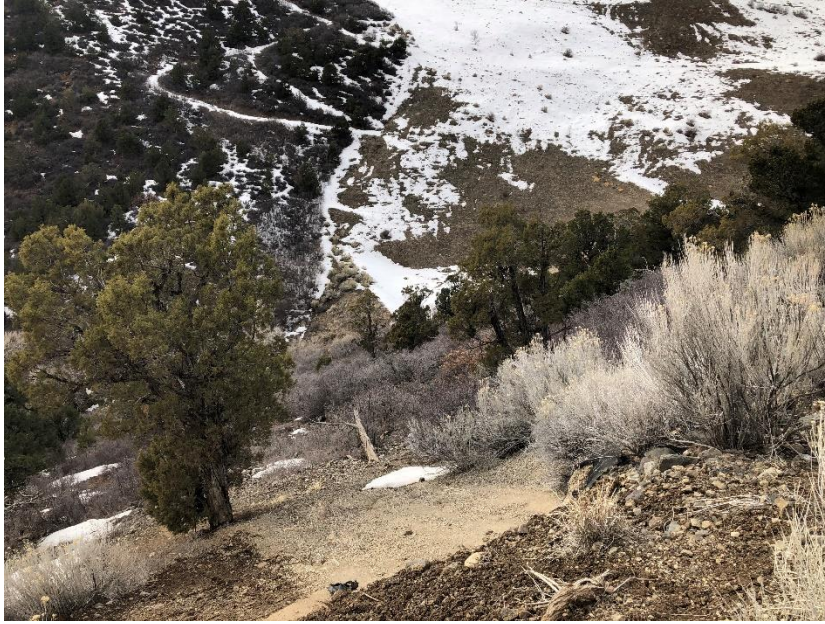
West Mine lower pond

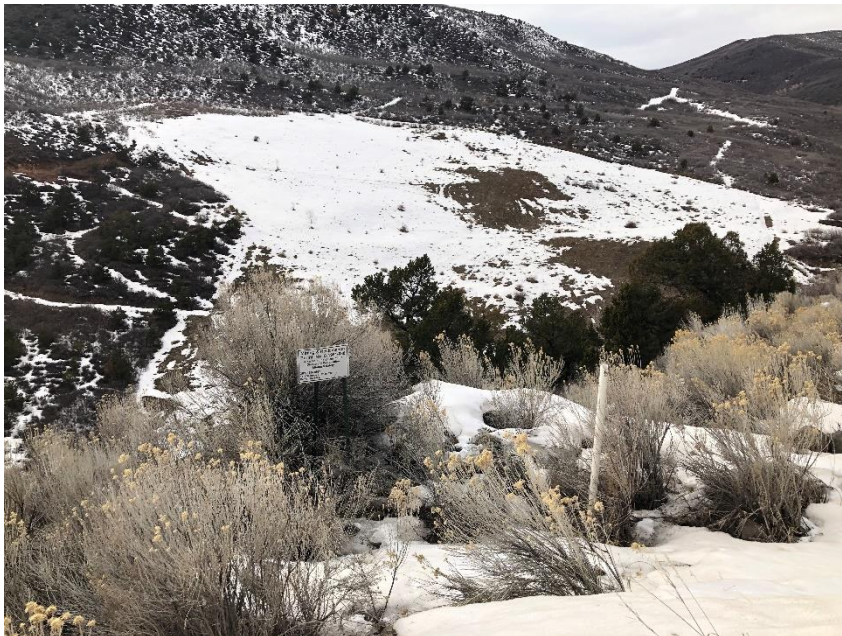
West Mine sign and slope
