# **Bowie No. 2 inspection report**

Permit Number: C-1996-083 Mine Name: Bowie No. 2 Mine Operator: Bowie Resources, LLC Operator Address: Mr. Basil Bear P.O. Box 1488 Paonia, CO 81428 County: Delta Operation Type: Underground Permit Status: Active Ownership: Private

Inspection Start Date: March 3, 2 Inspection Start Time: 12:00 Inspection End Date: March 3, 2 Inspection End Time: 14:40			<b>Inspection Type:</b> Coal Comp <b>Inspection Reason:</b> Normal I <b>Weather:</b> Clear	*
Joint Inspection Agency:		Joint Inspection Contacts:		
None				
Post Inspection Agency:		Post	Inspection Contacts:	
None				
Inspector(s):	Inspecto	r's Sig	gnature:	Signature Date:
Robert Zuber, P.E.	Phot D. Zh			
				3/6/2022

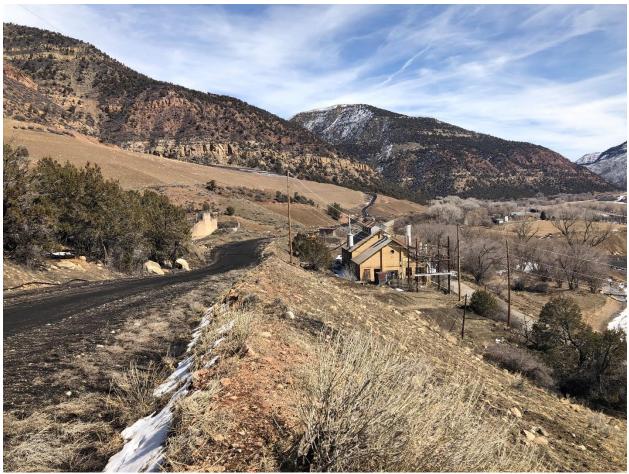
The road to Gob Pile #2 was very muddy.

Road to Gob Pile #2, west of old power plant (pile on upper left)

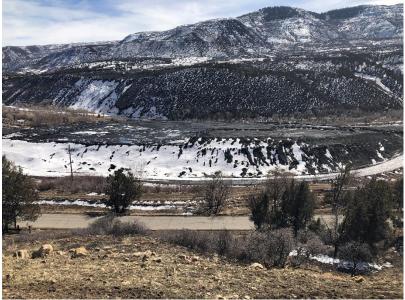
Overall the gob piles appeared stable. Due to extremely muddy conditions, the piles were observed from afar.

North side of Gob Pile #3

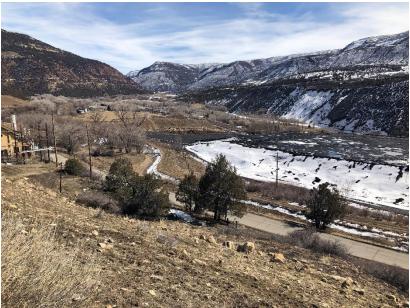
East end of Gob Pile #3

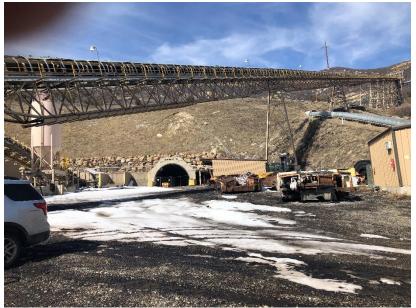
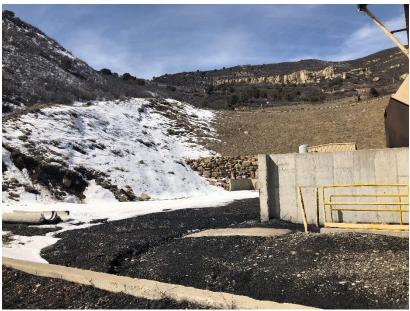
**B** Portal bench

It appears that slumps have not moved significantly in the recent past. These include slumps by the B Portal and by Curve Number 11 along the Haul Road. The Division recommends that these continue to be monitored closely by BRL.

All benches appeared stable with no signs of erosion. These include the pads for the Utility Bench, B Portal bench and the D Portal bench. Other comments on facilities:

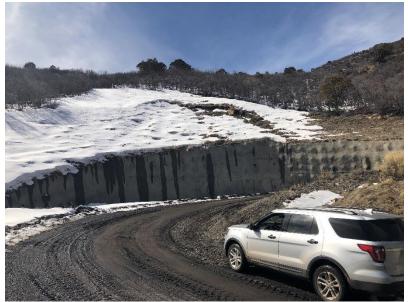
Curve 11 slump

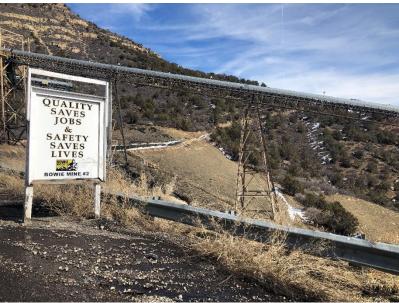
Slope below D Portal bench

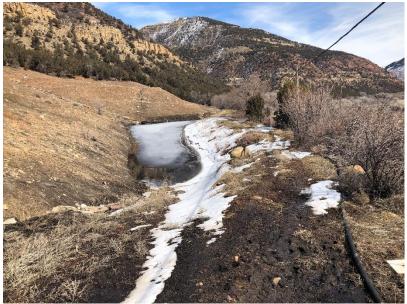
Pond F

Six sediment ponds were inspected: B, C, D, F, J, and K. None of the ponds were discharging. Five of the ponds contained water from recent precipitation, but none of the ponds were close to full. (In Pond K, there was no standing water but the soil was muddy.) No significant problems were identified with embankments, spillways, inlet channels, or other features of the ponds.
