RE: 2021 Annual Report, Henderson Mine and Mill, Permit No M-1977-342

Re: **#1333.0 - Henderson Mill
TSF Flood Storage**

Subject: Annual (Year 2021) Tailings Storage Facility Evaluation, Henderson Tailings Storage Facility, Permit No. M-1977-342, Henderson Mill, Colorado

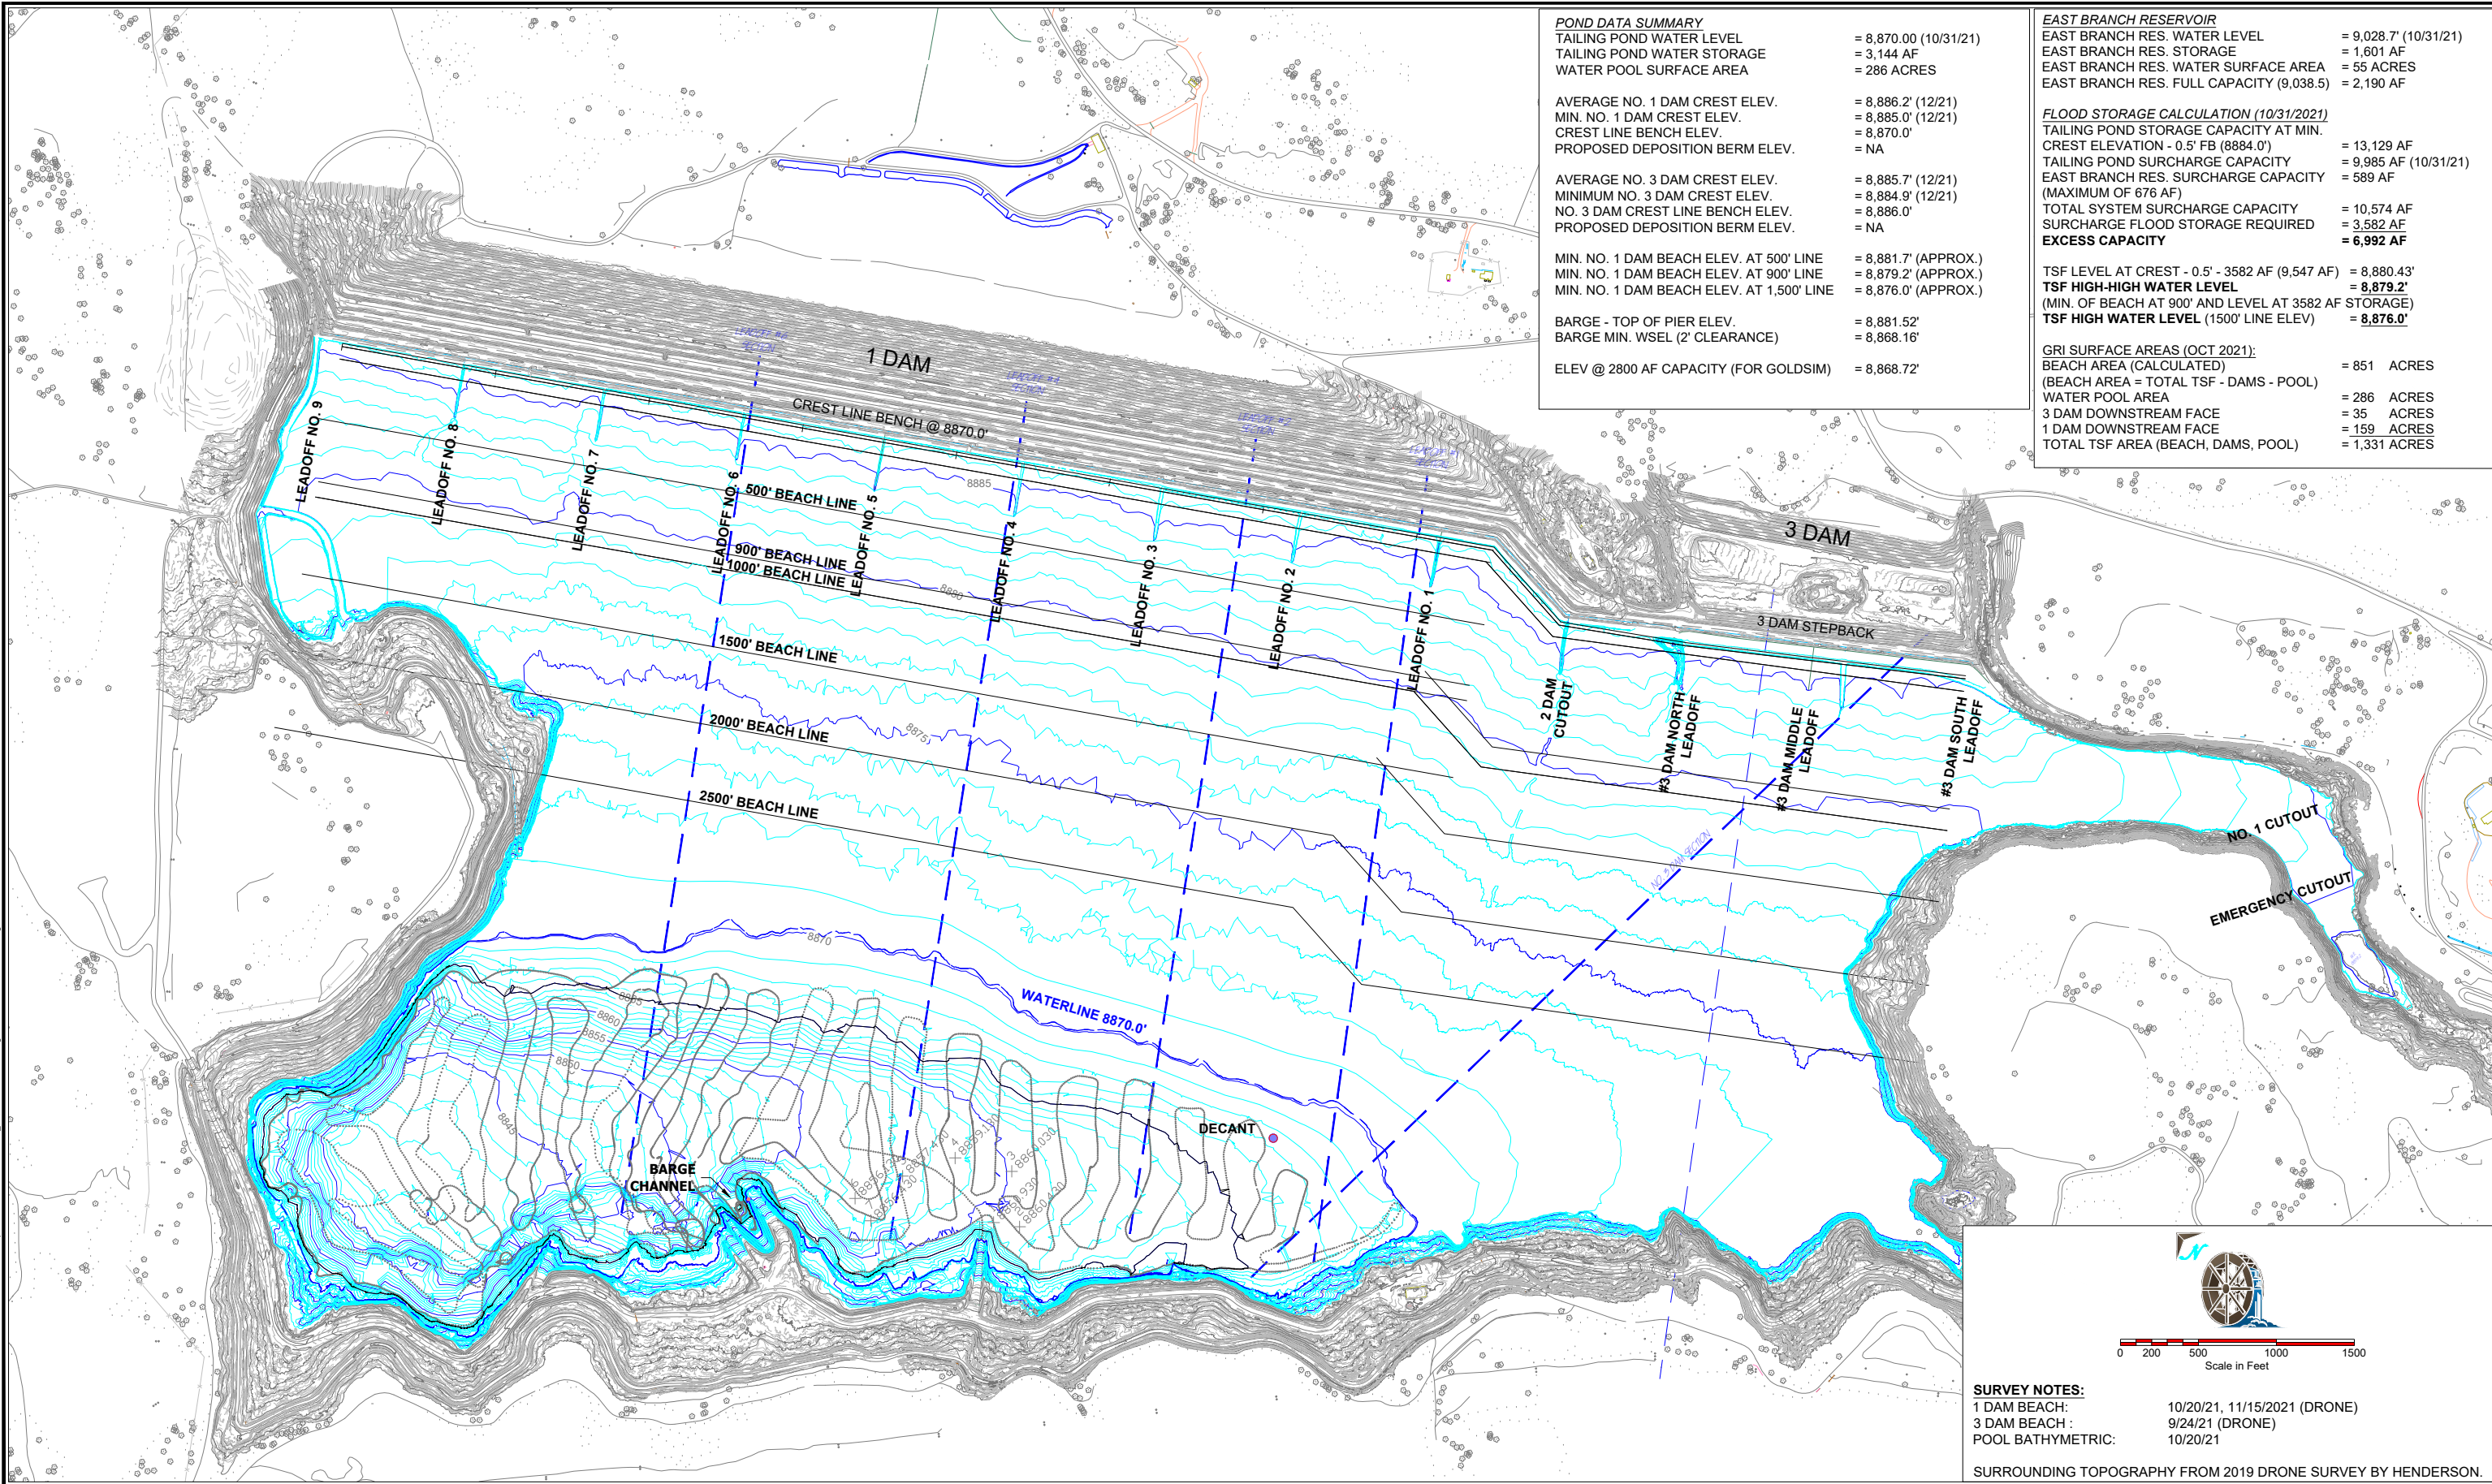
HENDERSON MILL TAILINGS STORAGE FACILITY		Climax Molybdenum Henderson Mill Parshall, CO		
BEACH AND POND SURVEY	SAA	11/21	SCALE	AS NOTED
FALL 2021 SURVEY	CHECKED BY SMM	11/21		DRAWING NO.
DATES: SEE SURVEY NOTES	ACCEPTED BY ...			FIGURE 1

One of the primary uses of the survey data is to evaluate the flood storage capacity conditions in the water system. As summarized on Figure 1, at the approximate time of the fall survey there was a total system surcharge storage capacity of about **10,574 acre-feet** in the system. This capacity includes both the TSF and East Branch Reservoir and is based on 0.5 feet of residual freeboard below the minimum dam crest elevation of 8,885.0' and a October 31st water level of 8,870.0 feet. The flood storage requirement for the system is **3,582 acre-feet**. This requirement is based on hydrologic modeling of the probable maximum precipitation (PMP) event. The available flood storage capacity in the system at

the time of the survey significantly exceeds the storage requirement. However, this excess capacity will decrease throughout the coming year as additional inflows to the system occur and a portion of the storage space is filled with deposited tailing.
