MINERALS PROGRAM INSPECTION REPORT
PHONE: (303) 866-3567

MINE NAME: Farnsworth Gr Pit 2	MINE/PROSPECTING ID#: M-1982-154	MINERAL: Sand and gravel	COUNTY: Delta
INSPECTION TYPE: Monitoring	INSPECTOR(S): Robert Zuber, P.E.	INSP. DATE: March 4, 2022	INSP. TIME: 07:50
OPERATOR: Farnsworth Construction and Gravel Company	OPERATOR REPRESENTATIVE: Cecil and Patricia Farnsworth	TYPE OF OPERATION: 110c - Construction Limited Impact	
REASON FOR INSPECTION: Normal I&E Program	BOND CALCULATION TYPE: Complete Bond	BOND AMOUNT: \$2,271.00	
DATE OF COMPLAINT: NA	POST INSP. CONTACTS: None	JOINT INSP. AGENCY: None	
WEATHER: Cloudy	INSPECTOR'S SIGNATURE:

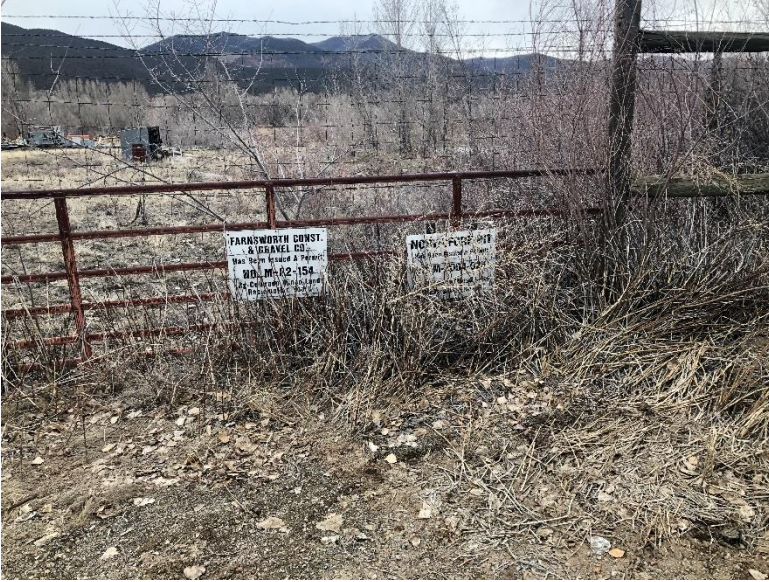
The entrance sign on the gate included the necessary information.

Entrance sign partially covered by vegetation that should be removed

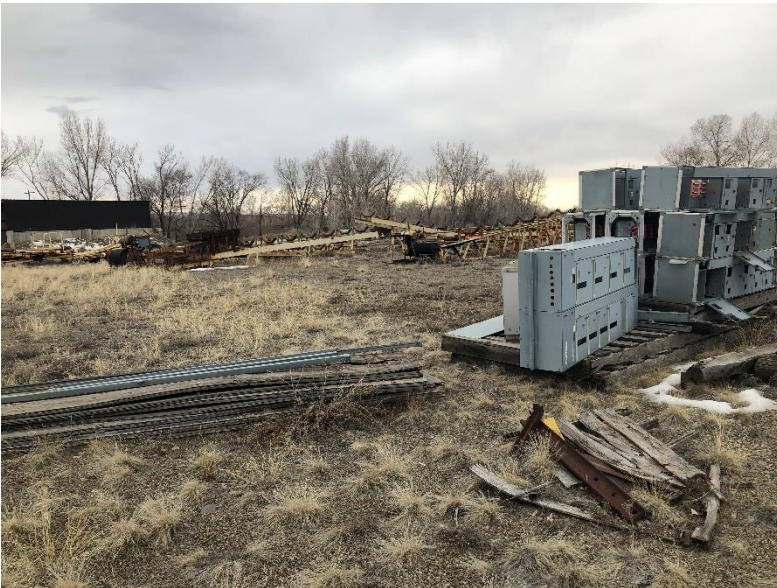
Conveyors and other equipment are stored on site. No fuel was stored at the site. The approved post-mining land use for this site is storage of equipment.

Equipment stored on site

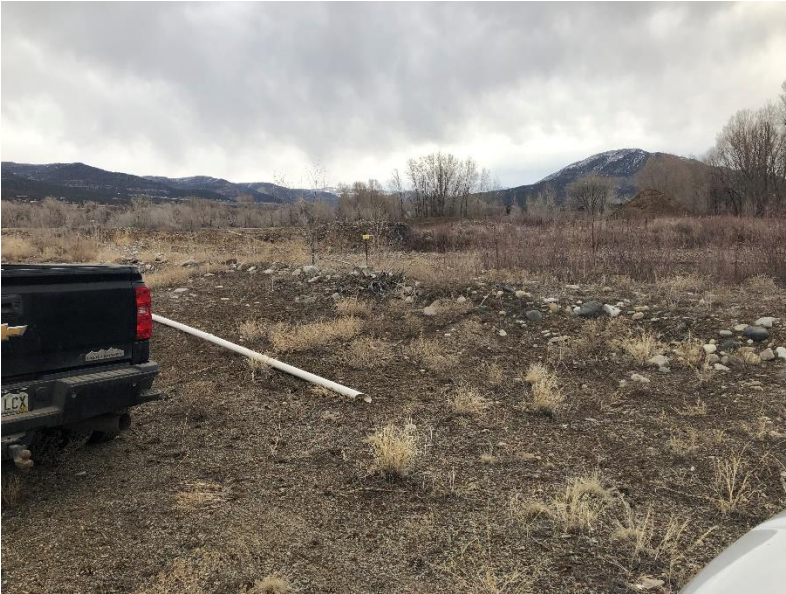
Permit boundary markers were seen around the site, including fences on the south, east, and west sides. On the north side there are no markers, because the boundary is in the river.

Fence with boundary sign

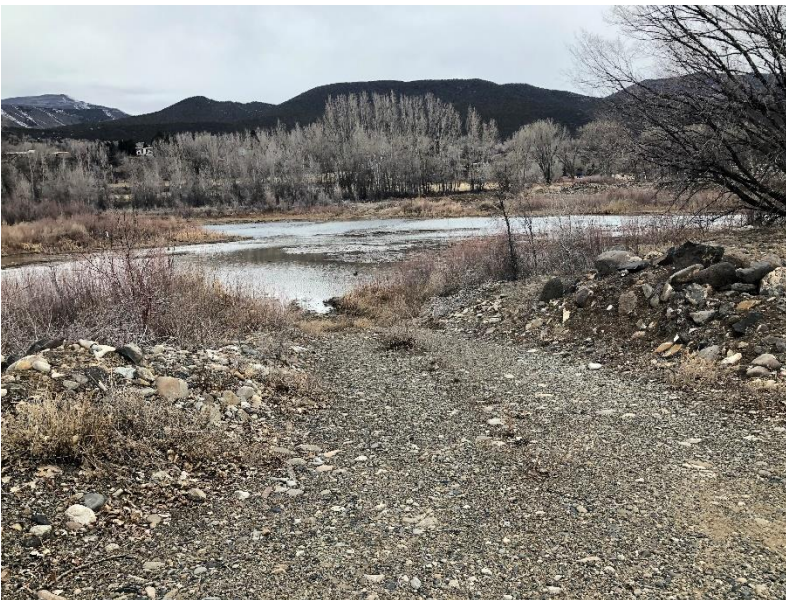
There was no sign of a dike in the river to aid this operation, and the Farnsworths indicated that they have not had one for many years.

Access to river for sand and gravel extraction

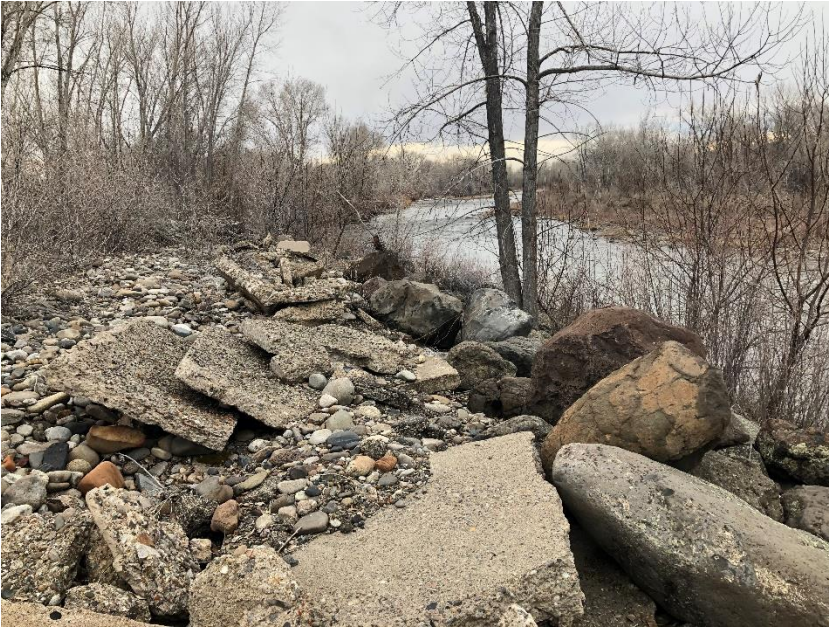
There was no indication that runoff from the site is causing problems off site. Large riprap has been placed along the river bank (west side of permit area) to protect the bank from erosion.

Riprap on river bank (North Fork of the Gunnison)
