**MINERALS PROGRAM INSPECTION REPORT**  
**PHONE: (303) 866-3567**

<b>MINE NAME:</b> Solberg Pit	<b>MINE/PROSPECTING ID#:</b> M-1981-044	<b>MINERAL:</b> Sand and gravel	<b>COUNTY:</b> El Paso
<b>INSPECTION TYPE:</b> Preoperation Inspection	<b>INSPECTOR(S):</b> Timothy Cazier, P.E.	<b>INSP. DATE:</b> February 4, 2022	<b>INSP. TIME:</b> 11:55
<b>OPERATOR:</b> Solberg Gravel LLC	<b>OPERATOR REPRESENTATIVE:</b> Jason Ulmer	<b>TYPE OF OPERATION:</b> 112c - Construction Regular Operation	
<b>REASON FOR INSPECTION:</b> Preoperation Inspection	<b>BOND CALCULATION TYPE:</b> Complete Bond	<b>BOND AMOUNT:</b> \$272,610.00	
<b>DATE OF COMPLAINT:</b> NA	<b>POST INSP. CONTACTS:</b> None	<b>JOINT INSP. AGENCY:</b> None	
<b>WEATHER:</b> Clear	<b>INSPECTOR'S SIGNATURE:</b>

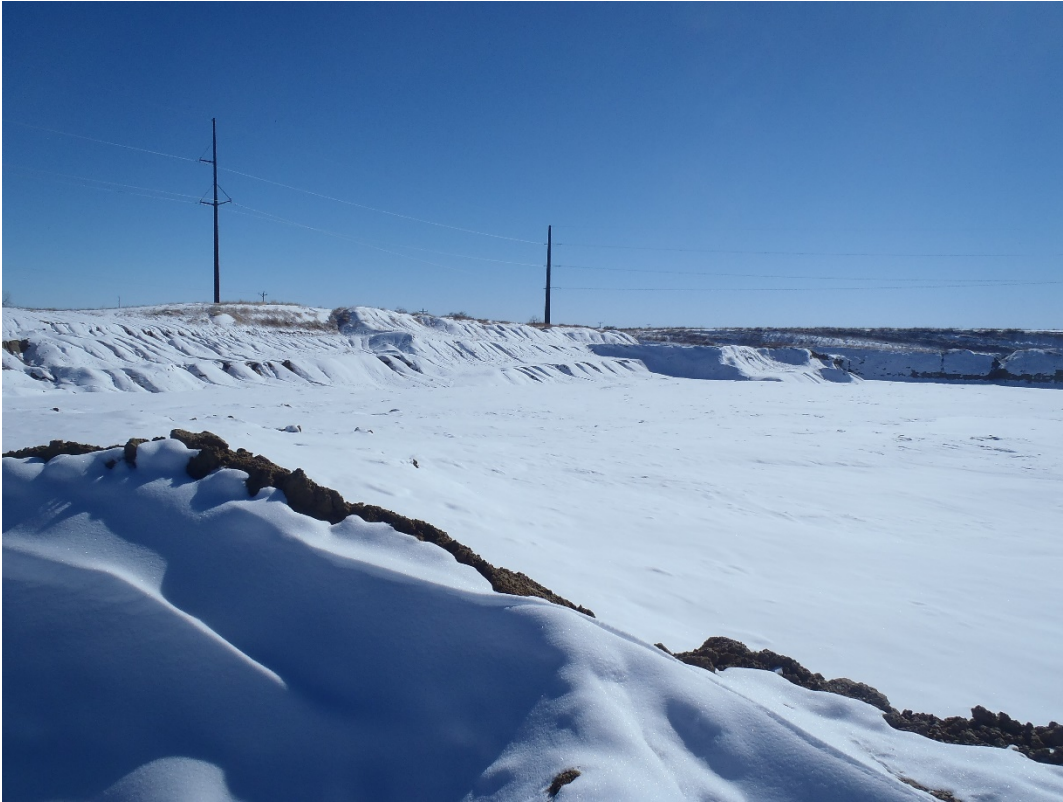
Backfilling and Grading: The southeast corner pit that had observed to have been excavated to as much as 40 feet below grade during the previous inspection was mostly backfilled (see **Photos 1 and 2**).

Photo 1. Backfill in SE corner pit (looking SSE).

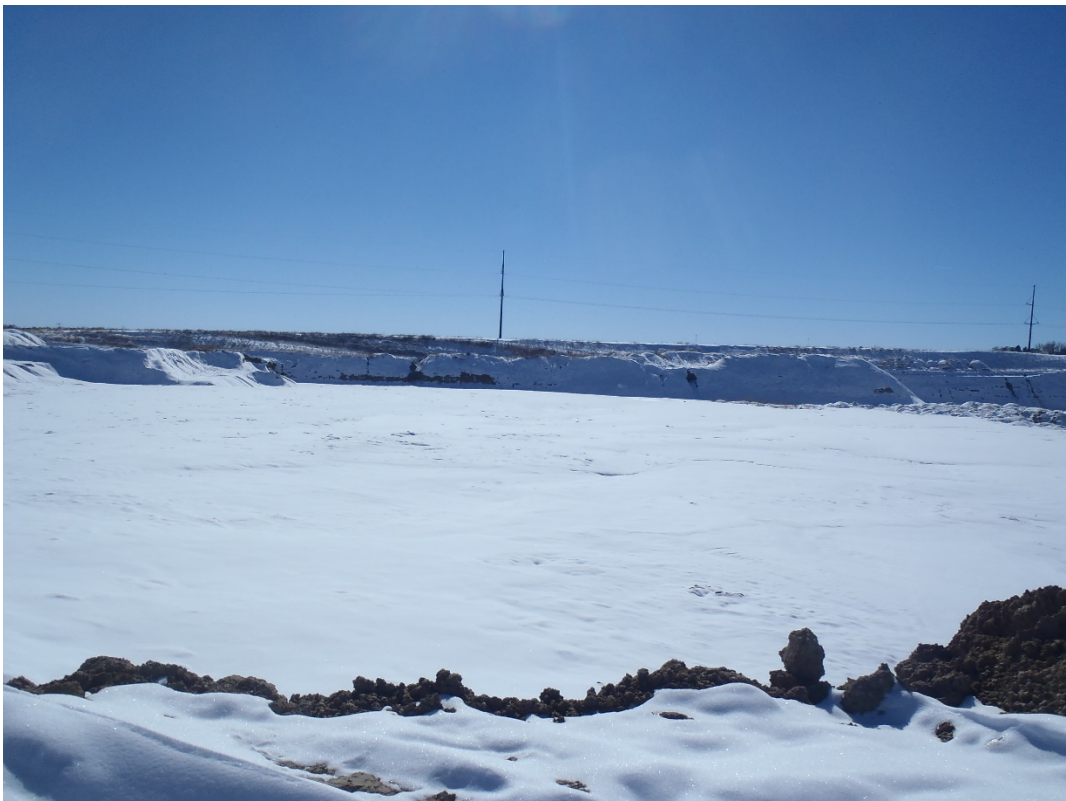
Photo 2. Backfill in SE corner pit (looking south).

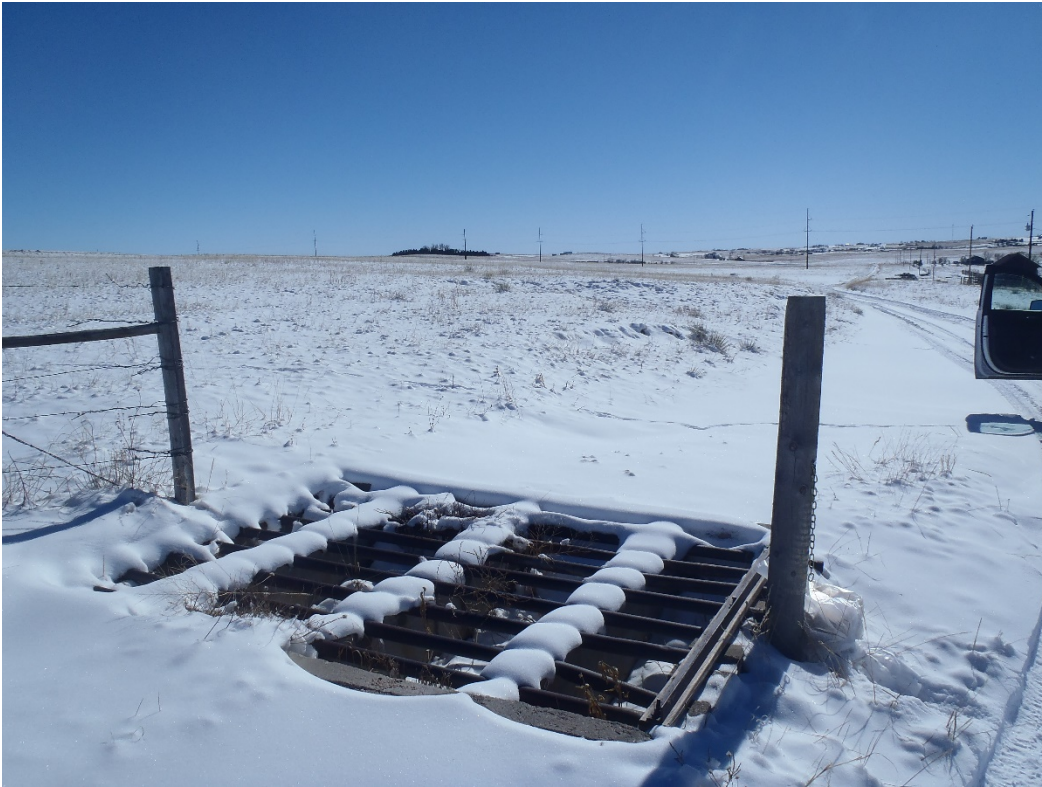
The DRMS had potential stability concerns during the review of the AM-3 with respect to the private access road on the west side of the proposed expansion area. The observed topography (see **Photo 3**), indicating the existing ground elevation along the proposed west boundary is significantly lower than the ridge to be mined to the east; along with the proposed pit floor boundary being graded to drain to the east; alleviated concerns of deep excavations near the private access road.

Photo 3. Lower topography elevation on proposed west boundary at private road (looking south).

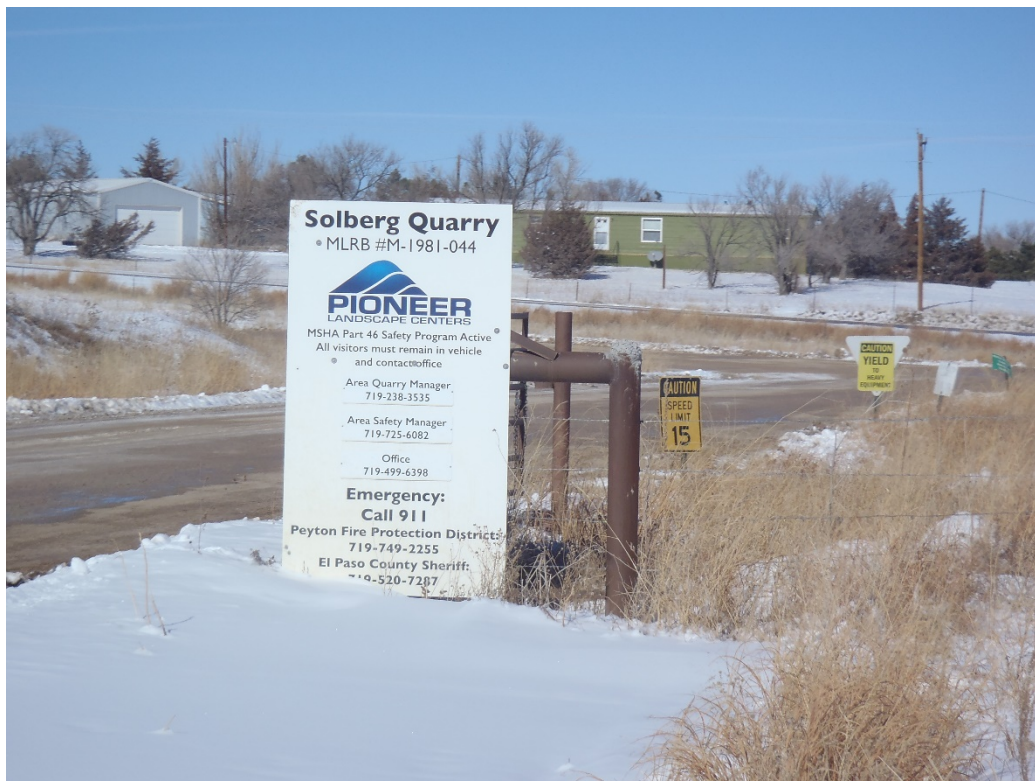
Photo 4. Permit sign (at entrance off Curtis Rd).

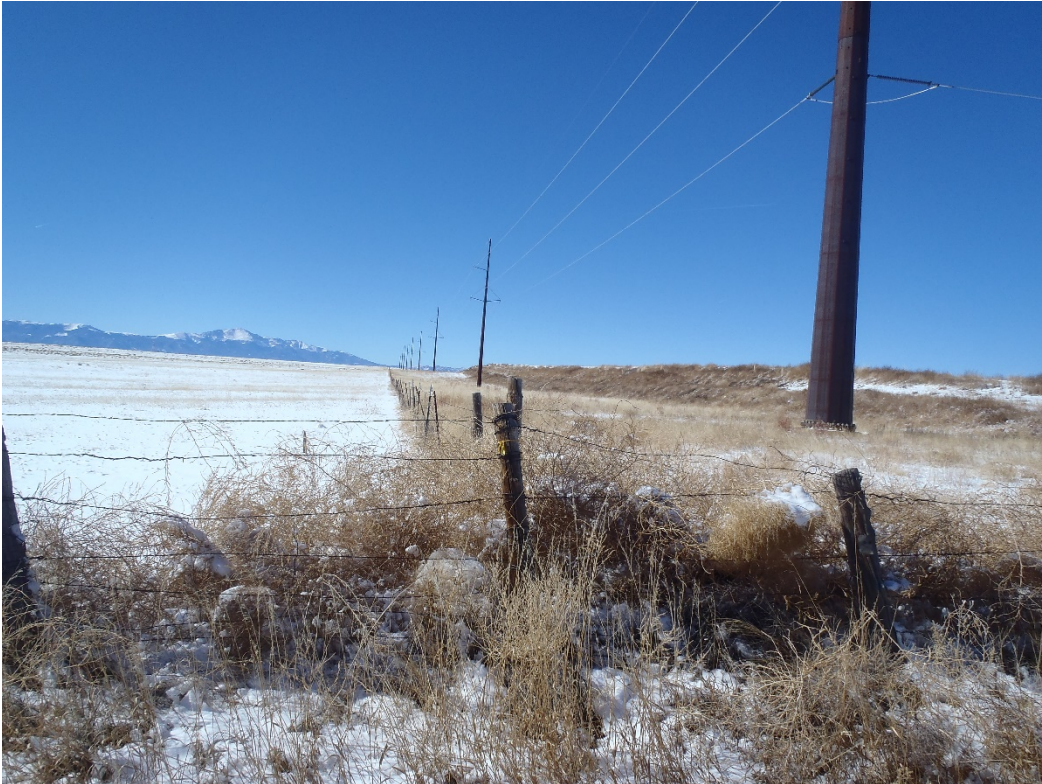
Signs and Markers: The permit sign was properly posted (see **Photo 4**). The fence line on the east and south sides of the permit boundary were observed (see **Photos 5 and 6**). The current offset for the affected area boundary includes the powerline. However, topsoil and overburden stockpiles were observed to be within an estimated 25 feet of the powerlines. Updated Exhibit C and F maps from the Applicant have partially clarified the affected area boundaries discrepancies. However, subsequent discussions with the Applicant have indicated the affected area boundary may have to be revised to accommodate recent requirements from El Paso County.

Photo 5. SE corner of existing permit boundary (looking west – note utility poles and mine stockpiles).

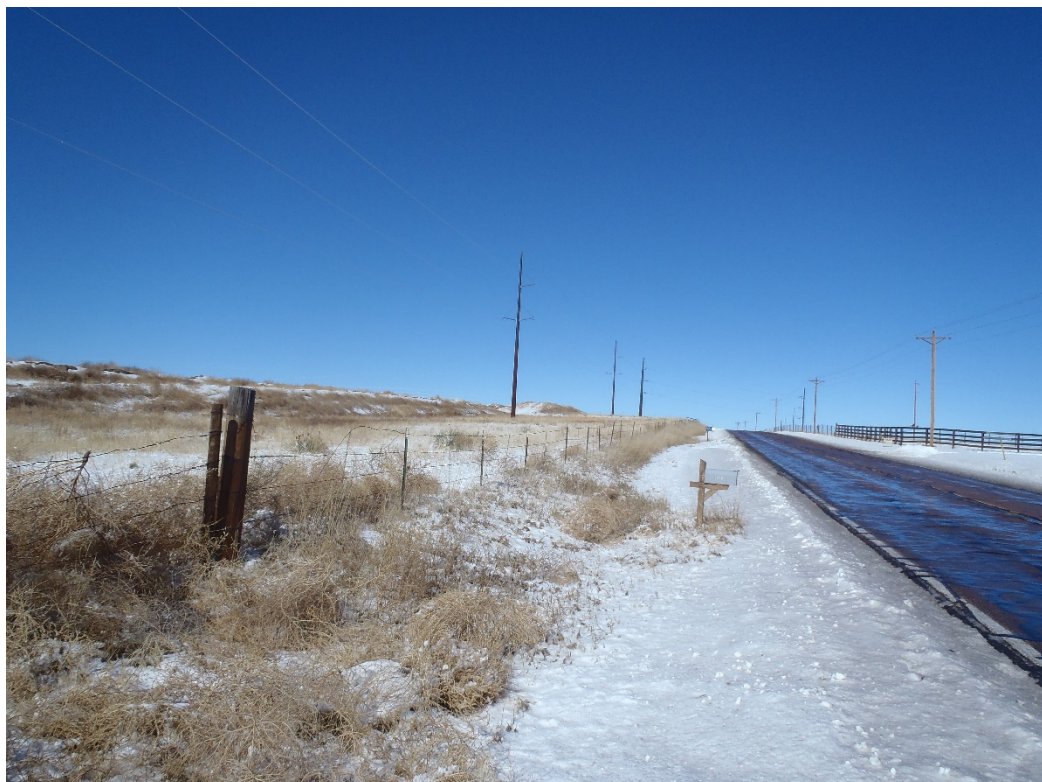
Photo 6. SE corner of existing permit boundary (looking north – note utility poles and mine stockpiles).
