MINERALS PROGRAM INSPECTION REPORT
PHONE: (303) 866-3567

MINE NAME: Lyons Quarry	MINE/PROSPECTING ID#: M-1977-208	MINERAL: Limestone (general)	COUNTY: Boulder
INSPECTION TYPE: Monitoring	INSPECTOR(S): Amy Eschberger	INSP. DATE: March 3, 2022	INSP. TIME: 10:00
OPERATOR: CEMEX, Inc.	OPERATOR REPRESENTATIVE: Scott Marcus, Patrick Chalupsky, Erik Estrada	TYPE OF OPERATION: 112c - Construction Regular Operation

REASON FOR INSPECTION: Citizen Complaint	BOND CALCULATION TYPE: None	BOND AMOUNT: \$8,953,127.00
DATE OF COMPLAINT: February 8, 2022	POST INSP. CONTACTS: None	JOINT INSP. AGENCY: None
WEATHER: Clear	INSPECTOR'S SIGNATURE:

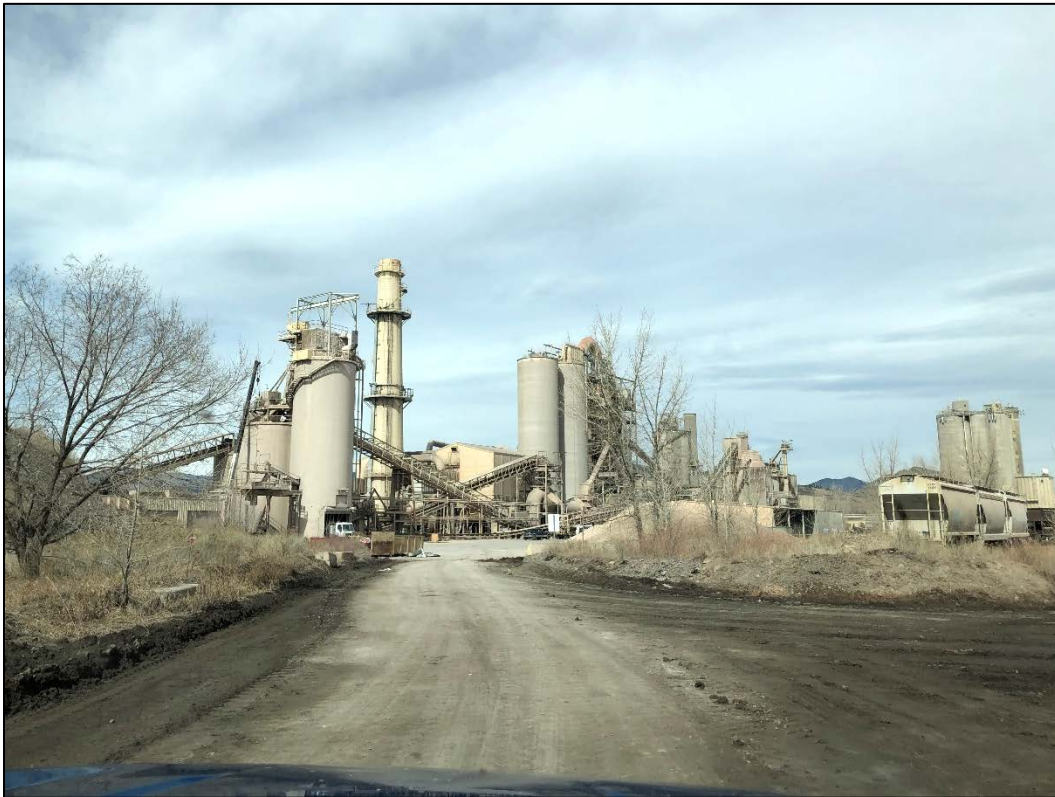
Photo 1. View looking south from main access road at cement plant.

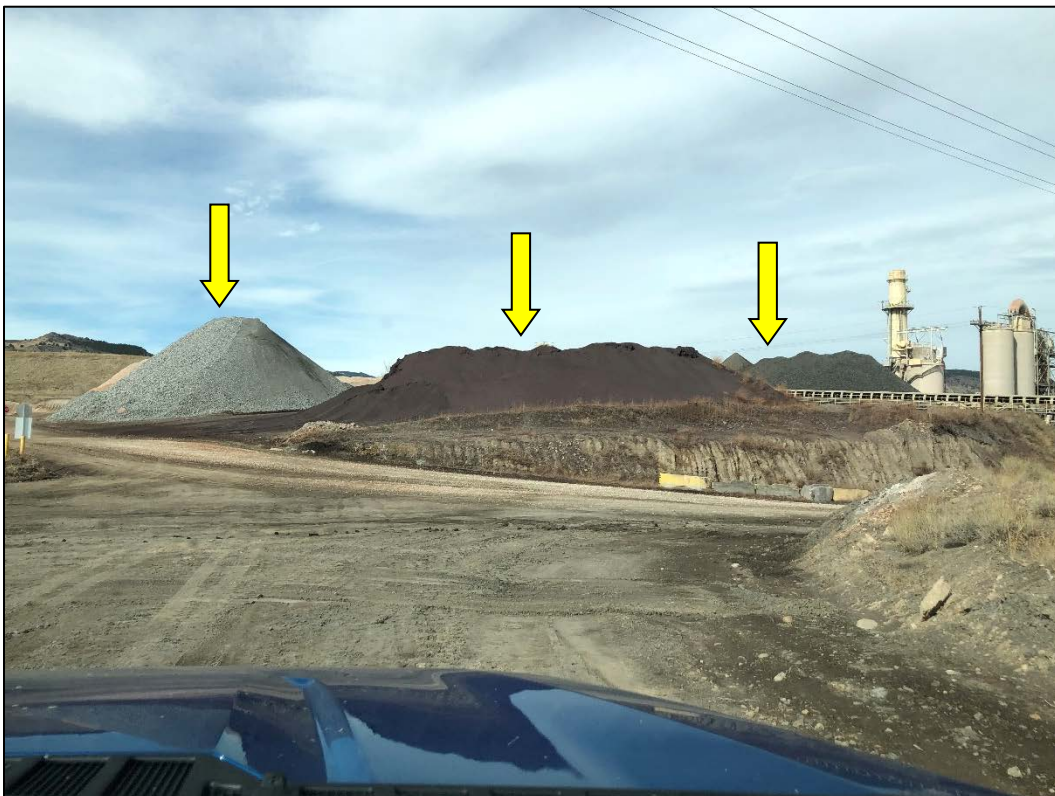
Photo 2. View looking west at raw material stockpile area (indicated) located south of cement plant.

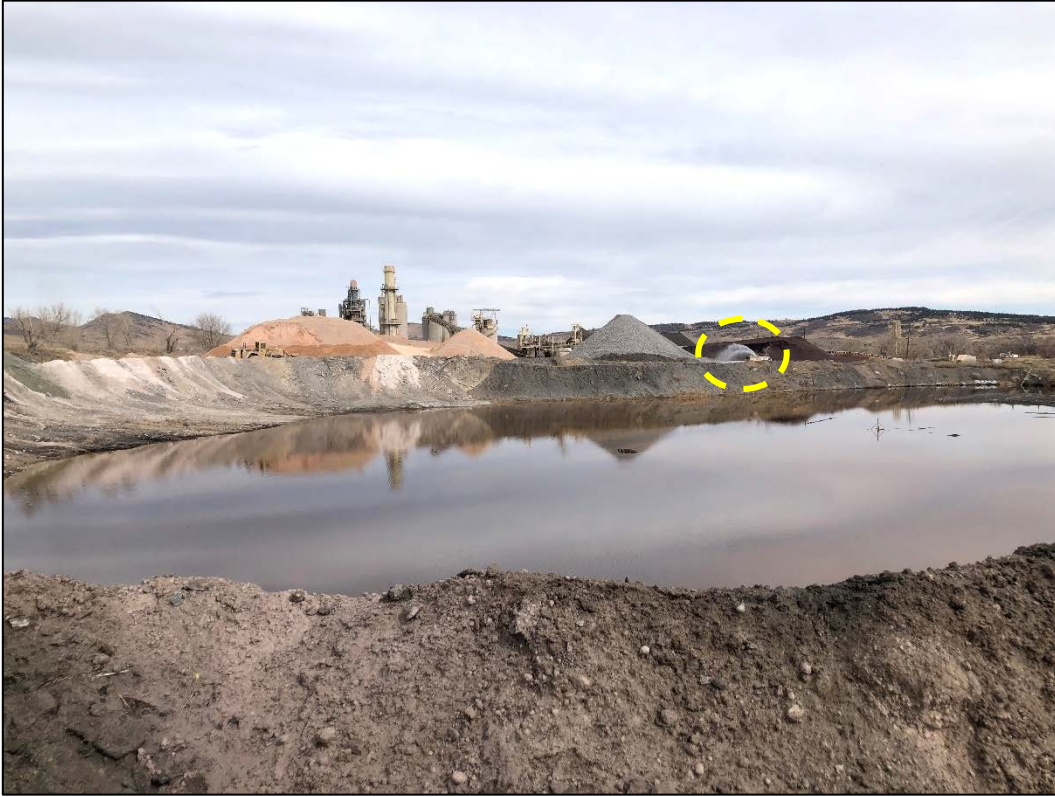
Photo 3. View looking north across northeastern unbackfilled portion of Pit C with ponded water. Note water truck (circled in background) spraying raw material stockpile area located north of Pit C.

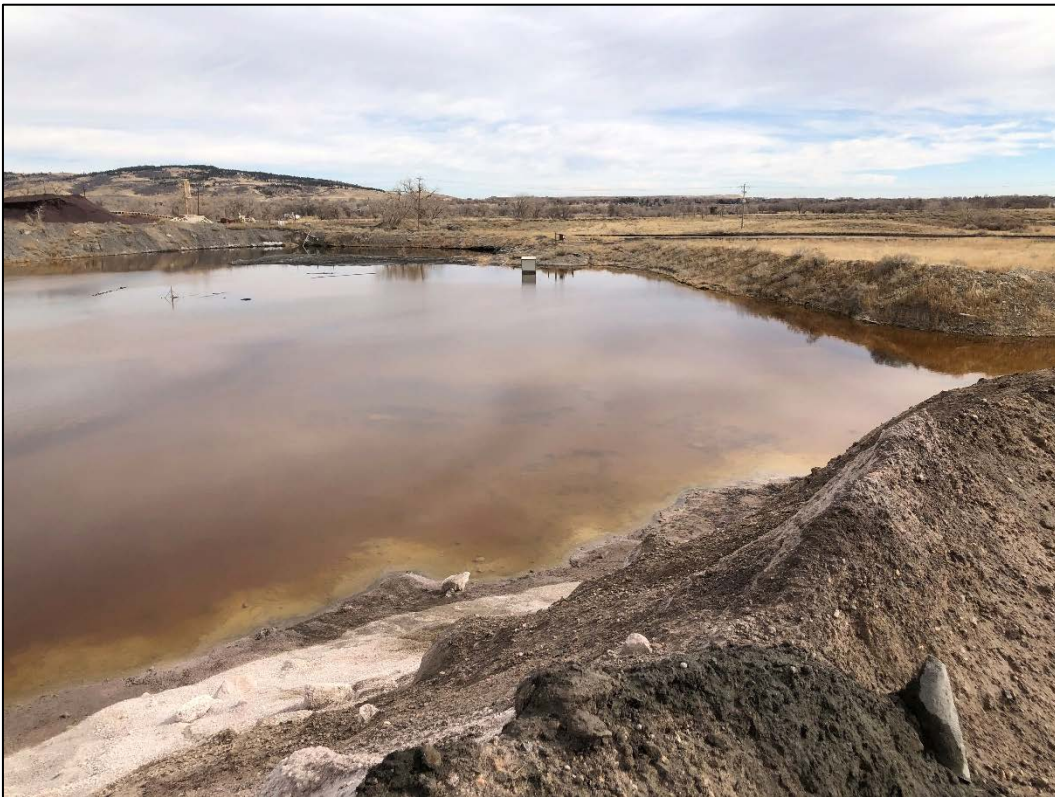
Photo 4. View looking northeast across northeastern unbackfilled portion of Pit C with ponded water.

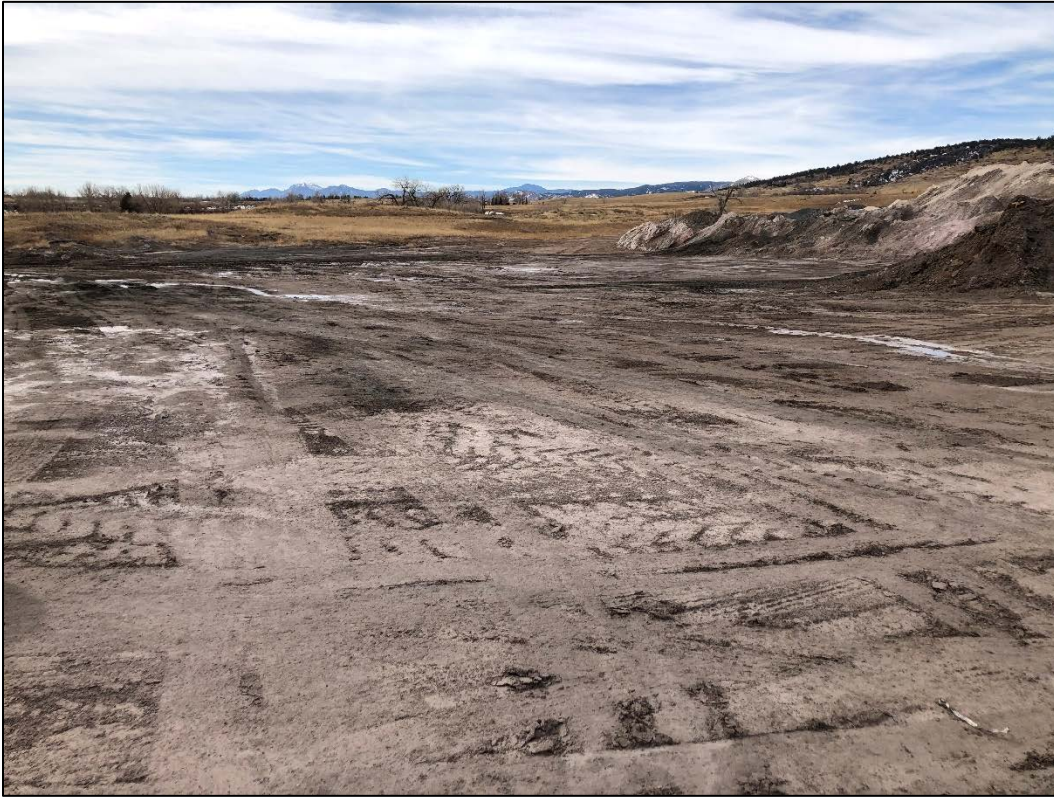
Photo 5. View looking south across southwestern portion of Pit C which has been backfilled with CKD but not yet capped with shale and clay material.

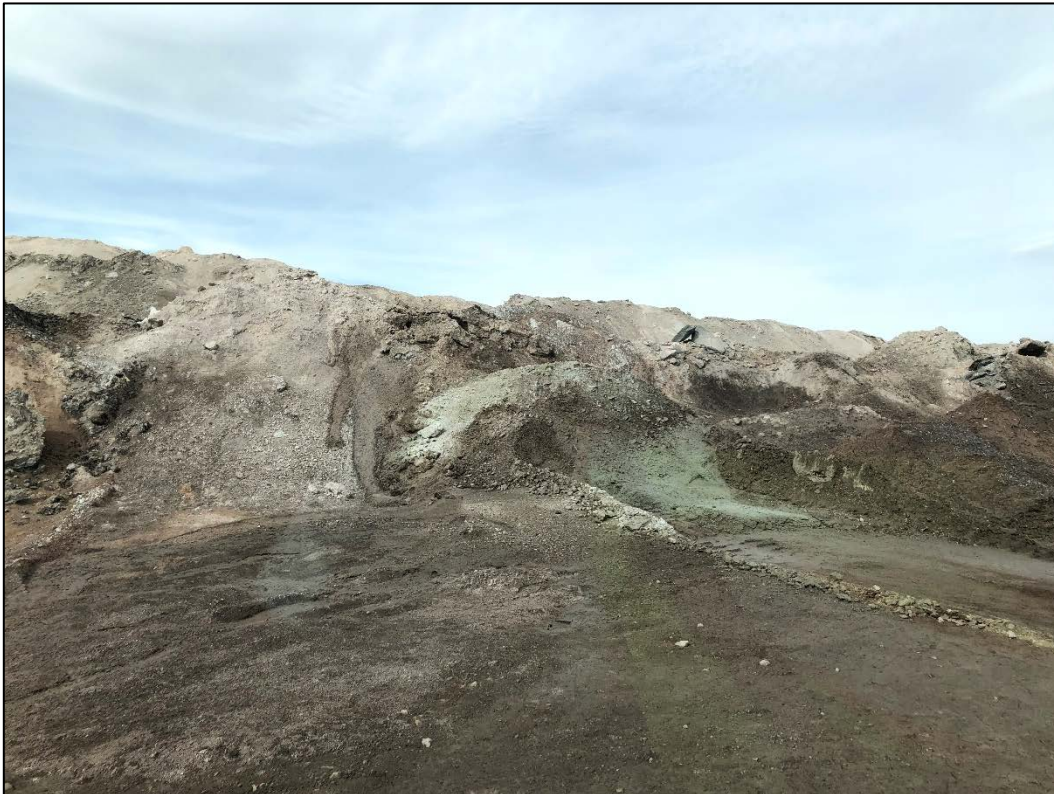
Photo 6. View looking west at CKD material temporarily stockpiled in uncapped portion of Pit C.

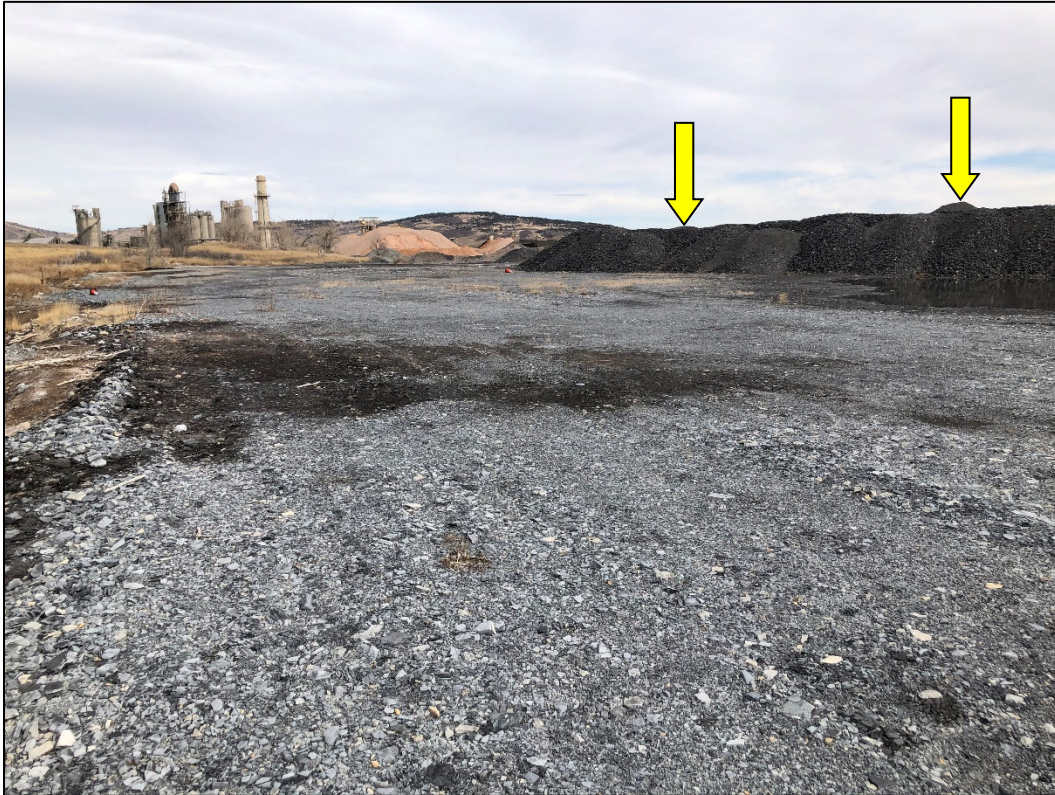
Photo 7. View looking north across western backfilled portion of Pit C which has been capped with shale and clay material. Note additional capping material (indicated) stockpiled in this area for future use.

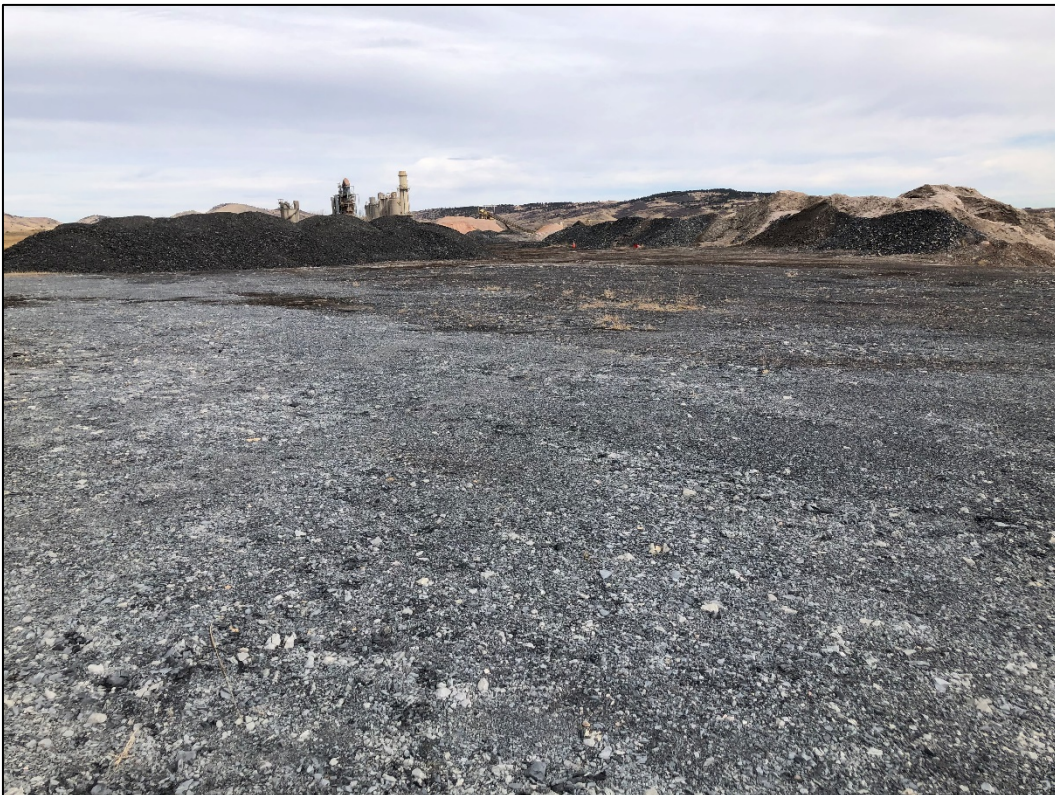
Photo 8. View looking north across southwestern backfilled portion of Pit C which has been capped with shale and clay material.

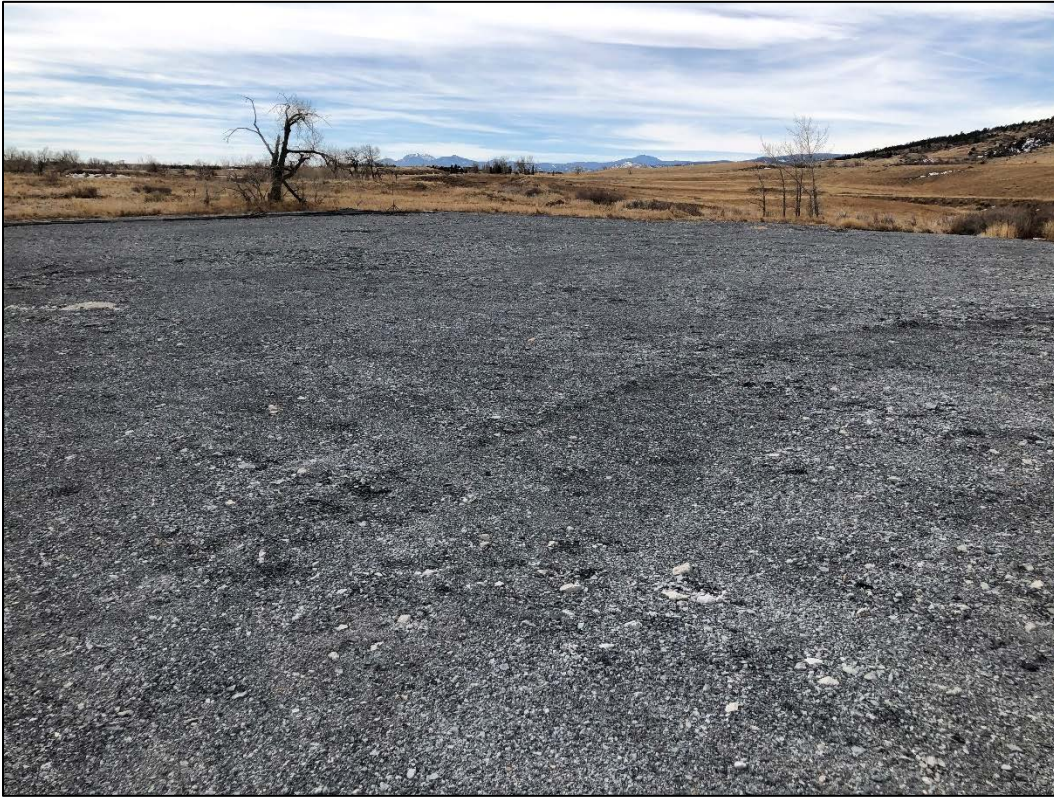
Photo 9. View looking south across southern backfilled portion of Pit C which has been capped with shale and clay material.

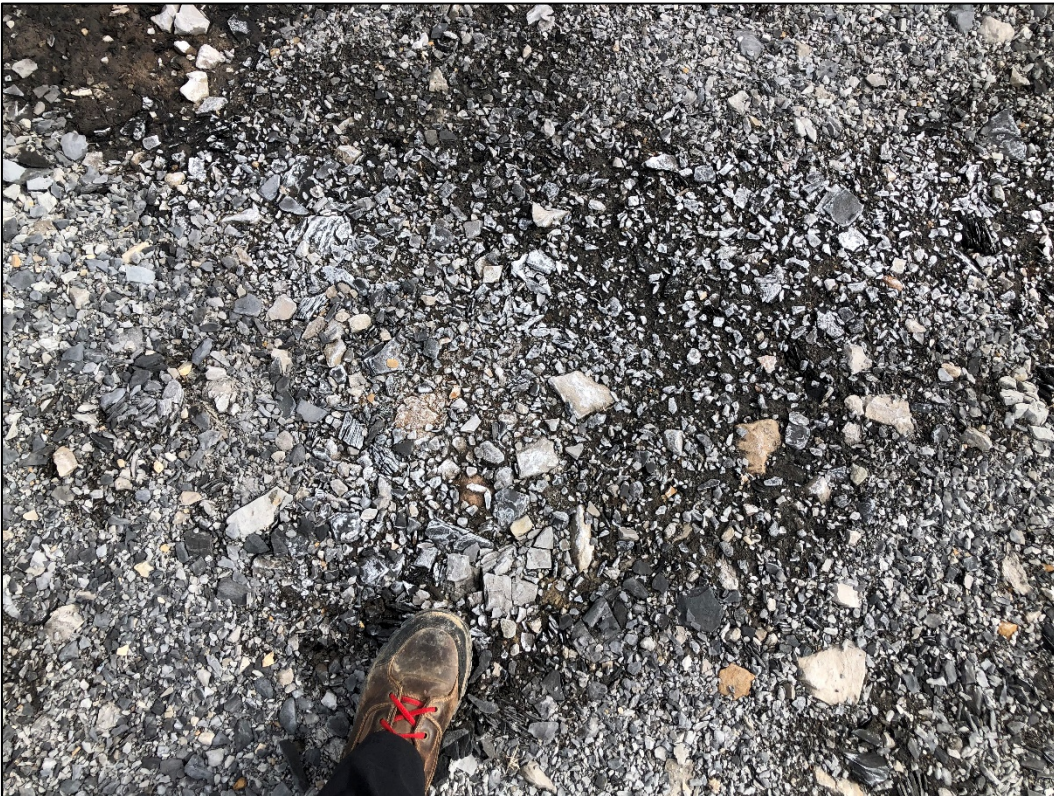
Photo 10. Ground view of shale and clay cap placed on backfilled portion of Pit C.

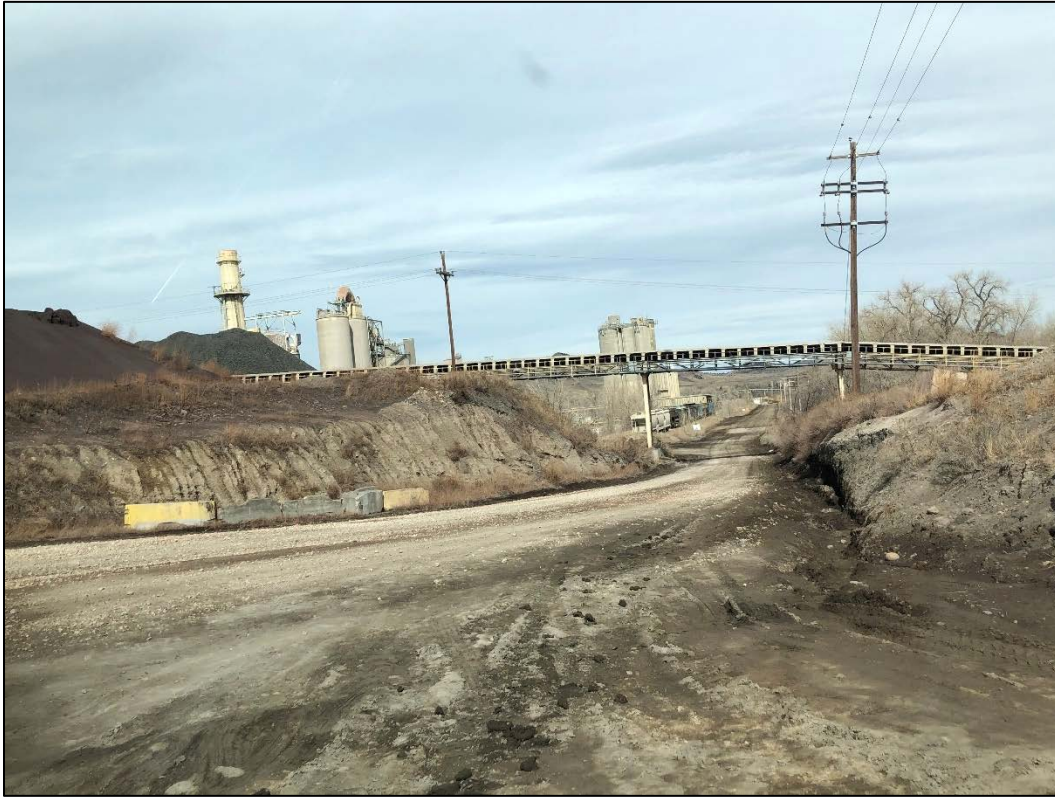
Photo 11. View looking north at access road connecting cement plant area in the north to pit areas in the south (including Pit C). Note overhead conveyor crossing this road (in background).

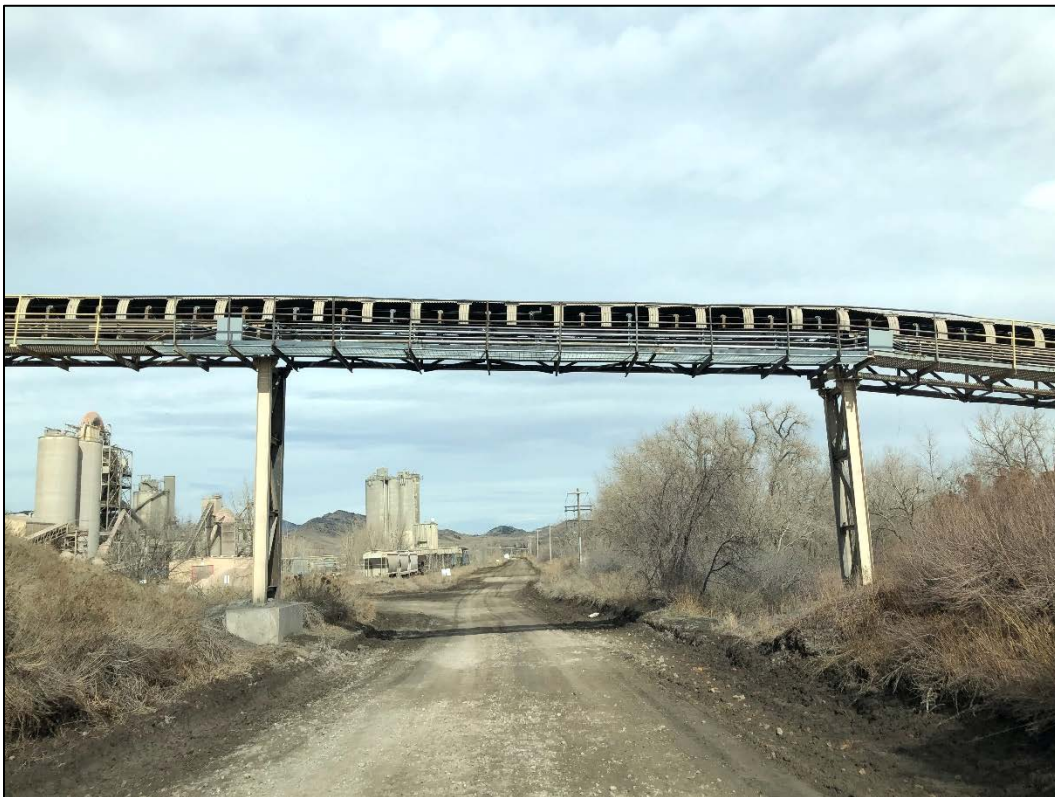
The operator also stated that operations were suspended that day due to an accident that had occurred on site. A haul truck returning to the plant after having dumped CKD material at Pit C accidentally left its bed in a raised position which collided with the overhead conveyor that runs across the access road. According to the operator, operations were suspended for 4 days while the damaged portions of the conveyor were being repaired. During this time, equipment access to the CKD disposal area was limited, as the road beneath the conveyor is the only access road to the area south of the plant. This meant that water trucks were unable to access Pit C to water the freshly dumped CKD material. Considering the high wind gusts that occurred on January 31, 2022 and the operator's inability to get water trucks to the CKD disposal area during that time, it seems likely the dust was generated from the CKD disposal area (as well as from the raw material stockpile area). The photos provided with the complaint appear to support this.

Photo 12. Closer view (looking north) of overhead conveyor which was damaged in truck accident, after which, equipment access to Pit C was restricted until the conveyor was repaired.

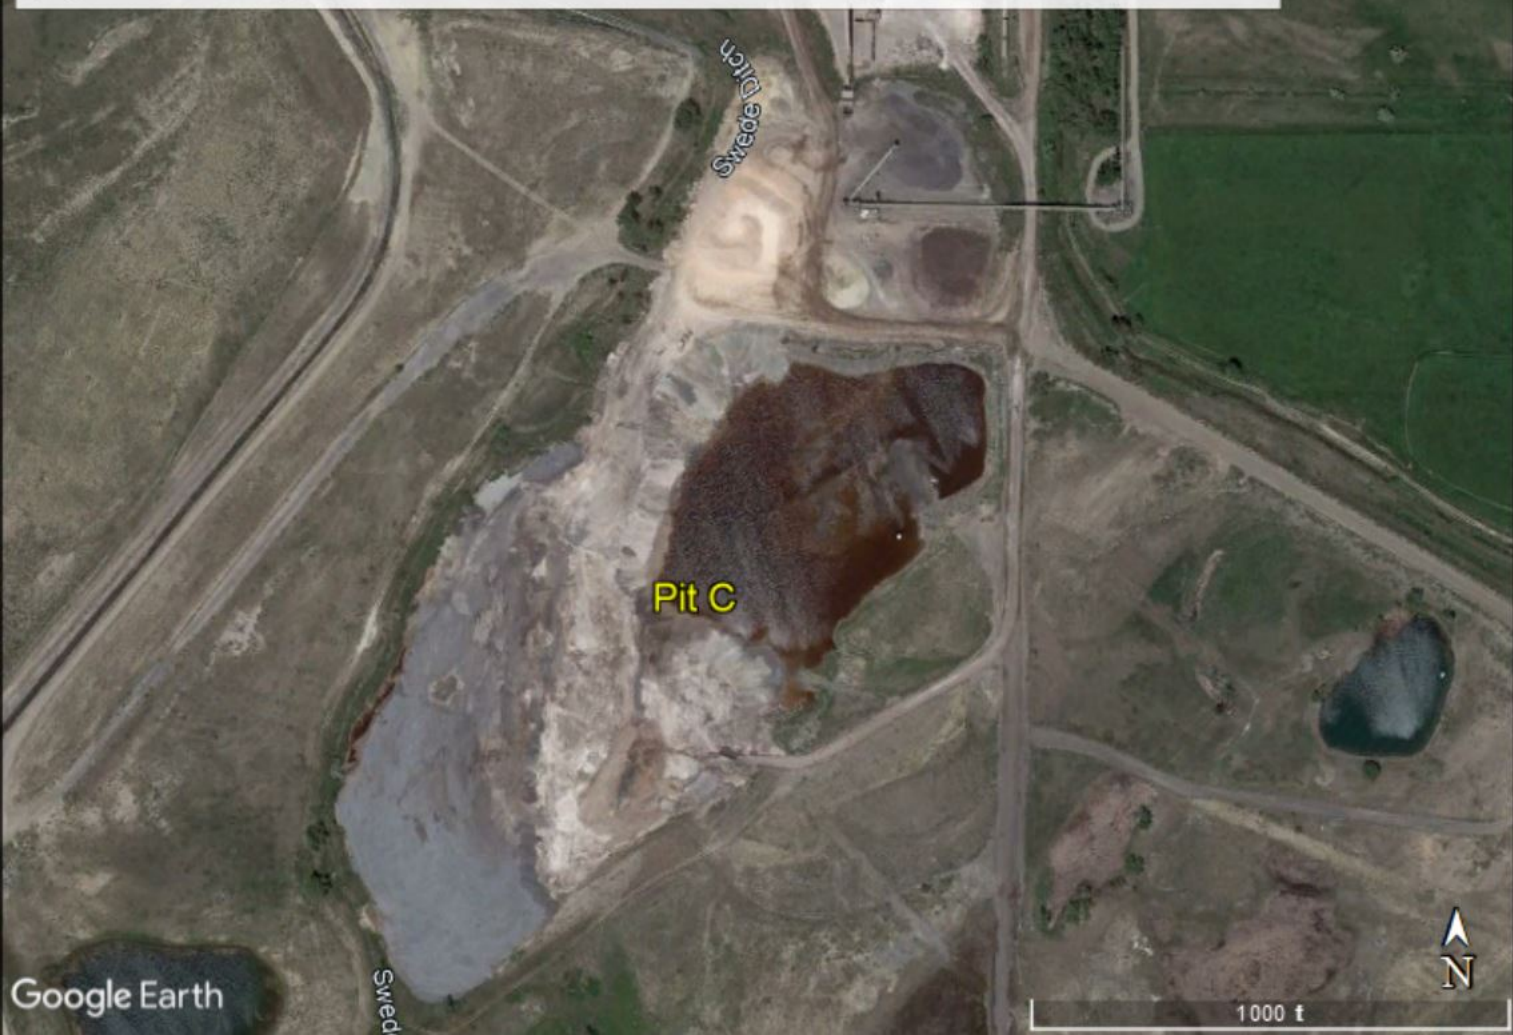
Close-up of Pit C (CKD disposal area) and raw material stockpile area located south of cement plant.
(Image data from 6/10/2021)
