MINERALS PROGRAM INSPECTION REPORT
PHONE: (303) 866-3567

MINE NAME: Dellacroce Pit	MINE/PROSPECTING ID#: M-1993-050	MINERAL: Gravel	COUNTY: El Paso
INSPECTION TYPE: Monitoring	INSPECTOR(S): Timothy Cazier, P.E.	INSP. DATE: February 4, 2022	INSP. TIME: 14:05
OPERATOR: Raymond F. & Robert W. Dellacroce	OPERATOR REPRESENTATIVE: Jason Ulmer	TYPE OF OPERATION: 112c - Construction Regular Operation	
REASON FOR INSPECTION: Normal I&E Program	BOND CALCULATION TYPE: None	BOND AMOUNT: \$74,200.00	
DATE OF COMPLAINT: NA	POST INSP. CONTACTS: None	JOINT INSP. AGENCY: None	
WEATHER: Clear	INSPECTOR'S SIGNATURE:

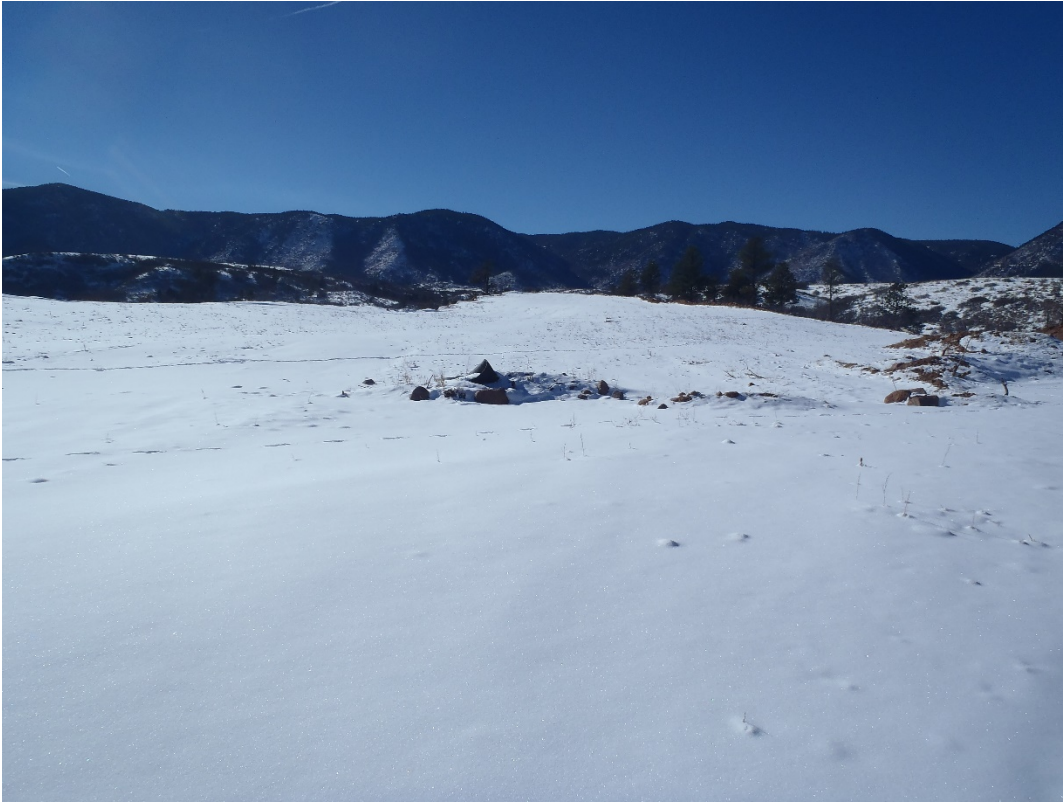
Backfilling and Grading: In general, the site grading was observed to be 3H:1V or flatter (see **Photos 1 - 4**). The exception was the most recent active highwall on the north side of the pit (see **Photo 5**). Mr. Ulmer explained this highwall was not day-lighted to the north in order to maintain a visual berm for the residents north of the site. He said they would be backfilled to 3H:1V or flatter prior to spreading topsoil.

Photo 1. Graded elevated pit floor (looking west).

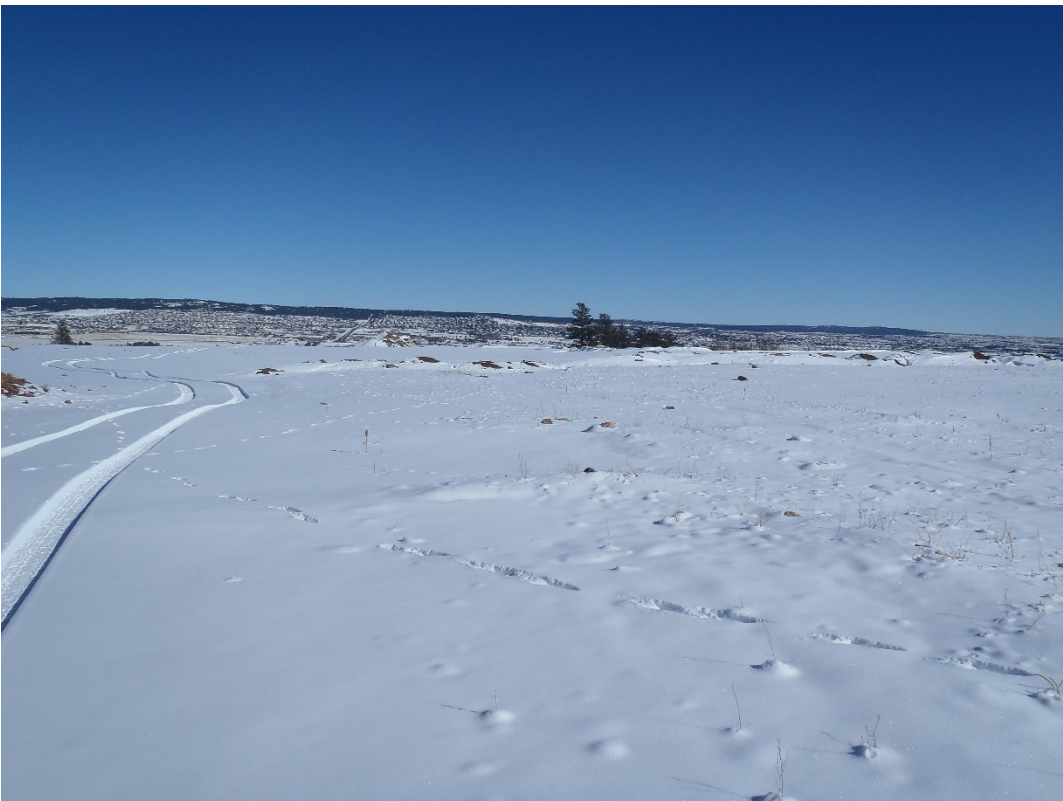
Photo 2. Graded elevated pit floor (looking east).

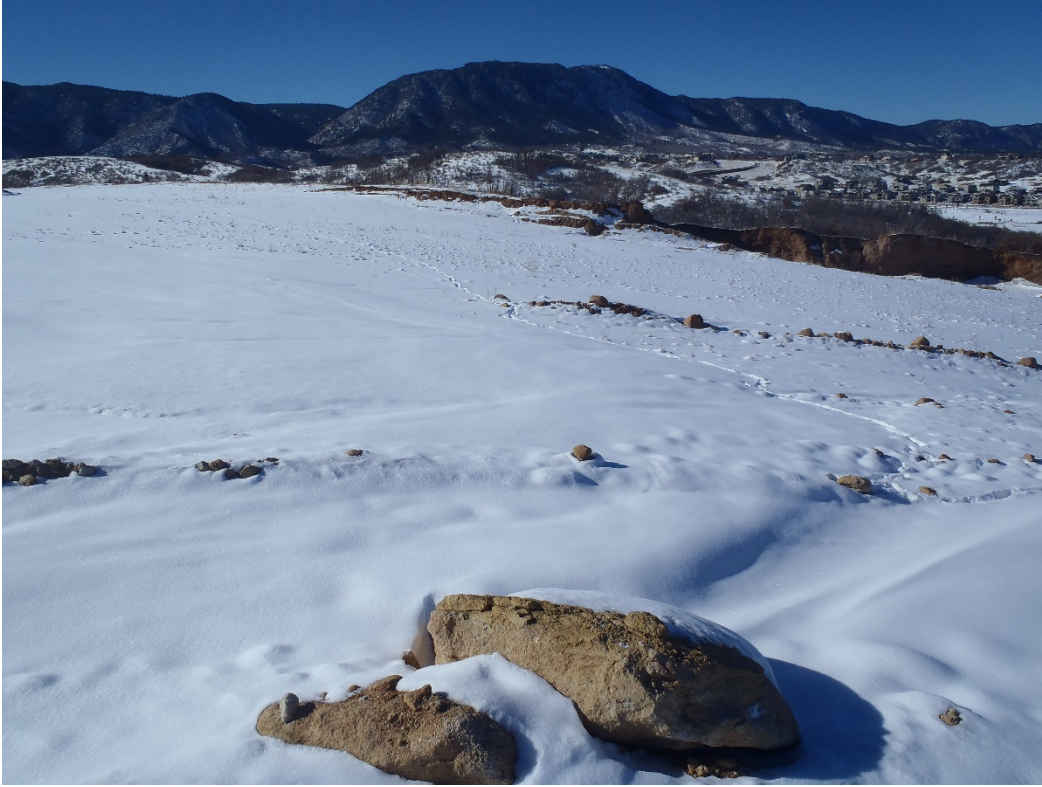
Photo 3. Graded slope transition from elevated pit floor to north pit floor (looking NW).

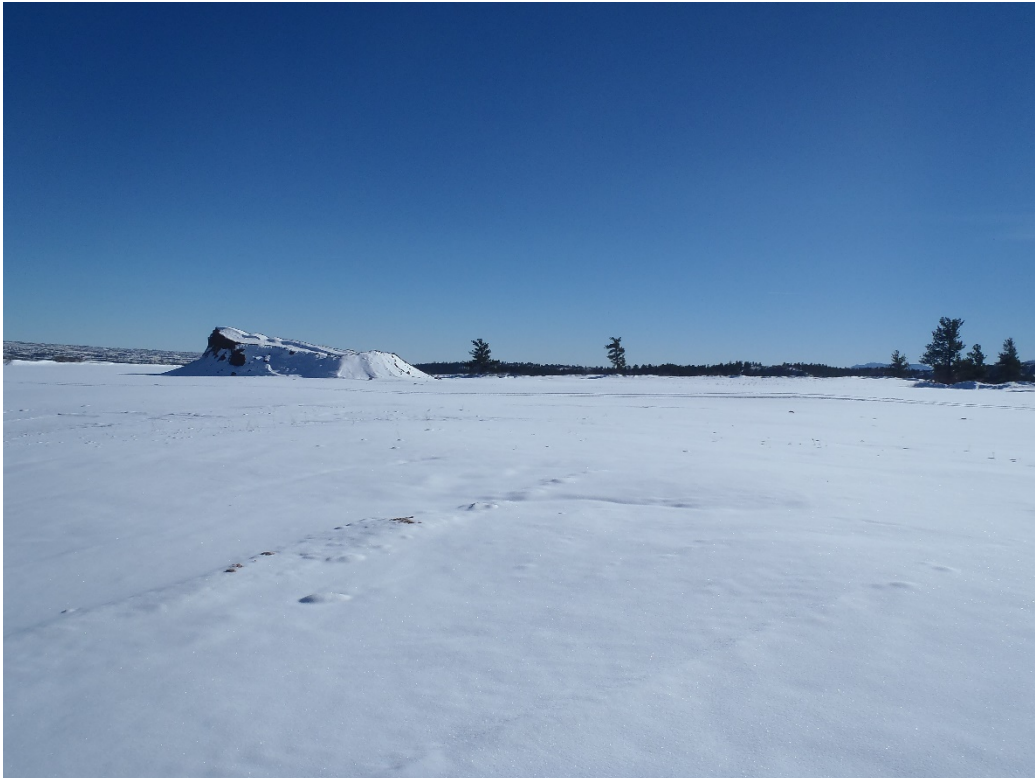
Topsoil: Four topsoil stockpiles were observed on the elevated portion of the pit floor (see **Photos 4, 6 and 7**).

Photo 4. Graded elevated pit floor (looking ESE, Note eastern most topsoil stockpile).

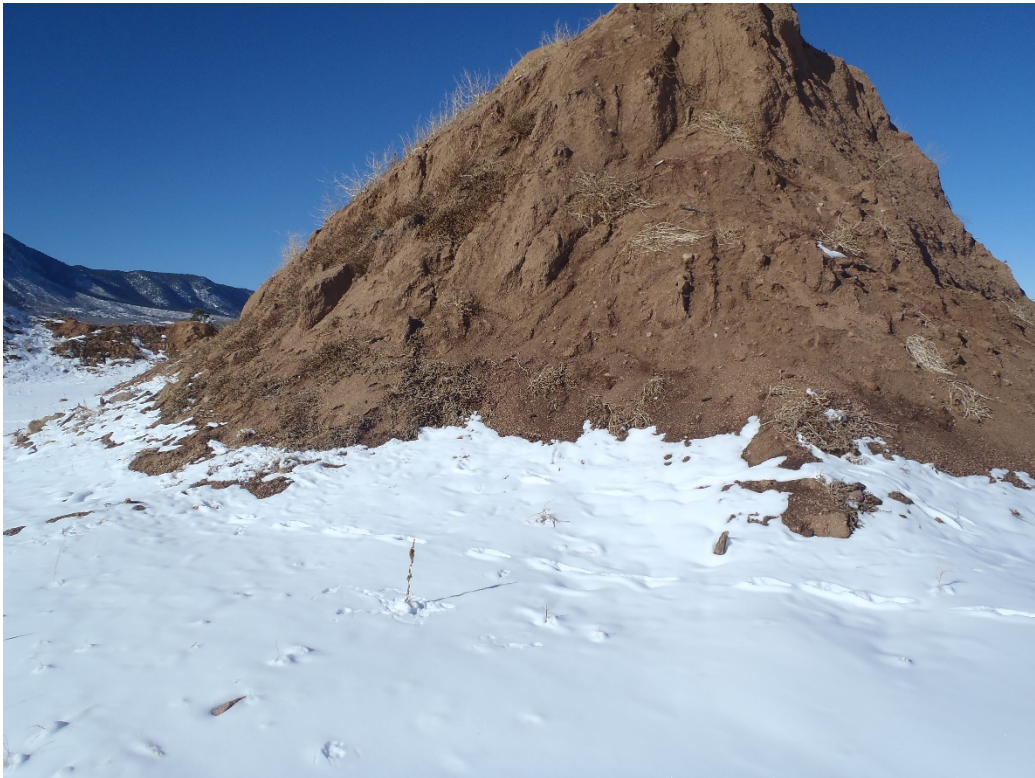
Photo 6. Topsoil stockpiles – west of center (looking NW, western most stockpile on left, background).

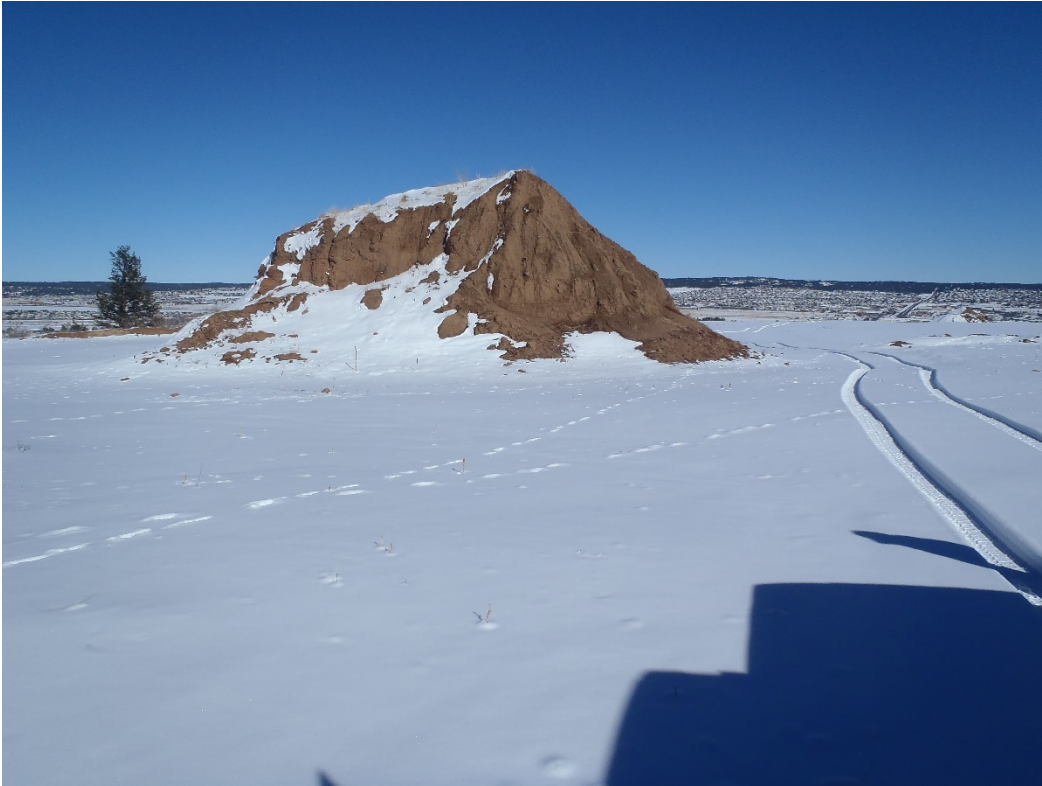
Photo 7. Topsoil stockpile – east of center (looking east).
