MINERALS PROGRAM INSPECTION REPORT
PHONE: (303) 866-3567

MINE NAME: Twin Crk Campground	MINE/PROSPECTING ID#: M-1989-044	MINERAL: Sand and gravel	COUNTY: Teller
INSPECTION TYPE: Monitoring	INSPECTOR(S): Elliott Russell	INSP. DATE: November 10, 2021	INSP. TIME: 12:15
OPERATOR: The Clare Corporation	OPERATOR REPRESENTATIVE: None	TYPE OF OPERATION: 110c - Construction Limited Impact	
REASON FOR INSPECTION: Normal I&E Program	BOND CALCULATION TYPE: Partial Bond	BOND AMOUNT: \$5,000.00	
DATE OF COMPLAINT: NA	POST INSP. CONTACTS: None	JOINT INSP. AGENCY: None	
WEATHER: Clear	INSPECTOR'S SIGNATURE:

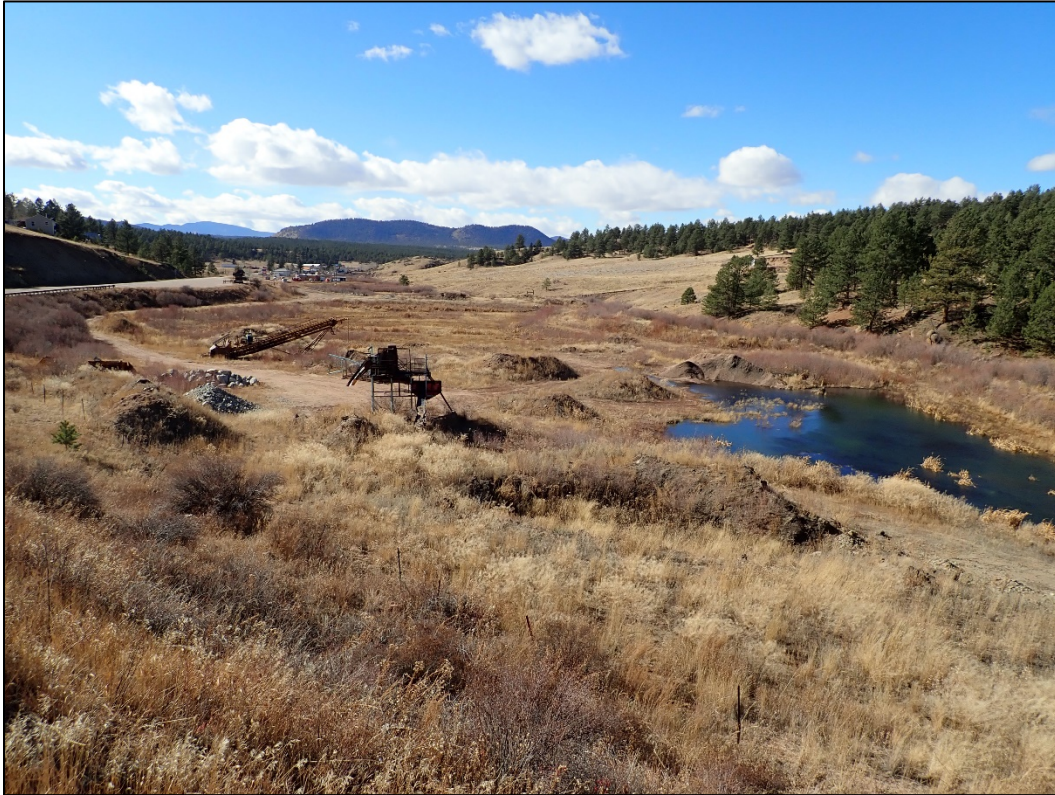
Photo 1. Site overview from Highway 24; looking west.

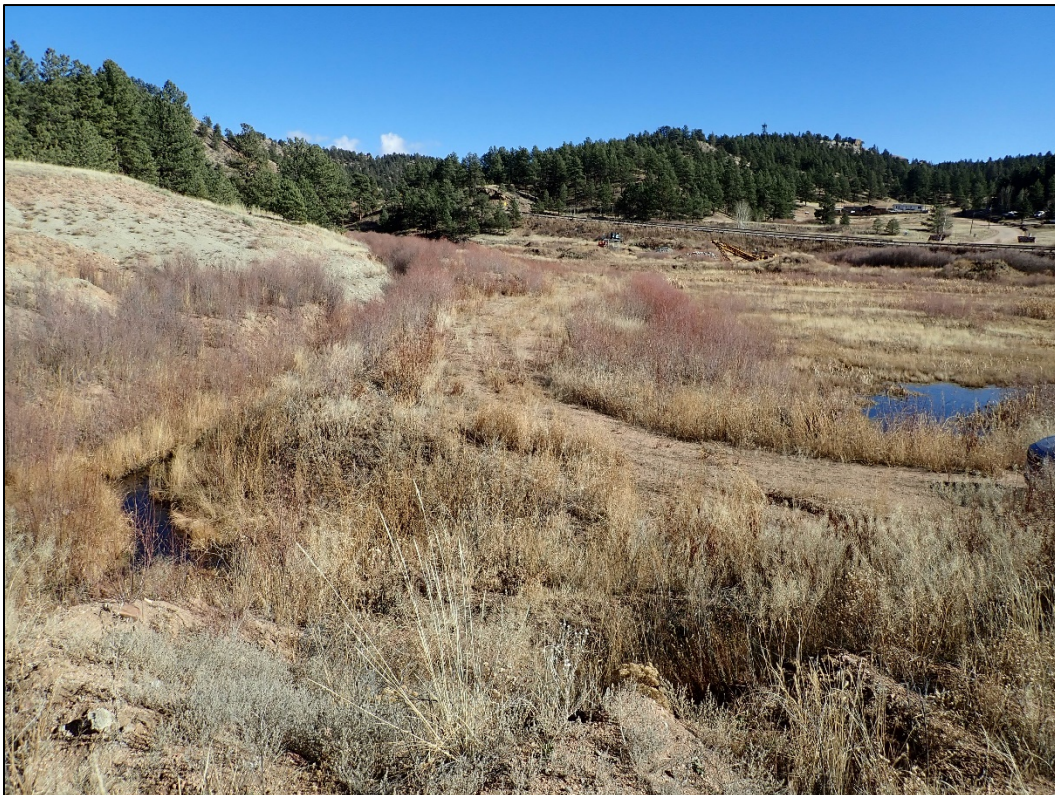
Photo 2. Northwest corner of permit, twin creek is on the left side of image; looking east.

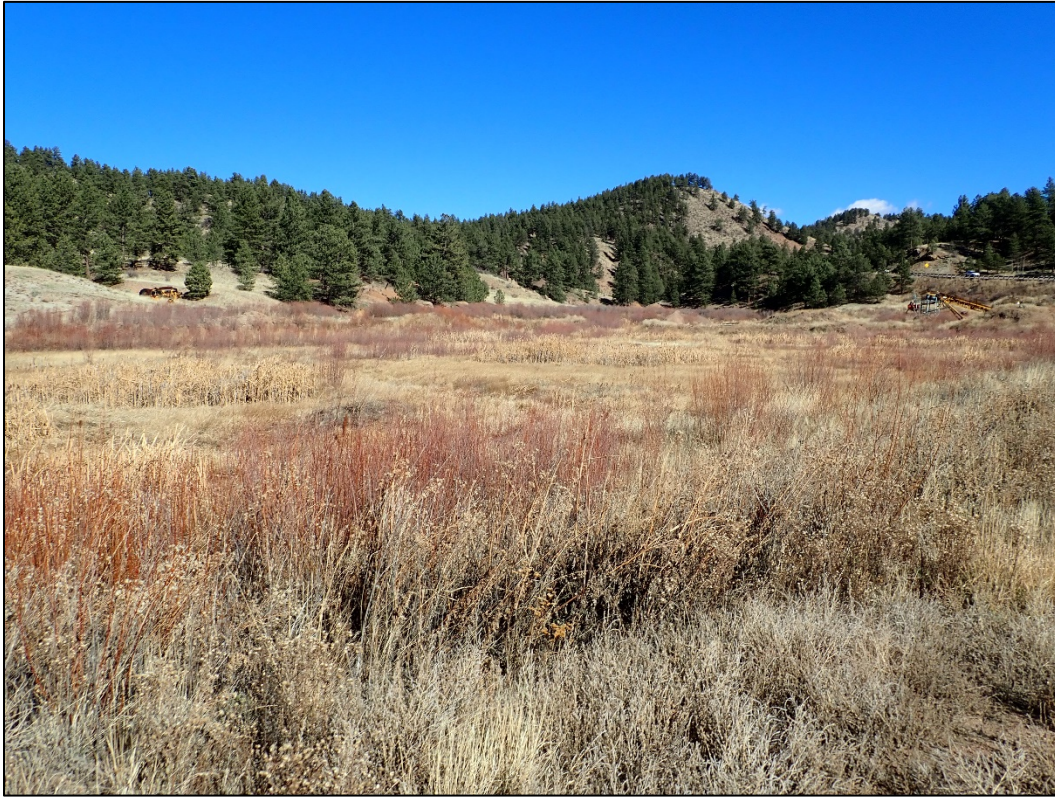
Photo 3. Central are of the permit where the meandering channel has been established; looking northeast.
