MINERALS PROGRAM INSPECTION REPORT
PHONE: (303) 866-3567

MINE NAME: McCormick Pit 1	MINE/PROSPECTING ID#: M-2020-017	MINERAL: Sand and gravel	COUNTY: Kit Carson
INSPECTION TYPE: Monitoring	INSPECTOR(S): Elliott Russell	INSP. DATE: November 9, 2021	INSP. TIME: 15:00
OPERATOR: McCormick Excavation & Paving, LLC	OPERATOR REPRESENTATIVE: None	TYPE OF OPERATION: 110c - Construction Limited Impact	
REASON FOR INSPECTION: Normal I&E Program	BOND CALCULATION TYPE: Complete Bond	BOND AMOUNT: \$30,000.00	
DATE OF COMPLAINT: NA	POST INSP. CONTACTS: None	JOINT INSP. AGENCY: None	
WEATHER: Cloudy	INSPECTOR'S SIGNATURE:

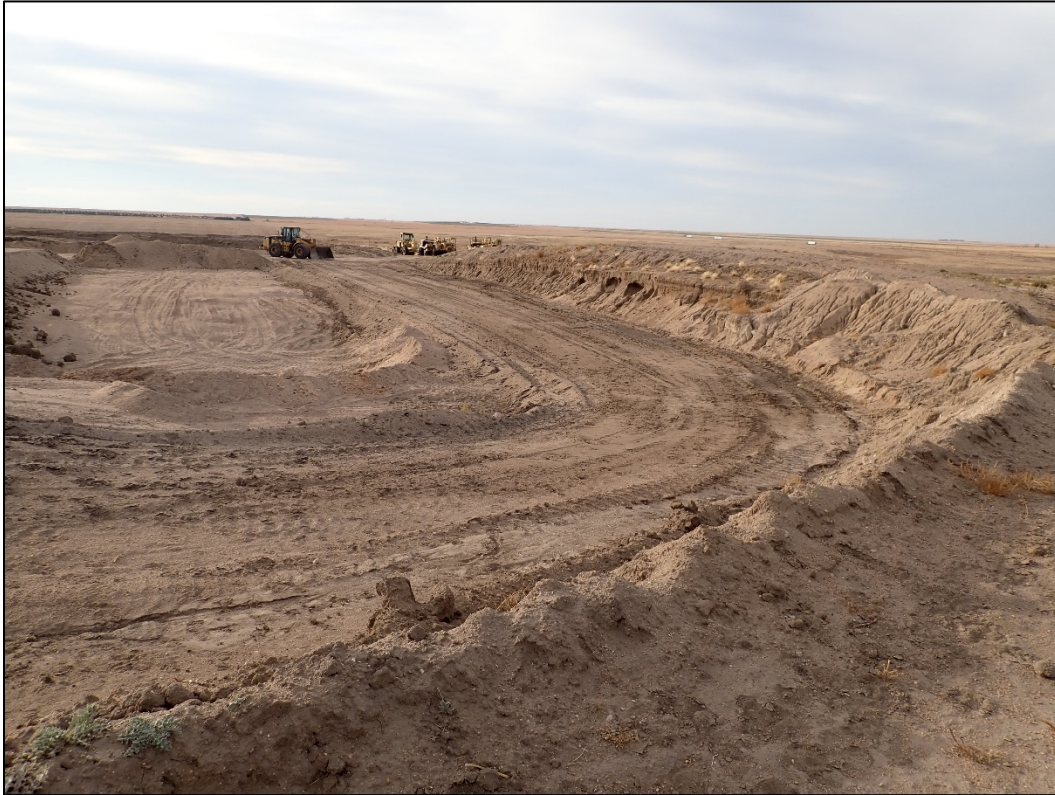
Photo 1. Pit overview; looking west.

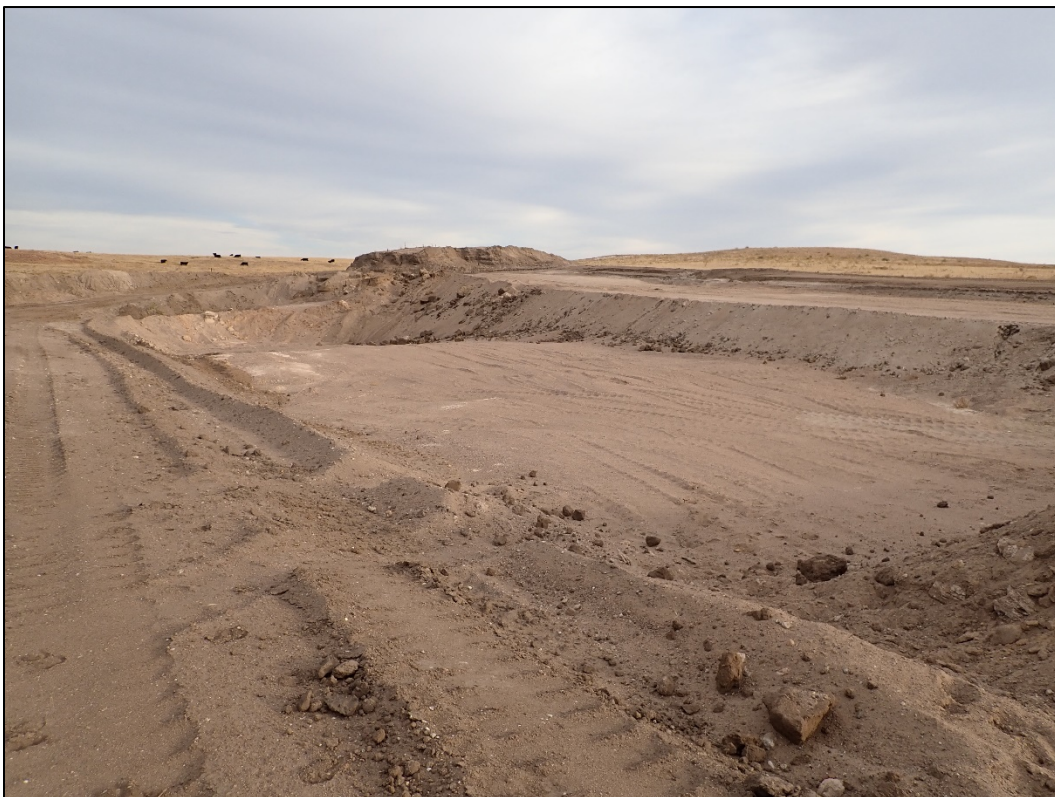
Photo 2. Pit overview; looking east.

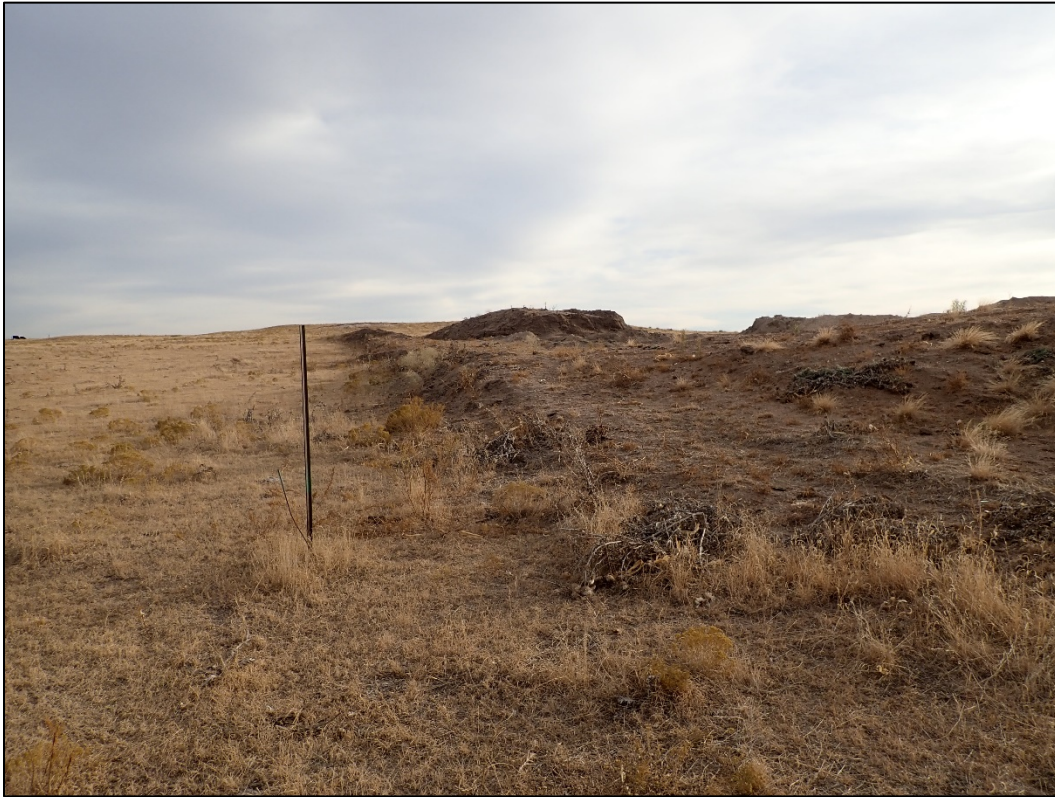
Photo 3. Northeast boundary marker, topsoil stockpiled along permit boundary; looking southeast.

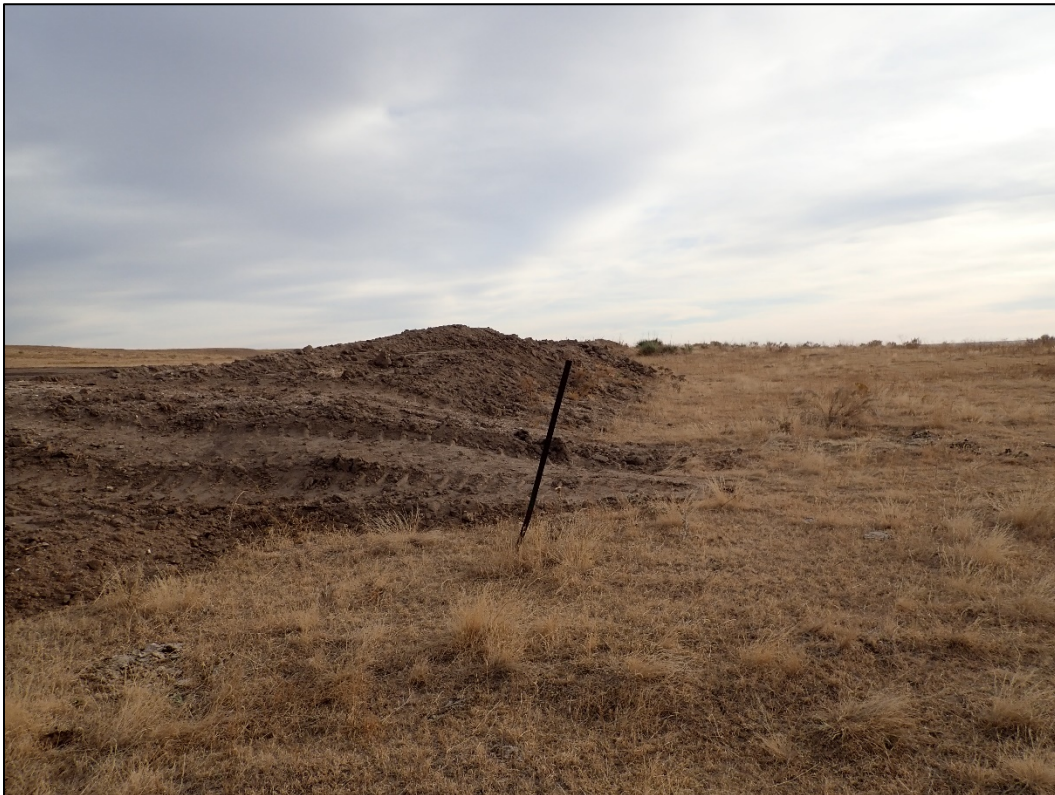
Photo 4. Northwest boundary marker, topsoil stockpiled along permit boundary; looking south.

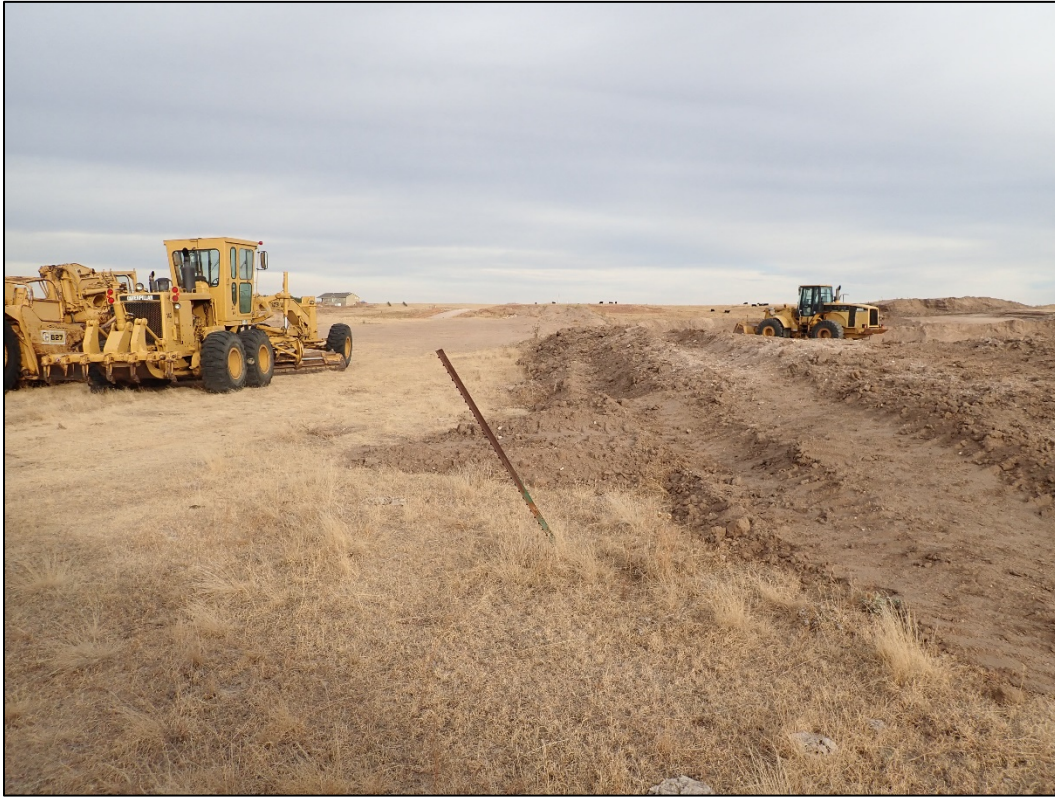
Photo 5. Northwest boundary marker, topsoil stockpiled along permit boundary; looking east.
