**MINERALS PROGRAM INSPECTION REPORT**  
**PHONE: (303) 866-3567**

<b>MINE NAME:</b> Eberhart Pit	<b>MINE/PROSPECTING ID#:</b> M-1982-054	<b>MINERAL:</b> Sand and gravel	<b>COUNTY:</b> Kit Carson
<b>INSPECTION TYPE:</b> Monitoring	<b>INSPECTOR(S):</b> Elliott Russell	<b>INSP. DATE:</b> November 9, 2021	<b>INSP. TIME:</b> 13:30
<b>OPERATOR:</b> Kit Carson County	<b>OPERATOR REPRESENTATIVE:</b> Dave Hornung	<b>TYPE OF OPERATION:</b> 112c - Construction Regular Operation	
<b>REASON FOR INSPECTION:</b> Normal I&E Program	<b>BOND CALCULATION TYPE:</b> None	<b>BOND AMOUNT:</b> N/A	
<b>DATE OF COMPLAINT:</b> NA	<b>POST INSP. CONTACTS:</b> None	<b>JOINT INSP. AGENCY:</b> None	
<b>WEATHER:</b> Clear	<b>INSPECTOR'S SIGNATURE:</b>

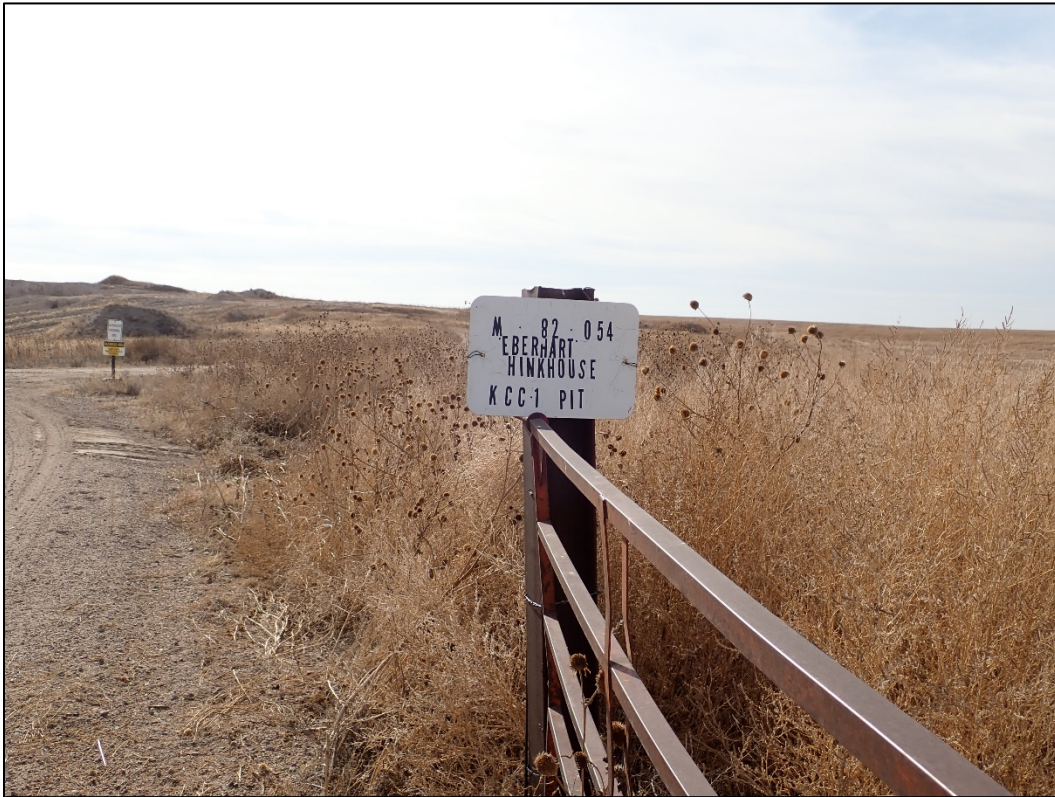
Signs and Markers: The permit sign was posted at the site entrance. The permit boundary was delineated by metal t-posts and fence lines. The Division recommends the Operator clearly delineate the permit boundary located between the access road and the northwest topsoil stockpile to ensure mining activity is confined to the approved permitted area.

**Photo 1.** Permit identification sign; looking southwest.

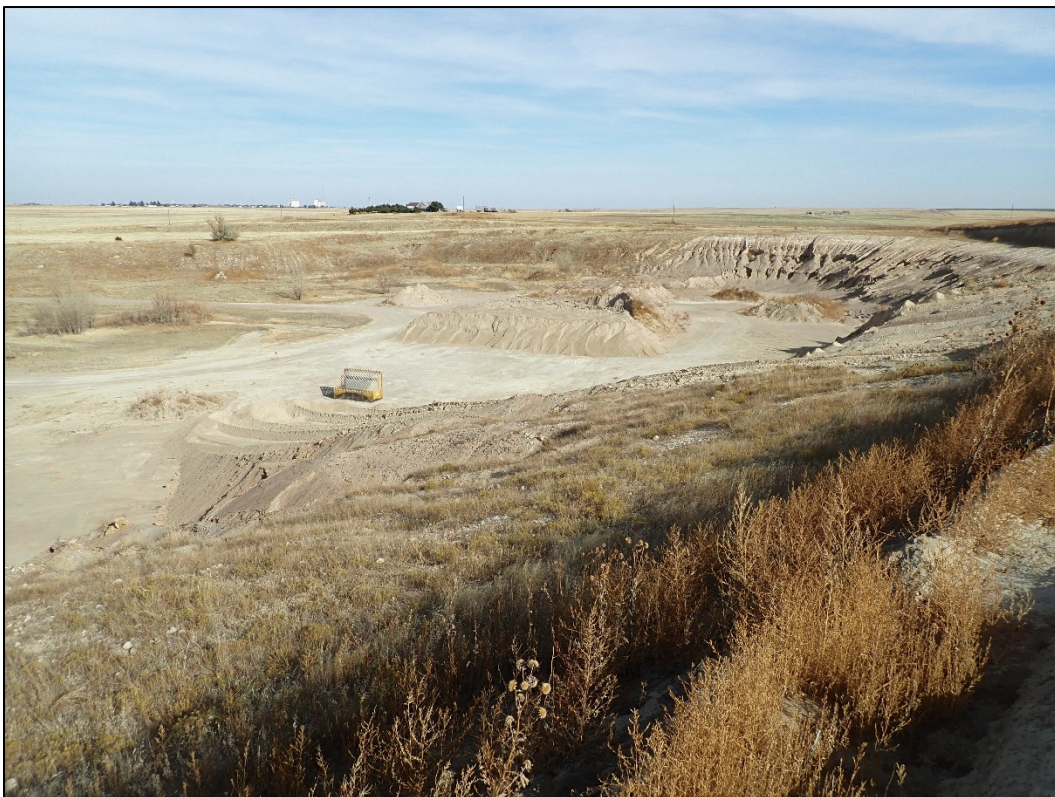
**Photo 2.** Pit overview; looking east.

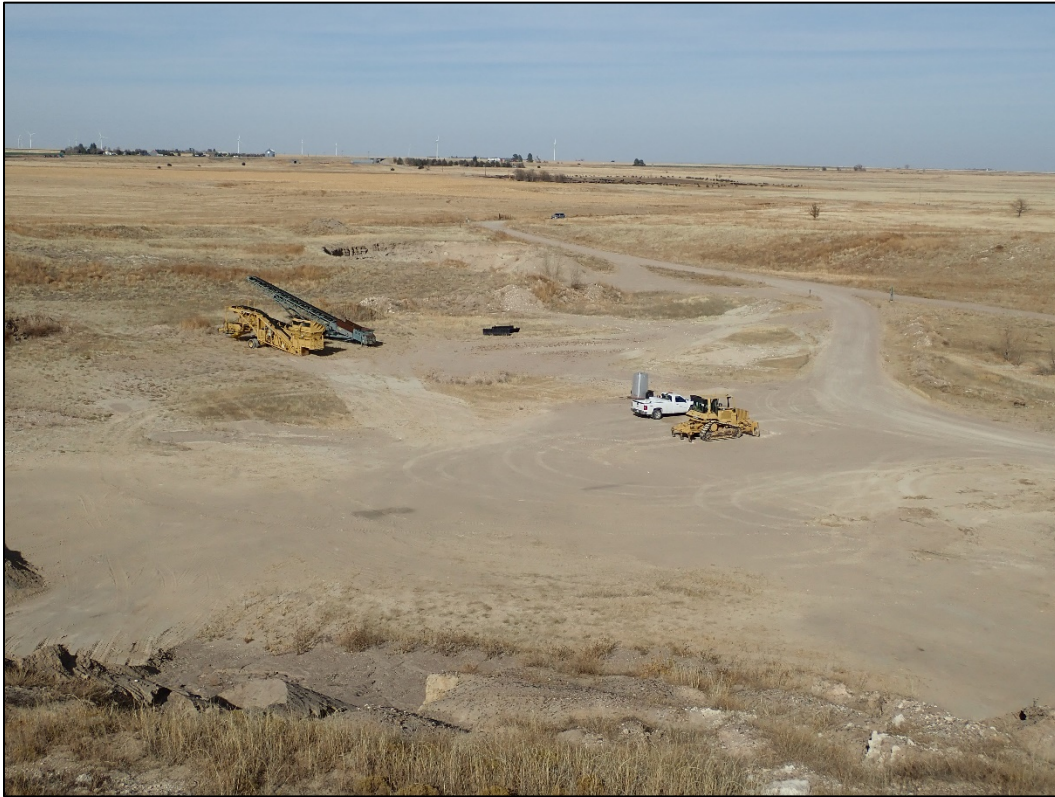
**Photo 3.** Pit overview; looking northeast.

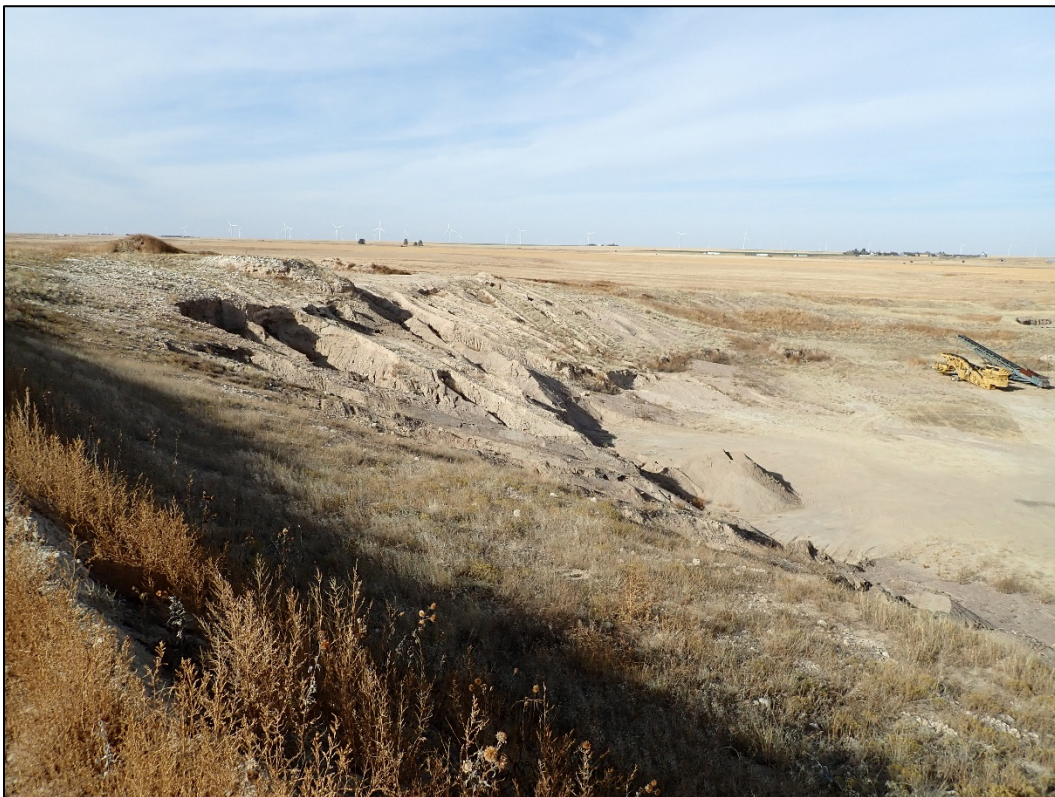
**Photo 4.** Pit overview; looking north.

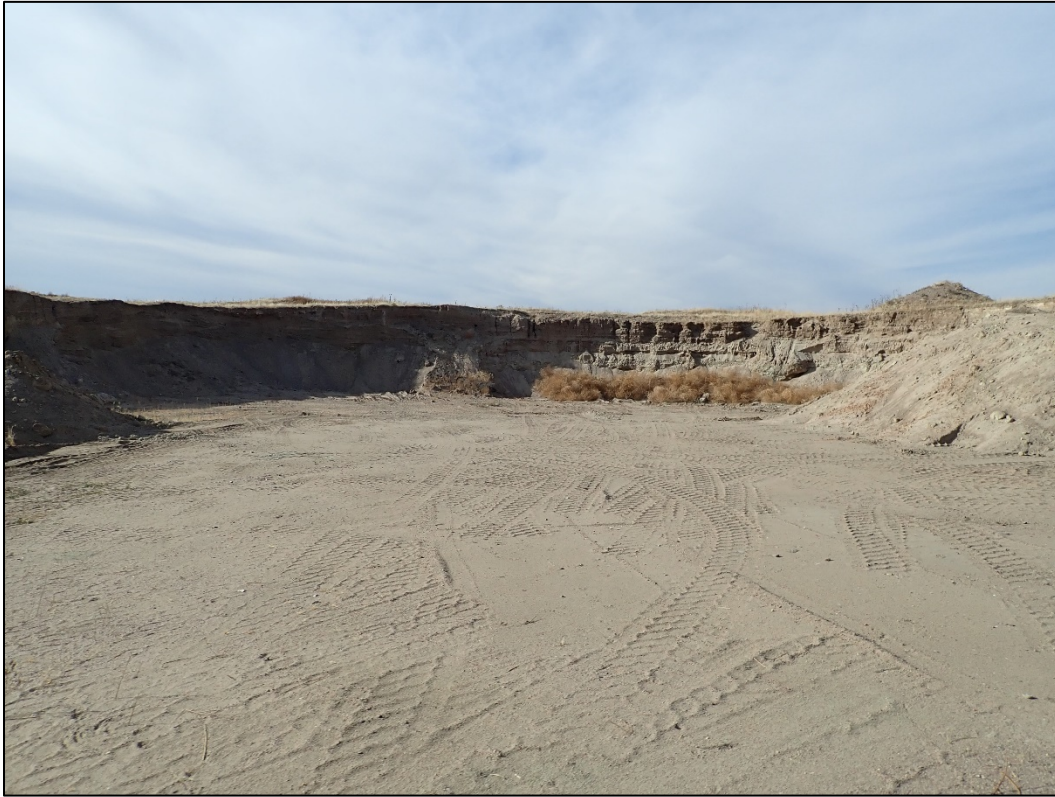
**Photo 5.** Secondary excavation area; looking northwest.

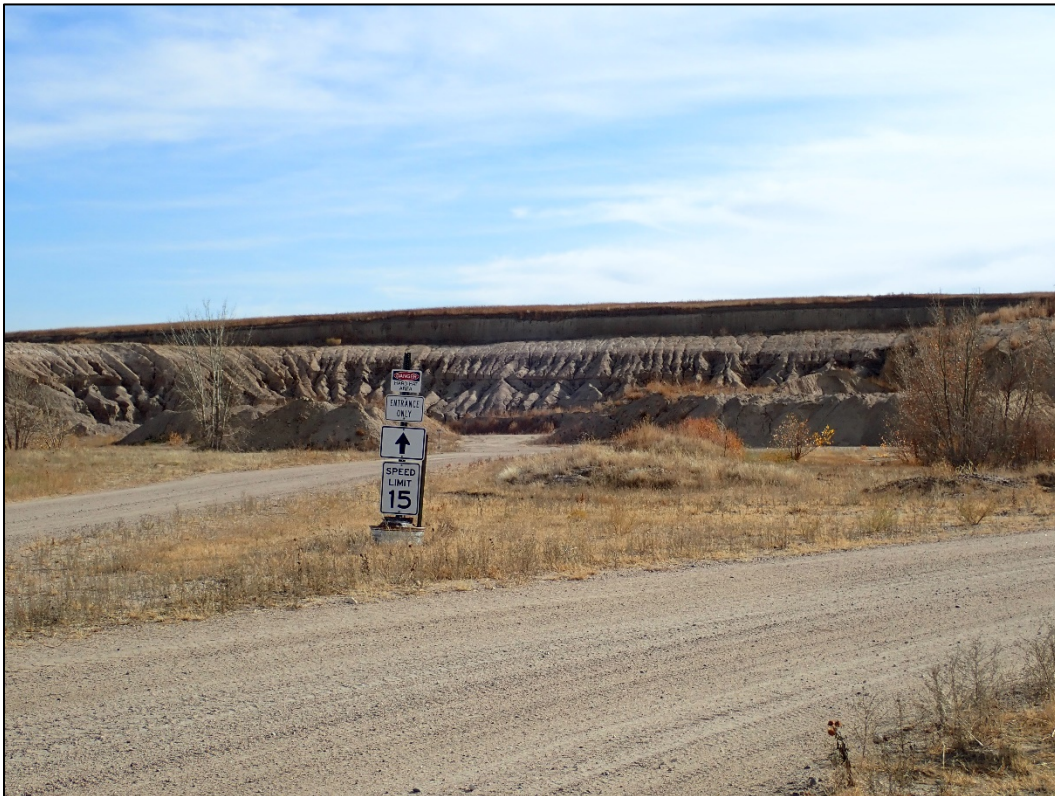
Topsoil: Topsoil was salvaged and stockpiled along the southern permit boundary and in the northwest corner of the pit. The mining excavation has approached the southern topsoil stockpile and a small highwall now exists along the toe of the northern edge of this stockpile. The Operator will need to ensure this highwall is backfilled with overburden/waste material from below as now the traditional and most-efficient cut/fill method will consume the stockpiled topsoil.

**Photo 6.** North facing mining slope and topsoil stockpile along the southern boundary; looking south.

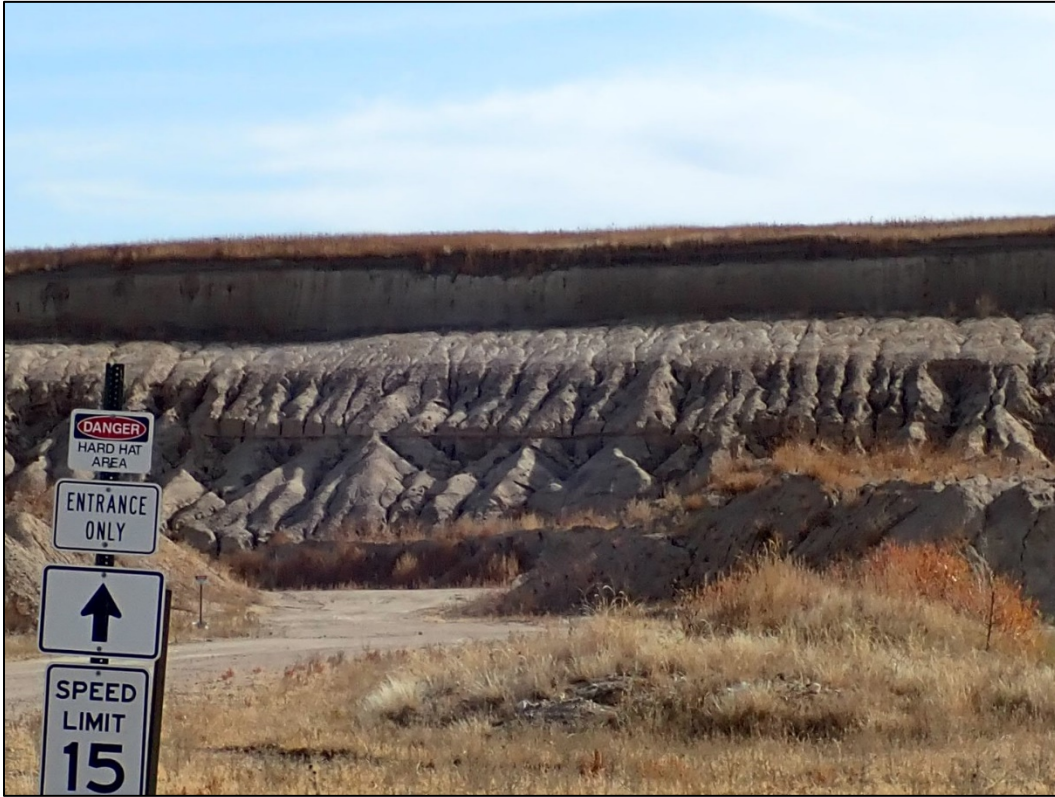
**Photo 7.** Zoomed in area of Photo 6 to highlight the topsoil stockpile and mining slope concern; looking south.
