MINERALS PROGRAM INSPECTION REPORT
PHONE: (303) 866-3567

| MINE NAME: Beeson Pit | MINE/PROSPECTING ID#: M-1982-186 | MINERAL: Sand and gravel | COUNTY: Kit Carson |
| INSPECTION TYPE: Monitoring | INSPECTOR(S): Elliott Russell | INSP. DATE: November 9, 2021 | INSP. TIME: 11:30 |

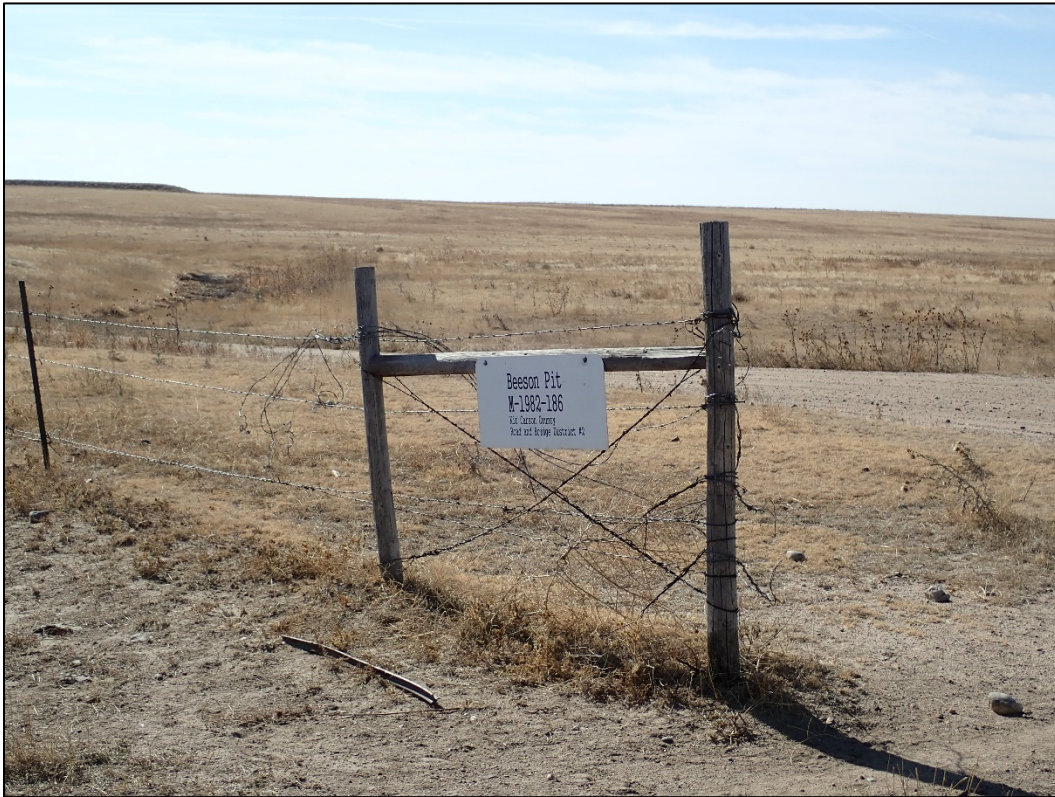
Signs and Markers: The permit sign was posted at the site entrance. The permit boundary was delineated by metal t-posts. The Division recommends the Operator clearly delineate the permit boundary located between the access road and the northwest topsoil stockpile to ensure mining activity is confined to the approved permitted area.

Photo 1. Permit identification sign; looking southwest.

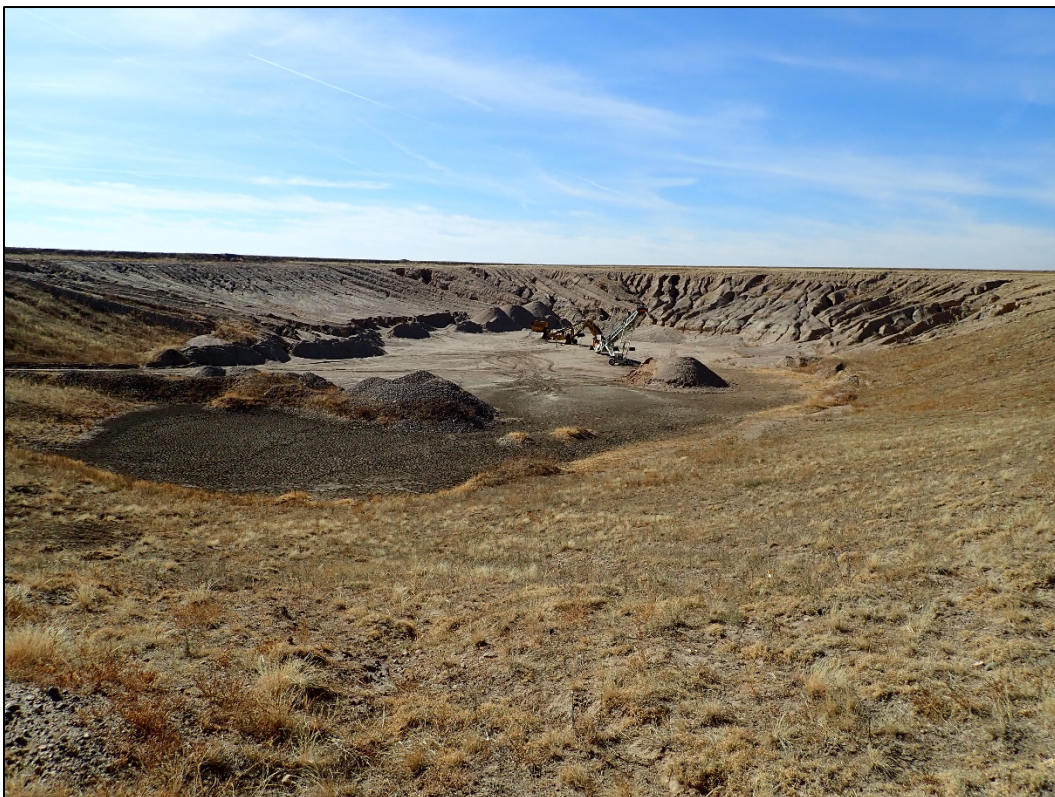
Photo 2. Pit overview; looking southwest.

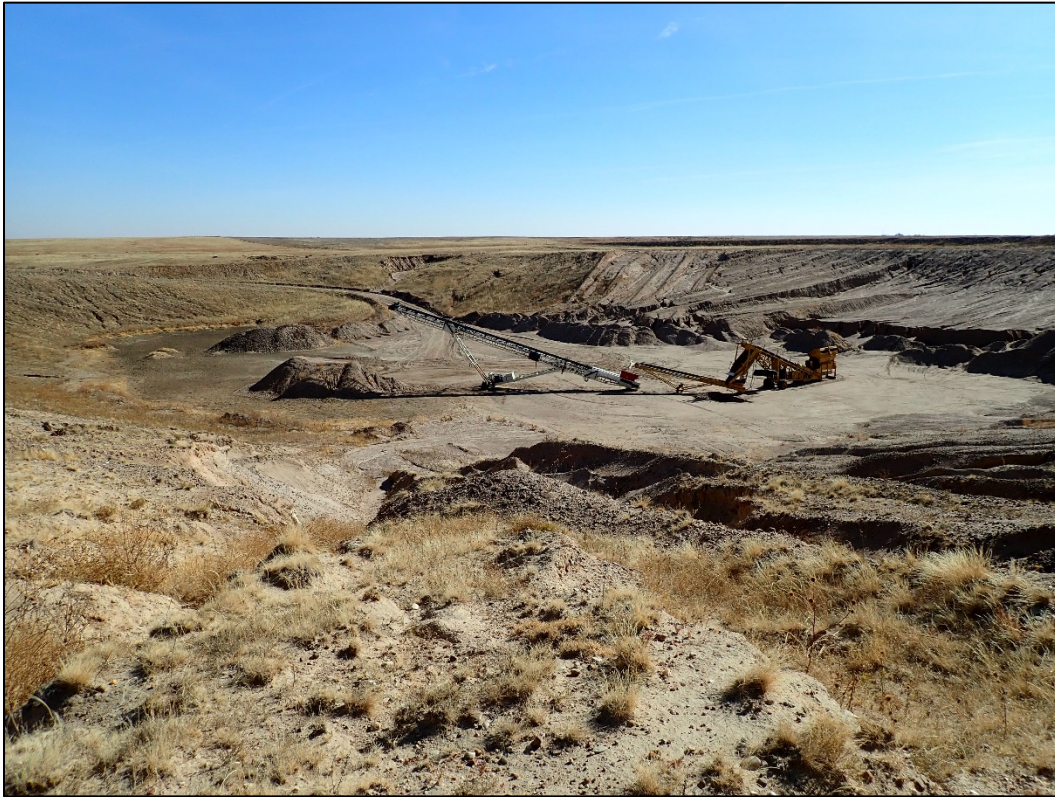
Photo 3. Pit overview; looking southeast.

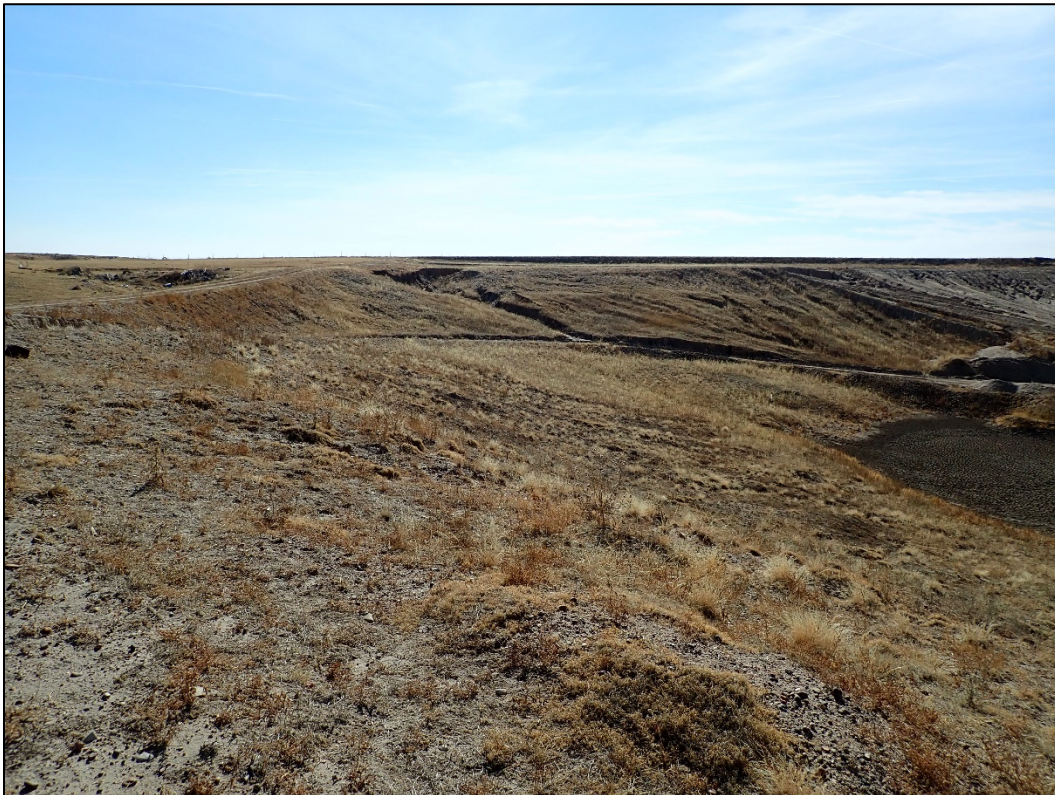
Photo 4. Erosional feature of concern located in southeast corner of the pit; looking south.

Sediment Control: No erosion problems were observed and no BMPs are needed at this time. However, the Division still recommends the Operator monitor an erosional feature located in the southeast corner of the pit as it has the potential to migrate further southeast and impact off-site lands.

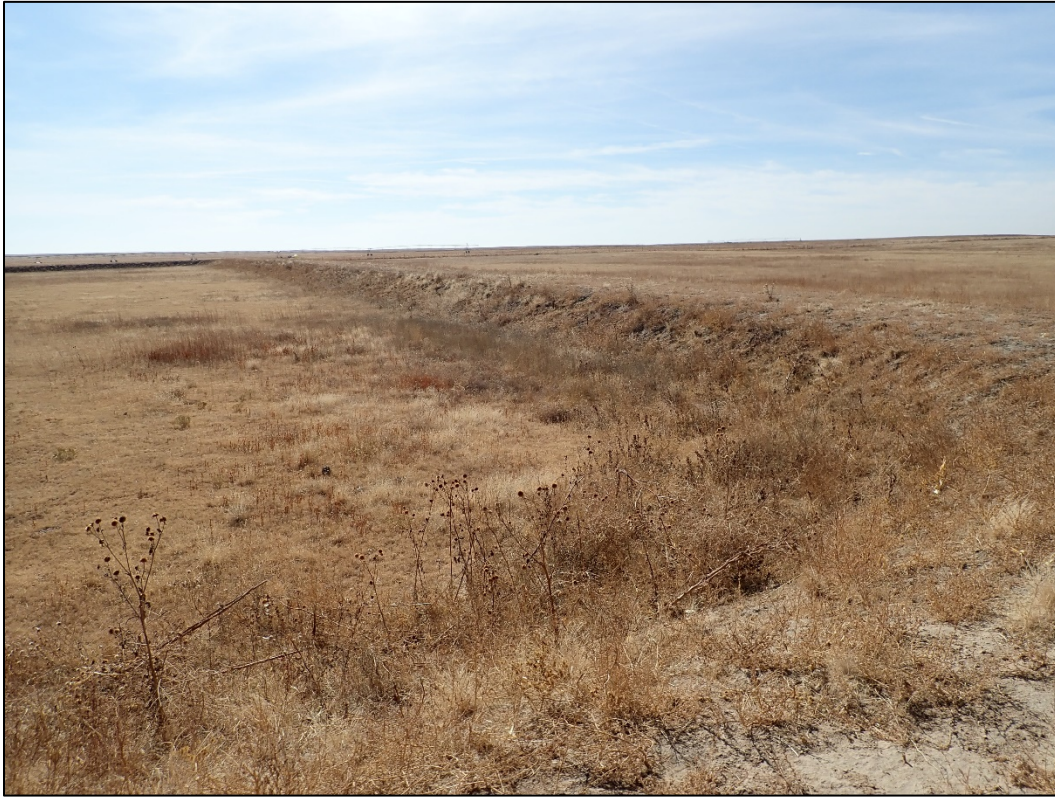
Topsoil: Topsoil was salvaged and stockpiled in a horseshoe shape along the northwest, west, and south permit boundary.

Photo 5. Topsoil stockpile along the western boundary; looking southwest.
