MINERALS PROGRAM INSPECTION REPORT
PHONE: (303) 866-3567

MINE NAME: Pickard Pit	MINE/PROSPECTING ID#: M-2012-048	MINERAL: Gravel	COUNTY: Kit Carson
INSPECTION TYPE: Monitoring	INSPECTOR(S): Elliott Russell	INSP. DATE: November 9, 2021	INSP. TIME: 10:45
OPERATOR: Kit Carson County	OPERATOR REPRESENTATIVE: Dave Hornung	TYPE OF OPERATION: 110c - Construction Limited Impact	
REASON FOR INSPECTION: Normal I&E Program	BOND CALCULATION TYPE: None	BOND AMOUNT: N/A	
DATE OF COMPLAINT: NA	POST INSP. CONTACTS: None	JOINT INSP. AGENCY: None	
WEATHER: Clear	INSPECTOR'S SIGNATURE:

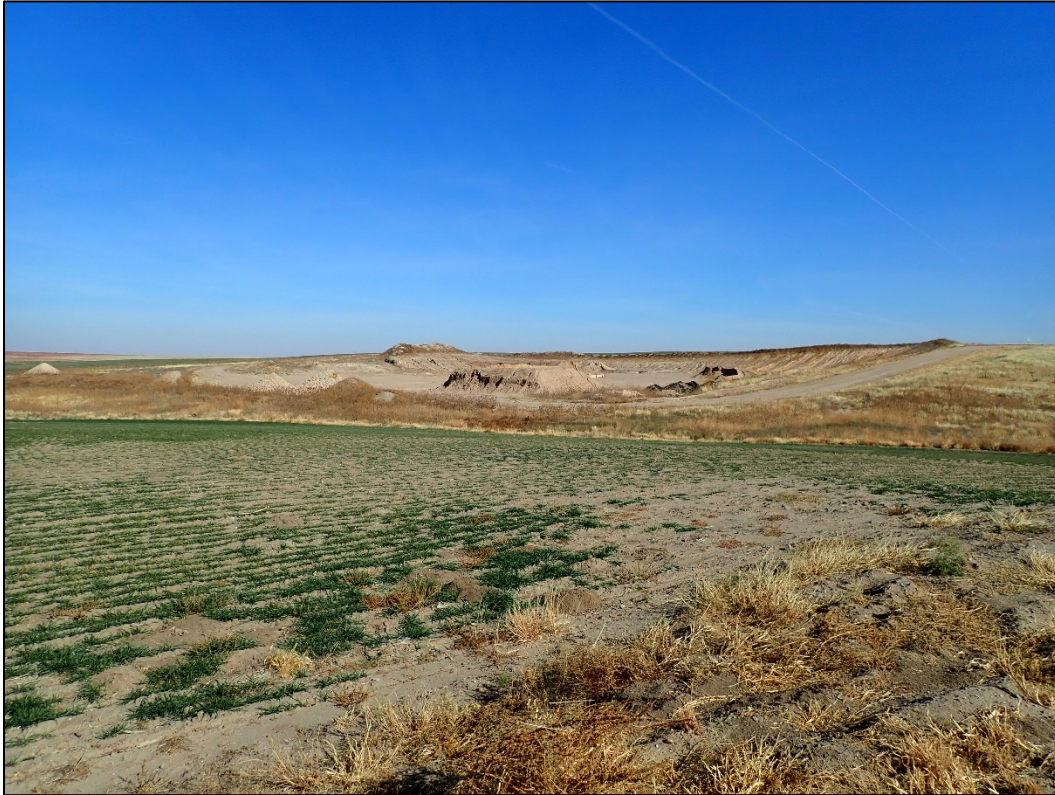
Photo 1. Site overview from County Road W; looking northeast.

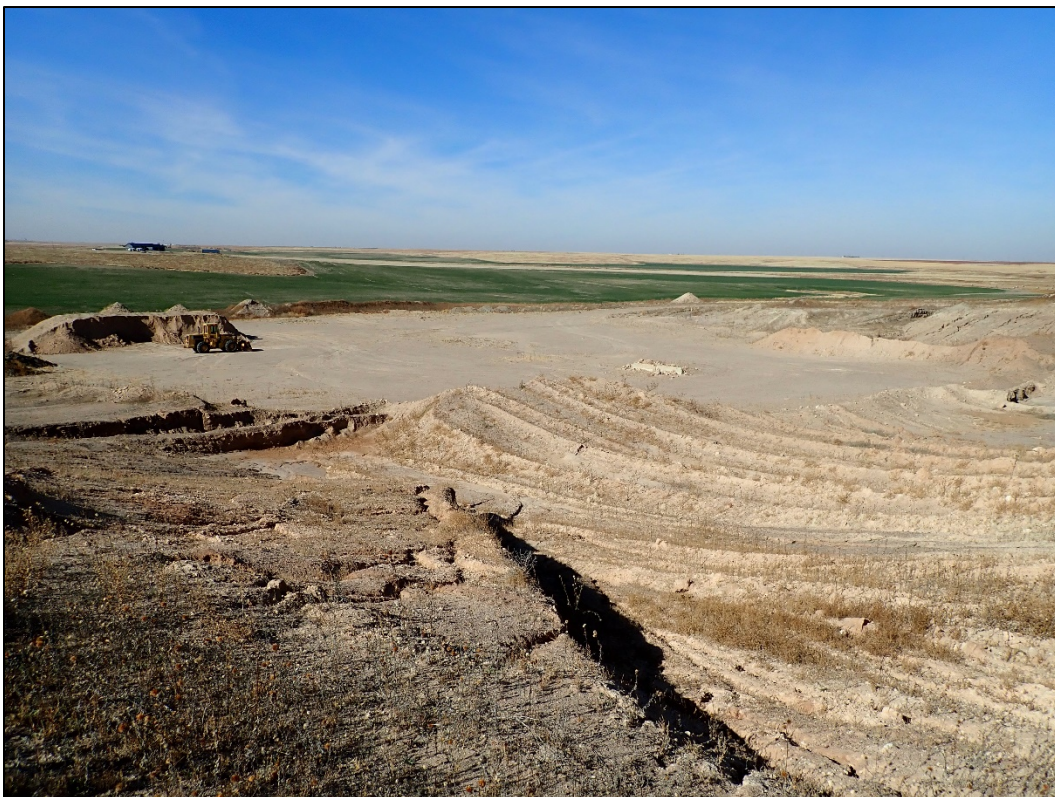
Photo 2. Site overview; looking northwest.

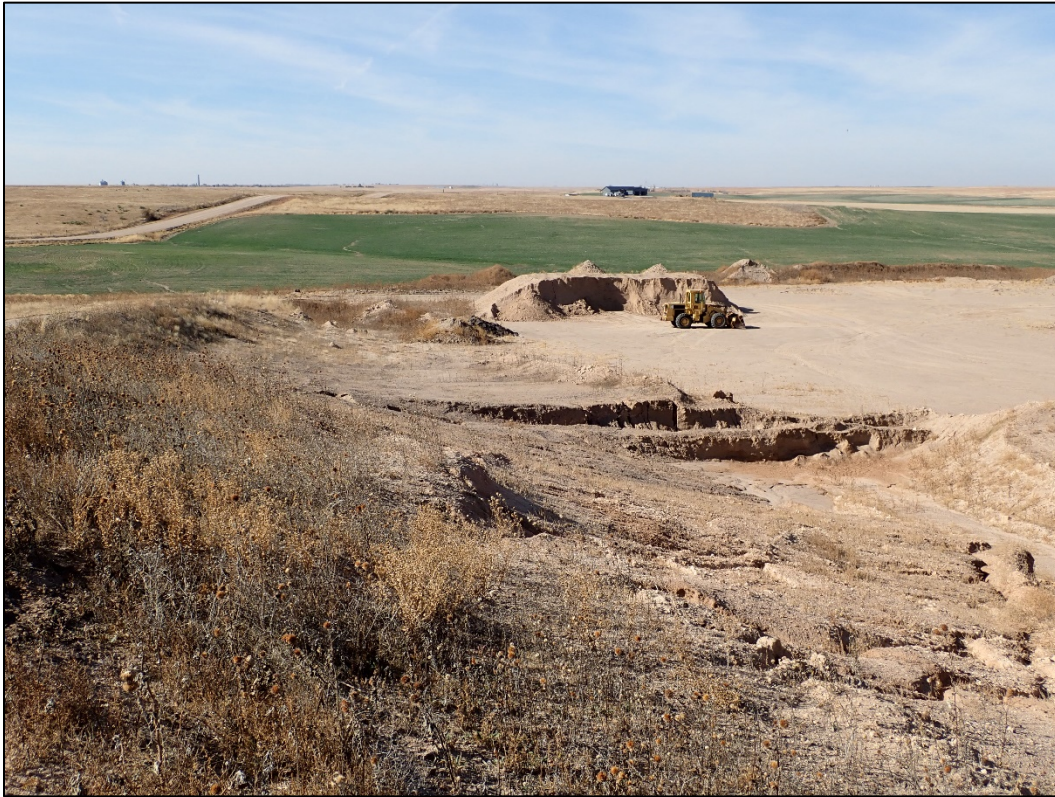
Photo 3. Southern portion of excavation; looking west.

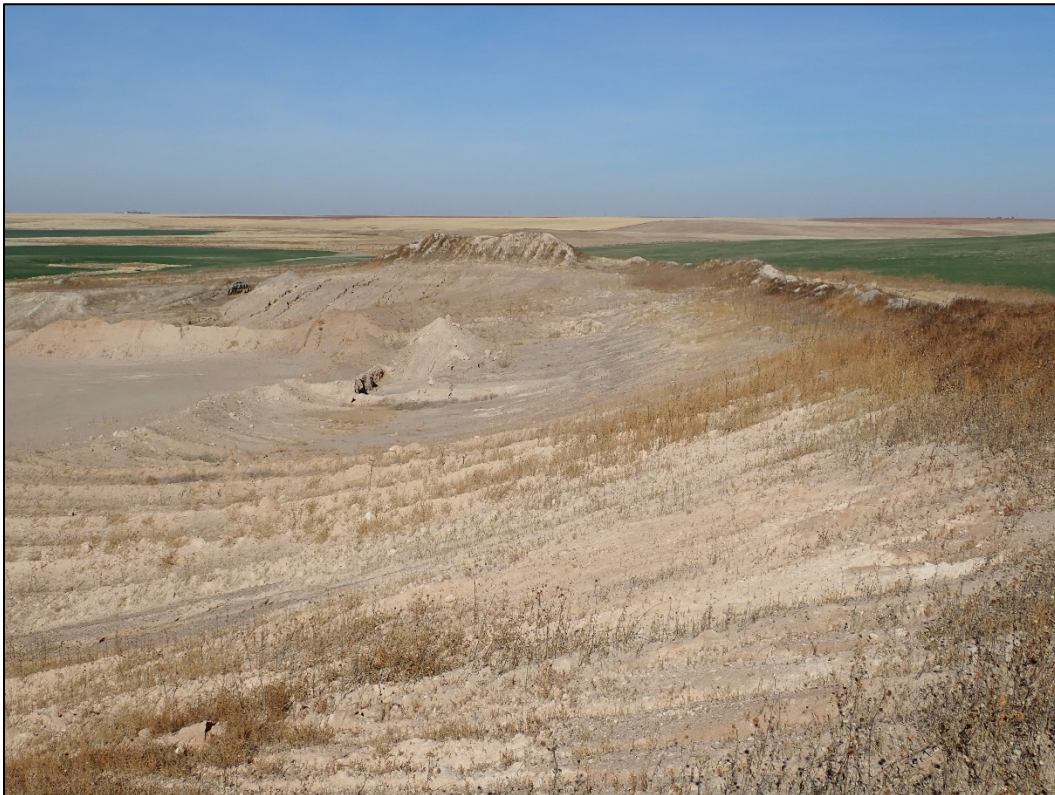
Photo 4. Eastern portion of excavation; looking north.

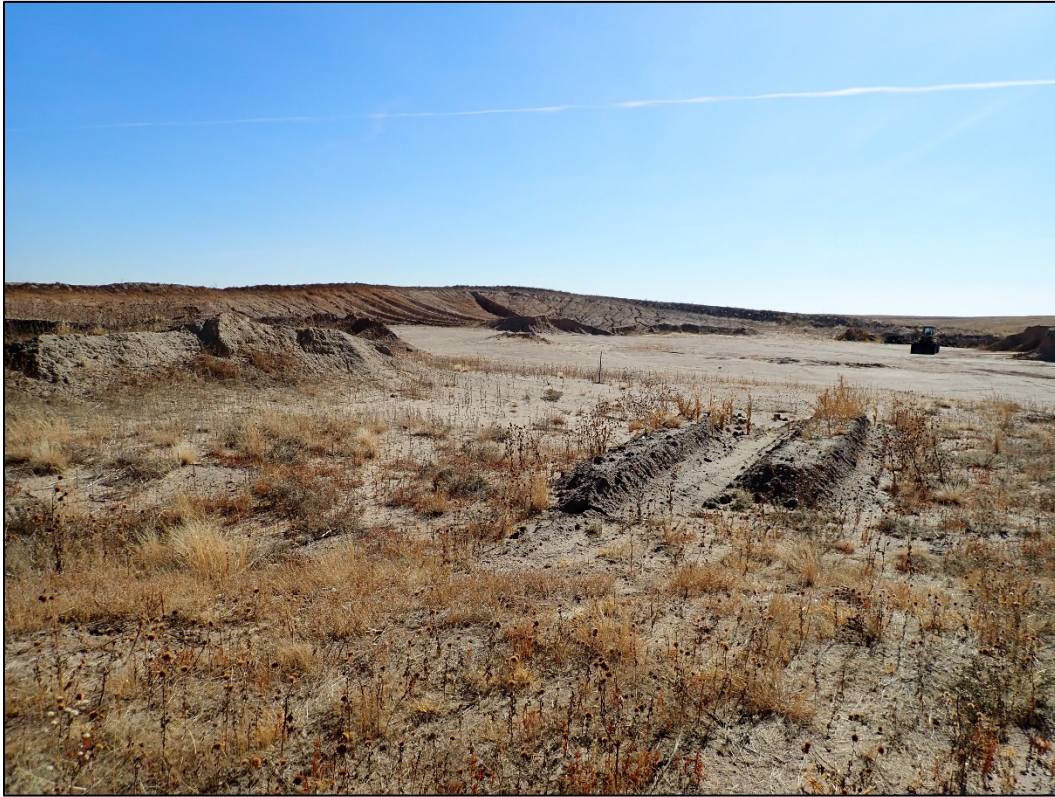
Photo 5. Site overview; looking southeast.
